RE: Orchard Mesa Aggr, Permit No. M-1995-005, Complaint Resolved

MINERALS PROGRAM INSPECTION REPORT
PHONE: (303) 866-3567

| MINE NAME: Orchard Mesa Aggr | MINE/PROSPECTING ID#: M-1995-005 | MINERAL: Gravel | COUNTY: Mesa |
| INSPECTION TYPE: Multi Person Inspection | WEATHER: Windy | INSP. DATE: April 18, 2023 | INSP. TIME: 10:00 |

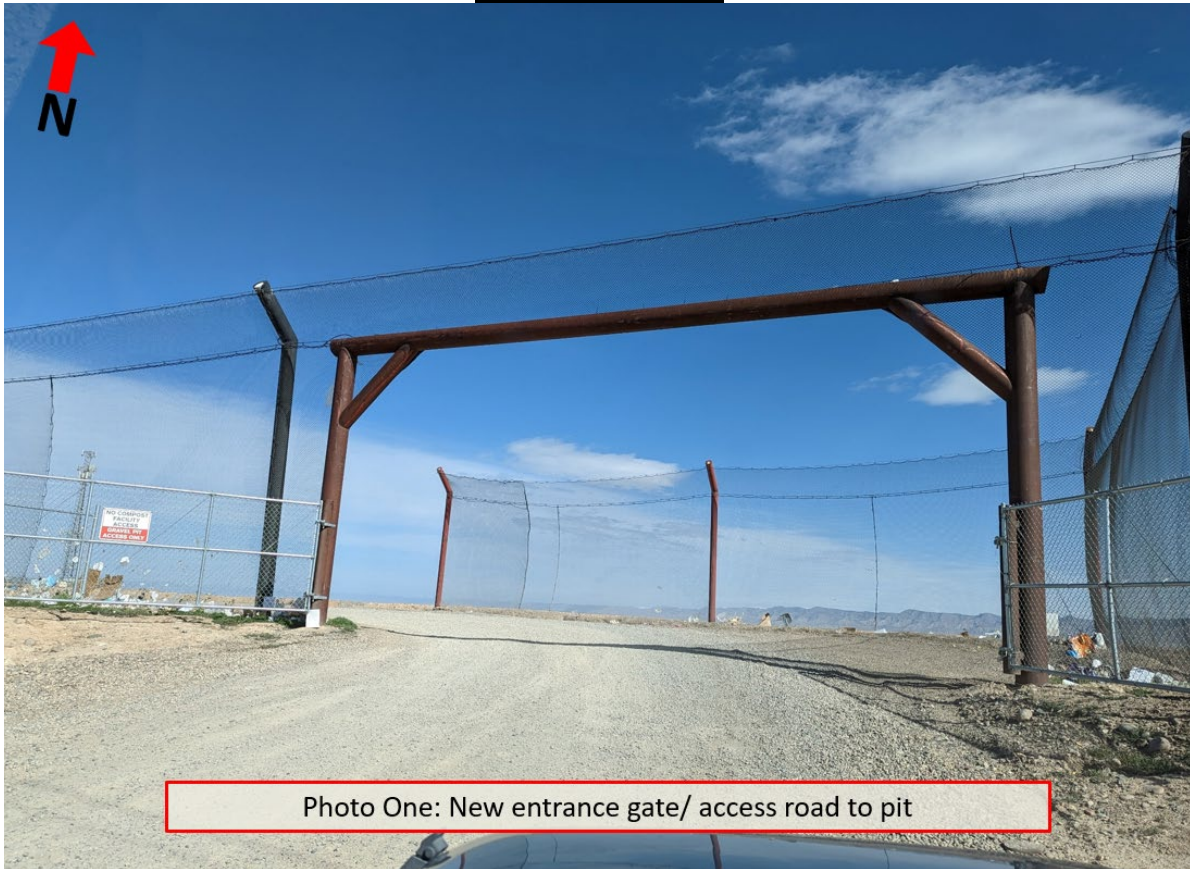
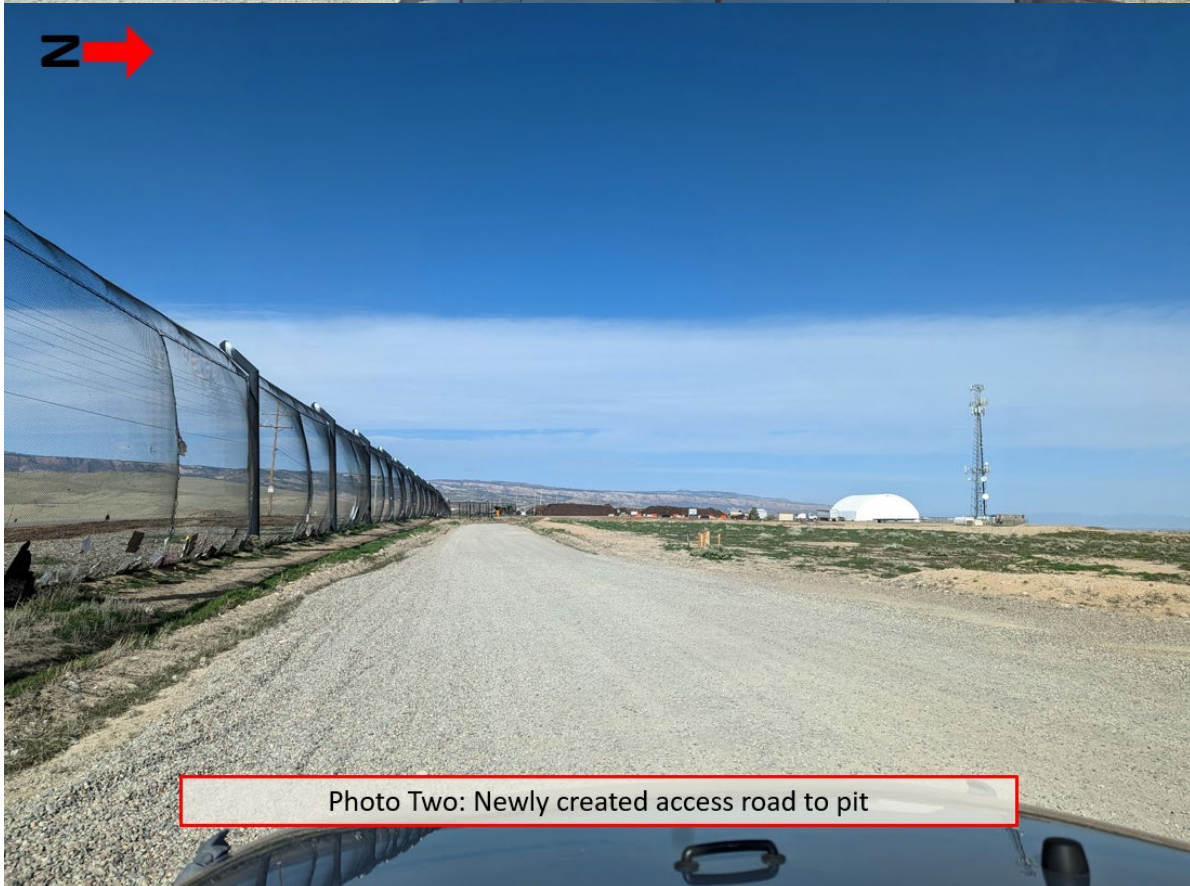
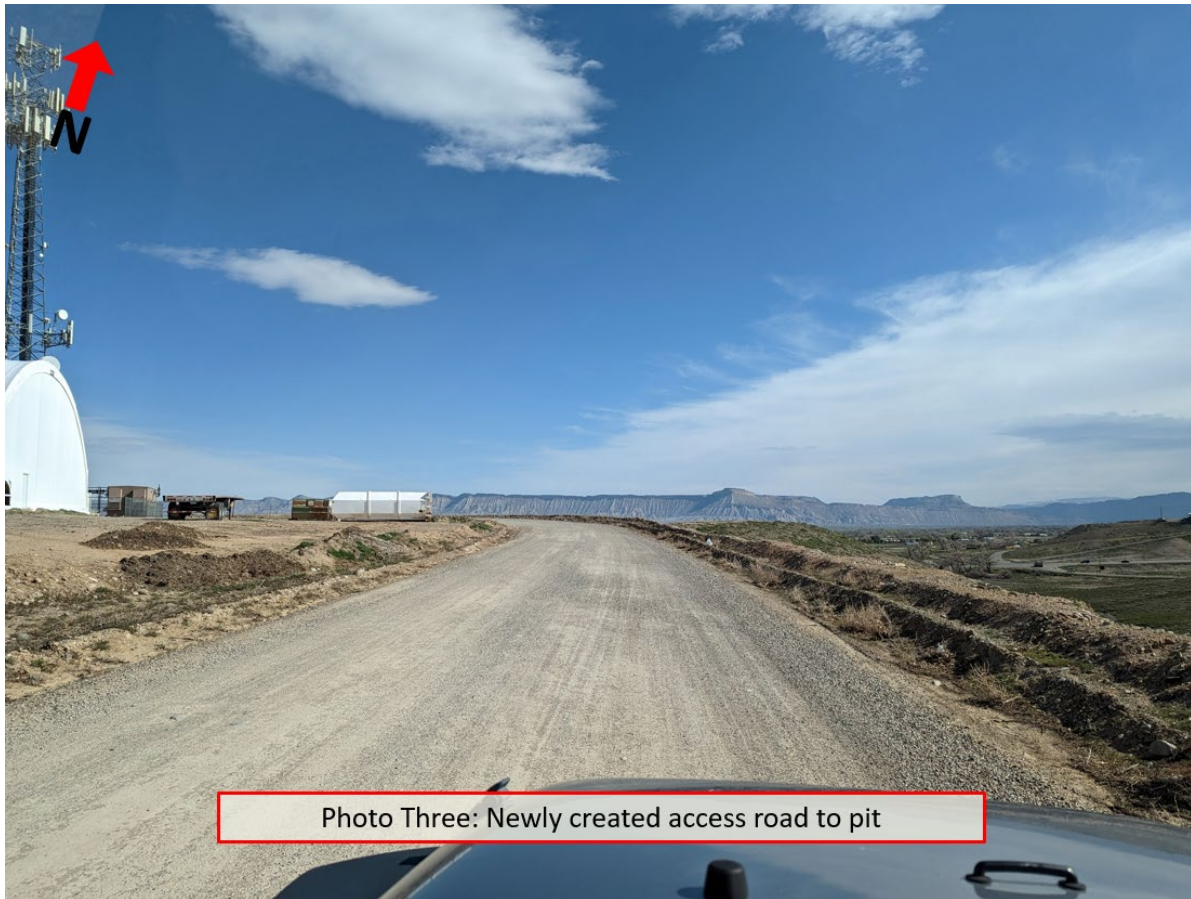
POSSIBLE VIOLATION: By creating a new off-site access road land has been affected outside of the approved permit boundary. This is a possible violation at this time pursuant to C.R.S. 34-32.5-116(4)(i) for failure to protect areas outside of the affected land from slides or damages occurring during the mining operation.

A new access road has been created to access the pit (Photos One to Three). Previously the mine was accessed through the compost facility. Since the last inspection the Operator has created a new mine access road to avoid traveling through the compost facility. It begins at the radio tower and parallels the trash fence along the north side of the compost facility to the facility entrance gate. The new road portion is 1750 LF averaging 30 ft wide for a total of 1.21 ac affected. This road is in support of a mining operation and should be considered affected lands however it is not within the permit boundary. Therefor the construction of a new mine access road is cited as a Possible Violation of C.R.S. 34-32.5-116(4)(i) for failure to protect areas outside of the affected land from slides or damages occurring during the mining operation. This possible violation will require a hearing before the Mined Land Reclamation Board. The schedule and other details for the MLRB hearing will be provided in a separate document, a Reason to Believe a Violation Exists letter which will be sent via certified mail. If at the hearing a violation is found the Operator will be required to submit an amendment application to incorporate all affected lands into the permit boundary and gain approval from the Division within all statutory deadlines. The Operator is encouraged to submit an application prior to the June 21-22, 2023 MLRB Meeting.

CORRECTIVE ACTIONS: This possible violation will require a hearing before the Mined Land Reclamation Board. The schedule and other details for the MLRB hearing will be provided under a separate document to be sent via certified mail to the operator.

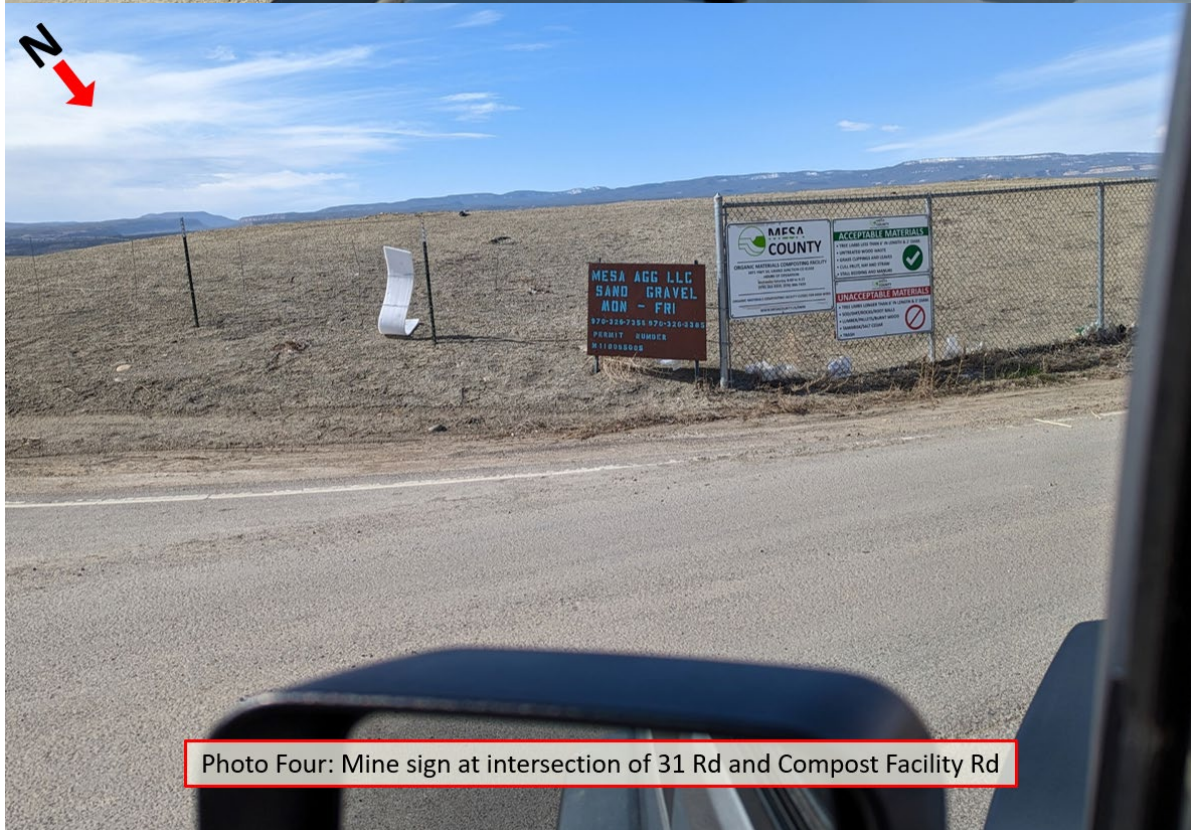
The mine identification sign in place and in compliance with Rule 3.1.12. A sign is attached to the main gate 31 Road at the turn off to the compost facility county landfill (Photo Four). A scale and scale house is located along the mine access road near the gate to the composting area of the county landfill (Photo Five).

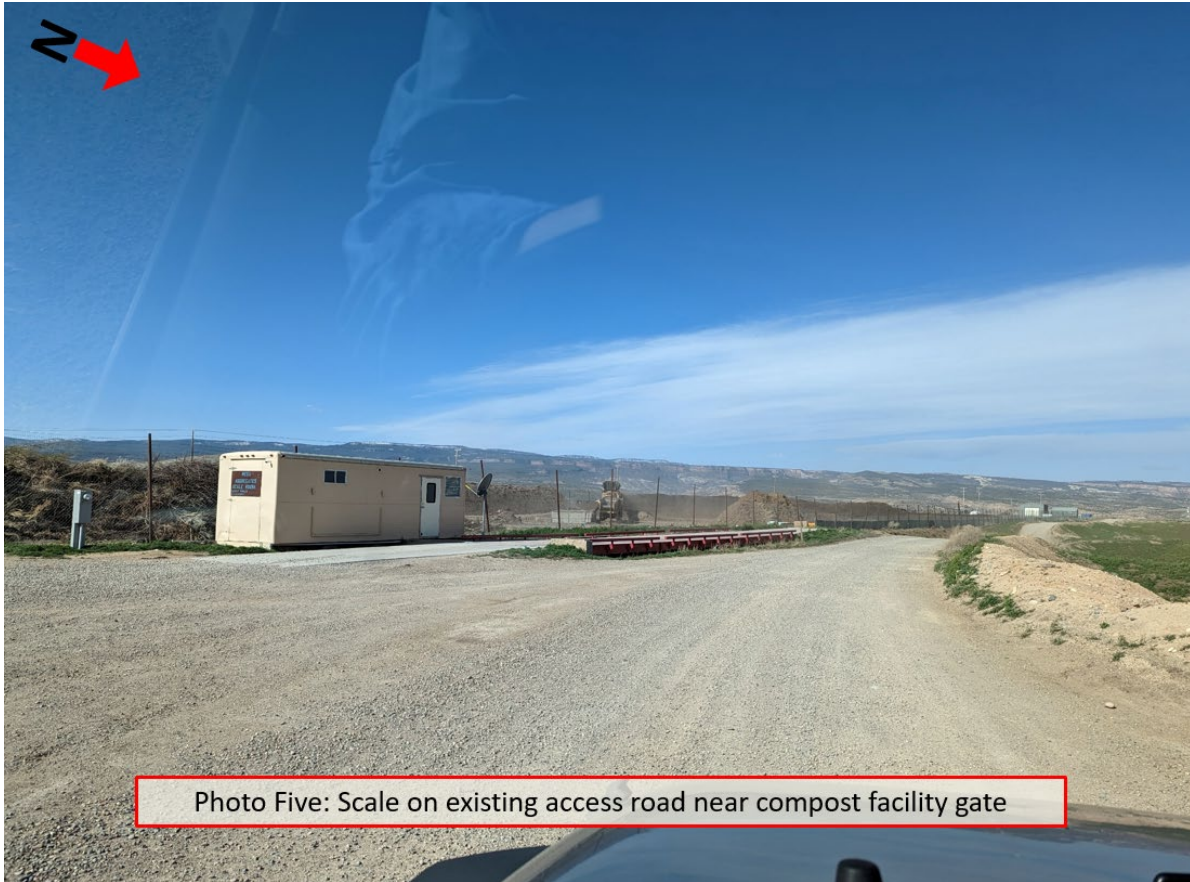
Photo Five: Scale on existing access road near compost facility gate

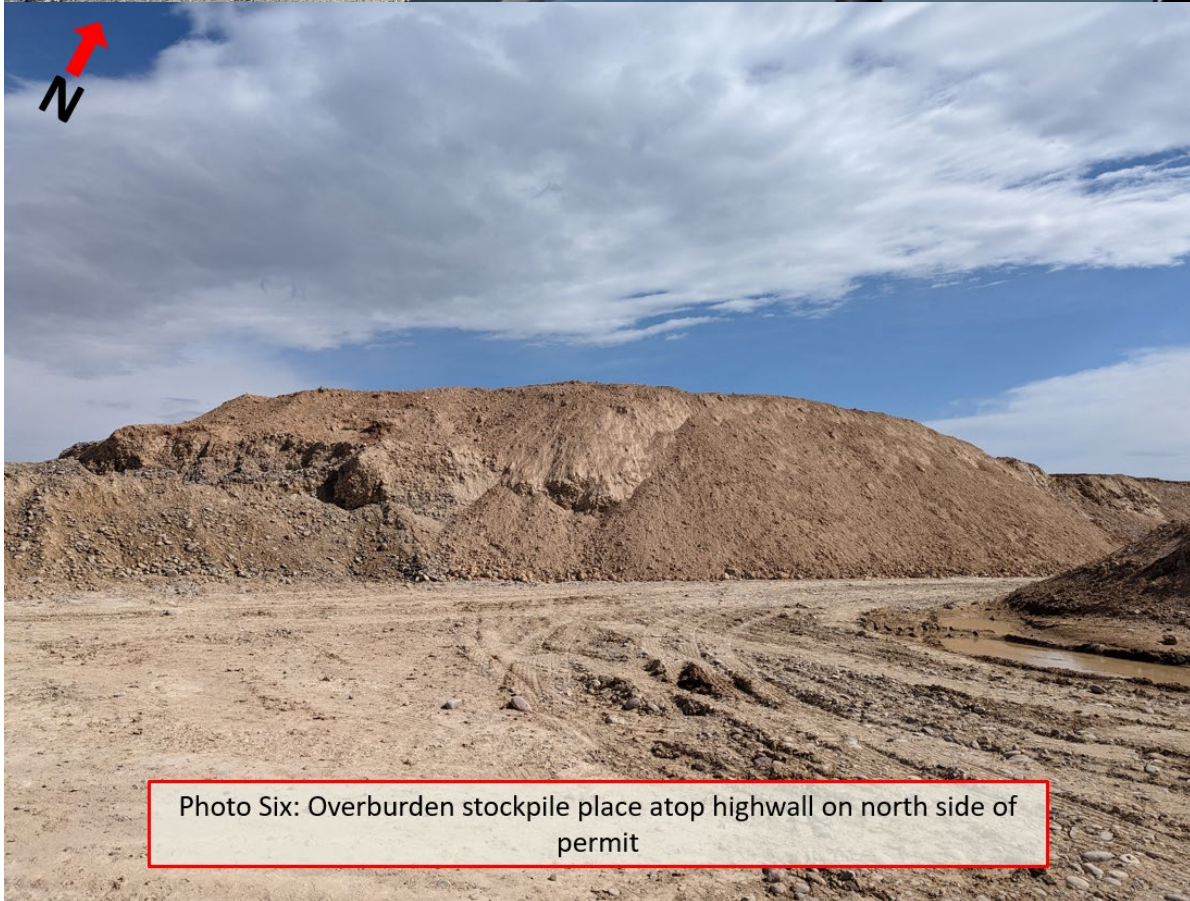
Once on site the Division discussed the details leading up to the citizen's complaint. Mr. Baker explained that he had an employee place overburden along the northern edge of the current mining area (Photo Six). The mine site is on a mesa to the south above a neighborhood and resulted in dust blowing straight off of the overburden pile and into the neighbor's property (Photo Seven). Best the management practice would have been to place material on the south side of the permit within the mined pit floor away from the edge of the mesa. This is where the majority of other stockpiles are stored. Mr. Baker has since educated his employees to prevent this from occurring in the future. Additionally the overburden pile was dozed and flattened out so that it is now approximately six feet shorter in an effort to decrease material blowing off the stockpile.

Photo Six: Overburden stockpile place atop highwall on north side of permit

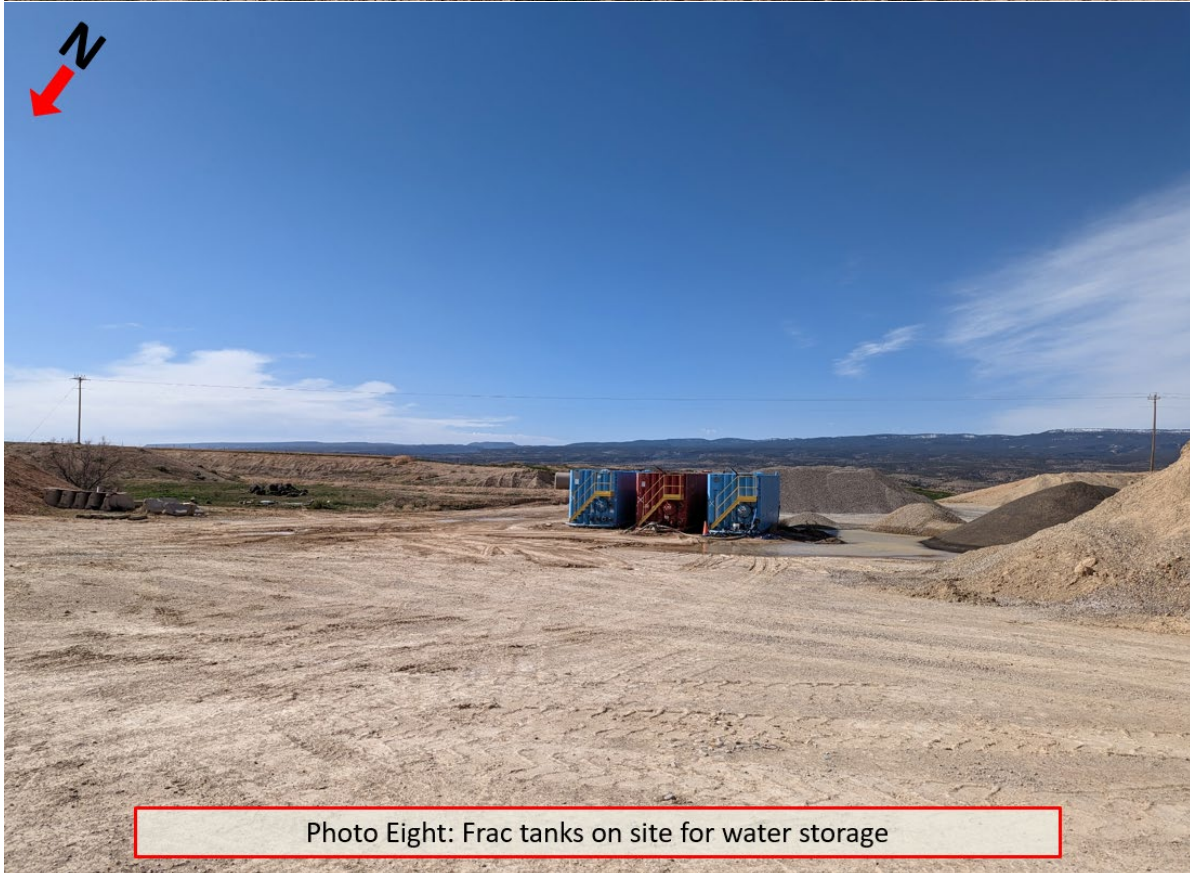
Currently this site uses a 2,000 gallon water truck with sprayer nozzle to moisten stockpiles and roads for dust suppression. Three frack tanks, and two large water tanks were observed on site for storing additional water

(Photo Eight). Recently the site has been accepted into the Ute Water District. The Operator is working with a consultant to engineer plans to pipe water to the site to be used for dust suppression. The utilization of Ute Water is anticipated for summer of 2023.

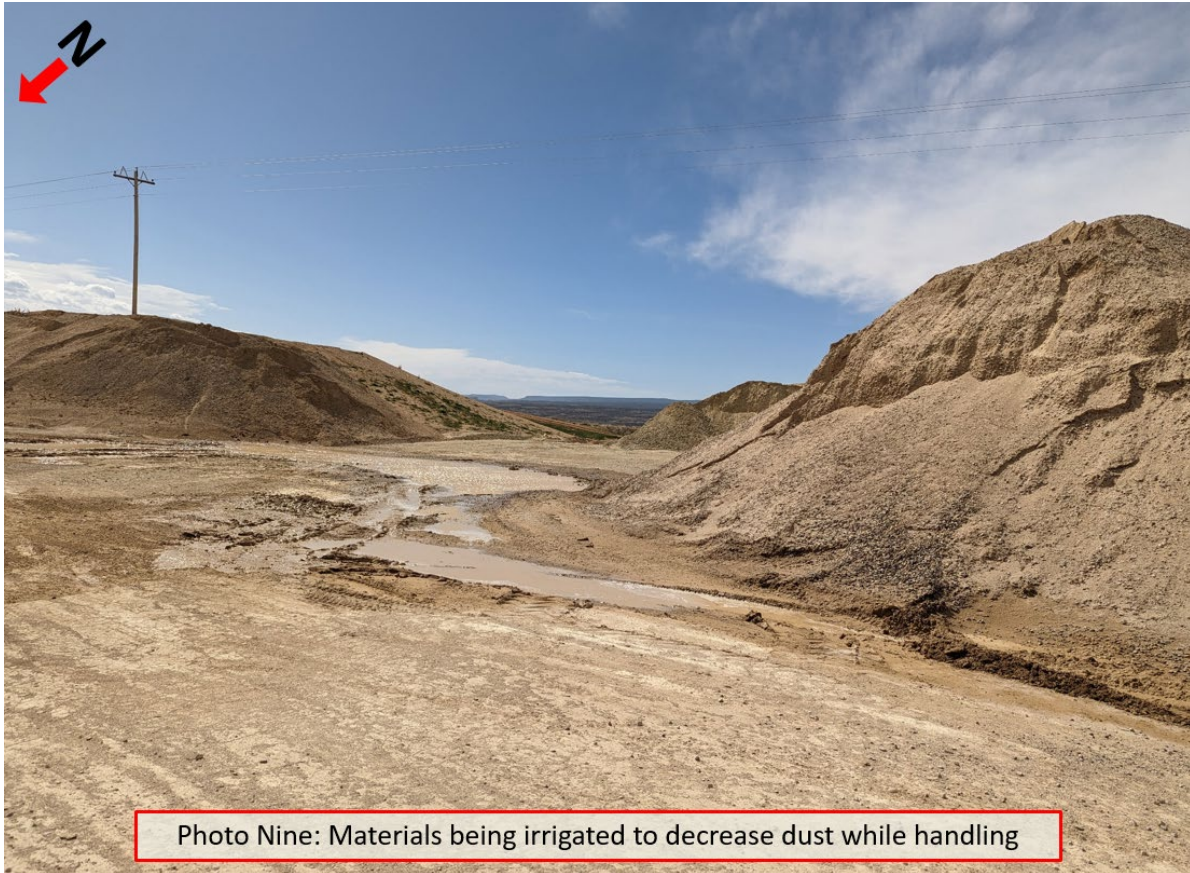
As a best management practice the Operator also tries to shut down during periods of high winds. While on site Mr. Baker verbally committed to continue this practice and be more diligent about high wind shut downs in an effort to be a good neighbor. The operator is also irrigating pit run to decrease dust generated during crushing and screening operations (Photo Nine).

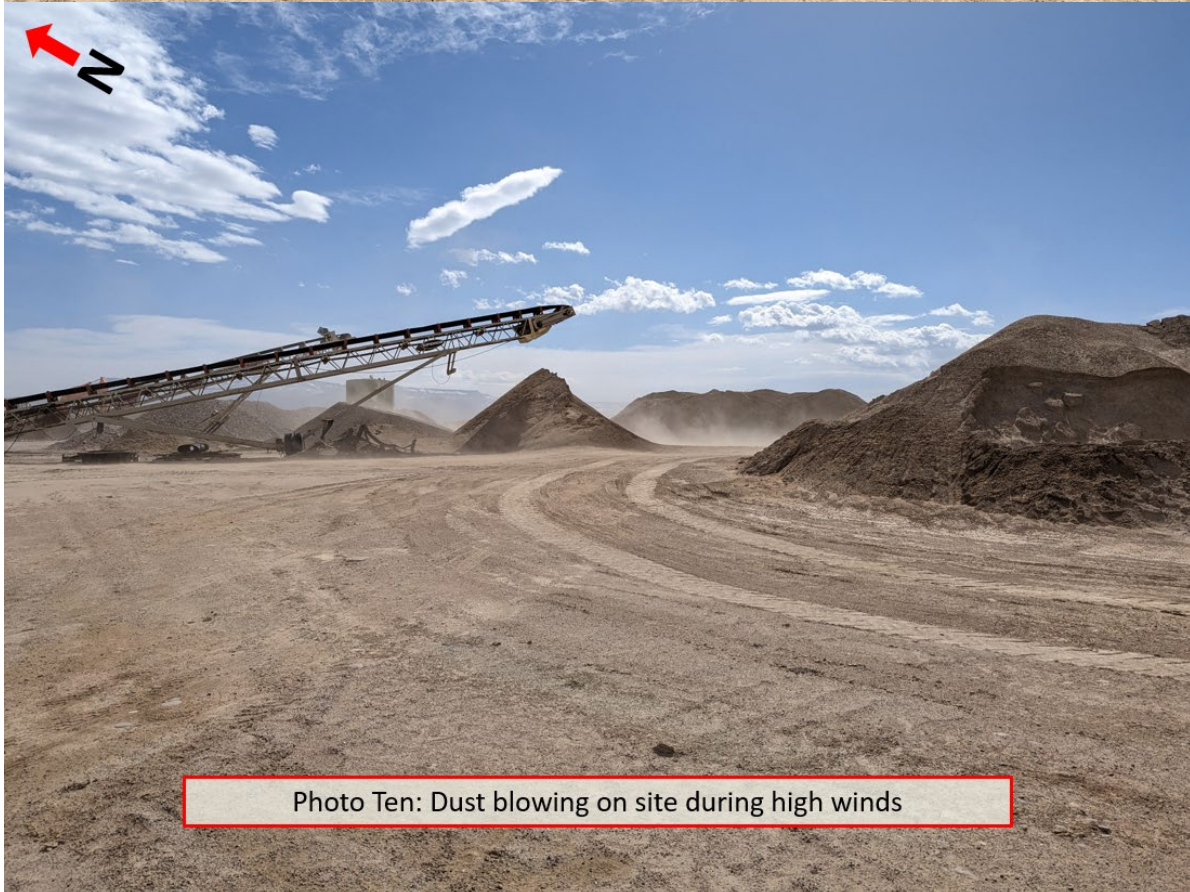
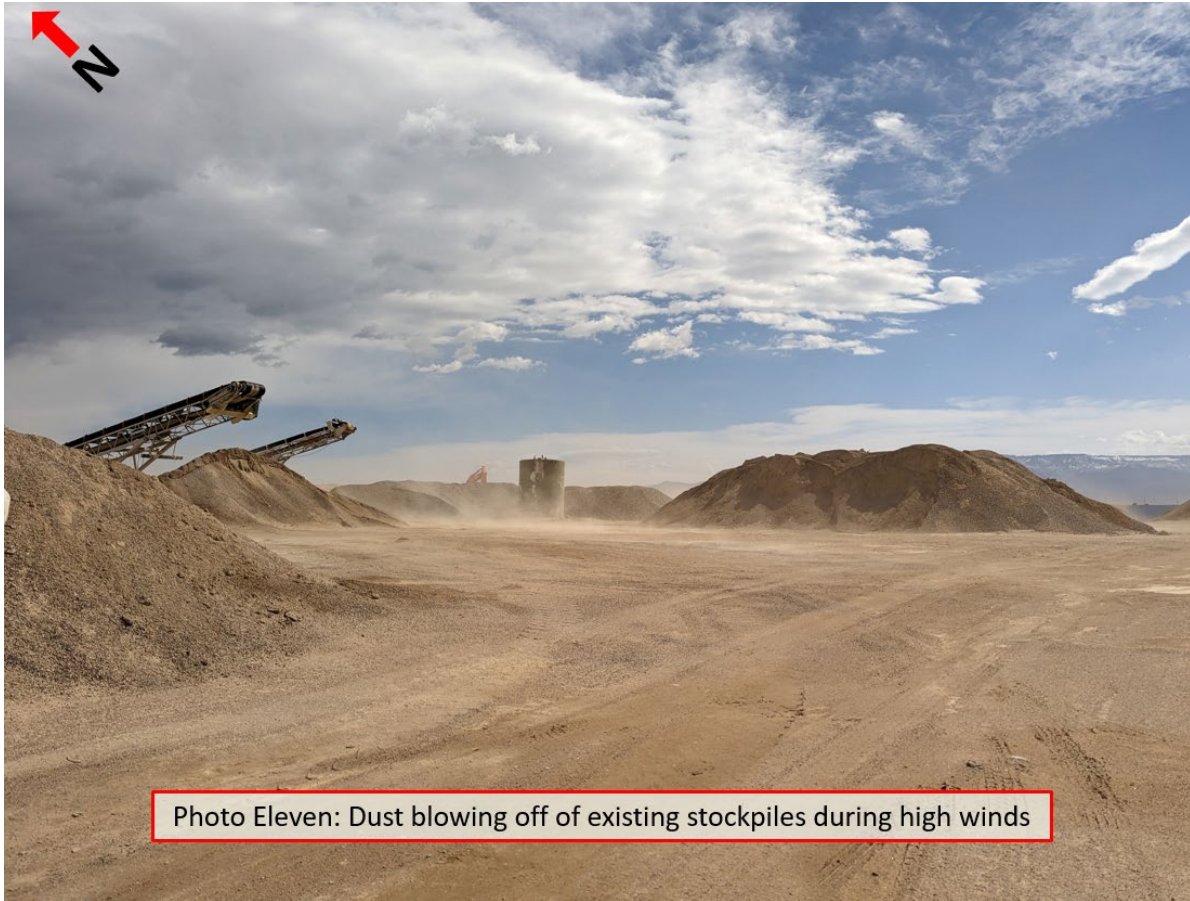
During the inspection dust was observed coming off of the mine site (Photos Ten and Eleven). The dust was mostly blowing off of the existing stockpiles located on the south side of the pit. No topsoil was observed leaving the site. Evidence of a recent attempt to manage dust was visible based on puddles located throughout the pit. The Division recommends that the operator spray down stockpiles that are being worked more frequently to avoid the potential for dust. It is acknowledged that dust is generally not within the jurisdiction of DRMS and is handled at a county level or through CDPHE. However, it is a Division permit condition that the Operator maintains compliance with all other agencies required permits.

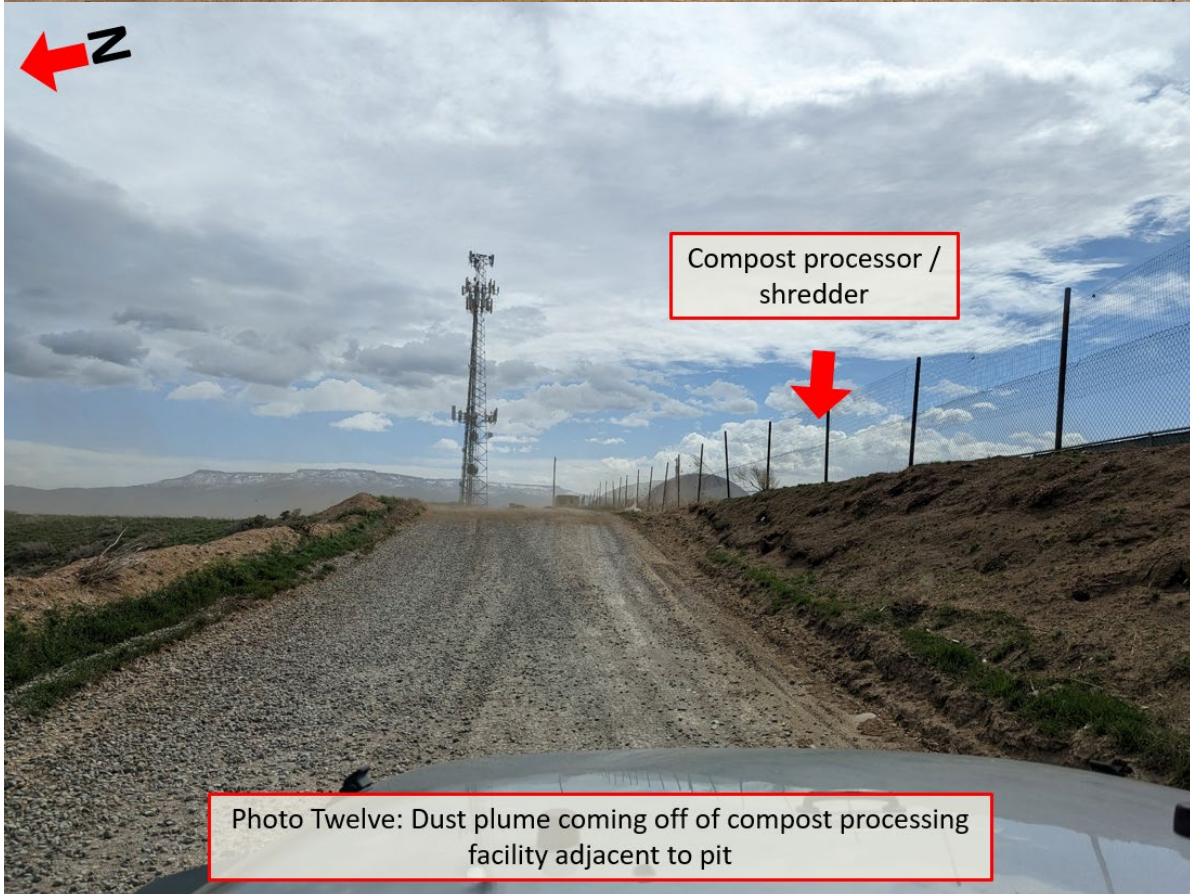
While entering and exiting the pit a large plume of dust was observed coming off of the county compost crusher/shredder. Material was actively being loaded despite high winds. A plume of dust was observed each time the processing plant received a new load of compost (Photo Twelve). This may also be an additional local source of dust, especially during times of high wind.

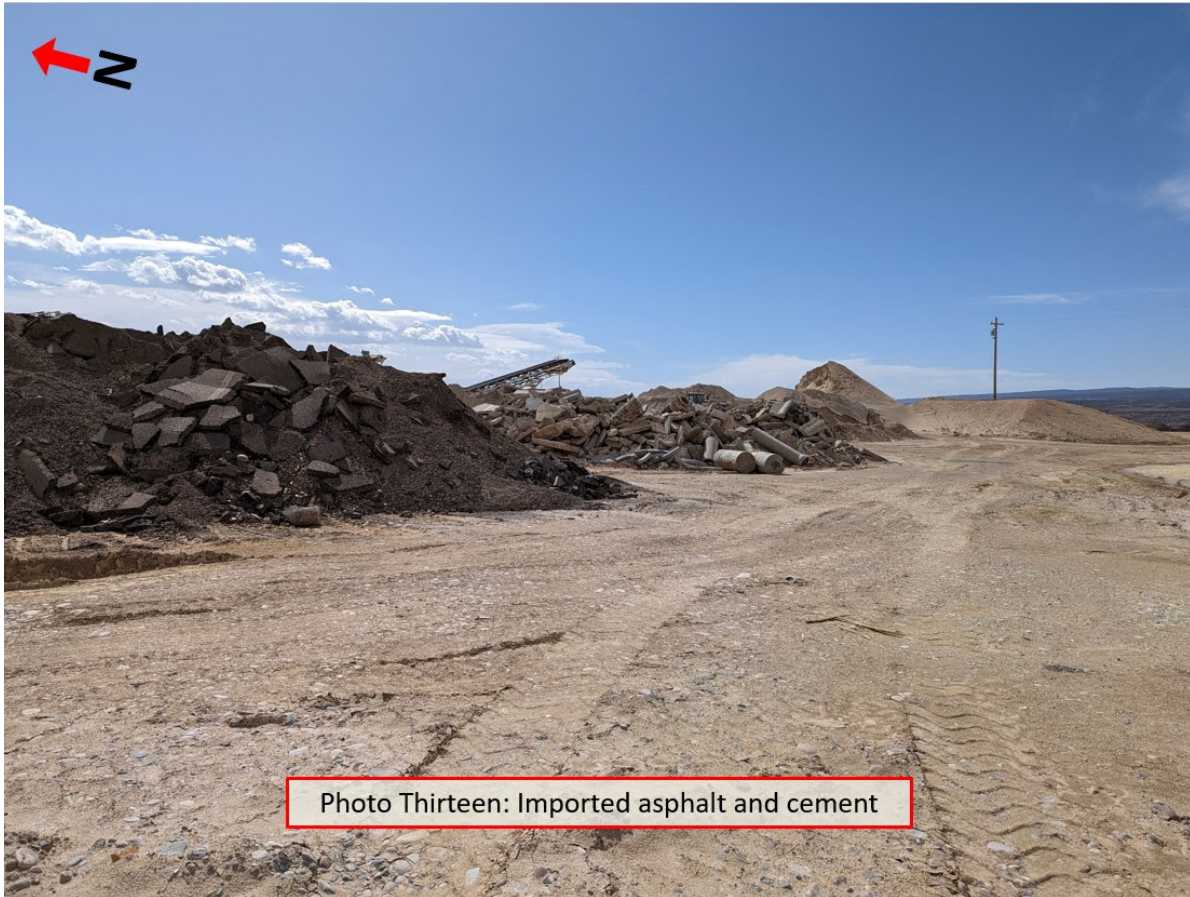
Asphalt and cement are being imported recycled to create additional export products (Photo Thirteen). This activity was approved under TR-2. A crusher and screen were on site though not operating that the time of the inspection (Photo Fourteen). Stockpiles of mined material are generally located on the south side of the pit. Processed material is located to the east of the processing plant. Topsoil soil is located southeast of the active mining area. Mining is continuing to progress to the west. It is approaching the edge of the current bluff and will progress to the next bluff to the west. Approximately 800 LF of near vertical highwall was observed. A portion may require backfill rather than cut fill making which is comparable to the previously bonded amount of 200 LF cut/fill (Photo Fifteen). Several pieces of equipment were observed on site. Fuel is currently stored in a mobile double walled tank near the entrance ramp into the pit floor.

Photo Thirteen: Imported asphalt and cement

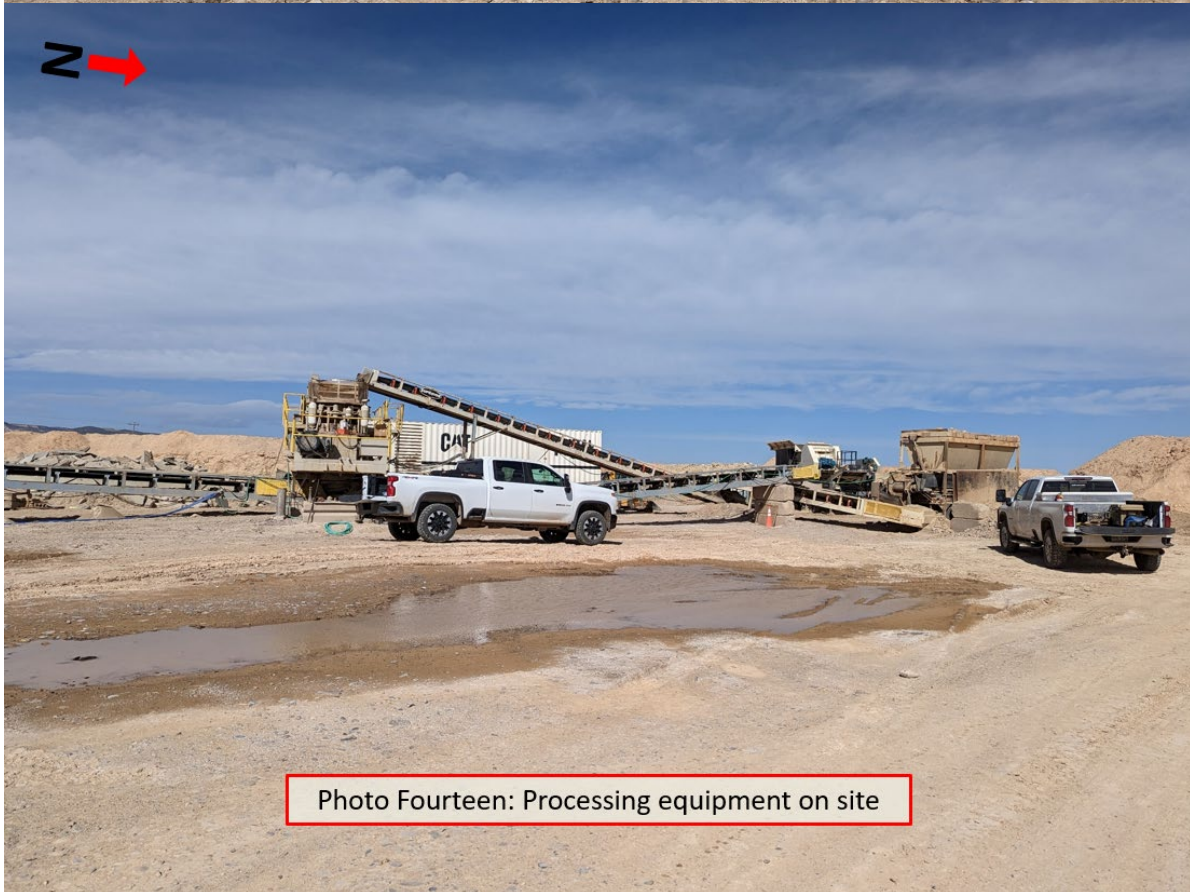
Photo Fourteen: Processing equipment on site

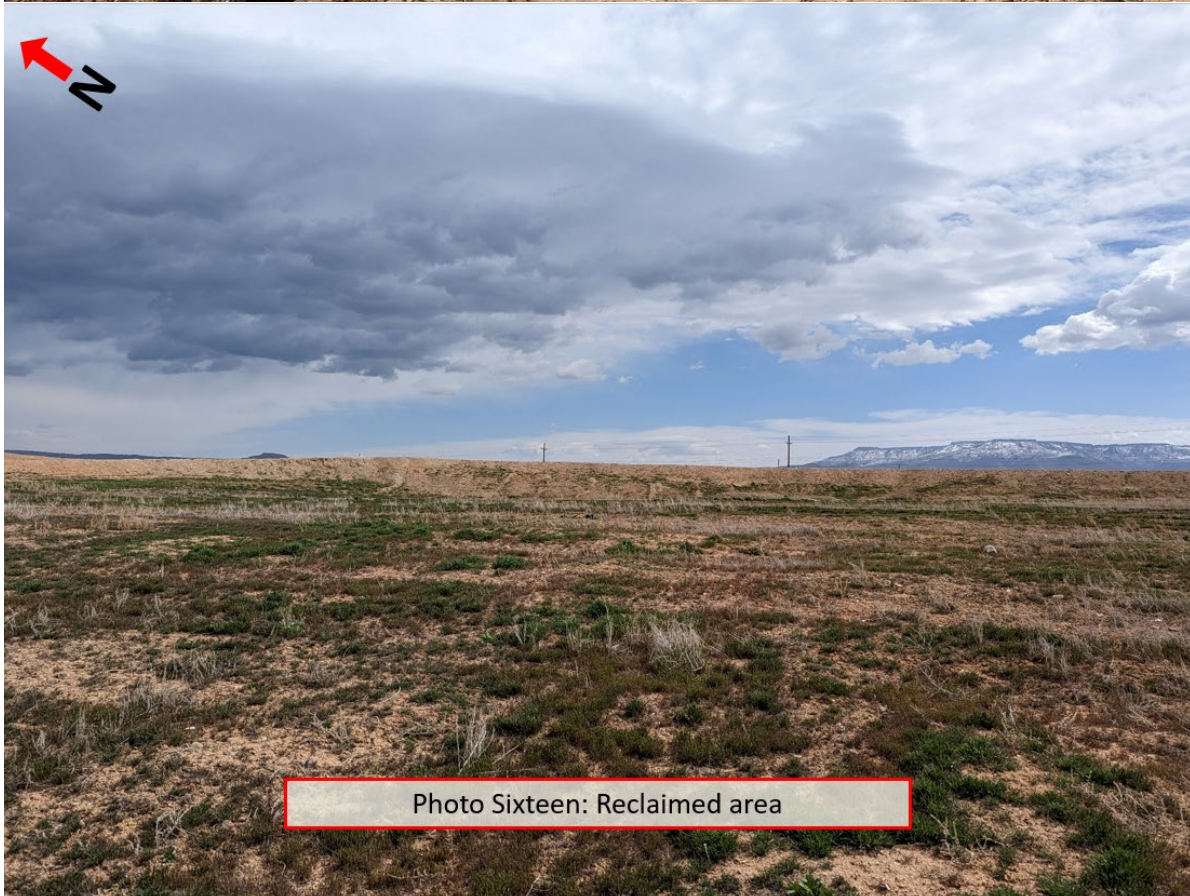
Division staff also inspected the approximately 3 ac. of land noted as being reclaimed on the most recent annual report (Photo Sixteen). Vegetation has begun to germinate however there is a high frequency of noxious weeds present. Based on timing it is difficult to differentiate between desirable and noxious grass species. The Operator is encouraged to monitor germination and growth throughout the season. Noxious weed species should be managed to the extent practical to avoid negative impacts to desired reclamation species. If desirable species begin to outcompete the noxious species present, please contact the Division to coordinate a release inspection. The Division acknowledges that the surrounding vegetation is significantly different than the approved Reclamation Plan seed mix. This makes it difficult to determine when successful reclamation has been achieved.
