MINERALS PROGRAM INSPECTION REPORT
PHONE: (303) 866-3567

MINE NAME: Logan Wash	MINE/PROSPECTING ID#: M-1977-424	MINERAL: Oil shale	COUNTY: Garfield
INSPECTION TYPE: Monitoring	WEATHER: Clear	INSP. DATE: April 21, 2023	INSP. TIME: 13:30
OPERATOR: Occidental Oil Shale, Inc.	OPERATOR REPRESENTATIVE: Bruce Smith	TYPE OF OPERATION: 112 - Hard Rock Regular Operation	
REASON FOR INSPECTION: High Priority	BOND CALCULATION TYPE: None	BOND AMOUNT: \$570,428.00	
DATE OF COMPLAINT: NA	POST INSP. CONTACTS: None	JOINT INSP. AGENCY: None	
INSPECTOR(S): Amy Yeldell	INSPECTOR'S SIGNATURE:

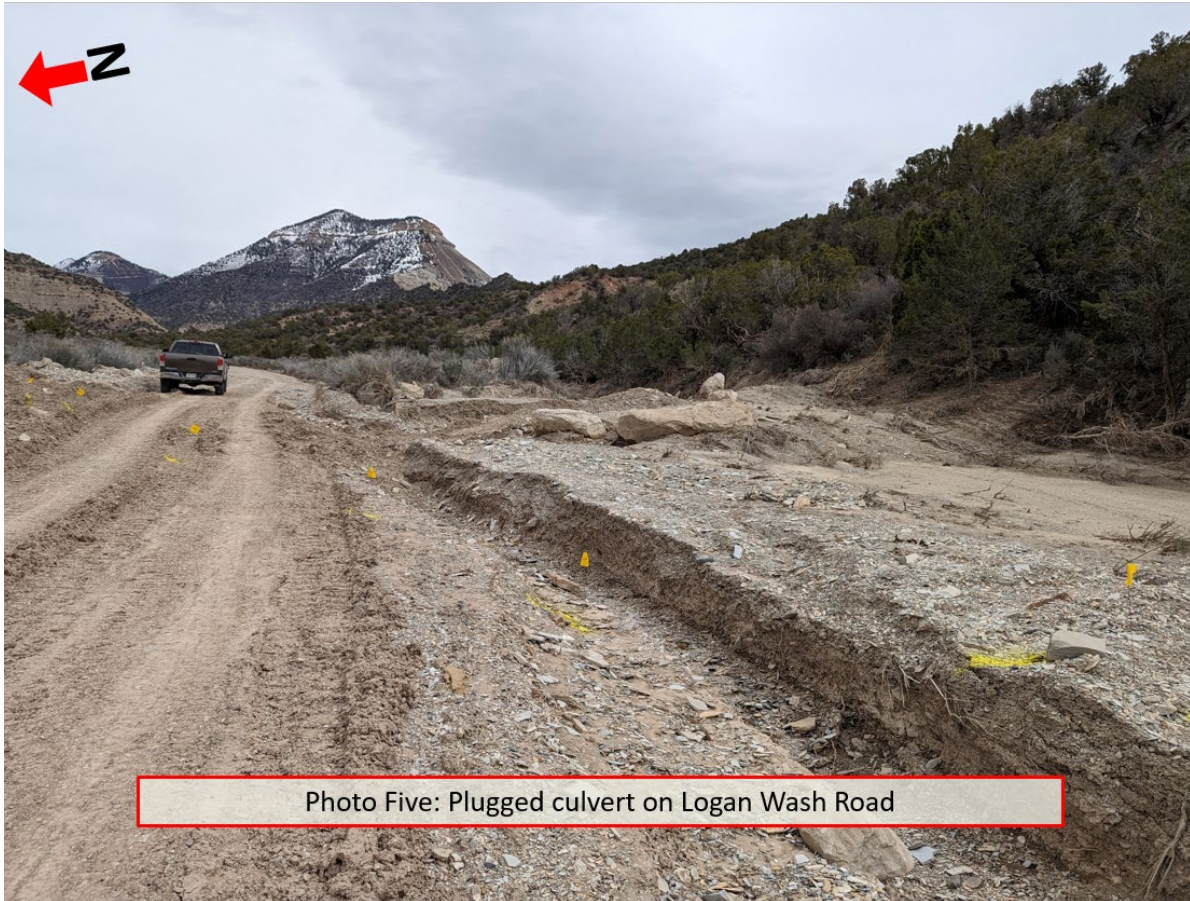
stormwater effectively and were likely a contributing factor to the conditions that resulted in the water line break. Also observed during this inspection were culverts further up the Logan Wash Road which had become plugged with sediment and rocks. The plugged 36" twin culverts are designed to direct Logan wash from the south side of the road to the north side. Without these culverts functioning stormwater is flowing across and down Logan Wash Road. Excessive amounts of sediment have been deposited on the road and shoulders.

Photo Five: Plugged culvert on Logan Wash Road

Follow up actions: 1) As soon as practicable provide the Division with a written report of the event pursuant to Rules 8.2.2 and 8.2.3. 2) Provide the Division with an interpretation of the sample results as well as raw data. Pending the soil sample results soil removal or remediation may be necessary. 3) Once BMP features have been repaired please provide the Division photo documentation and a summary of the work scope conducted to prevent future erosional issues along the water line.

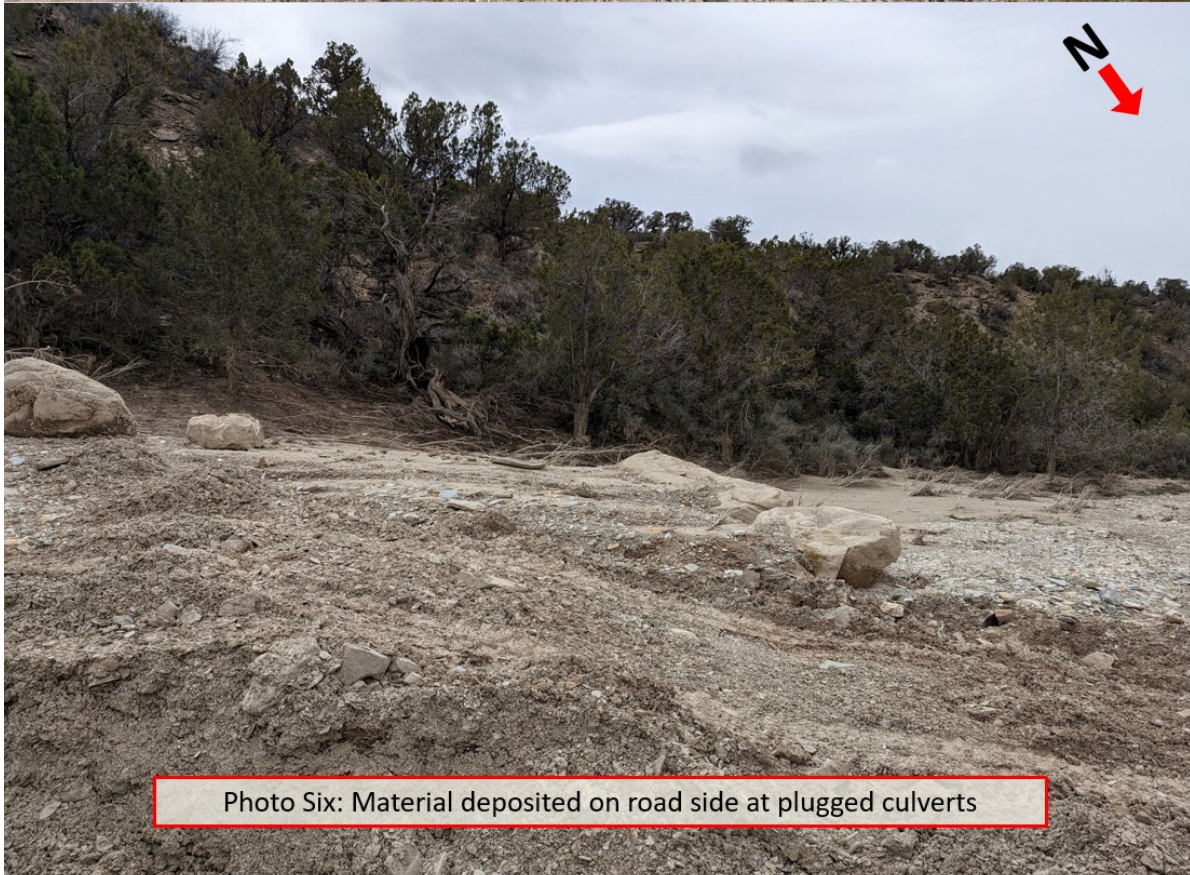
Photo Six: Material deposited on road side at plugged culverts
