Huddleston-Berry
Engineering & Testing, LLC

Subject: Summary of Instrumentation Monitoring
1st Quarter 2023
Bowie Coal Waste Disposal Area No. 2
Paonia, Colorado

SUBJECT: Summary Report, 1st Quarter 2023, Inclinator and Active Vibrating Wire Piezometer Data January through March 2023, Bowie Mine #2 Coal Waste Disposal Area (CWDA) #2

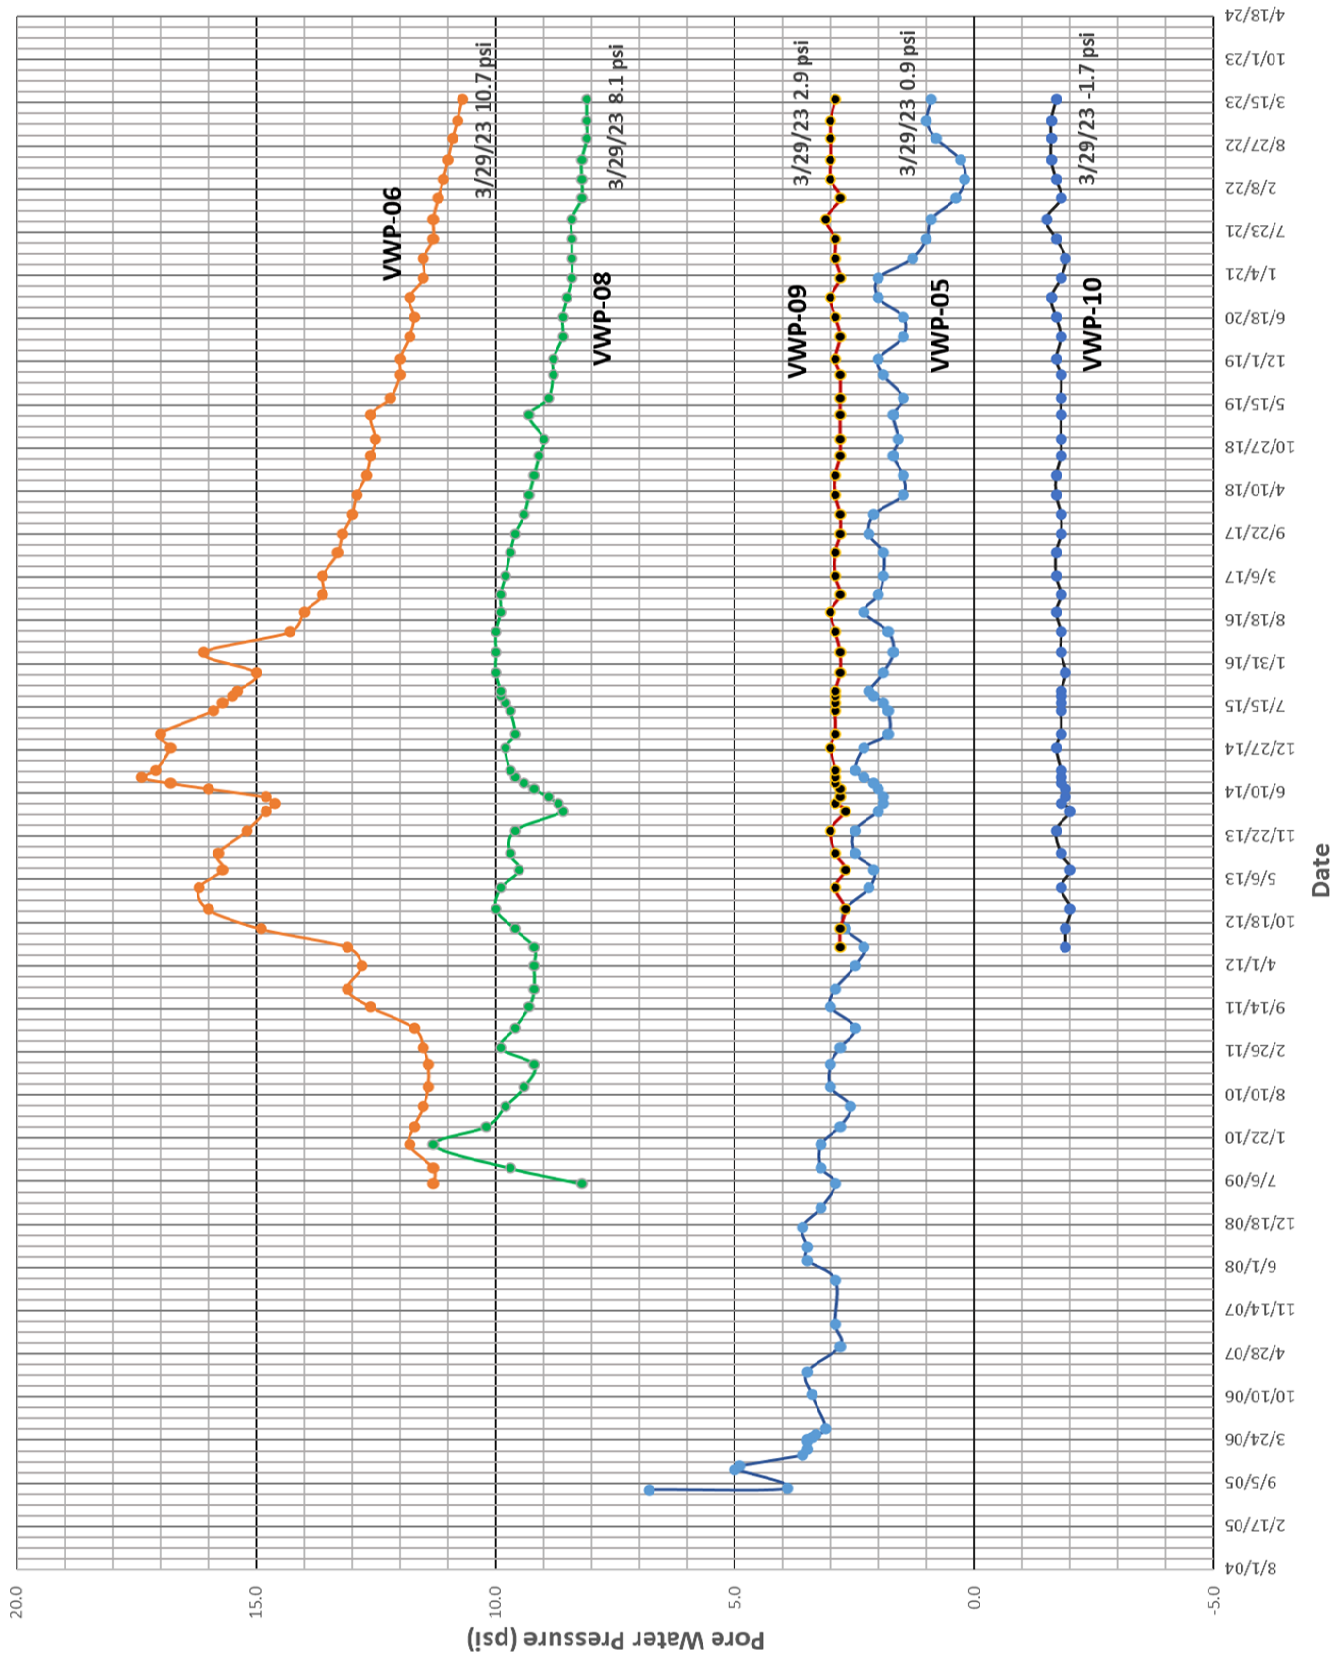
Figure 2 - Bowie Mine #2 - CWDA #2
Active Vibrating Wire Piezometer Data

As seen on Table 1 and Figure 2, the VWP readings and trends are consistent with recent and historic readings. Pore pressure readings changed by small amounts (-0.1 to -0.4 psi) for four of the five VWP's since the readings one year ago (Q1 2022), while VWP-05 changed by +0.7 psi. When compared with last quarter (Q4 2023), pore pressures also changed by relatively small amounts (0 to -0.1 psi) in all five VWP's. Although four of the five VWP's remain steady or have general declining trends in pore pressure over the life of the VWP's, one of the piezometers (VWP-05) has exhibited pronounced seasonal cyclical behavior for its lifespan. This piezometer shows pronounced seasonal fluctuations and a net loss of -5.9 psi over the lifetime of that VWP. The other four VWP's have experienced net changes of +/-0.6 psi or less since installation, meaning current readings are very similar to initial readings. For VWP-09 and VWP-10, pressures have been consistent throughout the lifetime of the piezometers; however, for VWP-06 and VWP-08, they experienced wild fluctuations in pore water pressure in the first half of their lifetimes, but have settled to pressures similar to the installation pressures in the past several years.

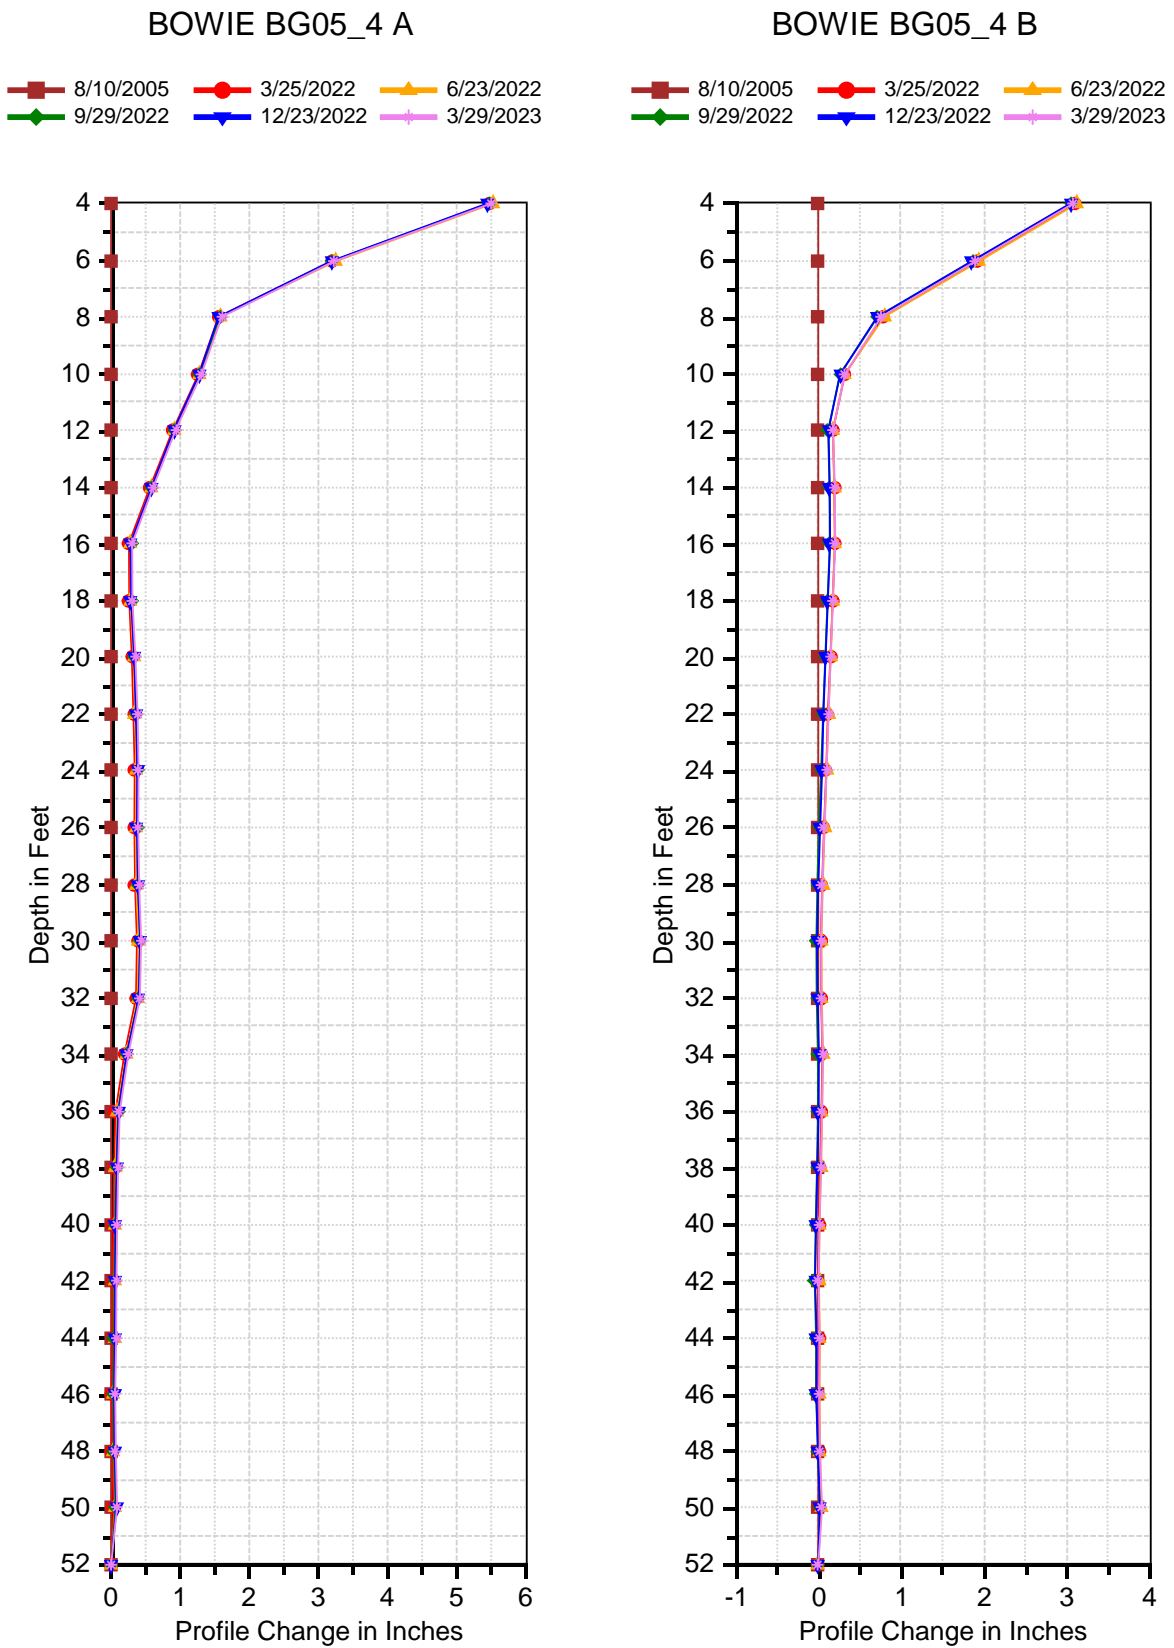
Figure 3 - Inclinator Displacement Curves

As described in previous reports, historic displacements indicated on the plots for the approximate upper 12-14 feet of the inclinometers since installation in 2005 are due to placement of cover soil on the face of the waste pile during revegetation operations in late 2006 and early 2007. This man-caused displacement is documented in a report by Buckhorn Geotech dated December 22, 2008 to Bowie Resources called *Revised Stability Evaluations for Coal Mine Waste Disposal Area No. 2, Bowie No. 2 Mine*.

Based on the current inclinometer readings, there has not been evidence of significant downslope movement (Axis A) in any of the inclinometers since 2007 and they are generally consistent with previous readings. Some "noise" which is understood to be relatively common in orthogonal direction (Axis B) readings, was observed over the past few years for all three inclinometers. This can be due to various mechanical or installation causes that are unrelated to slope movement. For example, grout voids, poor grout coverage, or soil settlement around the instrument can all contribute to vibrations and pipe movement that impacts inclinometer readings. Software bias adjustments were applied which filtered this noise. All readings were consistent with previous ones and the "displacement" error was within equipment tolerances and not deemed to be due to slope movement.

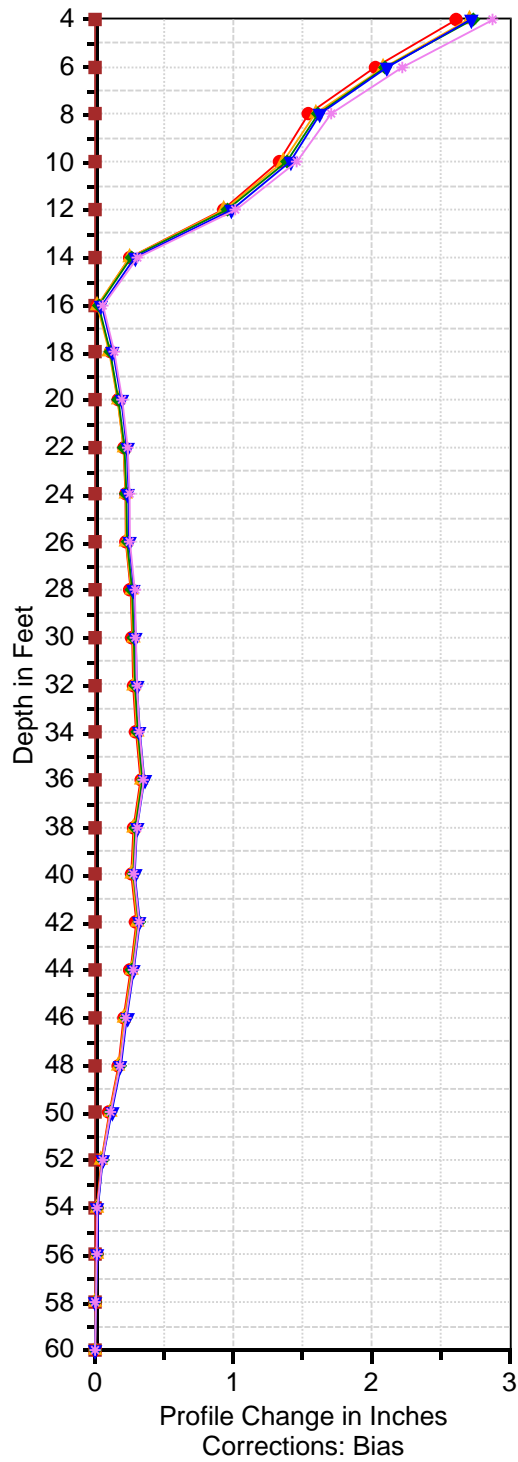
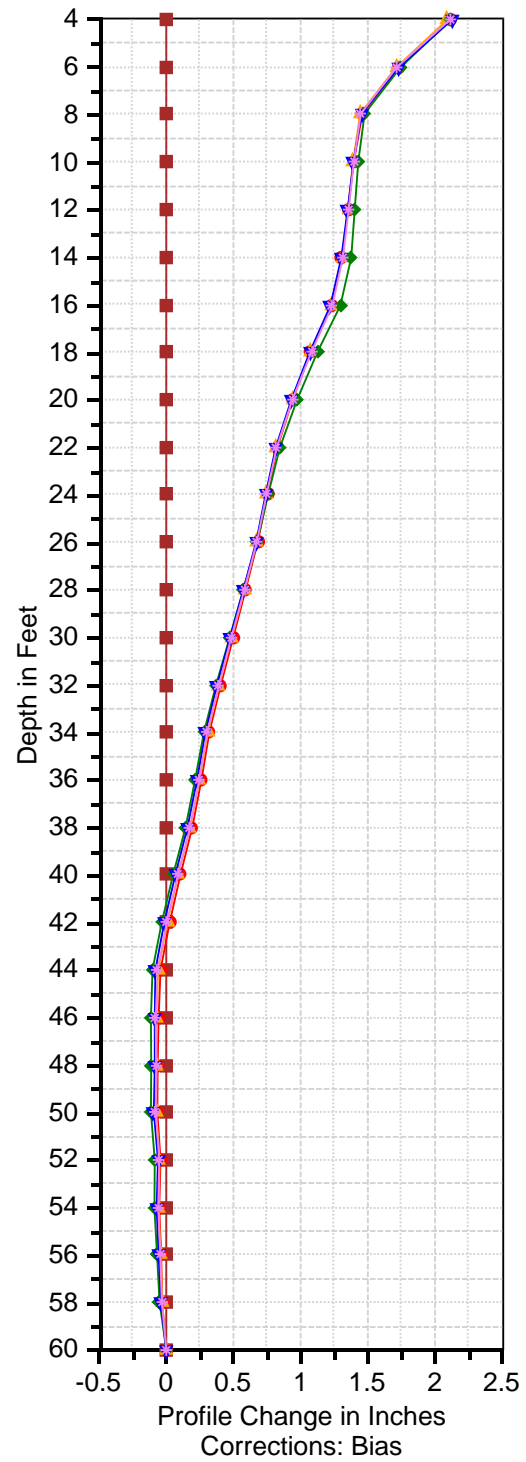
Standing water was at the surface at BG05-04 and measured at a depth of 8.5 feet in inclinometer BG05-7. Based on our observations there has usually been water in these pipes. Table 2 below shows water levels measured in the inclinometers for the past nine quarters. There was no water in the BG05-5 pipe and this inclinometer is typically dry. Worth noting is that water was not introduced in the inclinometer pipes during their construction. Therefore, water may enter the pipe if a seal is broken at the seams where the pipes snap together or there is a crack in the pipe, either due to slope movement or other pipe damage. Although it is not known for sure, we suspect the pipes cracked in 2006-2007 when the slope revegetation occurred and impacted the upper 12-14 feet of the inclinometers, thus allowing water to enter the pipes.
