MINERALS PROGRAM INSPECTION REPORT
PHONE: (303) 866-3567

MINE NAME: Fox #1 Clay Mine	MINE/PROSPECTING ID#: M-1977-219	MINERAL: Clay, sandstone, and borrow material	COUNTY: Pueblo
INSPECTION TYPE: Monitoring	WEATHER: Clear	INSP. DATE: March 28, 2023	INSP. TIME: 12:00
OPERATOR: Summit Brick & Tile Co.	OPERATOR REPRESENTATIVE: Julie Welte	TYPE OF OPERATION: 112c - Construction Regular Operation

Fox #1 Clay Mine
M-1977-219
March 2023 Inspection

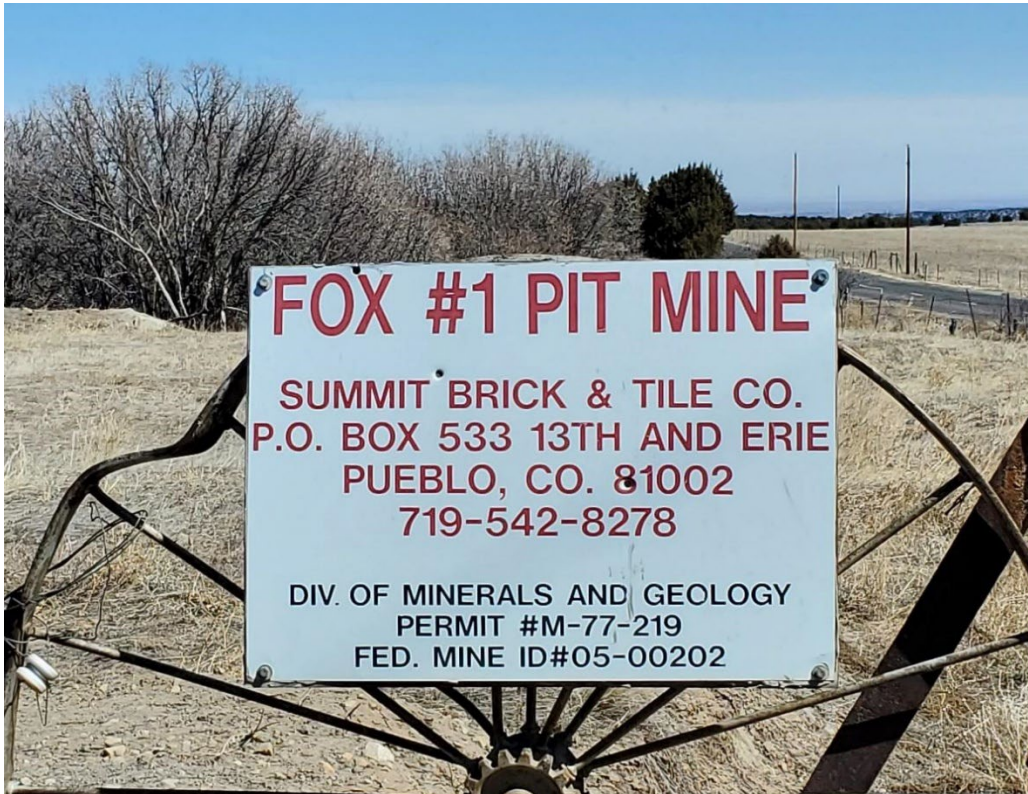
At this time, of the 8.7 acre backfilled and 6.2 acre graded areas marked as reclaimed on the 2023 annual report that were observed during the inspection, most appear to not yet be eligible for release. They appear to comply with the reclamation plan thus far, but they've yet to be sufficiently revegetated. However, the area north of the mine sign at the site entrance may soon be, if not already, eligible for a release request (Photo 1).

A mine sign in compliance with Rule 3.1.12 was observed on the north side of the entrance road (Photo 1).

Photo 1: Mine sign located to the north of the entrance road. The area behind the mine sign has been reclaimed.

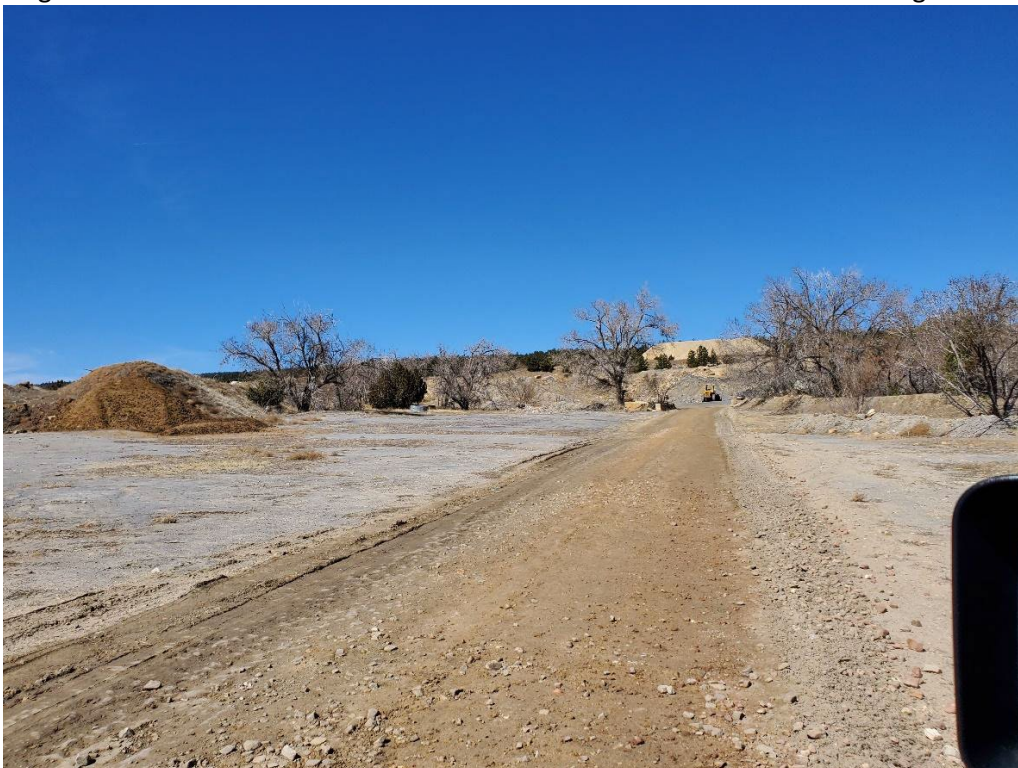
Four topsoil piles were observed onsite (Maps 2 and 3: Photos 2, 3, 8, 9, 15, 19 and 20). All four of the piles appeared to be in stable configurations and vegetated to reduce erosion in compliance with Rule 3.1.9. Additionally, all four piles are located up-gradient of drainage pathways as approved in the Operator's mining

Photo 2: Looking west at product stock piles and topsoil pile #4 from the entrance road.

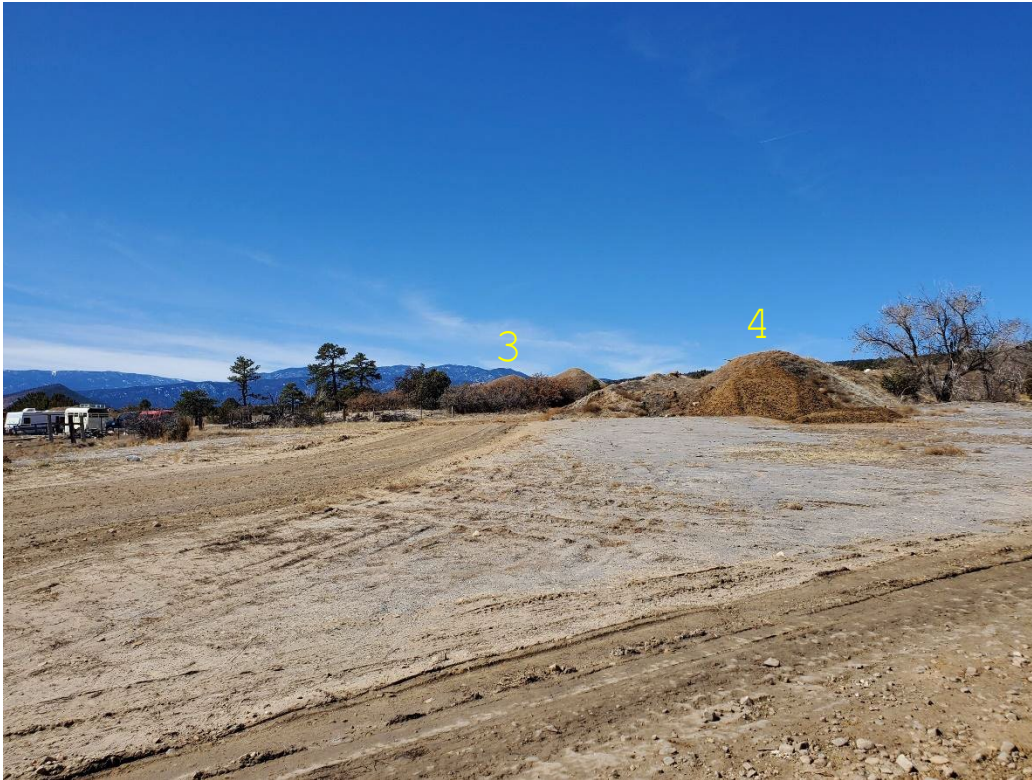
Photo 3: Looking southwest at topsoil piles #3 and #4 from the entrance road.

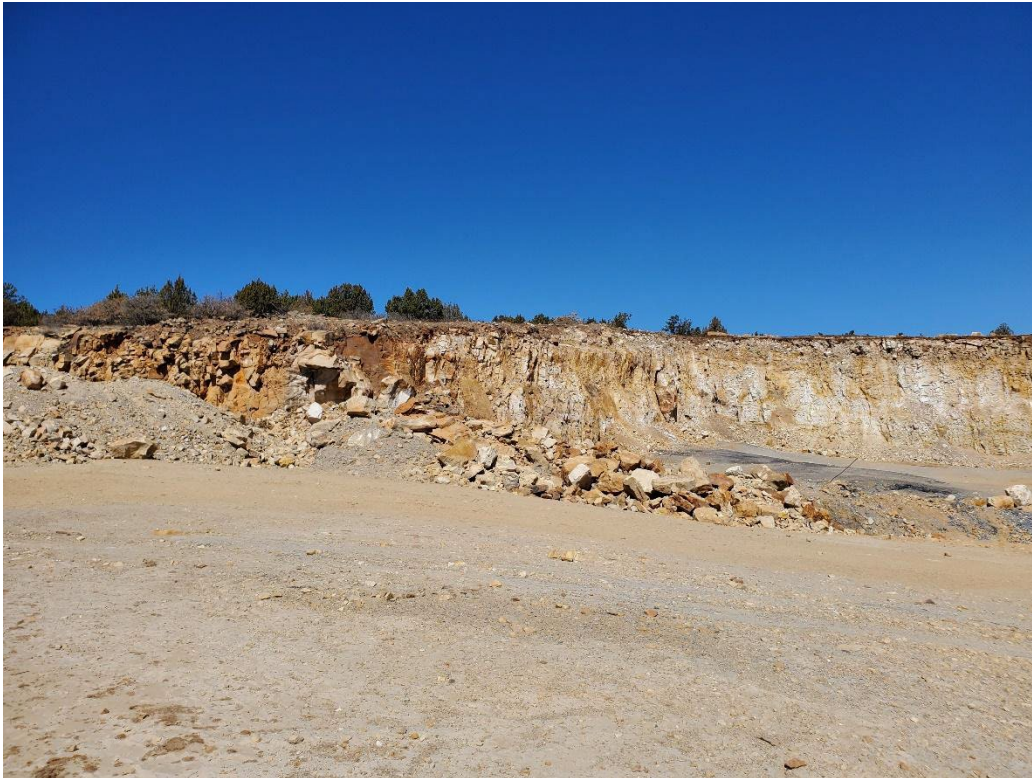
The area in Area B that has recently been blasted is the historic highwall that had been left from a 1976 pre-law mining operation (Photos 7 and 8). The observed piles of sandstone are resultant of the Operator's blasting the sandstone cliffs for the extraction of clay. Because the Operator is blasting previously existing highwalls, the newly affected highwall length has been incorporated into the reclamation costs.

Photo 7: Looking north from newly disturbed area at the historic highwalls.

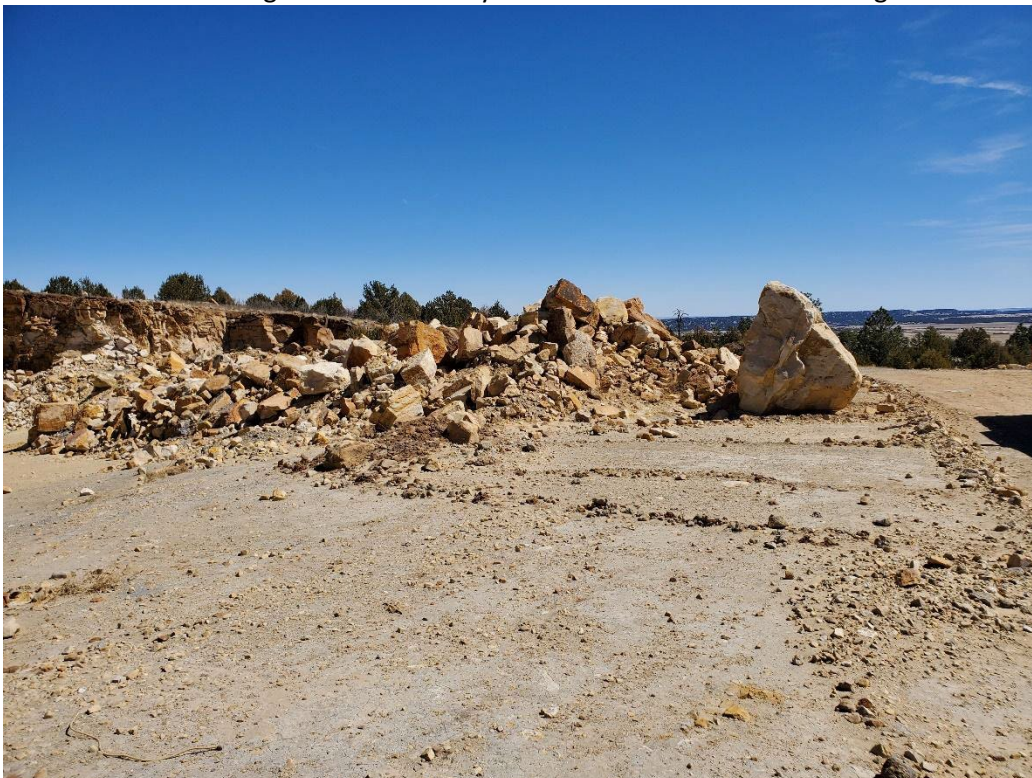
Photo 8: Looking west at rubble piles resultant from blasting the historic topsoil piles.

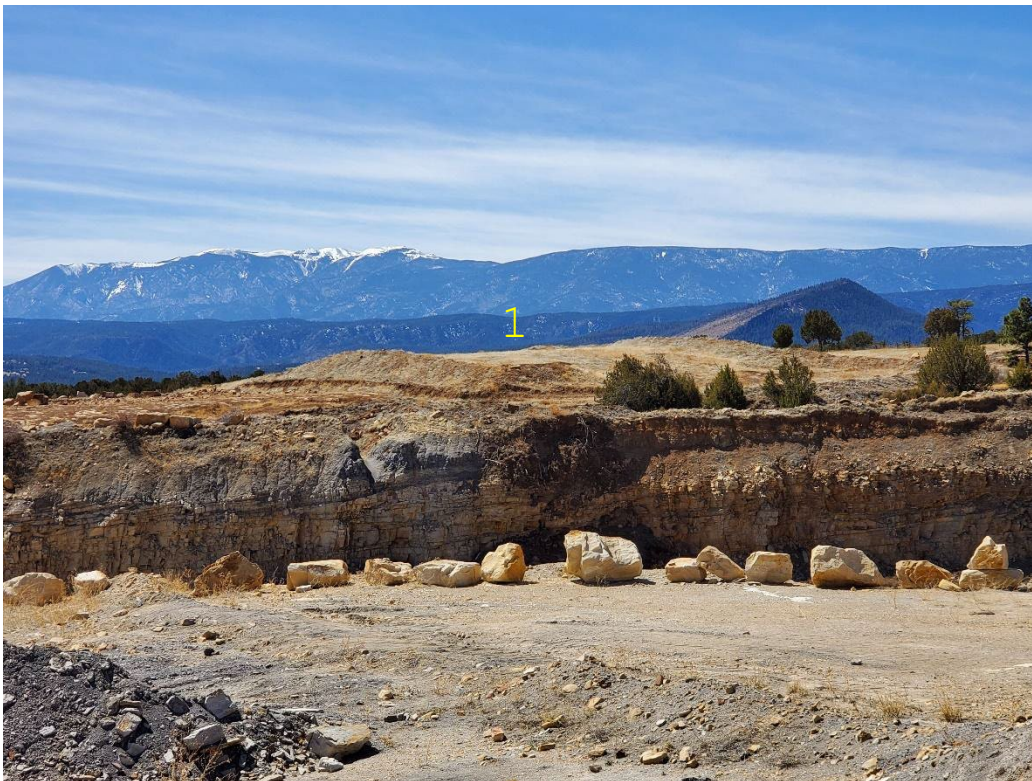
Photo 9: Looking southwest at topsoil pile #1 located along the western side of Area A.

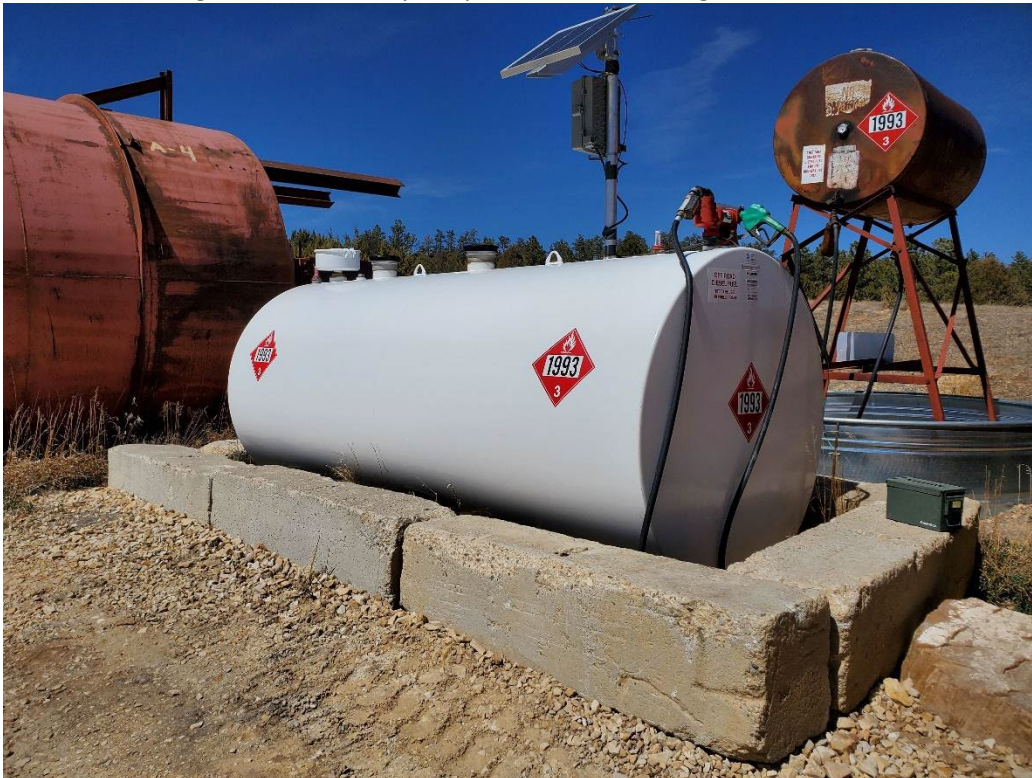
Fuel is stored on-site. The Operator stated that approximately two years ago, a new double-walled fuel tank with a concrete berm was installed. The fuel storage was observed during the inspection (Photo 10) and appears to be in good condition.

Photo 10: Looking north at the double-walled fuel tank with concrete berm.

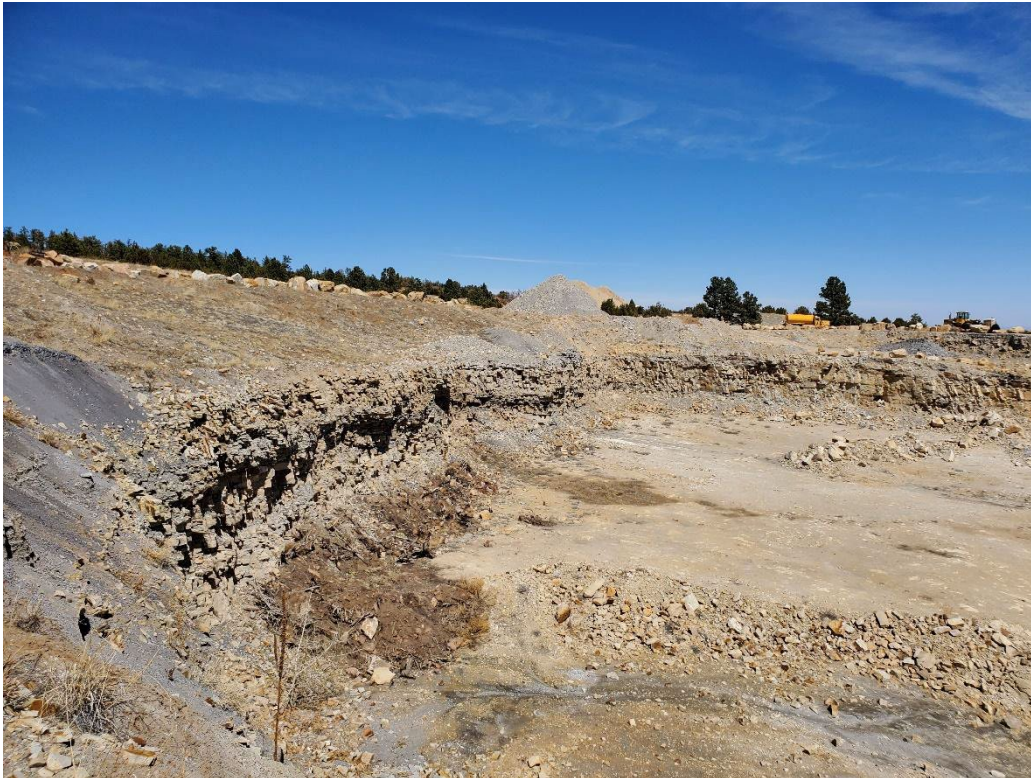
PROBLEM: The length of the highwalls measured at the site exceed what is allowed under the approved mining and reclamation plan. This is a problem at this time for failure to perform the reclamation prescribed by the reclamation plan in accordance with C.R.S. 34-32.5-116(1). Therefore, the current mine plan and reclamation plan needs to be updated and clarified pursuant to C.R.S. 34-32.5-112 (1)(c)(VI) and 34-32.5-112(2)(b). The Operator must provide sufficient information to describe or identify how the Operator intends to conduct the operation.

The current mining plan states that the maximum length that will require sloping is 1,000 linear feet. During the inspection, the observed highwalls in the active mining areas were measured using Esri Field Maps (Photos 11-13, 21-24, and 31-34; Maps 1, 3, & 4). The length of the highwalls measured during the inspection equaled 2,477 feet. Post inspection, 401 additional feet were measured using Google Earth for an area that was inaccessible during the inspection (Photo 17 and 22; Maps 1 & 3) as well an estimated 59 feet of historic highwall that has recently been blasted (Photo 7; Maps 1 & 3). The total highwall length determined for the site is currently 2,937 feet. A problem is cited at the beginning of this report regarding this issue. The Operator will need to submit a technical revision to allow for a greater maximum highwall length by the corrective action date. Alternatively, the Operator may choose to reclaim 1,937 feet of the currently exposed highwalls and backfill and grade them to a 3H:1V slope.

Photo 11: Looking north at the top of the pit area. Photo taken where the high wall measurement for this section began.

CORRECTIVE ACTIONS: The Operator shall submit a Technical Revision, with the required \$216 revision fee, to update and clarify the current approved mining and reclamation plan to reflect existing and proposed activities by the corrective action date. Or, the Operator may backfill and grade a portion of the existing highwall that is in excess of the 1000 foot maximum length allowed by the mining and reclamation plan.

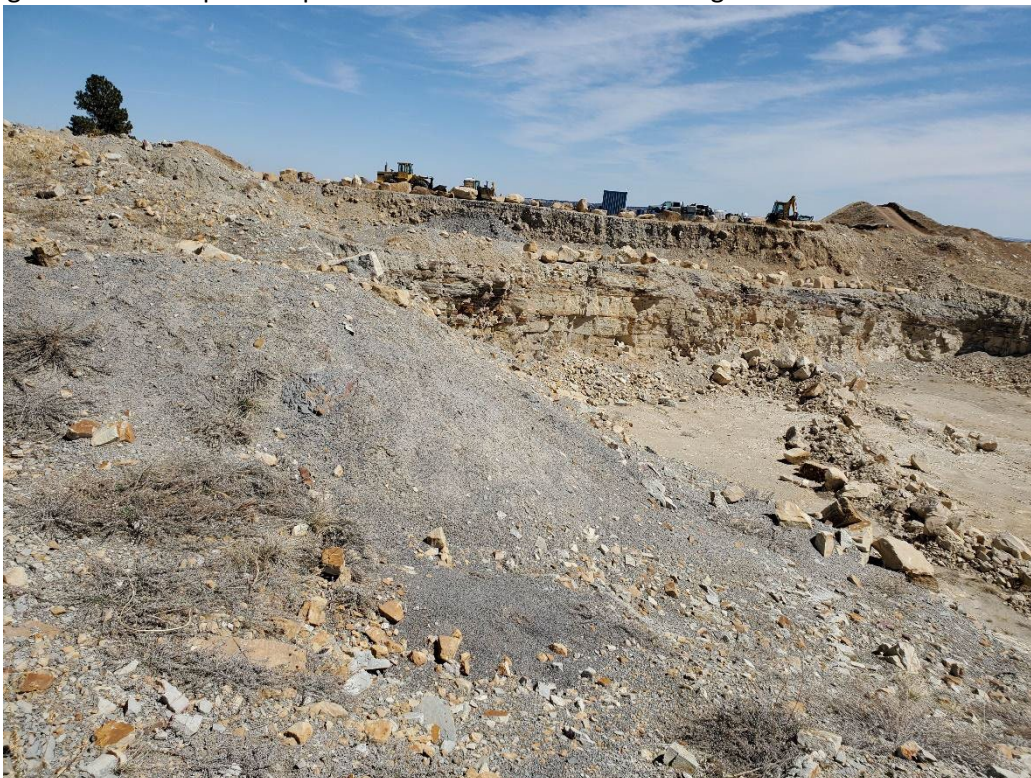
Photo 12: Looking north-east from the top of the pit area.

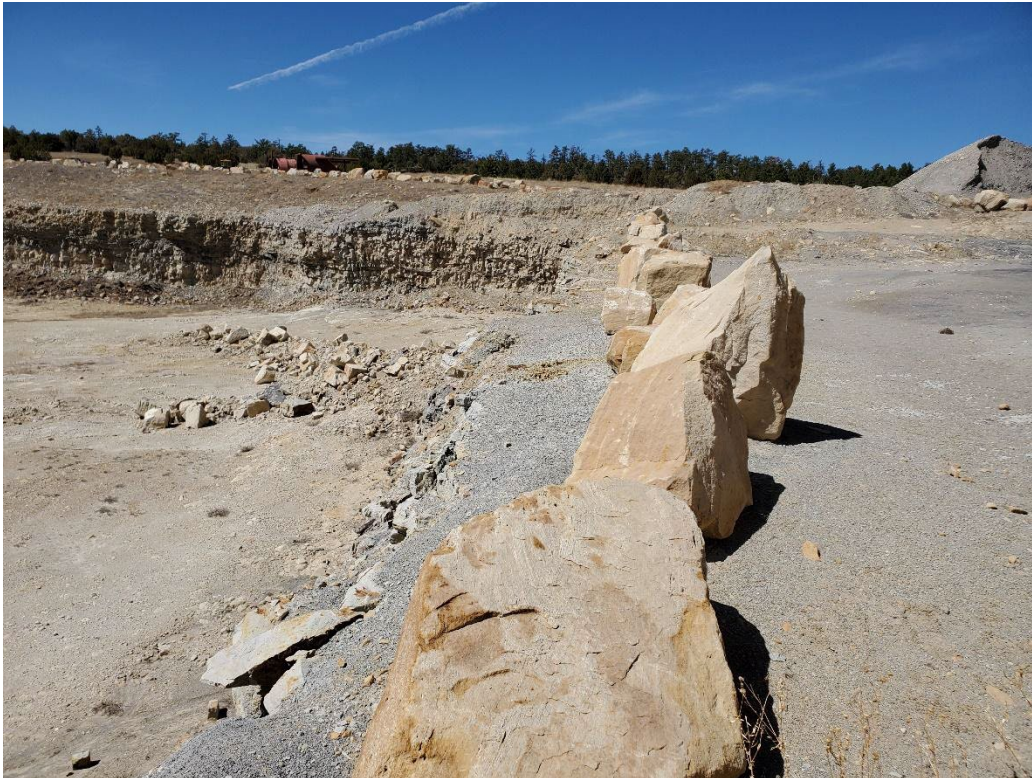
Photo 13: Looking west from the top of the pit area. Photo taken at the extent of the highwall measurement during the inspection for this pit.

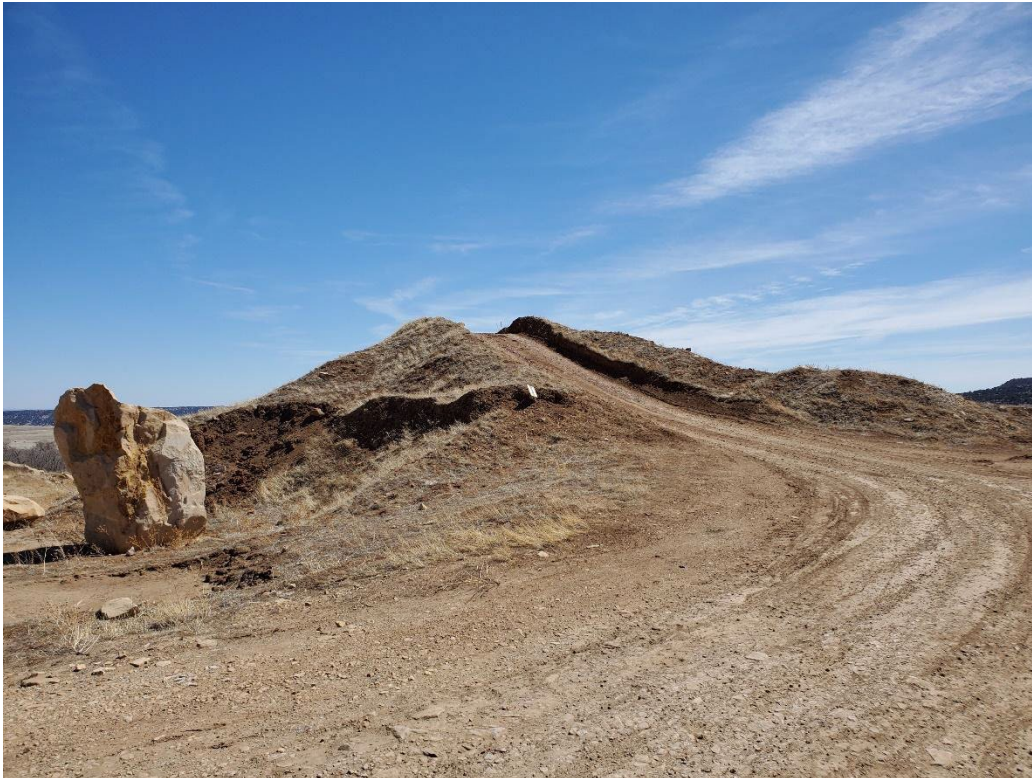
Photo 15: Looking south-east at the path up onto topsoil pile #2.

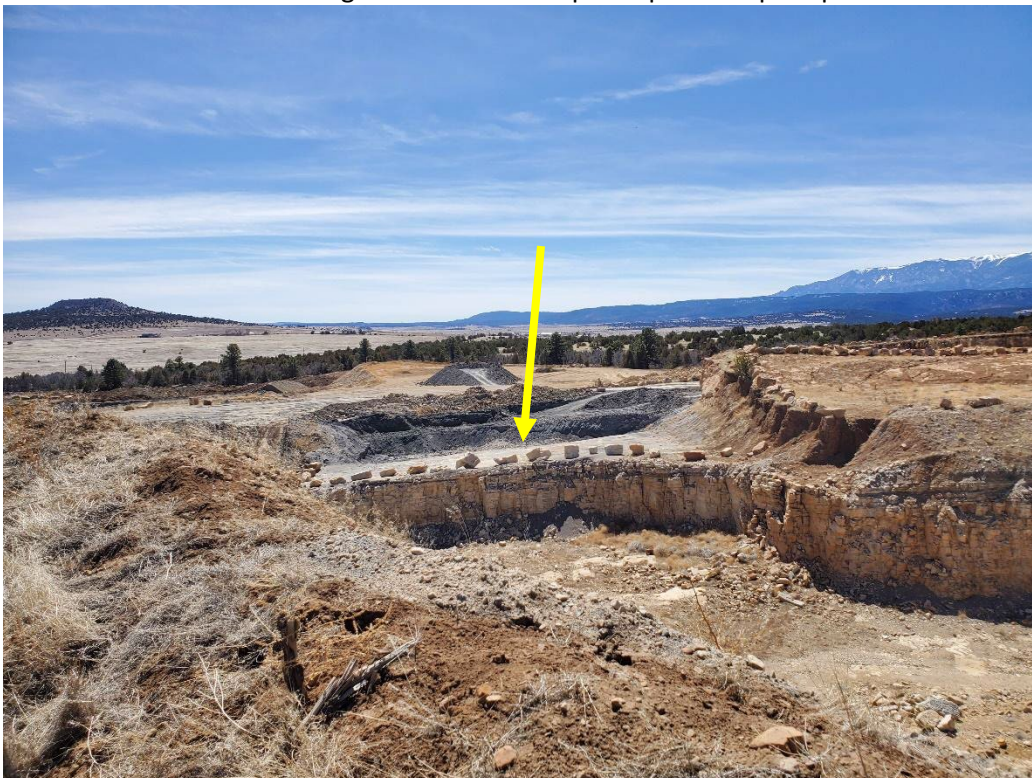
Photo 16: Looking south-east at the pits adjacent to those in photos 10-14. Arrow points to the middle-most highwall measured (featured in photos 21-22).

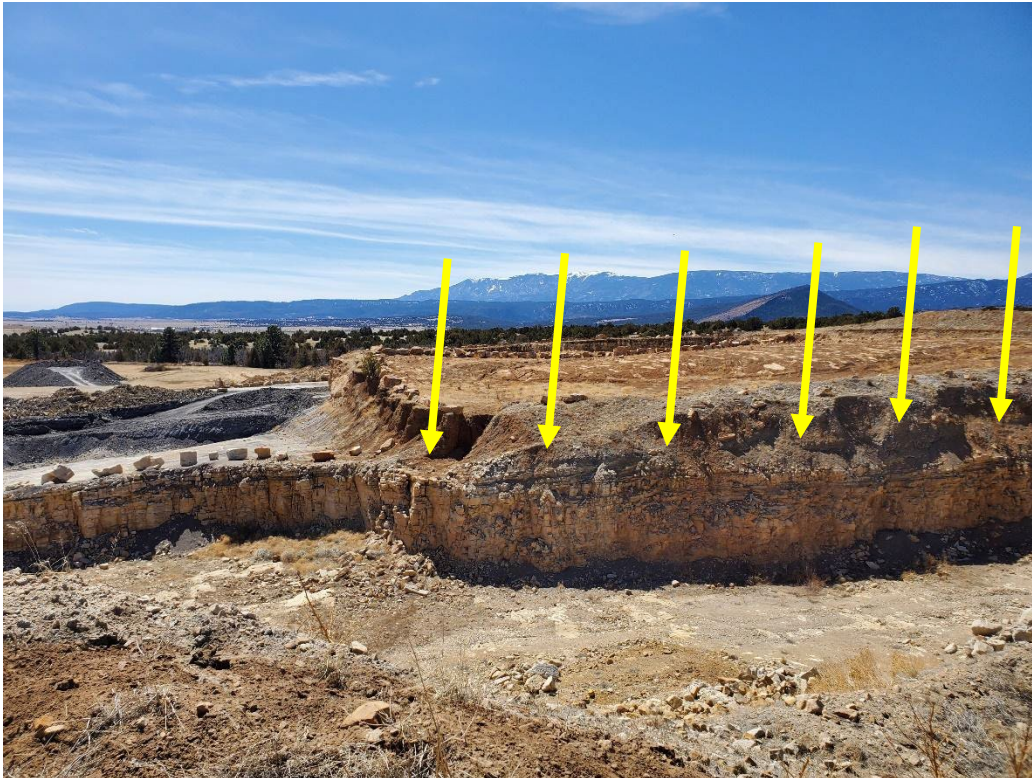
Photo 17: Looking west across south-east portion of the pit in photos 10-14. The yellow arrows point to the section of highwall that was inaccessible to measure in the field (in blue on Maps 1 and 3).

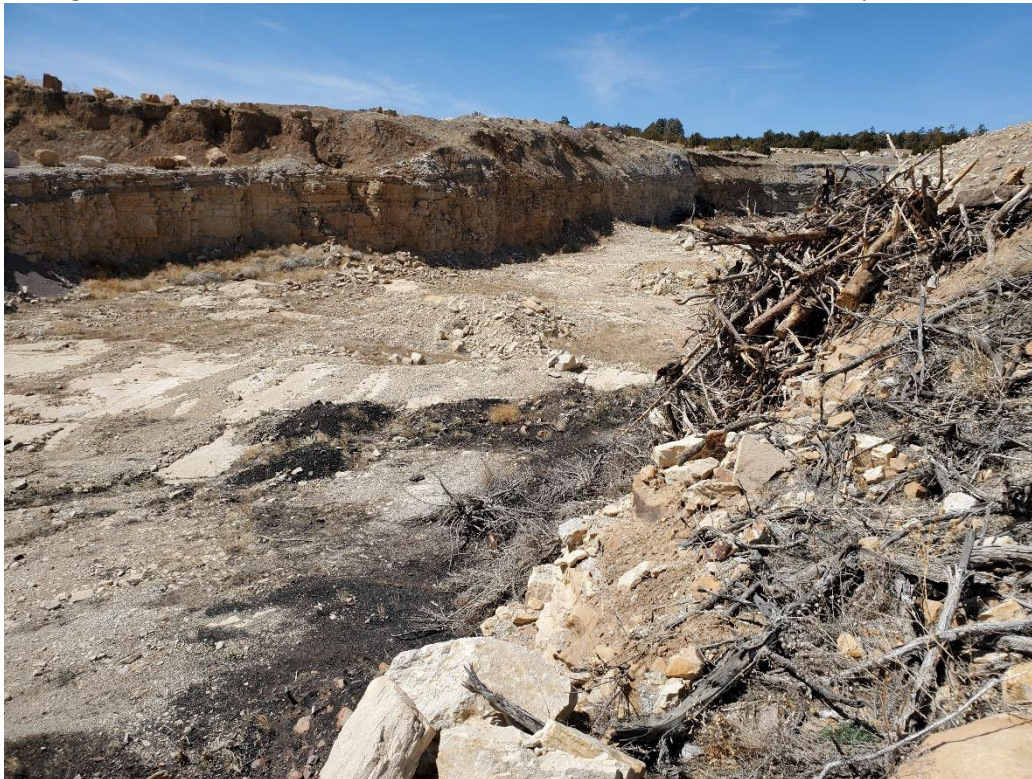
Woody debris was observed along the working area in the north-west portion of Area A (Photo 18). When asked about this, the Operator stated that that material was stockpiled while clearing the pit area and that it is systematically transported off-site to be used as firewood for their neighbors. The Operator reiterated that no woody debris is or has been used for backfill, complying with Rule 3.1.9(2).

Photo 18: Looking west from the top of the highwall located near the south-east side of topsoil pile #2 at woody debris.

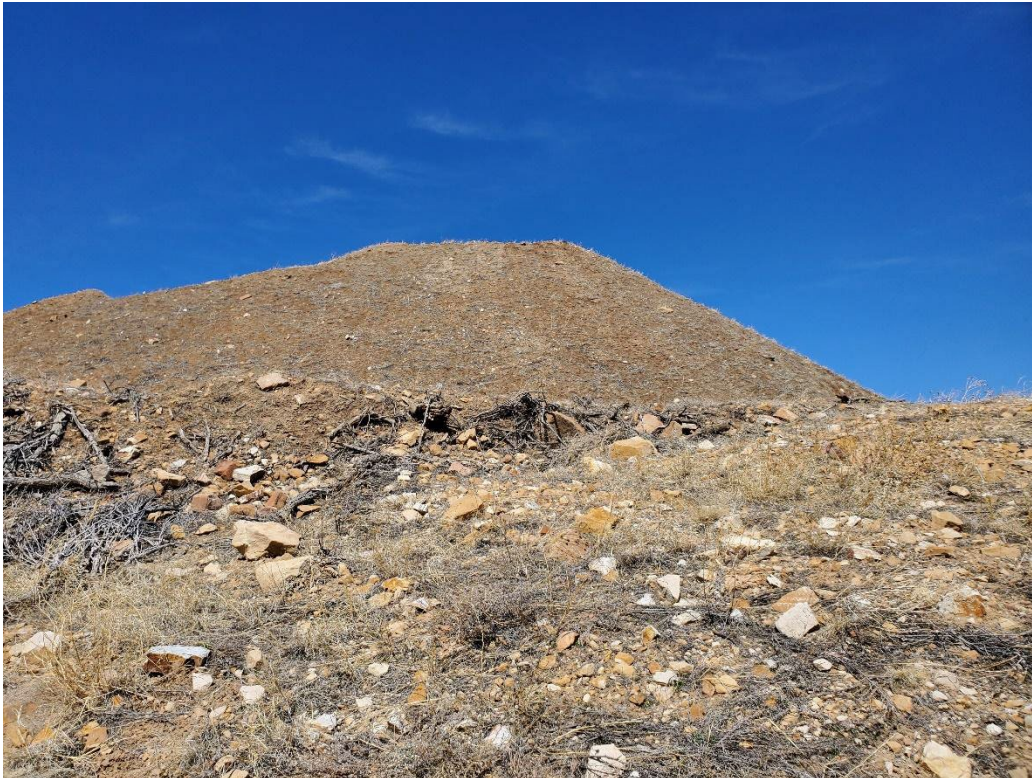
Photo 19: Looking north at topsoil pile #2 from top of the highwall.

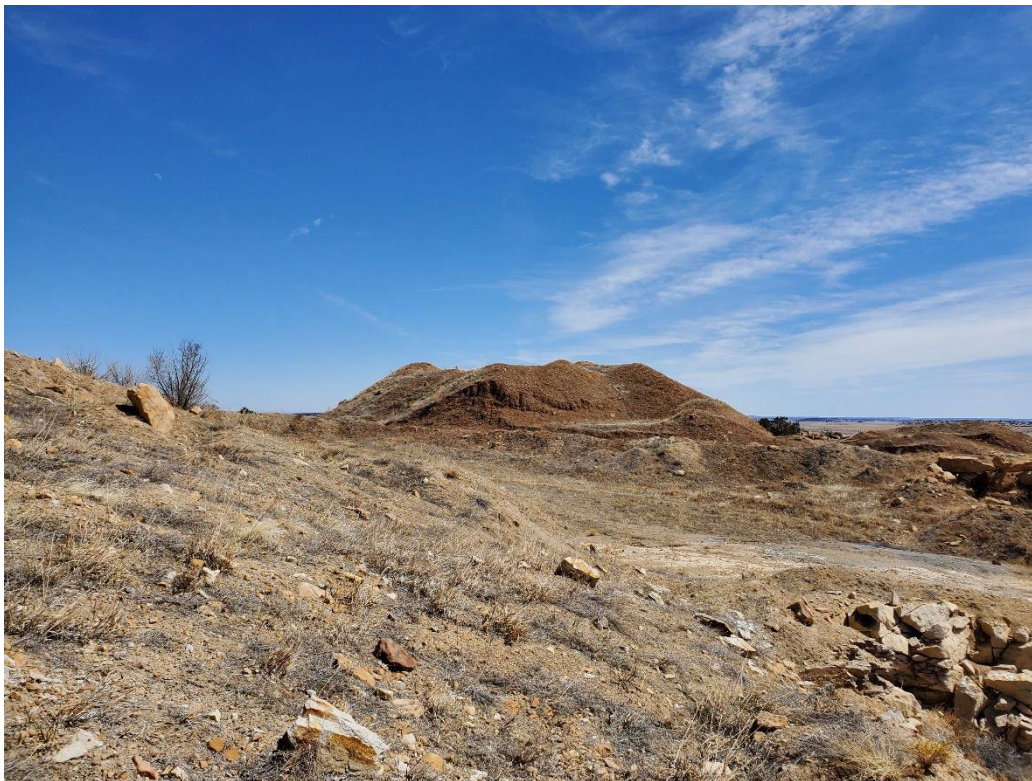
Photo 20: Looking south-east from top of the highwall, looking at topsoil pile #3.

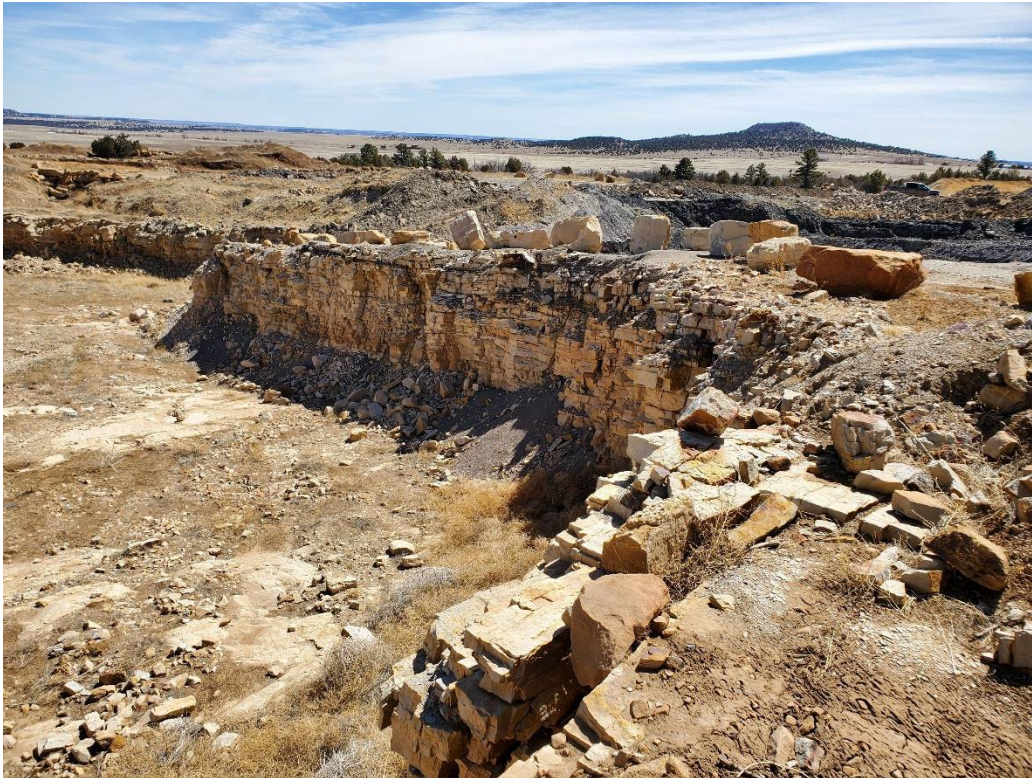
Photo 21: Looking south-east from middle highwall.

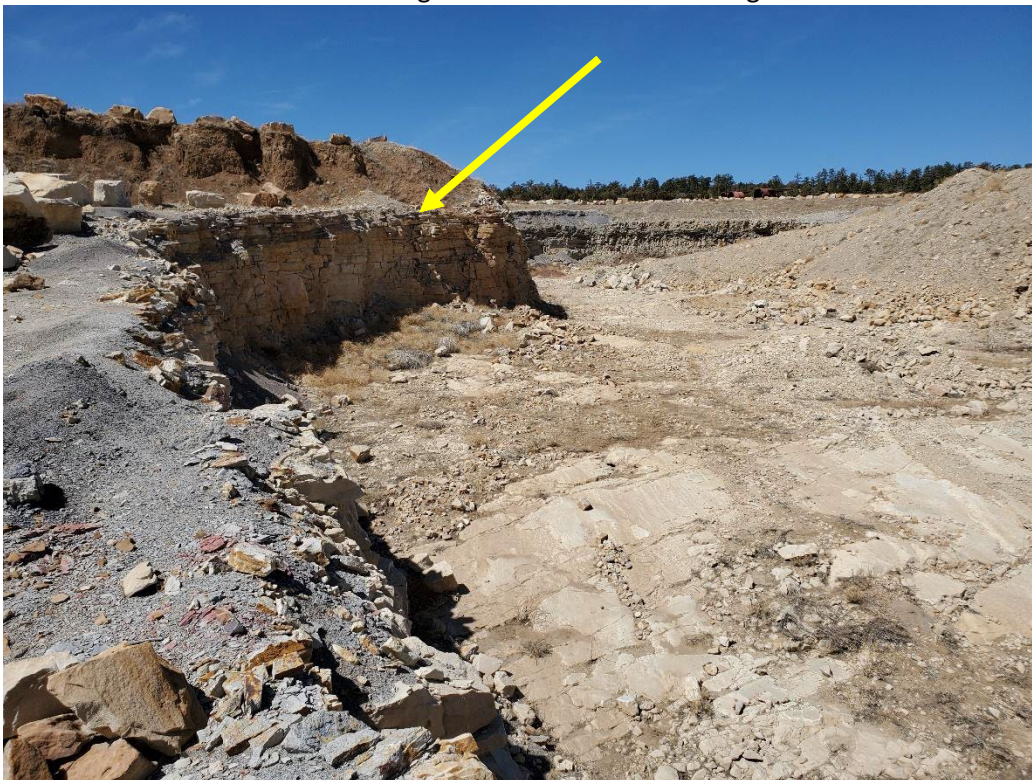
Photo 22: Looking northwest at the measured middle section of the highwall. The arrow points to the east edge of the unmeasured section (blue on Maps 1 and 3).

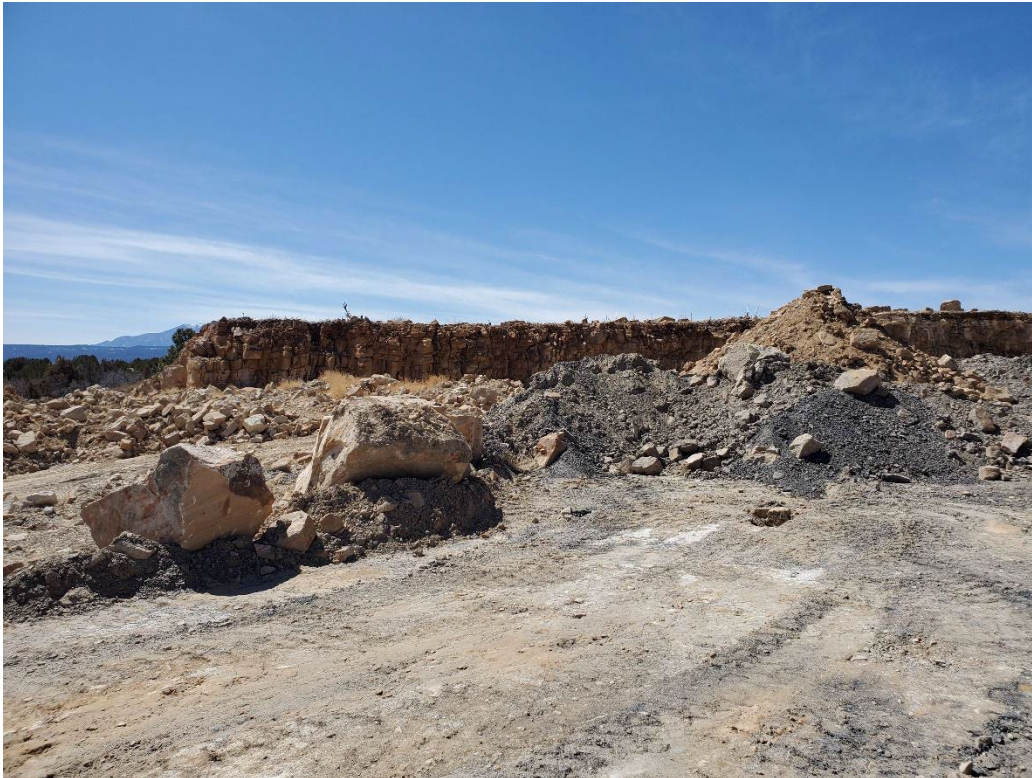
Photo 23: Entrance to south-west pit area, looking south.

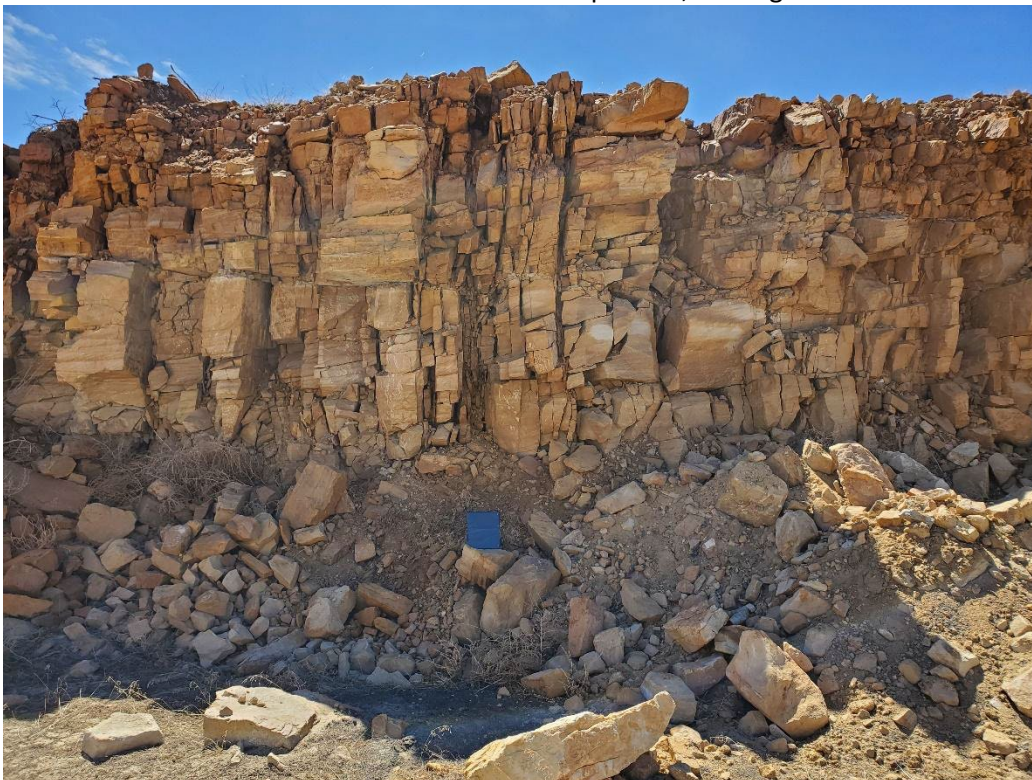
Photo 24: Highwall used to measure average highwall height. An 11.5" x 10" binder was used for scale, the highwall was approximately 18' tall.

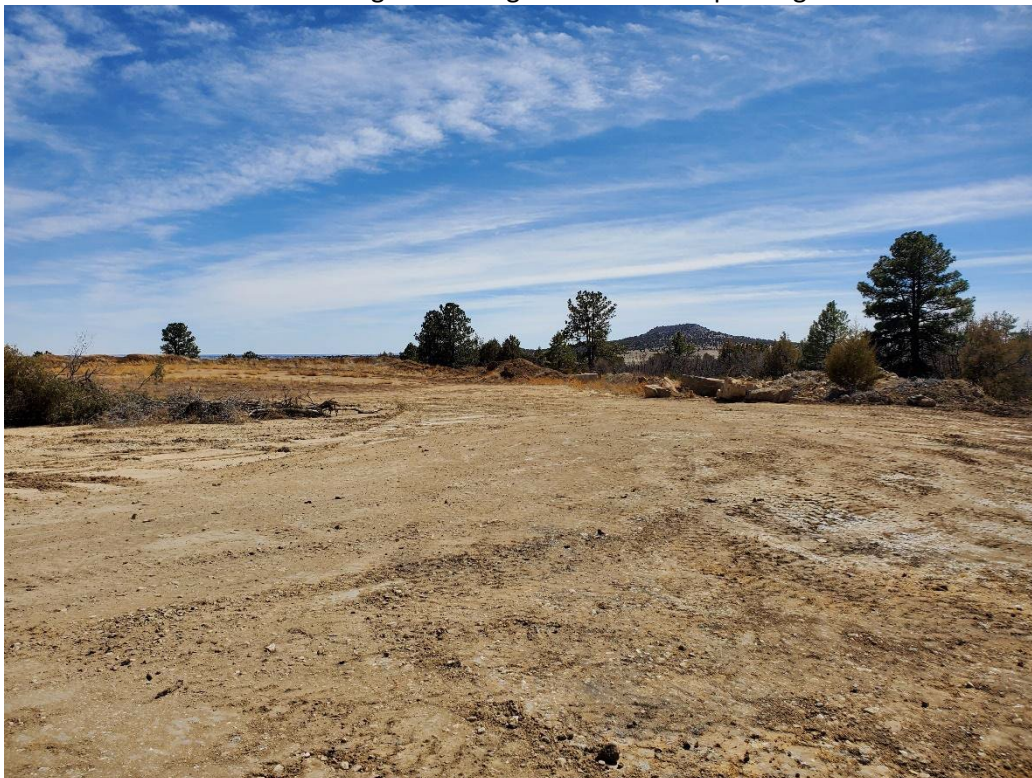
In the south-west portion of Area A, reclamation has recently begun. The Operator stated that they have recently graded this area and have yet to seed it (Photos 26 and 27). No slopes greater than 3H:1V were observed. Additionally, a clay stockpile that was not labeled on the Operator's most recent annual report was observed. The Operator stated that the pile had been placed in this area after the annual map was submitted (Photo 27). All observed product stockpiles onsite appeared to be well maintained and stable (Photos 2, 6, and

Photo 26: Looking at east across the recently reclaimed area in Area A.

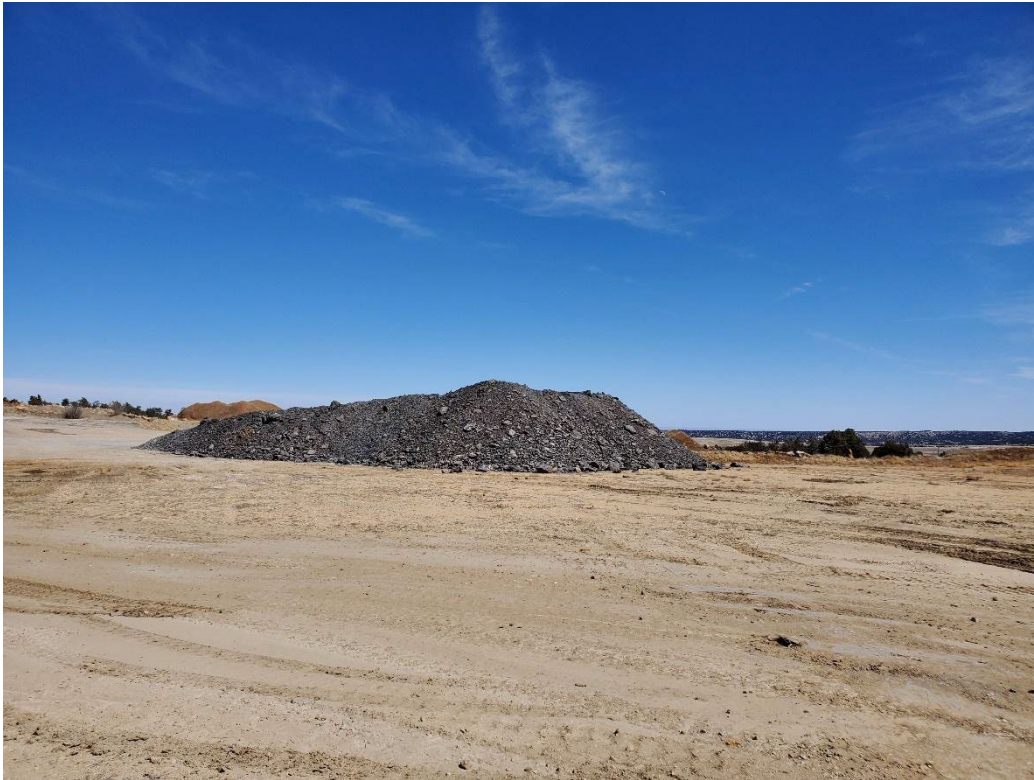
Photo 27: Looking north from the recently reclaimed land in Area A. A new clay stockpile was placed shortly before the Division's inspection.

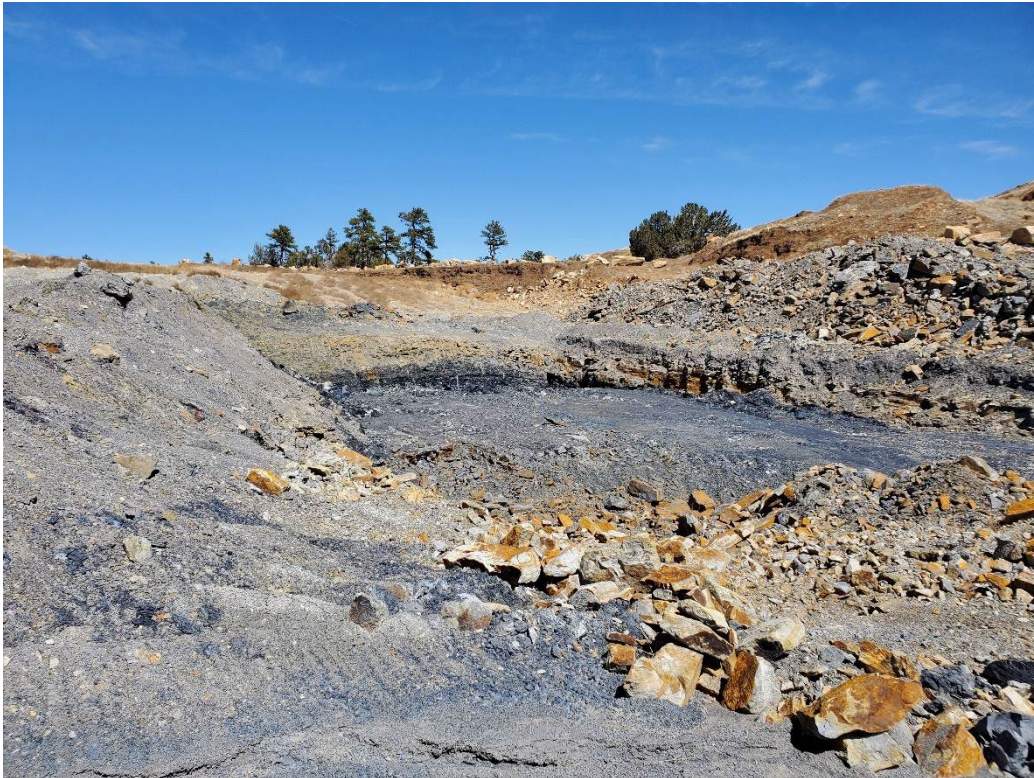
Photo 31: Looking north-east at eastern-most pit area.

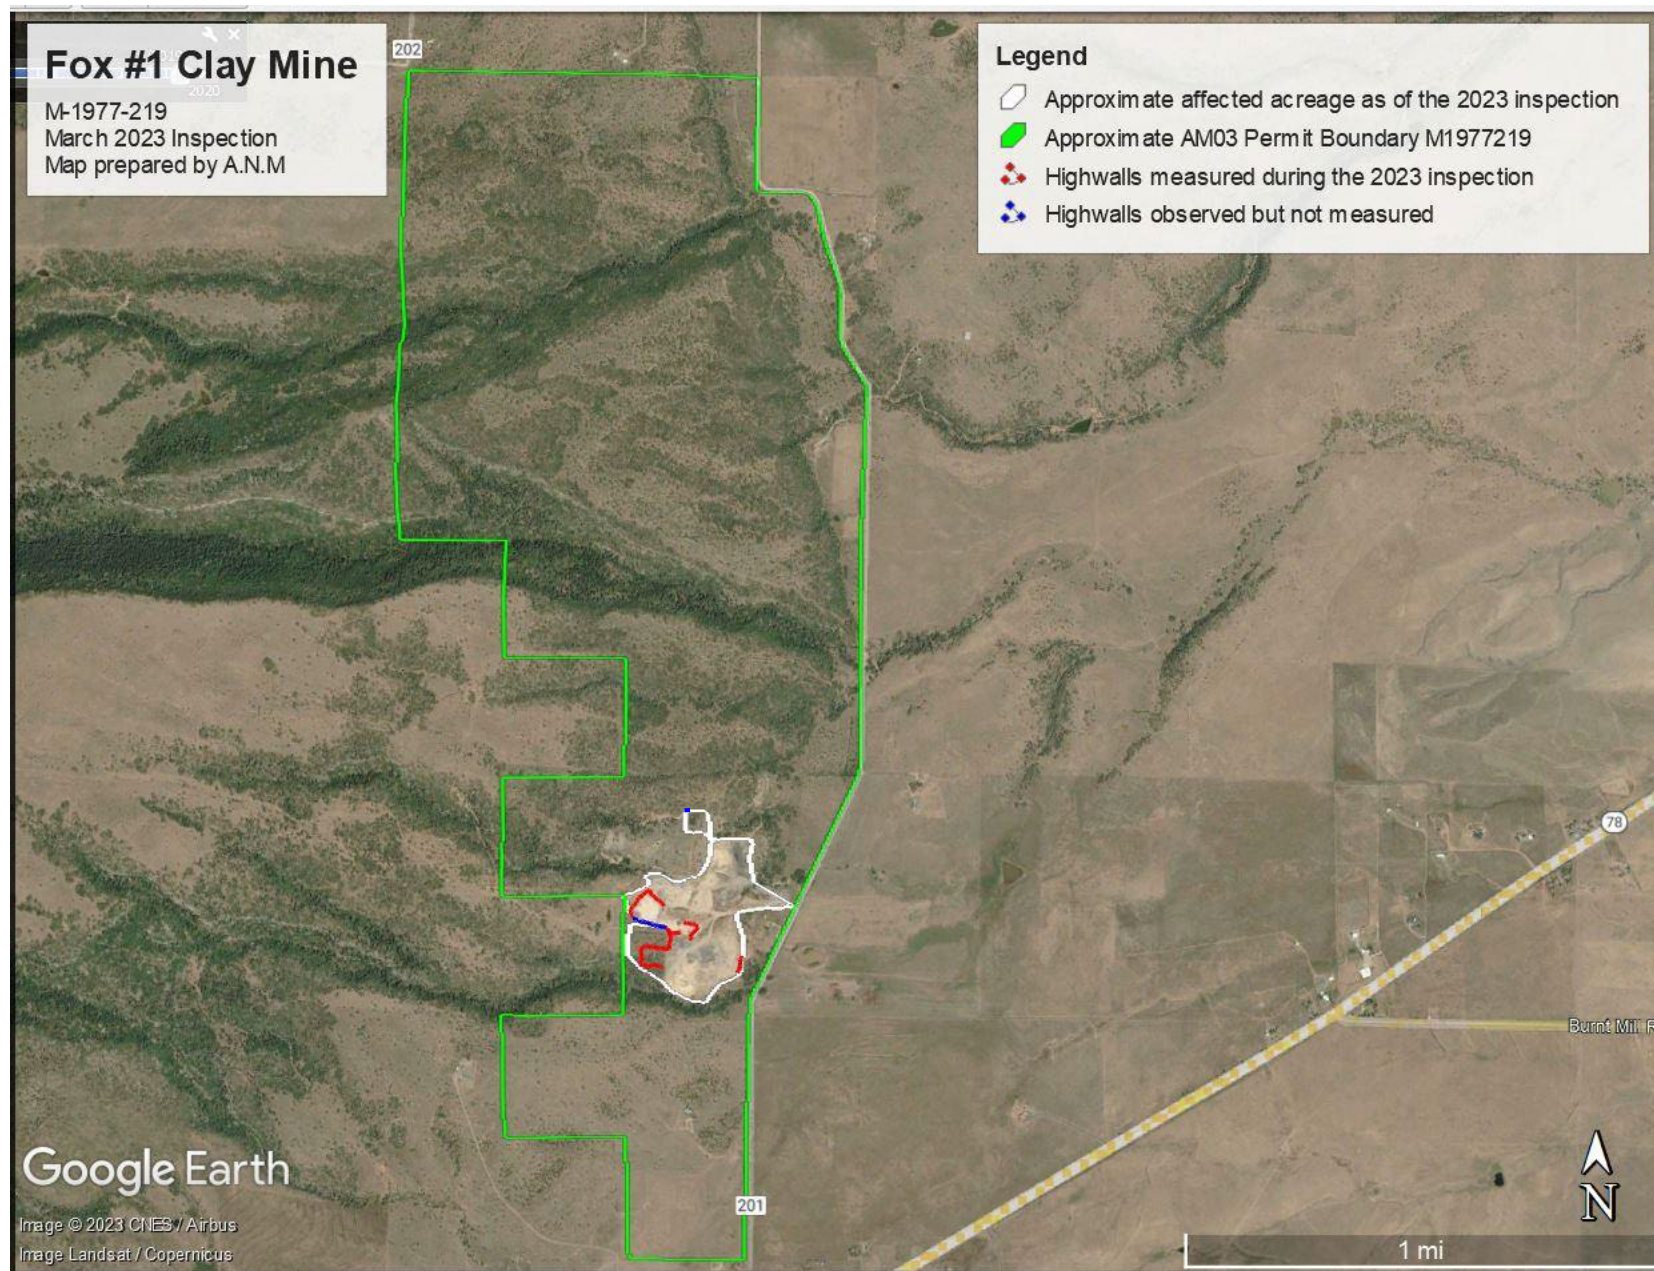
Map 1: Map generated in Google Earth Pro showing the approximate permit boundary, the field and Google Earth Pro measured highwall lengths, and the estimated current disturbance measured from field observations and Google Earth Pro.
