MINERALS PROGRAM INSPECTION REPORT
PHONE: (303) 866-3567

MINE NAME: Fox #1 Clay Mine	MINE/PROSPECTING ID#: M-1977-219	MINERAL: Clay, sandstone, and borrow material	COUNTY: Pueblo
INSPECTION TYPE: Monitoring	WEATHER: Clear	INSP. DATE: March 28, 2023	INSP. TIME: 12:00
OPERATOR: Summit Brick & Tile Co.	OPERATOR REPRESENTATIVE: Julie Welte	TYPE OF OPERATION: 112c - Construction Regular Operation

Fox #1 Clay Mine
M-1977-219
March 2023 Inspection

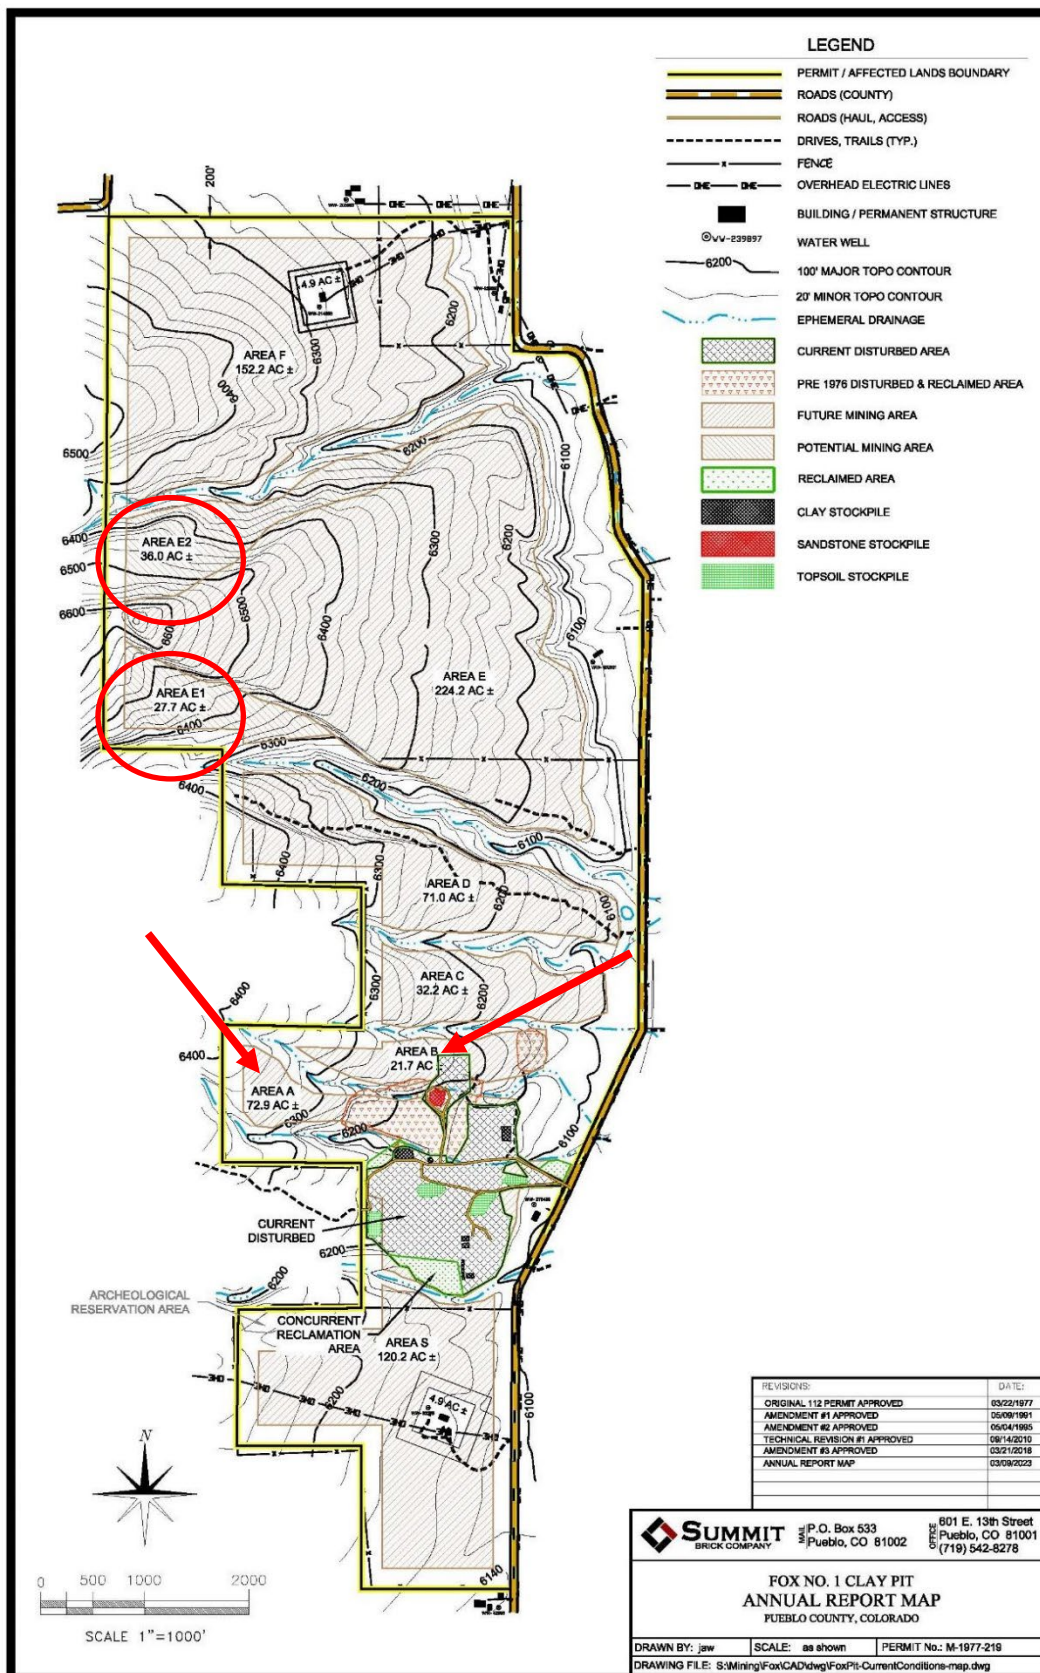
On the 2023 Annual Report Map (see Map 2), Areas E1 and E2 are labeled as potential mining areas. The Division's 2017 inspection report states that the canyon and drainage areas that cut through the mine site (Wales Canyon and Galbeth Creek) were not proposed to be mined and represent breaks in the mining area. When asked, the Operator stated that they'd follow up with the map preparer and ask why E1 and E2 were listed as potential mining areas. Upon following up, the Operator stated that their map preparer informed them that areas E1 and E2 are not actually part of the drainage ways of Galbeth Creek or Wales Canyon. She then said the preparer stated that in the field it is easier to see this, and it's more difficult on the topographical map due to the large contour intervals. The Operator reiterated that their approved mining plan states that all surface drainage ways will remain in their current state, and that they will adhere to this requirement when they mine near the drainage ways in the future.

Map 2: A copy of the Operator's 2023 Annual Report map edited to highlight the inspected mining Areas. The arrows indicate the current areas that have been disturbed by mining operations. Encircled are Areas E1 and E2 that are labeled as "potential mining areas" by the Operator.
