**PERMIT INFORMATION**

| <b>Permit Number:</b> C-1981-019<br><b>Mine Name:</b> Colowyo Coal Mine<br><b>Operator:</b> Colowyo Coal Company L.P.<br><b>Operator Address:</b><br>Mr Tony Tennyson<br>5731 State Highway 13<br>Meeker, CO 81641 | <b>County:</b> Moffat, Rio Blanco<br><b>Operation Type:</b> Surface<br><b>Permit Status:</b> Active<br><b>Ownership:</b> Private |

**INSPECTION INFORMATION**

| <b>Inspection Start Date:</b> April 20, 2023<br><b>Inspection Start Time:</b> 07:30<br><b>Inspection End Date:</b> April 20, 2023<br><b>Inspection End Time:</b> 13:00 | | <b>Inspection Type:</b> Coal Partial Inspection<br><b>Inspection Reason:</b> Normal I&E Program<br><b>Weather:</b> Clear | |

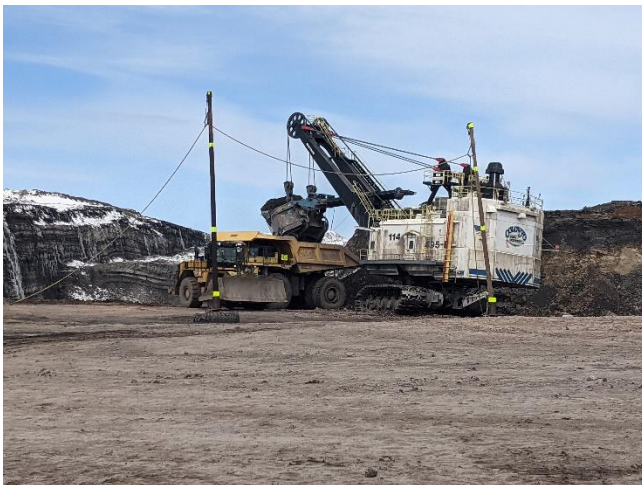
Truck and shovel operations were occurring in the Collom Pit. Spoil was being transported to the eastern side of the Collom Spoil Pile where it was being staged for spreading.

Truck and shovel operations at Collom Pit.

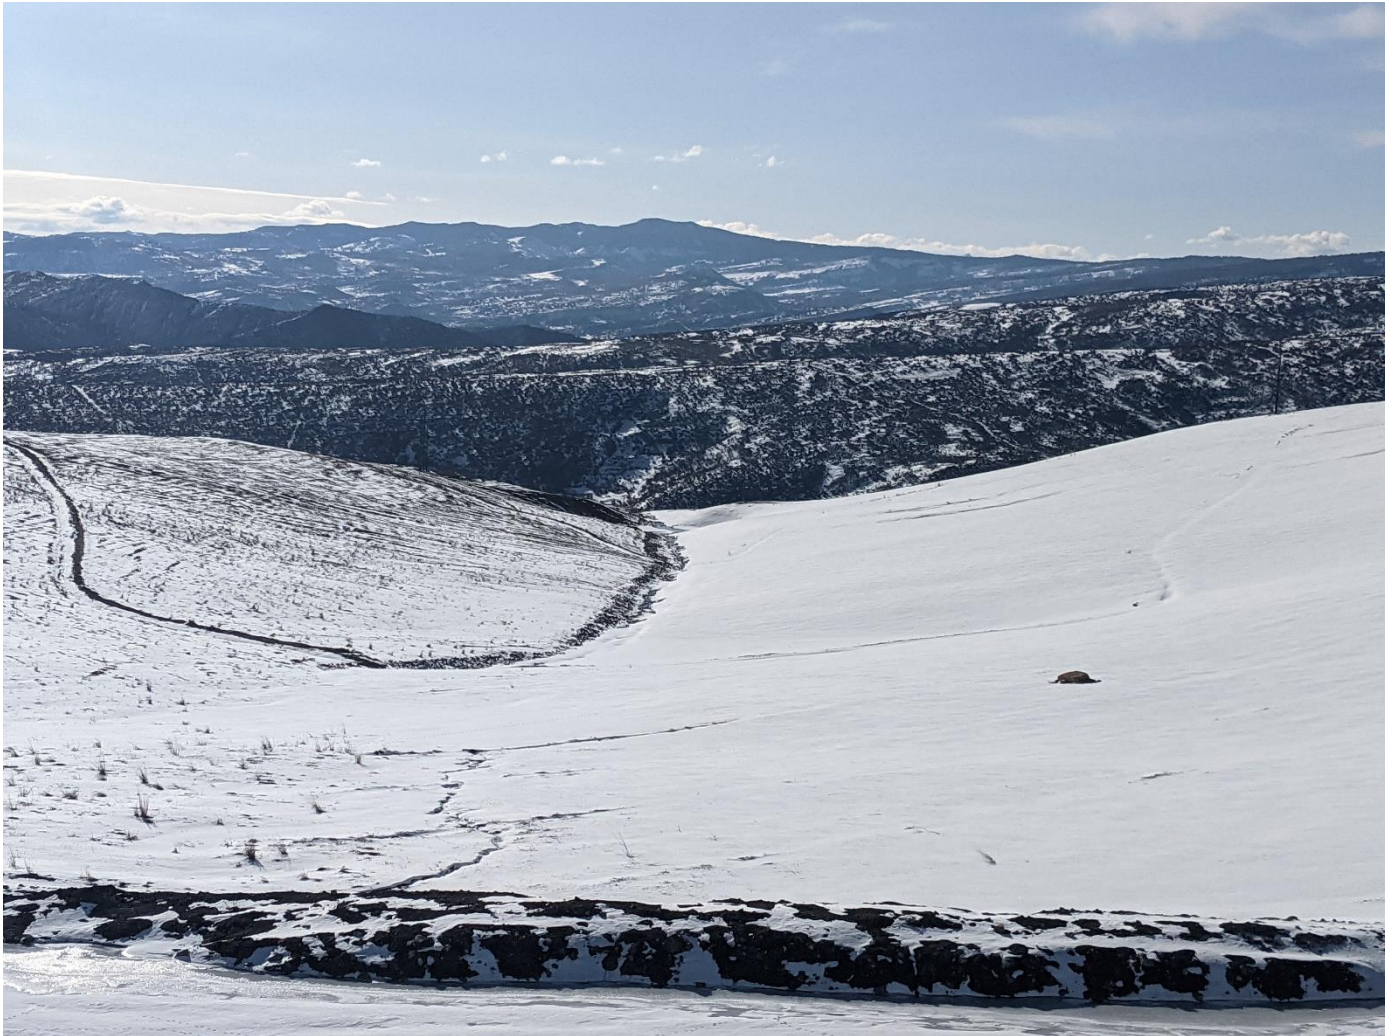
Reach 3 of the Final East Pit Ditch was inspected from above. The inspector attempted to access the ditch by foot however due to snow depths along with rapid snow melt, the area was muddy and difficult to traverse. As noted, the ditch was observed from above and only Reach 3 could be inspected. This portion of the Final East Pit Ditch was snow covered but appeared stable and no issues could be observed.

Reach 3 of Final East Pit Ditch.

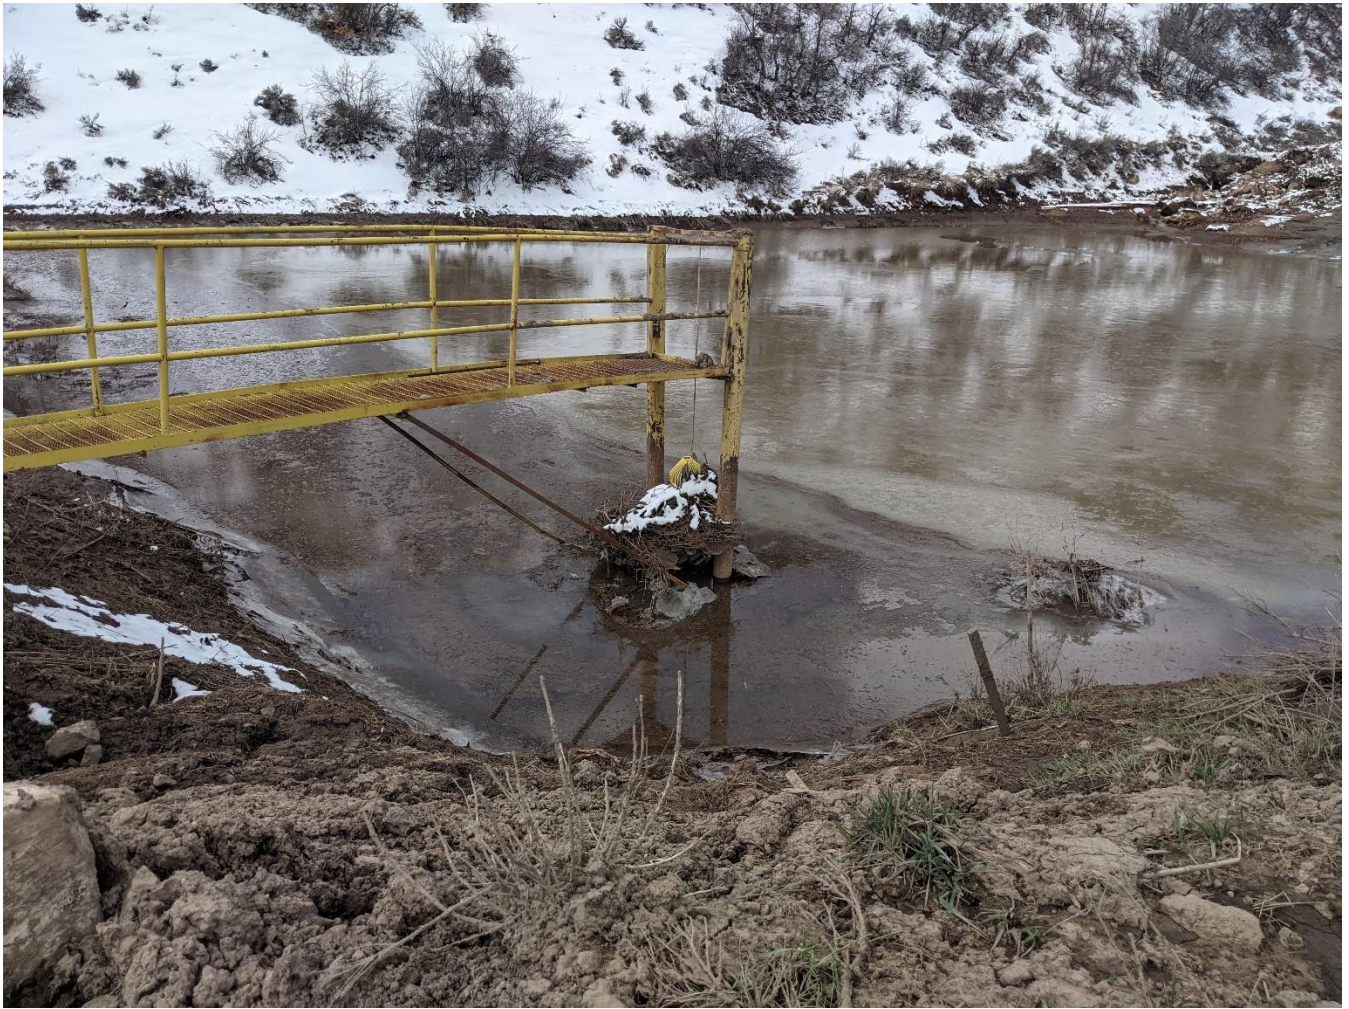
The Prospect and Streeter Ponds were inspected. These ponds are located along the Highway 13 corridor and receive surface runoff associated with the East Pit. Both ponds held water and were discharging during the inspection. As noted in previous inspections, the Prospect Pond was in the process of being cleaned. A portion of sediment has staged along the inner embankment of the pond for removal however, due to weather conditions, this has been postponed. The primary spillway associated with the Prospect Pond had debris such as sticks and dead vegetation frozen along the top of the trash rack. To ensure the spillway is fully functional, the debris will need to be removed from the top of the trash rack and this has been noted as a maintenance item. The mine representative stated the debris would be removed from the spillway. Both ponds were stable at the time of the inspection with no major issues observed.

Debris froze on trash rack of Prospect Pond spillway.

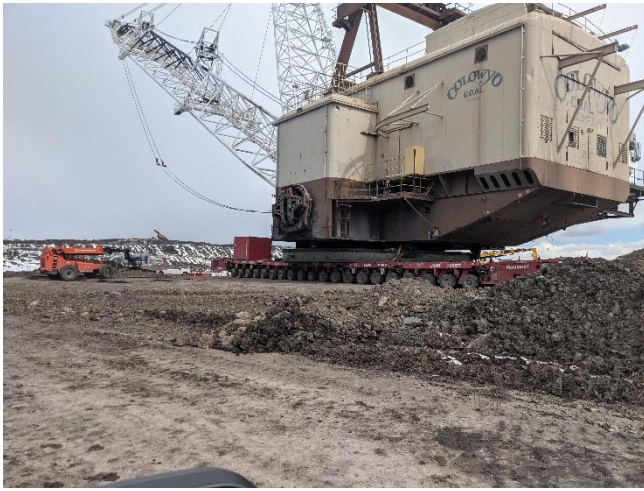
The dragline was being transported to the Collom Pit at the time of the inspection. The dragline was being staged near the Collom Pit to assist with backfill at the Collom Pit for contemporaneous reclamation.

Dragline transport.

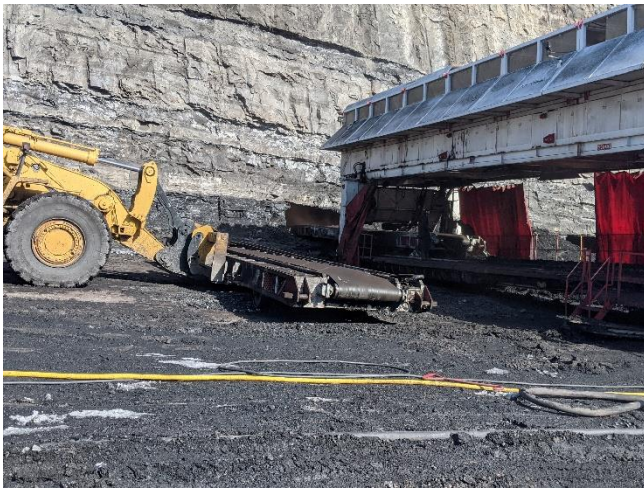
Highwall mining operations were observed in the South Taylor Pit. The operation was along the southern extent of the western highwall moving in the southern direction. Previously mined entries have been backfilled as required per the Rules.

Highwall mining operation at South Taylor Pit.
