Fall 2022 Subsidence and Geologic Field Observations

Southern Panels and Sunset Trail Mining Areas

Jonathan M. Kelly, P.E., Project Manager
Wright Water Engineers, Inc.

April 2023

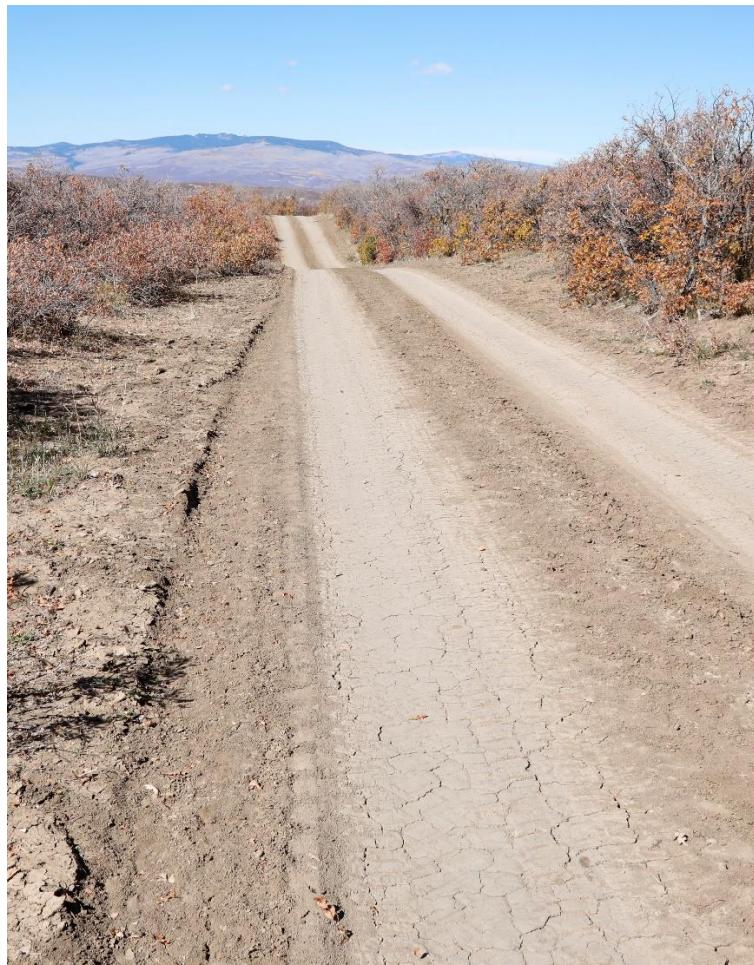
During the fall 2022 site visit, the previously observed cracks at Location 1 were no longer evident. There appears to have been recent rainfall and subsequent drying of the soil as evidenced by extensive desiccation cracking (Figure 1). The lack of observation of the previous cracks was not surprising since they were likely dynamic subsidence cracks that formed as the mining face passed

and subsequently healed. In addition, there was evidence of recent road work with heavy equipment present in the area that would make observations of the previously observed cracks difficult given their small size.

Figure 1: Southeast view of Location 1, where subsidence cracks were previously observed parallel to road on Traverse C-C' located over the E14 Headgate, between crosscuts 23 and 22.

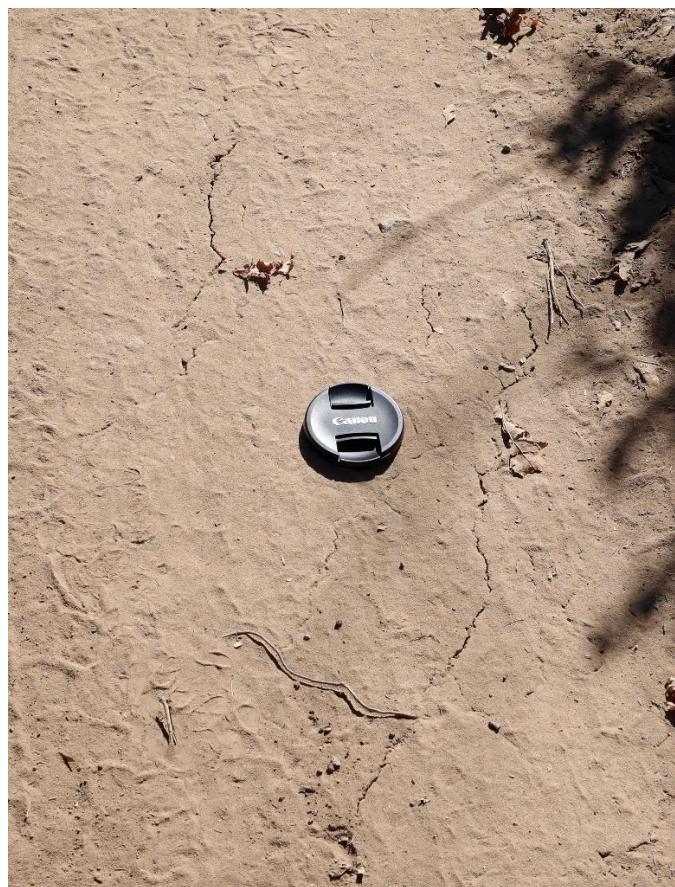
The cracks at Location 2 were no longer evident during the fall 2022 site visit. Approximately 100 feet to the southeast along the road, small residual cracking was observed near Location 2 with similar orientation to those previously observed nearby (Figure 2). The cracking was significantly less than the cracking observed near Location 2 during the spring 2022 visit.

Figure 2: East-Southeast view of small subsidence crack diagonal across road on Traverse C-C' near Location 2.

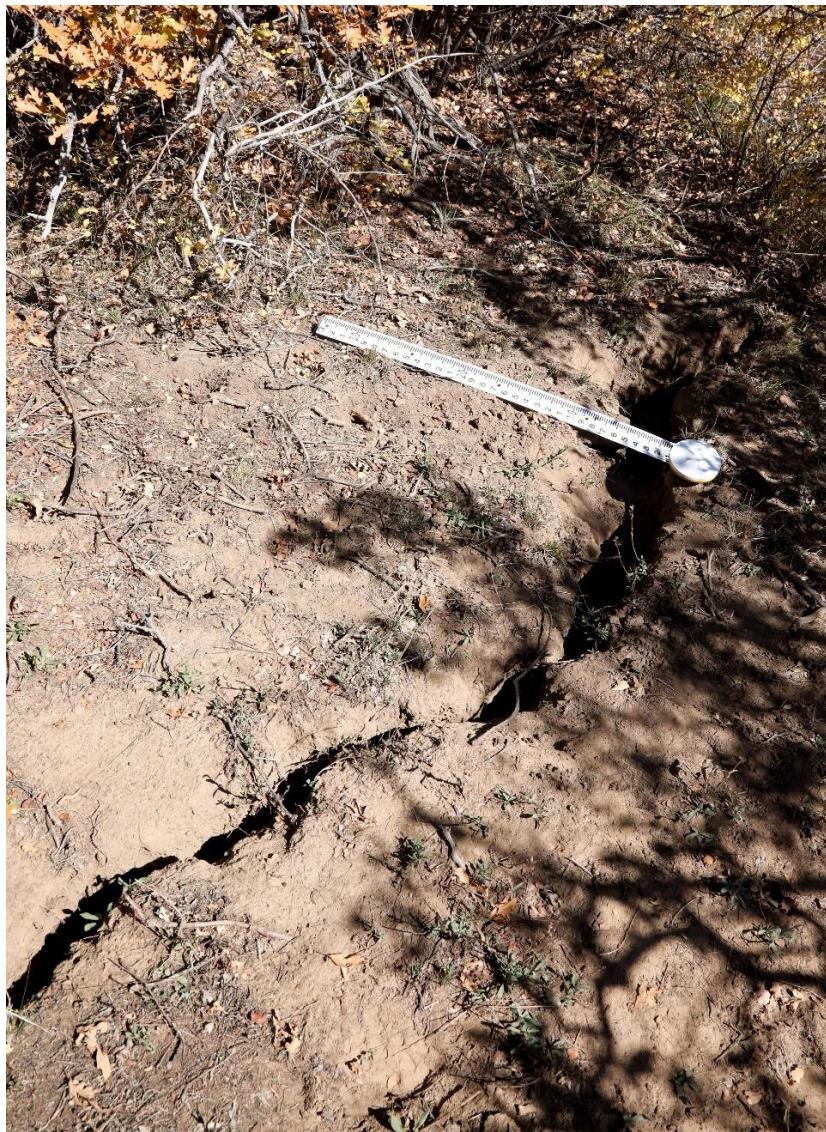
Headgate with an orientation of South 40° East. The cracks were spaced approximately 5 to 10 feet apart on a downhill slope of 5 to 15 degrees. The largest of the observed cracks followed the contour for approximately 100 feet. It had a maximum depth of 2.5 feet and a maximum width of 0.5 feet (Figure 3).

Figure 3: The largest of the cracks observed at Location 3, south of the across road on Traverse C-C'.

The location of these cracks is consistent with locations where the tilt and horizontal displacement are largest near the edge of the panel as shown in Figure 3 of Exhibit 60E (WWE 2018). The

existence of the series of parallel cracks was likely a combination of these horizontal strains in combination with the natural sloped hillside. In total, there were 5 cracks observed with the dimensions of the cracks generally decreasing in the downhill direction towards the center of the longwall panel. One of the downhill, parallel cracks is shown in Figure 4.

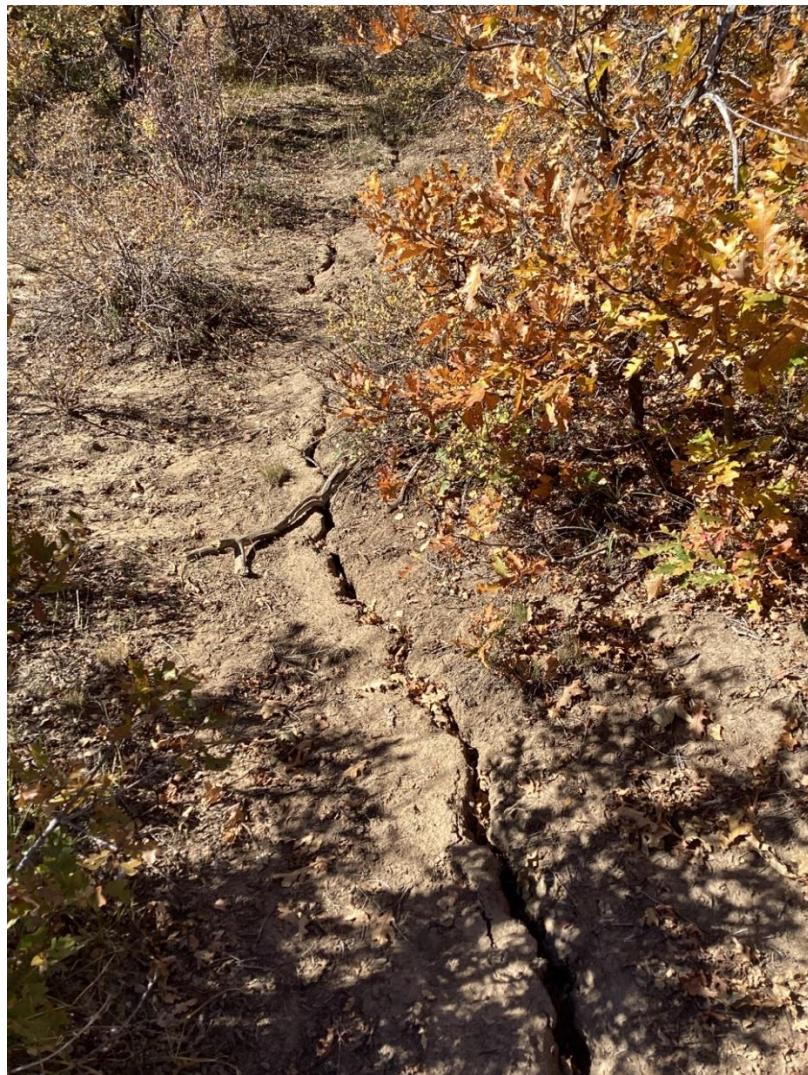
Figure 4: One of the downhill, parallel cracks observed at Location 3, south of the across road on Traverse C-C'.
