Inspection reports

<b>Permit Number:</b> C-1996-084 <b>Mine Name:</b> Lorencito Canyon Mine <b>Operator:</b> New Elk Coal Company, LLC <b>Operator Address:</b> Mr. Mark Gray 12250 Highway 12 Weston, CO 81091	<b>County:</b> Las Animas <b>Operation Type:</b> Surface <b>Permit Status:</b> Permanent Cessation <b>Ownership:</b> Private
	<b>Operator Representative Present:</b>  Bill Roddy
<b>Operator Representative Signature: (Field Issuance Only)</b>

<b>Inspection Start Date:</b> April 20, 2023 <b>Inspection Start Time:</b> 12:00 <b>Inspection End Date:</b> April 20, 2023 <b>Inspection End Time:</b> 14:00	<b>Inspection Type:</b> Coal Partial Inspection <b>Inspection Reason:</b> Normal I&E Program <b>Weather:</b> Clear
<b>Joint Inspection Agency:</b>  None	<b>Joint Inspection Contacts:</b>
<b>Post Inspection Agency:</b>  None	<b>Post Inspection Contacts:</b>
<b>Inspector(s):</b>  Brock Bowles	<b>Inspector's Signature:</b>

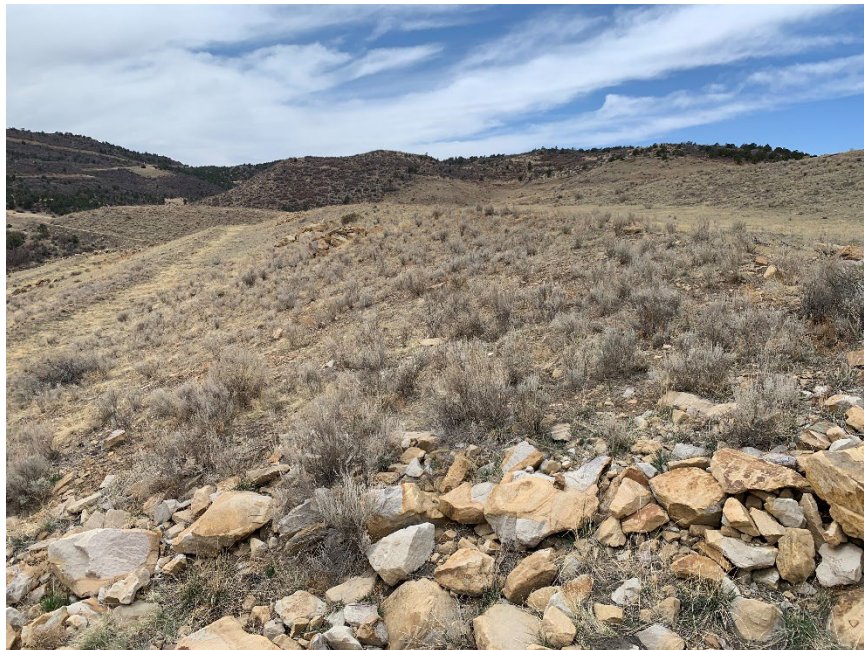
Fill 7 is in final reclamation. It has been graded, topsoiled and seeded. The lateral ditches were well vegetated and sloped appropriately to direct all surface runoff to the perimeter ditches (photo 1). The perimeter ditches were armored with large rocks and vegetation was growing between the rocks. The perimeter ditches appeared to be stable and no erosion was seen. A couple of rills were seen on the face of the fill. The rills appeared to be older as they were filling in with vegetation. This is a good sign that the vegetation is controlling erosion and stabilizing the soil (photo 2). No tension cracks were noted and no evidence of springs were seen. Fill #7 appears to be stable. In the section 'Documentation and Other Observations' of the March 28 fill report it states that the east armored down drain has a washed out spot that may need some repair. This spot was not observed during this inspection. DRMS will meet with the operator to locate this spot for evaluation.

Photo 1 – Lateral ditches on Fill 7

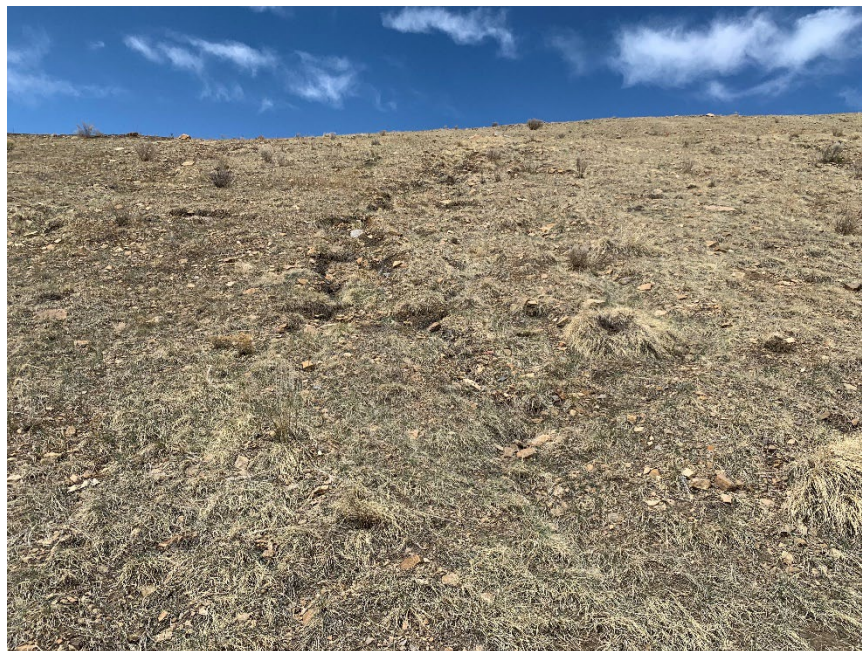
Photo 2 – Old rills filling in and stabilized with vegetation

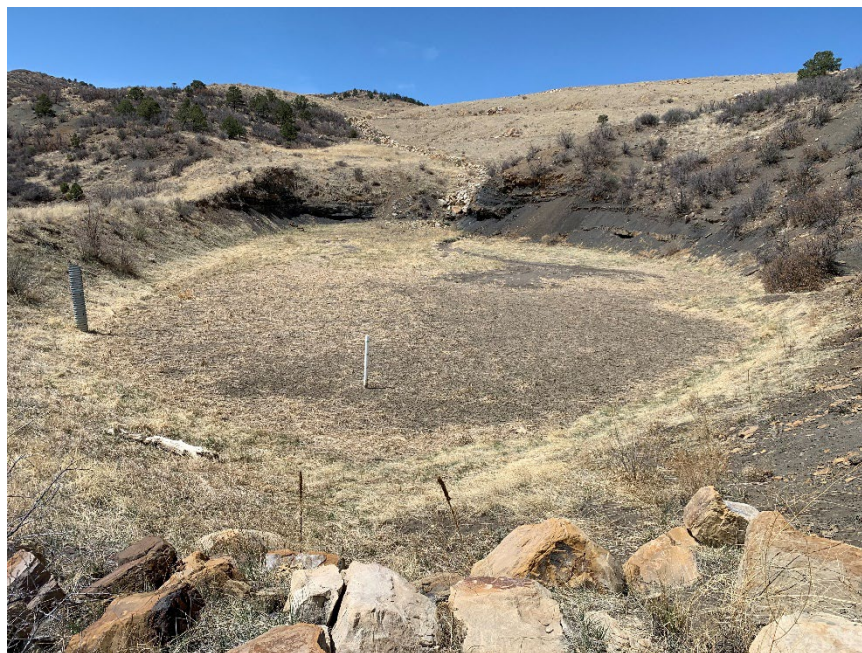
Pond 7 did not contain water. The bottom of the pond and embankment were well vegetated (photo 3). There were no observed tension cracks or animal burrows on the embankment.

Photo 3 – Pond 7

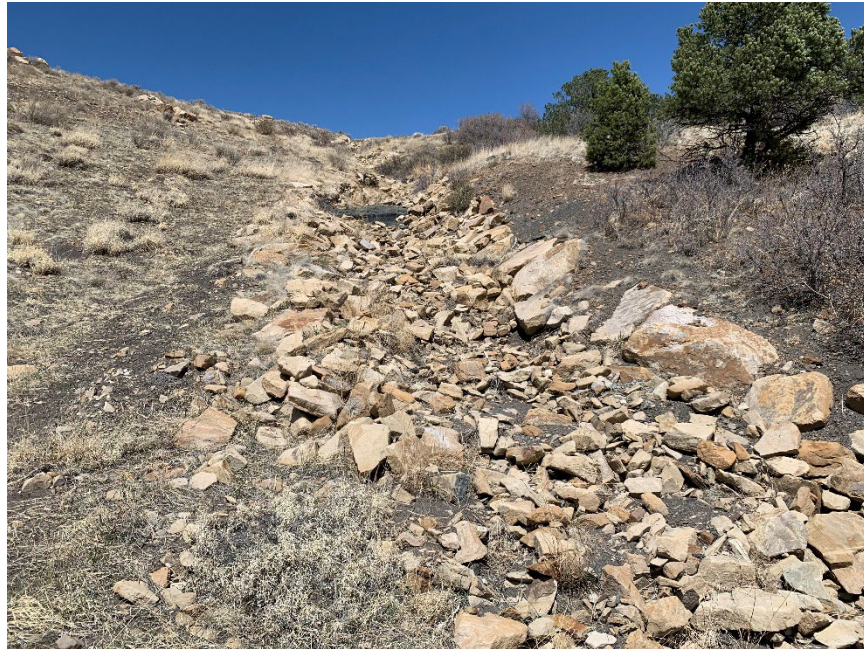
Fill 9 is in final reclamation. It has been graded, topsoiled and seeded. The lateral ditches were well vegetated and sloped appropriately to direct all surface runoff to the perimeter ditches. The perimeter ditches were armored with large rocks and vegetation was growing between the rocks (photo 4). The perimeter ditches appeared to be stable and no erosion was seen. The face of the fill was well vegetated and appears to be effectively controlling erosion (photo 5). No tension cracks were noted and no evidence of springs were seen. Fill #9 appears to be stable.

Photo 4 – Fill 9 east perimeter ditch

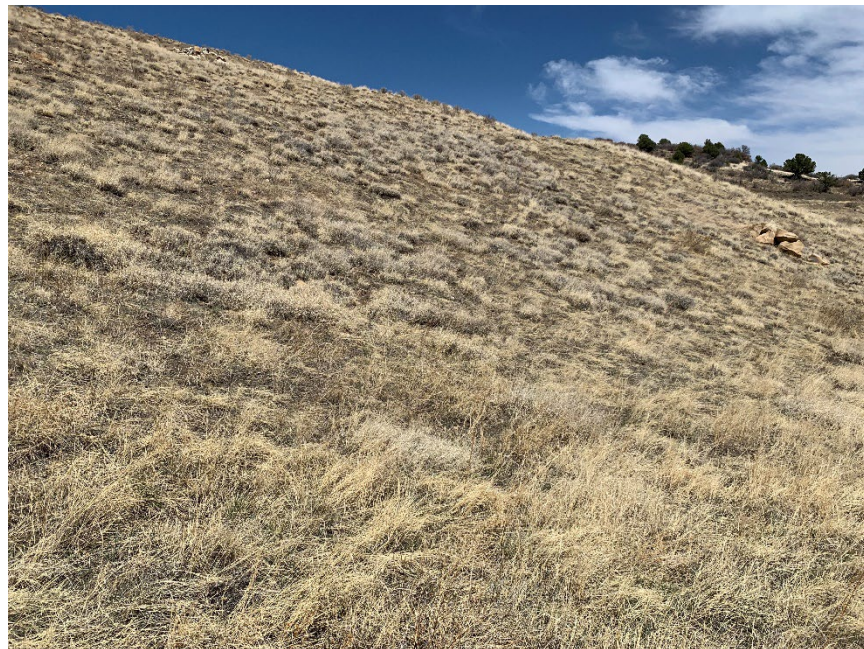
Photo 5 – Vegetation on face of Fill 9
