Inspection reports

PERMIT INFORMATION

Permit Number: C-1981-012 Mine Name: New Elk Mine Operator: New Elk Coal Company, LLC Operator Address: Mr. Mark Gray 12250 Highway 12 Weston, CO 81091	County: Las Animas Operation Type: Underground Permit Status: Active Ownership: Private
	Operator Representative Present: Bill Stormes
Operator Representative Signature: (Field Issuance Only)

Inspection Start Date: April 20, 2023 Inspection Start Time: 08:00 Inspection End Date: April 20, 2023 Inspection End Time: 12:00	Inspection Type: Coal Partial Inspection Inspection Reason: Normal I&E Program Weather: Clear
Joint Inspection Agency: None	Joint Inspection Contacts:
Post Inspection Agency: None	Post Inspection Contacts:
Inspector(s): Brock Bowles	Inspector's Signature:

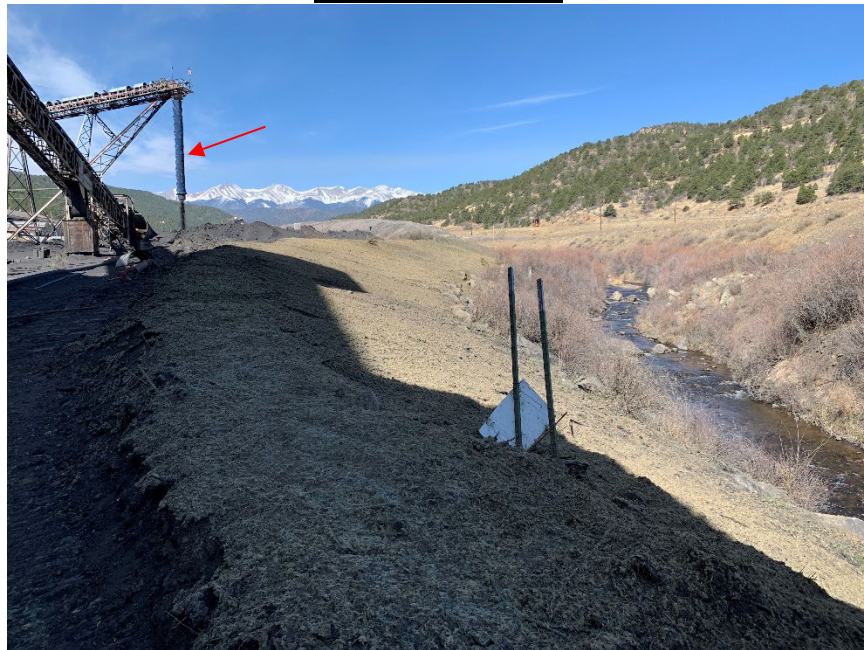
-A snorkel had been installed on the elevated conveyor belt which delivers coal to the raw coal pile (photo1). The snorkel is a device that directs the falling coal onto the top of the pile. The snorkel is adjustable so it can be set to within a couple of feet of the top of the pile, reducing the amount of time the falling coal is exposed to wind. This greatly reduced the amount of coal dust being blown off the pile.

-The dust that had blown off the pile has been cleaned up. The operator used a vacuum truck, hand tools and hand brooms to remove the coal dust from the stream buffer zone, among the rocks and around the willows. The areas where the coal dust had been removed were hydro seeded (photos 1 & 3).

Photo 1 – Snorkel on coal conveyor (arrow), hydro seeded stream buffer zone (right)

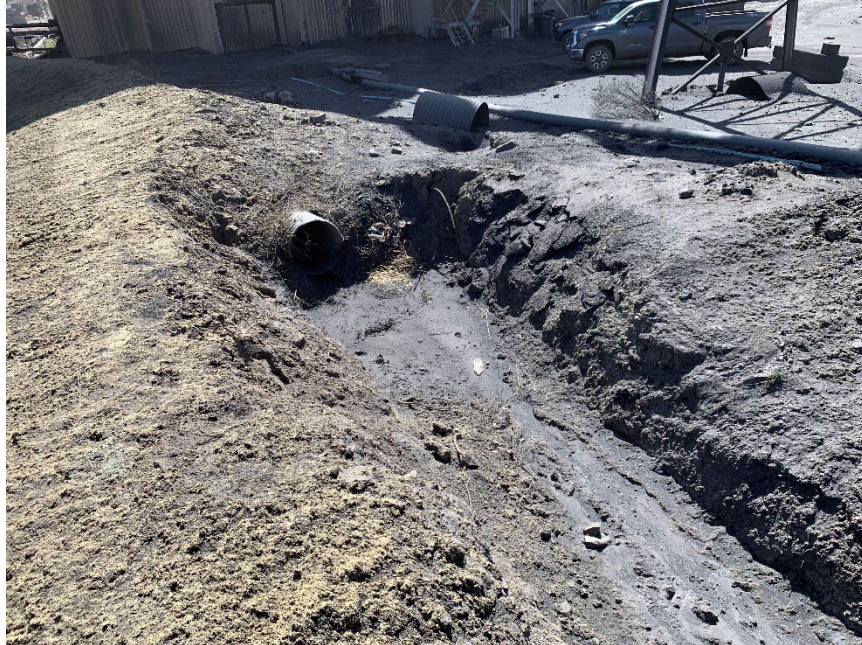
-Ditch D32 and Culvert C64 have been cleaned (photo 2).

Photo 2 - Ditch D32 and Culvert C64

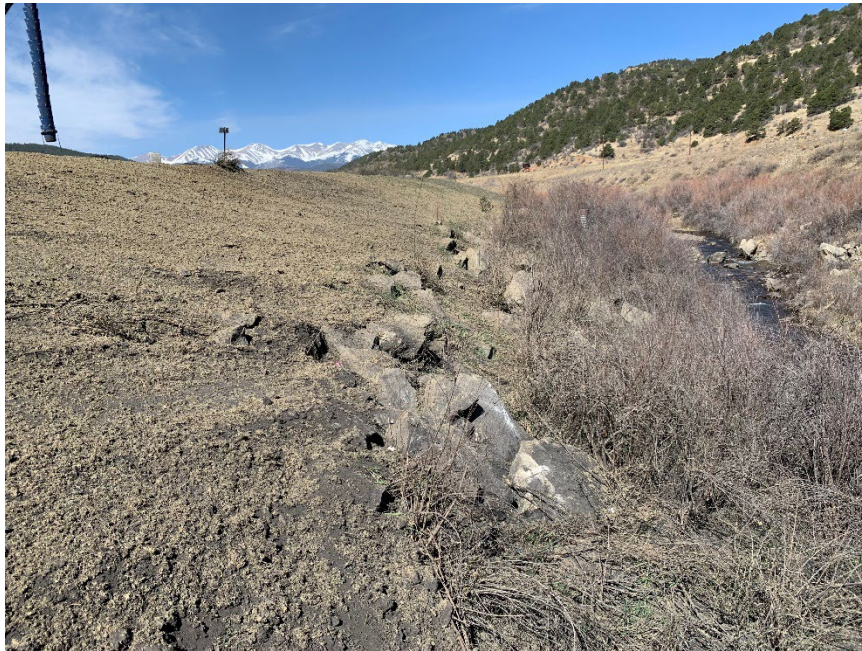
Photo 3 – Clean up and hydro seeded areas

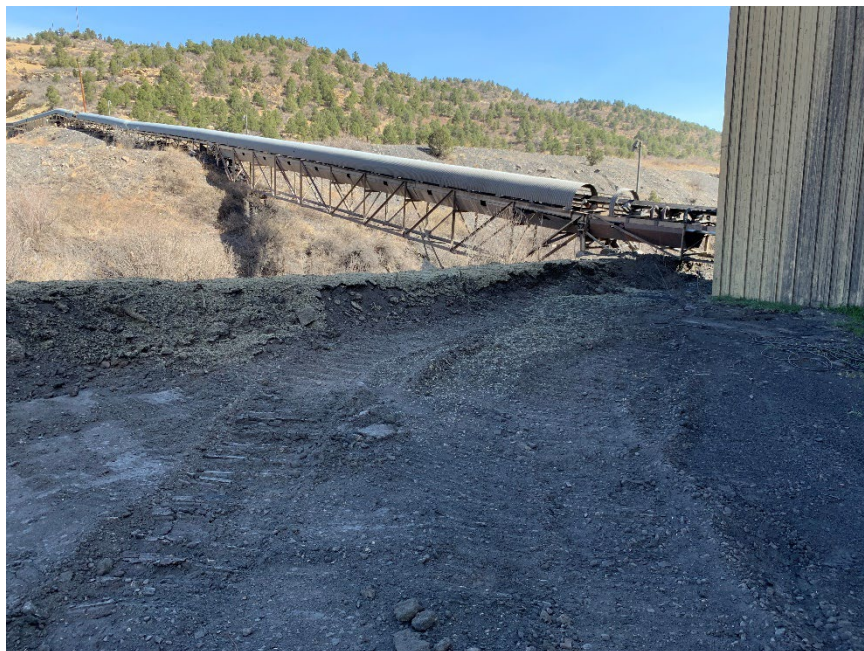
-The berm shown on Map 13 has been reestablished under the coal refuse conveyor belt (photo 4). The berm prevents disturbed area water from directly draining to the stream buffer zone and river. The berm directs disturbed area water to Pond 7 for treatment before discharging.

Photo 4 – Berm re-established under refuse disposal belt

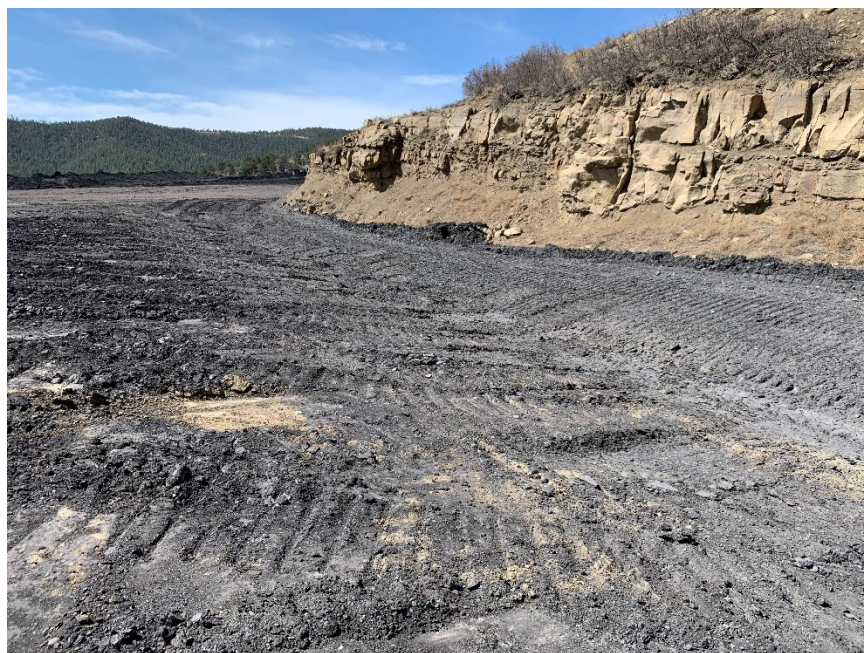
The top of the RDA pile and the surrounding drainage ditch have been recontoured to promote positive drainage (photo 5). The standing water noted in the last report has been drained.

Photo 5 – Drain ditch on top of RDA

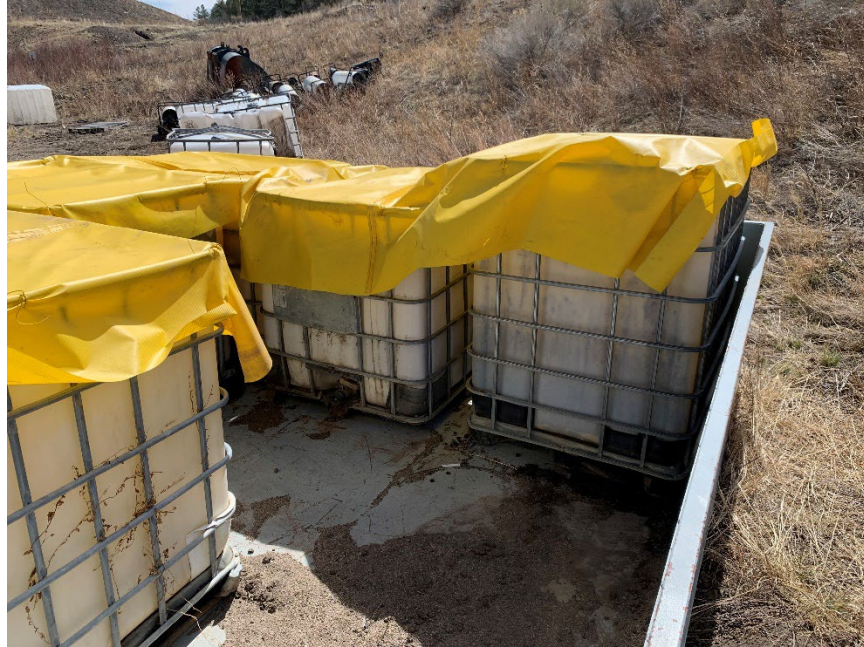
The large liquid containers stored in the Portable Explosive and Chemical Storage Area have been temporarily addressed. The damaged containers have been put into a large metal bin which is acting as secondary containment (photo 6). The damaged containers have also been covered in plastic to prevent precipitation from entering and overfilling the containers. New containers, also known as totes, are on order. The material in the damaged totes will be pumped to the new totes, when they arrive. All the liquids in the storage area are proposed to be inventoried, disposed of or consumed.

Photo 6 – Damaged totes covered and put in secondary containment
