To: Jerald Schnabel  
Riverbend Industries Inc.

From: Paul Kos  
Denver, CO 80222

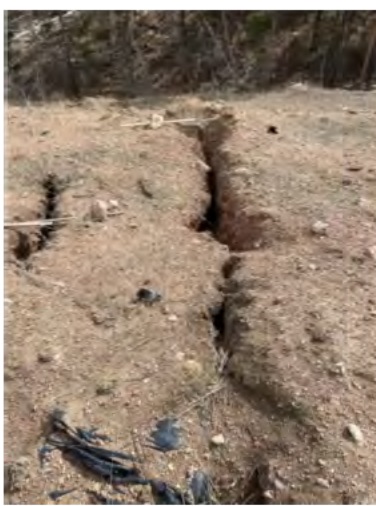
5. Cracks monitored on slopes

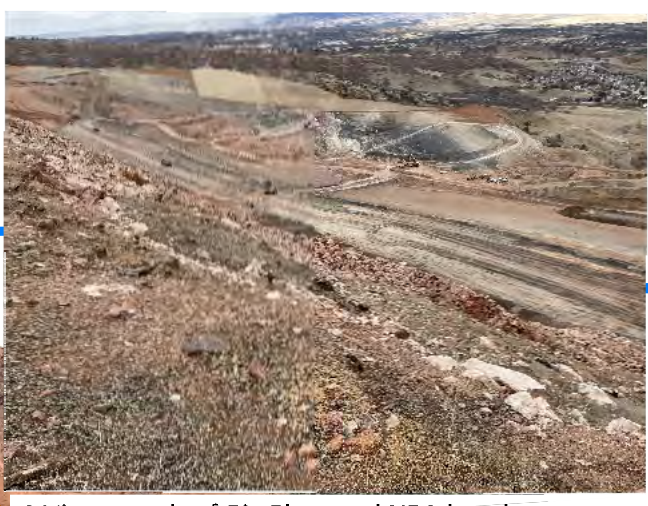
4. View north of Pit Floor and NBA benches
