## Foidel Creek Inspection Report

**PERMIT INFORMATION**

<b>Permit Number:</b> C-1982-056 <b>Mine Name:</b> Foidel Creek Mine <b>Operator:</b> Twentymile Coal, LLC <b>Operator Address:</b> Ms Miranda Kawcak 29515 Routt County Road No. 27 Oak Creek, CO 80467	<b>County:</b> Routt <b>Operation Type:</b> Underground <b>Permit Status:</b> Active <b>Ownership:</b> Private
	<b>Operator Representative Present:</b>  Miranda Kawcak
<b>Operator Representative Signature: (Field Issuance Only)</b>

<b>Inspection Start Date:</b> April 25, 2023 <b>Inspection Start Time:</b> 11:00 <b>Inspection End Date:</b> April 25, 2023 <b>Inspection End Time:</b> 13:00		<b>Inspection Type:</b> Coal Partial Inspection <b>Inspection Reason:</b> Normal I&E Program <b>Weather:</b> Raining/Snowing	
<b>Joint Inspection Agency:</b>  None		<b>Joint Inspection Contacts:</b>	
<b>Post Inspection Agency:</b>  None		<b>Post Inspection Contacts:</b>	
<b>Inspector(s):</b>  Hunter Ridley	<b>Inspector's Signature:</b>  <i>Hunter Ridley</i>		<b>Signature Date:</b>  5/1/2023

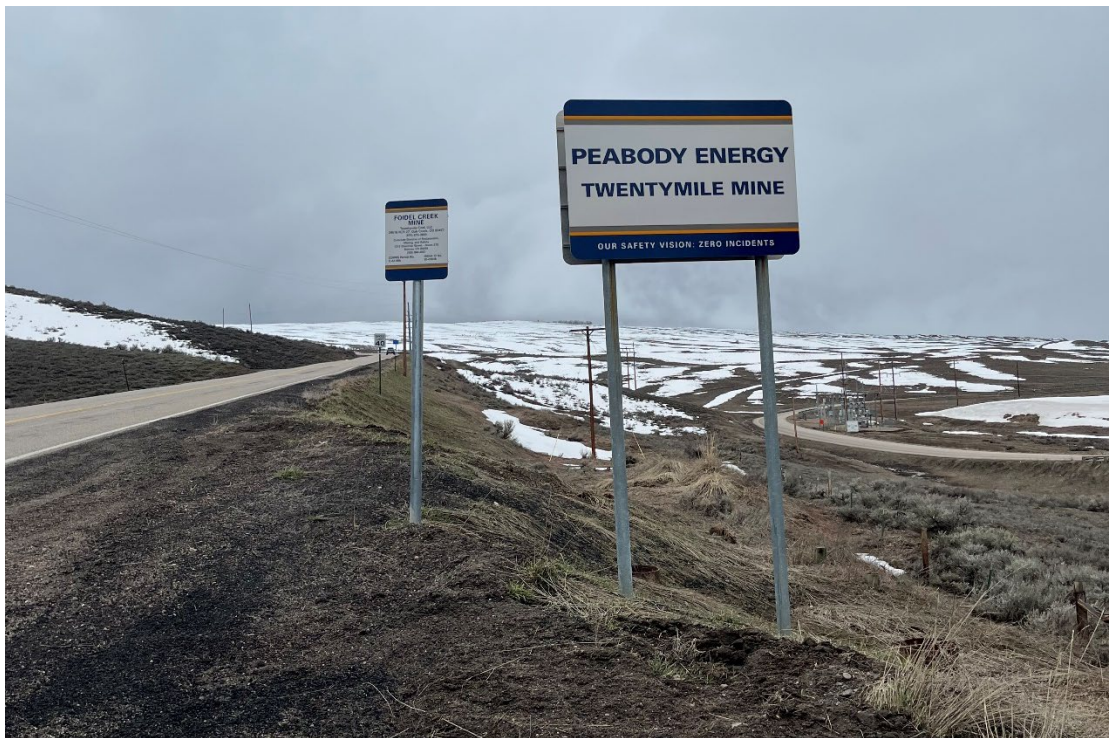
Mine identification markers were observed throughout the site (Photo 1). All information for compliance was present. The missing phone number information on mine signs for HG Loadout and Peabody Sage Creek Mine (see related inspection reports dated March 30, 2023) was discussed with the TC representative. **Please update the Division when signage has been appropriately amended.**

*Photo 1: Appropriate signage and mine identification information was present at the entrance to the mine site.*

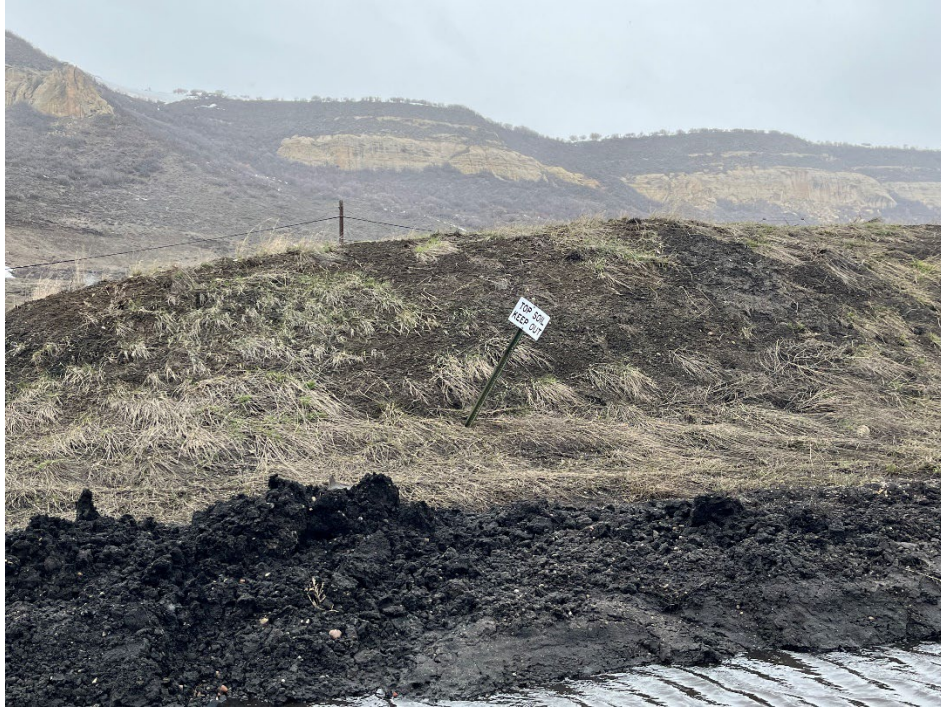
Topsoil piles were appropriately marked throughout the site (Photos 2, 3, 5, and 6). Last season's vegetation was still visible in small tufts on topsoil piles and along berms. TC representative noted that topsoil piles will be reseeded in the spring as rapid snowmelt has likely caused small erosional features on some of the piles.

*Photo 2: Topsoil piles throughout the site are appropriately marked and undisturbed by the winter season's snow plowing. Piles will be reseeded later in the spring.*

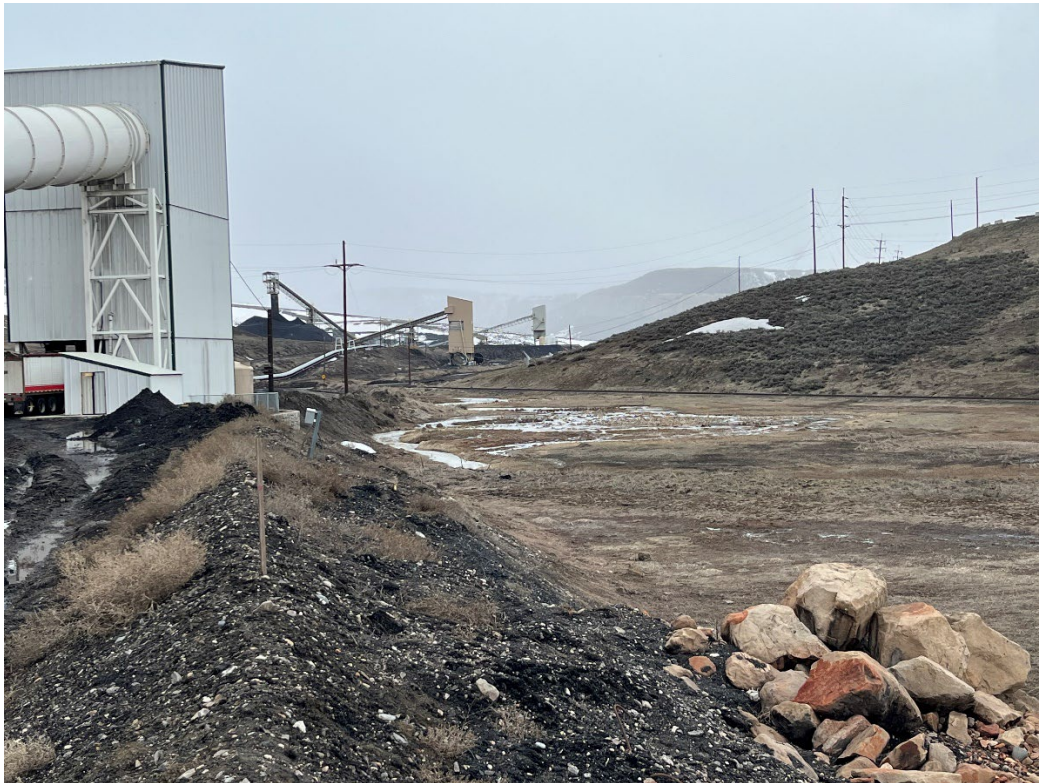
*Photo 3: View of the coal stoker loadout building. Berm leading up to this area is maintained with tufts of vegetation from last season still visible. A flooded Foidel Creek is visible behind the stoker loadout building.*

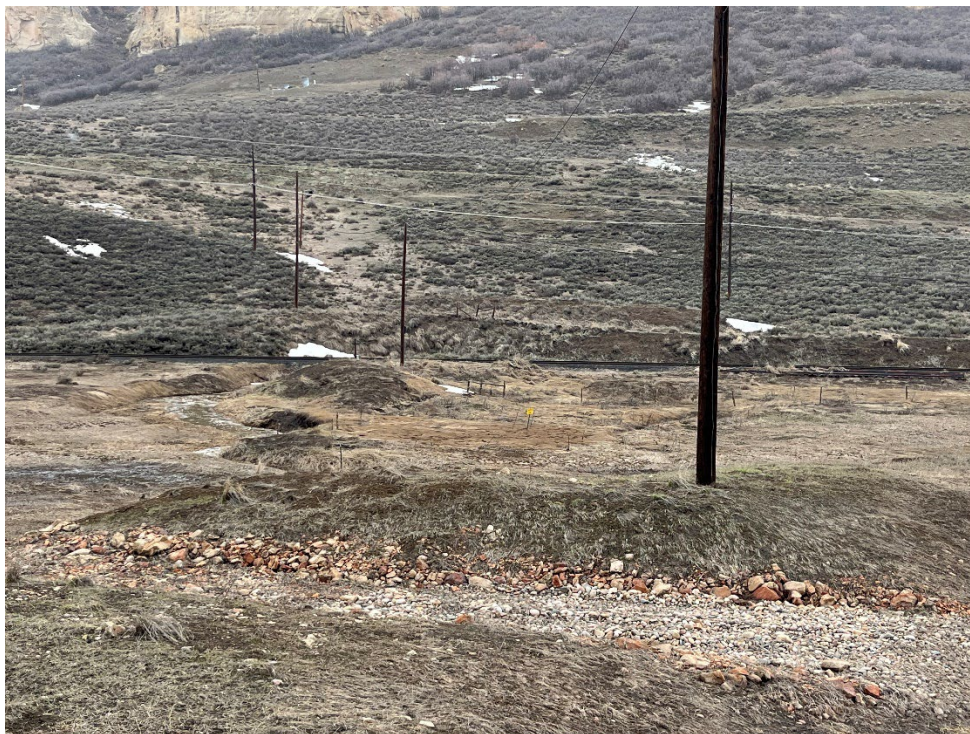
Buffer zones appear to be maintained. Vegetation was present within these zones and appropriate signage delineated the edge of the buffer zone which protects Foidel Creek (Photos 4 and 7).

*Photo 4: View northwest of Foidel Creek, creek location post markers and yellow buffer zone signs are visible.*

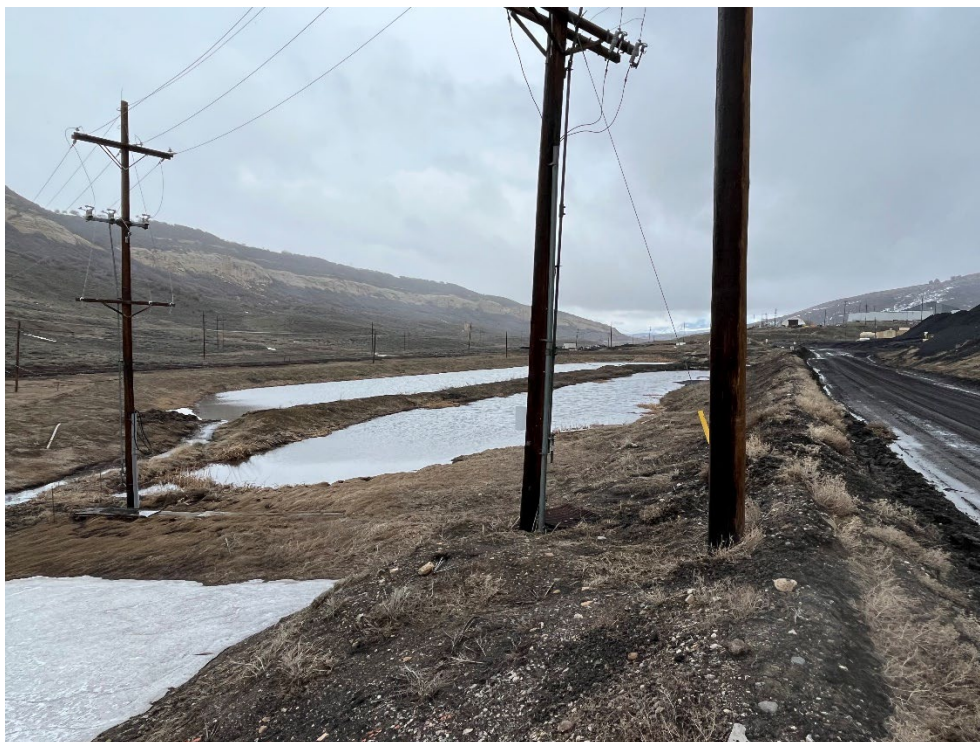
Nearly all ponds on site were holding water and discharging due to the recent rapid snowmelt and flooding events seen in this area of Routt County (Photos 5, 9, 10, and 11). Operator noted that continuous maintenance work was being done in the last few weeks to repair minor damages to existing water management structures as a result of this flooding. Culverts visible from the roadways were flowing and free of blockages (Photo 8).

*Photo 5: Pond E, currently discharging. Berm is maintained.*

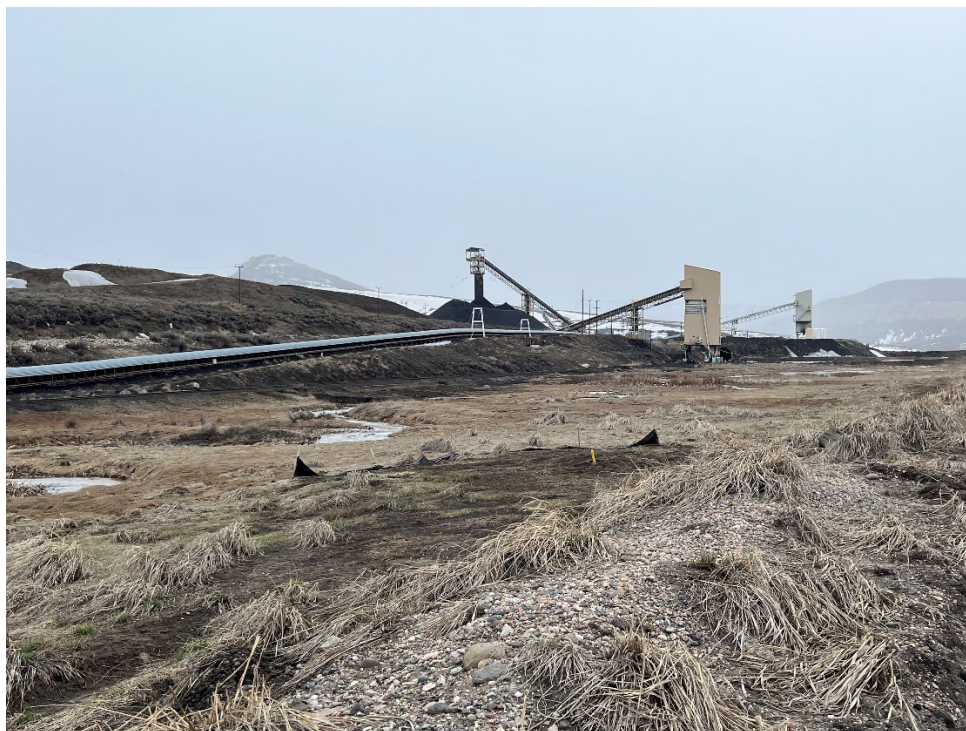
*Photo 6: View southwest of Foidel Creek. A conveyor is seen to the south. Photo was taken atop the berm to the north which is maintained and still vegetated from last season.*

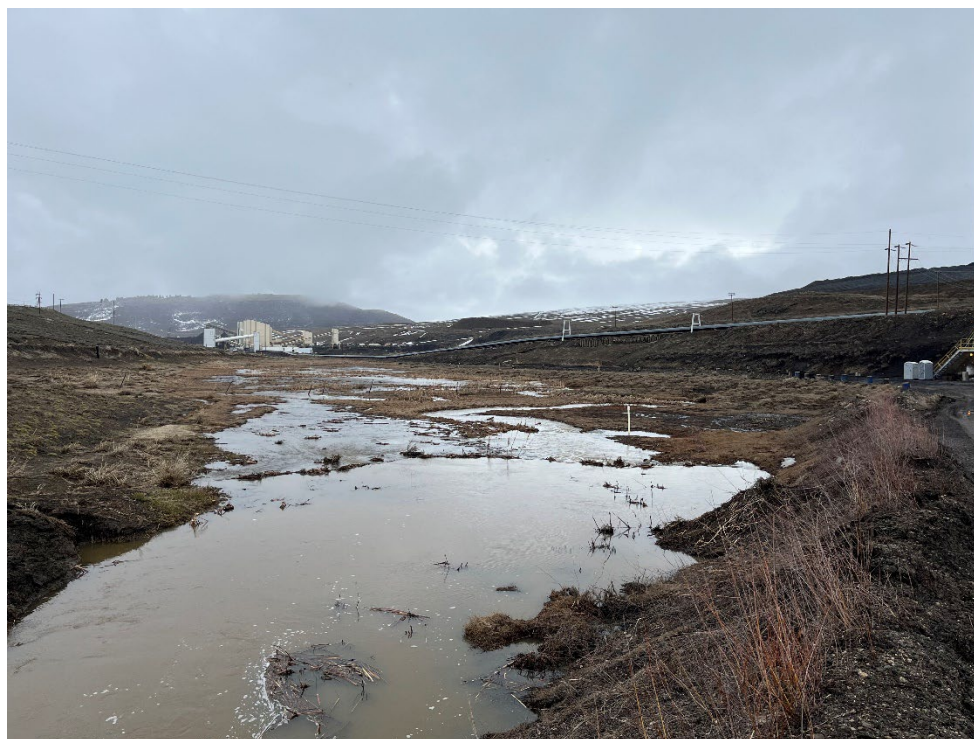
*Photo7: View east of Foidel Creek. Large amounts of snowmelt have flooded Foidel Creek considerably, poles marking the creek location are visible in the flooded channel.*

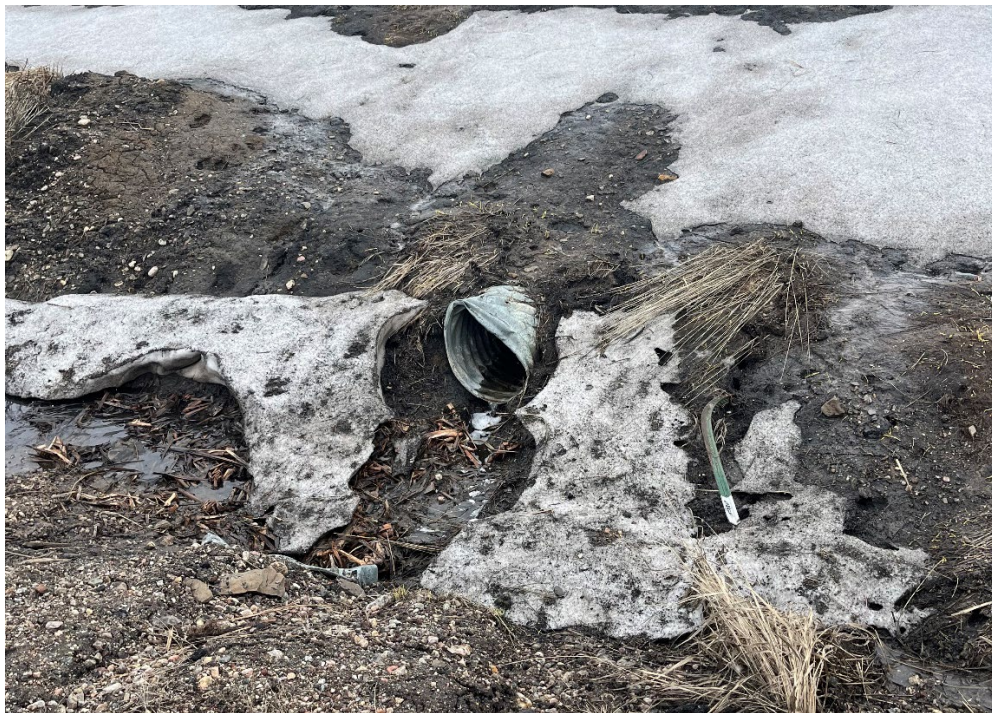
*Photo 8: Culvert which discharges Pond C, freely flowing.*

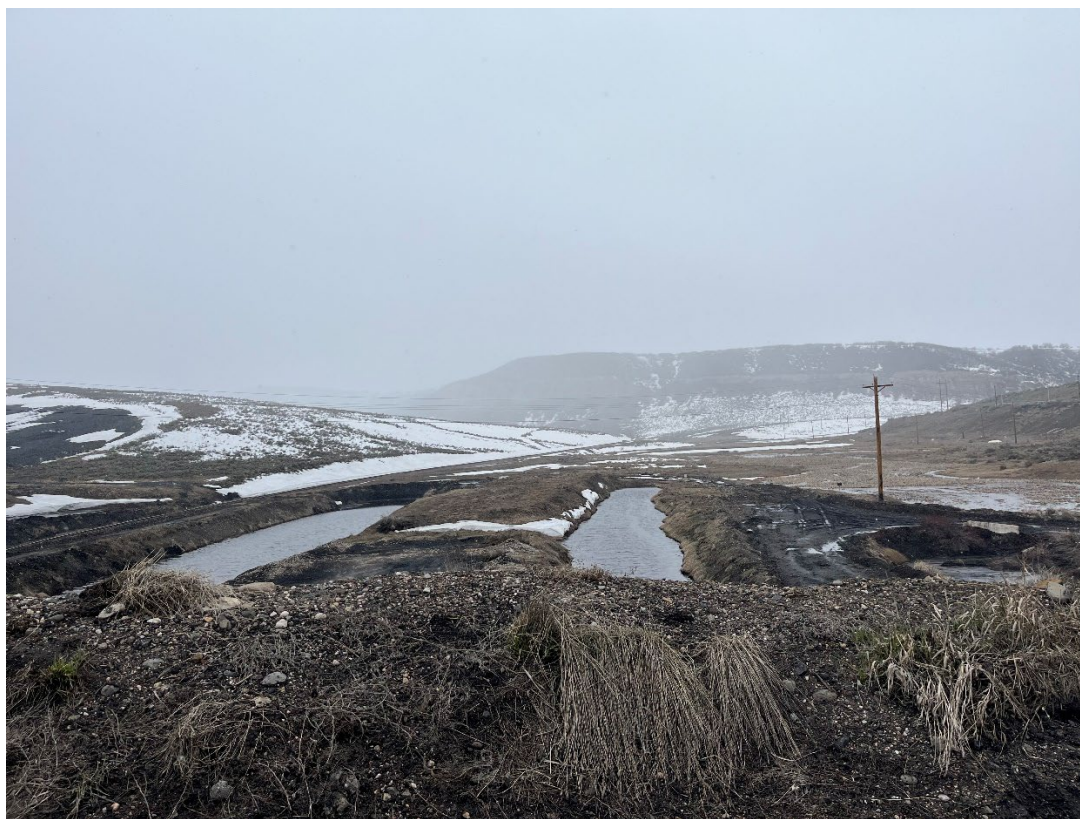
*Photo 9: Ponds B, currently discharging.*

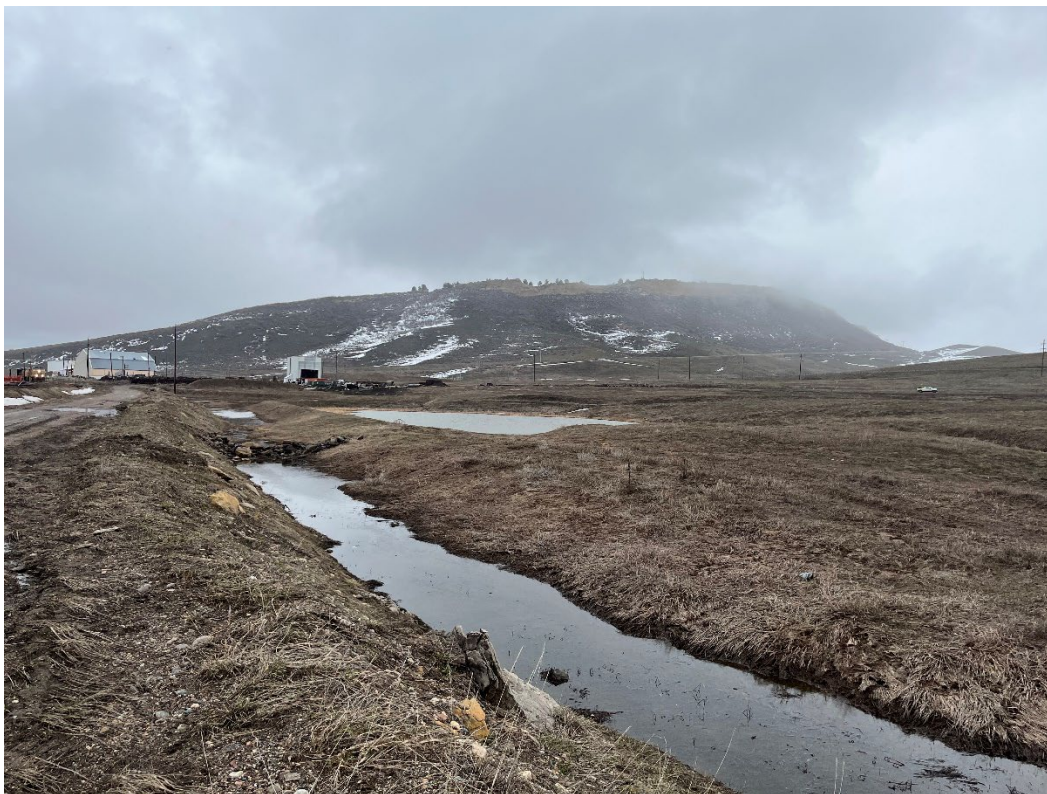
*Photo 10: View northeast of Pond F. Ditch is functioning properly to divert the large amounts of snowmelt flooding into Pond F.*

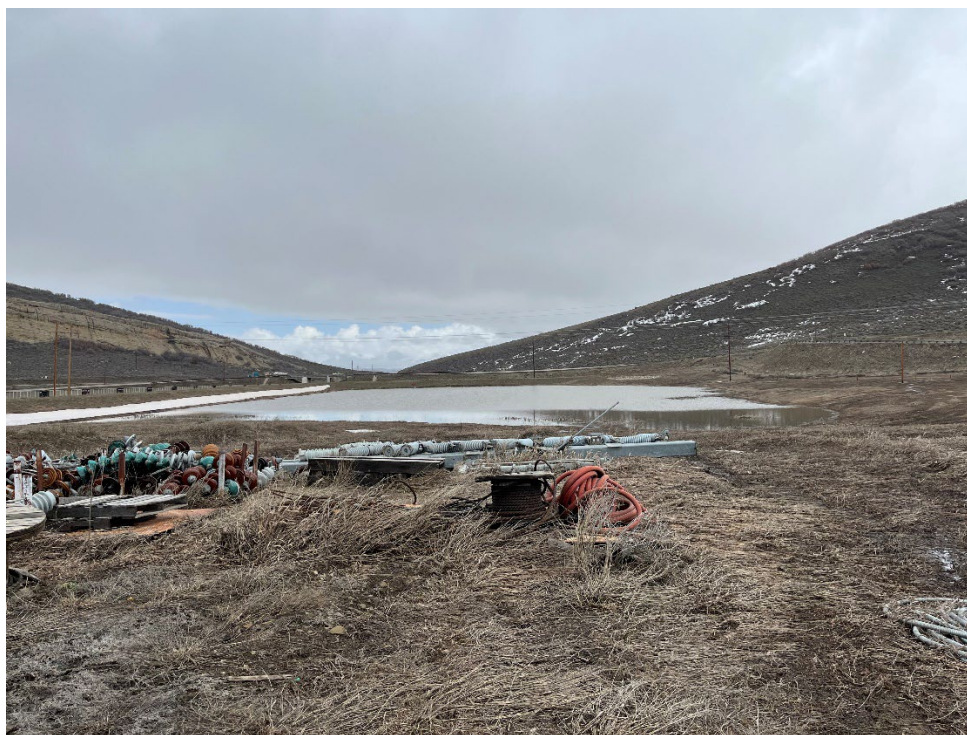
*Photo 11: Pond G, generally dry except in the spring.*

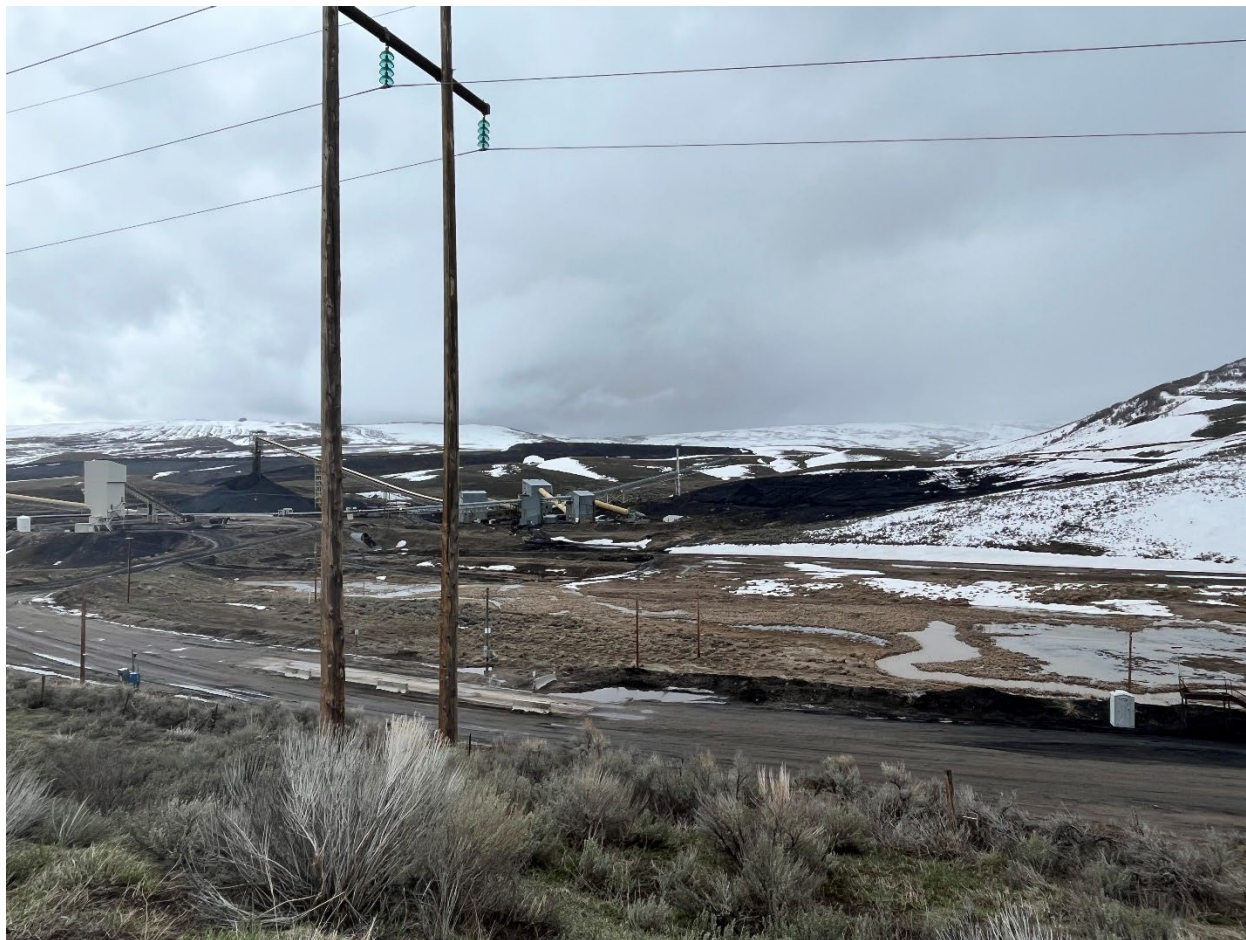
Two lifts of the refuse pile are already built, faced, and seeded (Photo 12). Lifts three and four are still under construction, with plans to face and seed these two lifts in the current year. Lifts are built facing downslope to encourage proper drainage into Pond D. Clay overburden material is then taken from the southern portion of the refuse area to cover the pile before adding topsoil from the nearby stockpile to the northeast.

*Photo 12: View south from Hwy 40 of Belt Out Back (BOB) pile, refuse area, and the flooded Foidel Creek channel.*

Compaction reports are conducted quarterly. The last noted compaction report received by the Division was for the 4<sup>th</sup> Quarter 2016. **In order to complete the public record, please submit all missing compaction reports, from 1<sup>st</sup> Quarter 2017 to present, to the Division and continue to submit these reports on a timely basis.**
