## Hayden Gulch Loadout Inspection Report, C-1992-081

**PERMIT INFORMATION**

**INSPECTION INFORMATION**

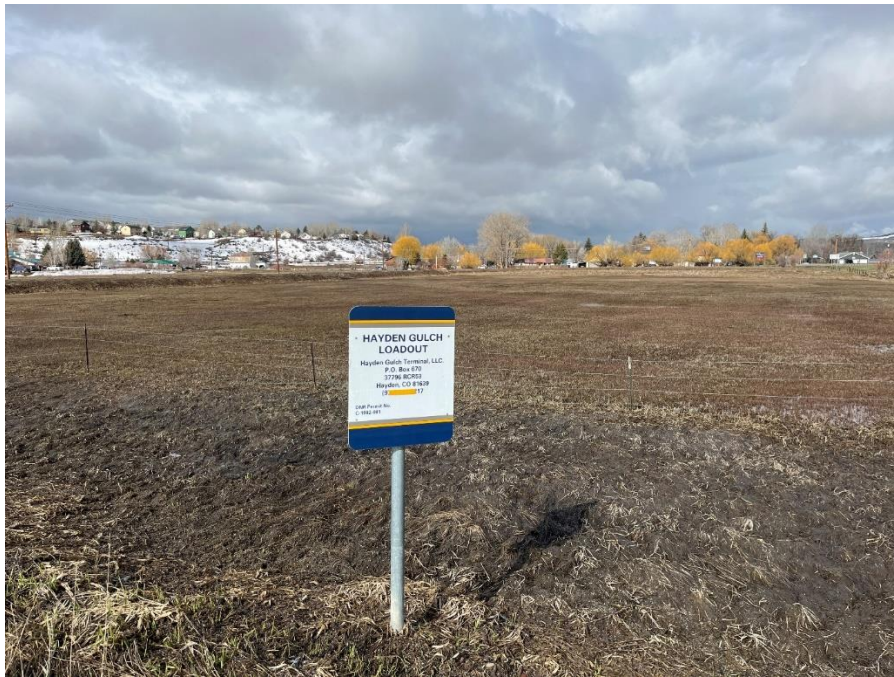
Mine identification markers were observed at the entrance to the unreleased haul road and adjacent to the unreleased agricultural section north and south of Hwy 40. The required phone number information is currently blocked off from signage (Photos 1 and 2). This was discussed with TC representative Miranda Kawcak at the Foidel Creek Mine inspection dated April 25, 2023. **Please update the division when signage has been appropriately amended.**

*Photo 2: Mine sign located at the northern entrance to the site, directly off Hwy 40.*

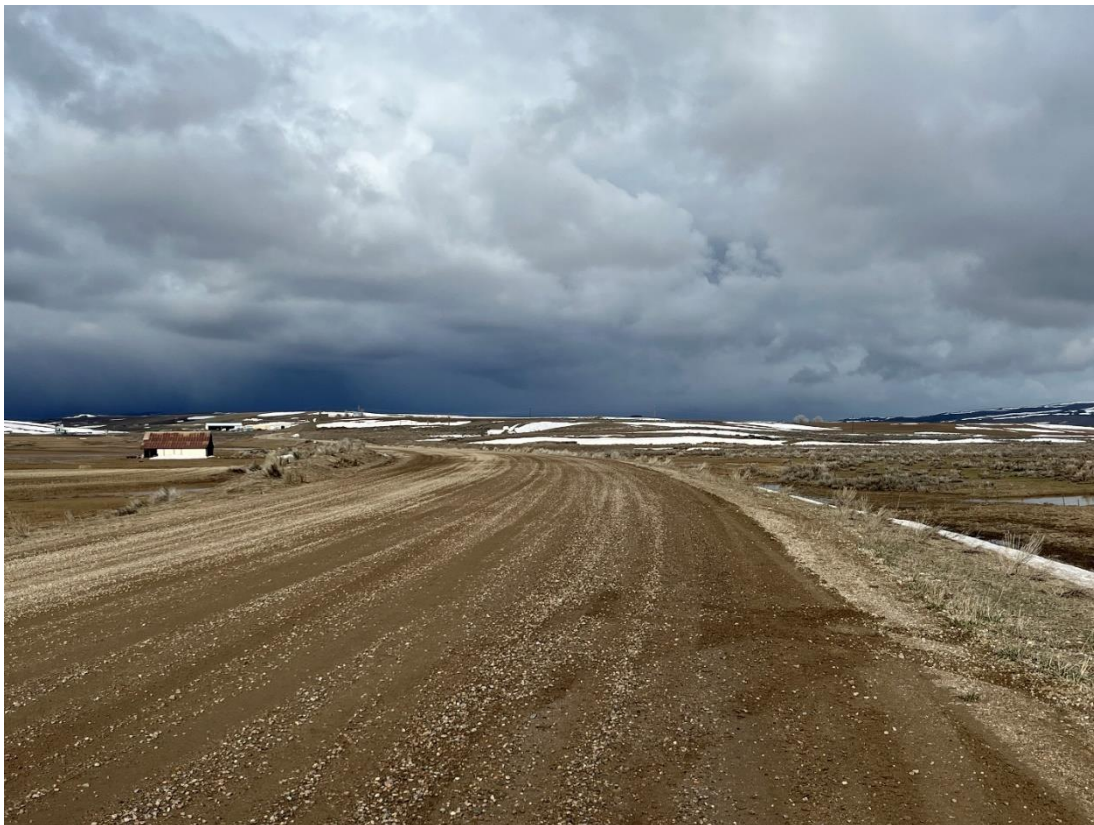
Areas not phase III bond released in the permit include the former haul road, maintained by Routt County (Photo 3). The haul road and associated areas includes 214.1 acres, of which 96.6 are disturbed. Technical Revision No. 12 (TR-12) allows for permanent retention of this haul road. The other remaining, not yet bond released area is directly north and south of Hwy 40, to be reclaimed to agricultural use. It is the only part of the previous rail loop not donated to Routt County. This area includes 6.8 acres of which 2.3 are disturbed (Photo 8).

The haul road was well maintained and free of erosional features despite the rapid snowmelt and consequential flooding seen recently in the Routt county area (Photo 3). This area will likely be ready for release in the upcoming months as the snow melts completely and the road and its associated features, such as permanent topsoil piles, can be fully inspected.

*Photo 3: View west, the haul road is well maintained and free of erosional features.*

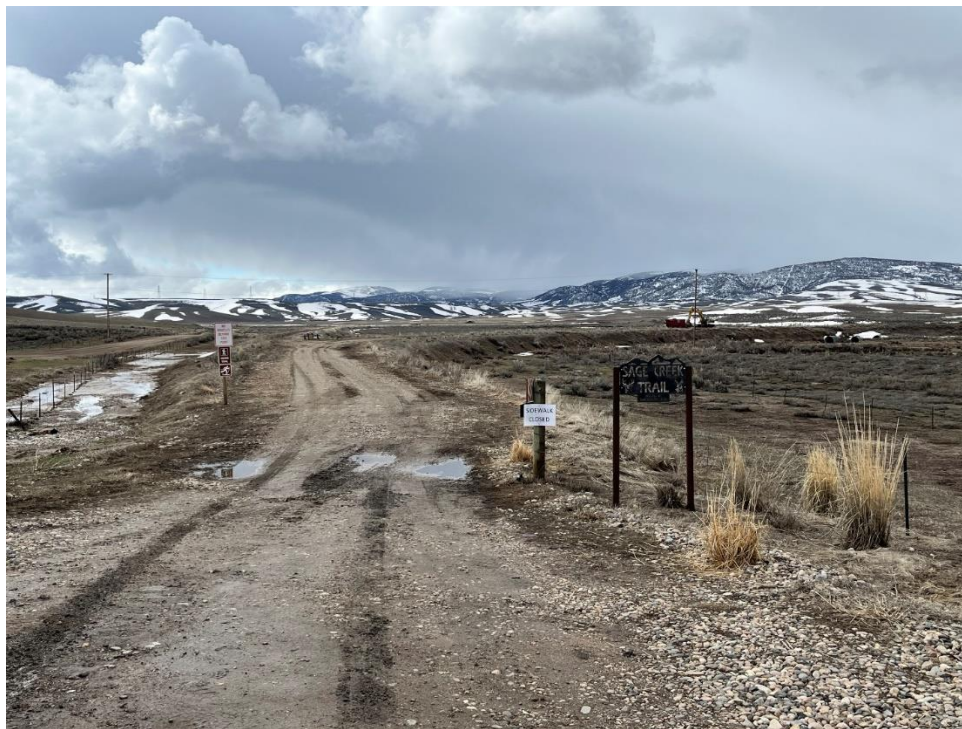
*Photo 4: View south of the southern entrance to the Tracks-to-Trails area previously released from this site. Rail Loop Pond 002 is accessed by walking this loop.*

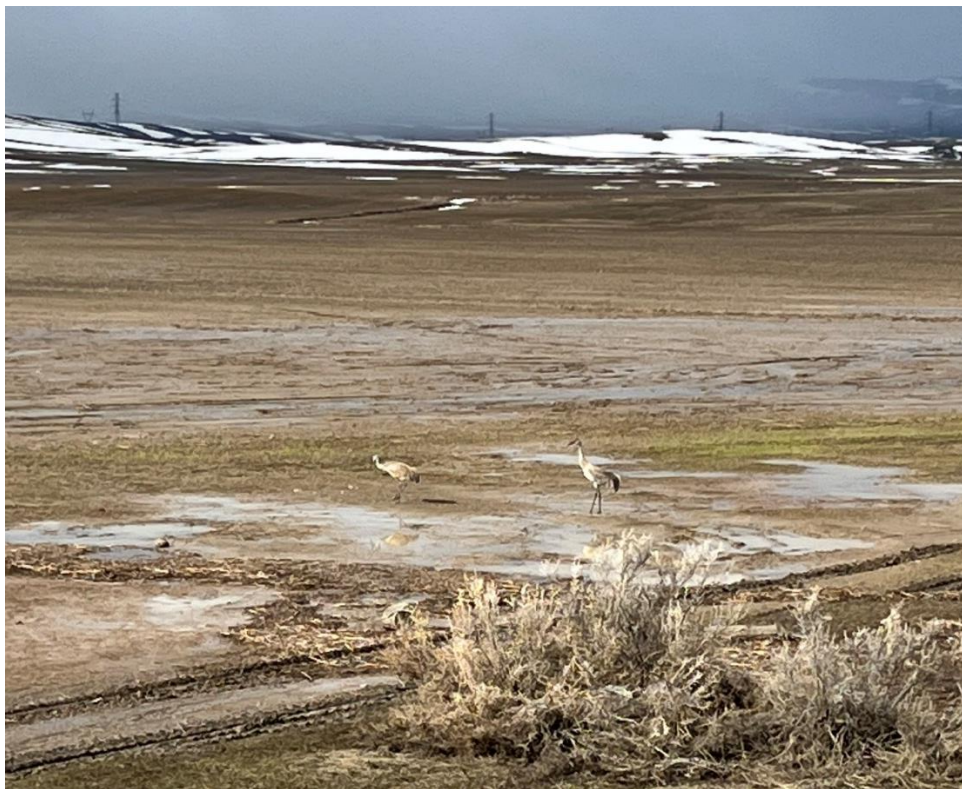
*Photo 5: Two migrating Sandhill Cranes were seen in and around the southern boundary of the site.*

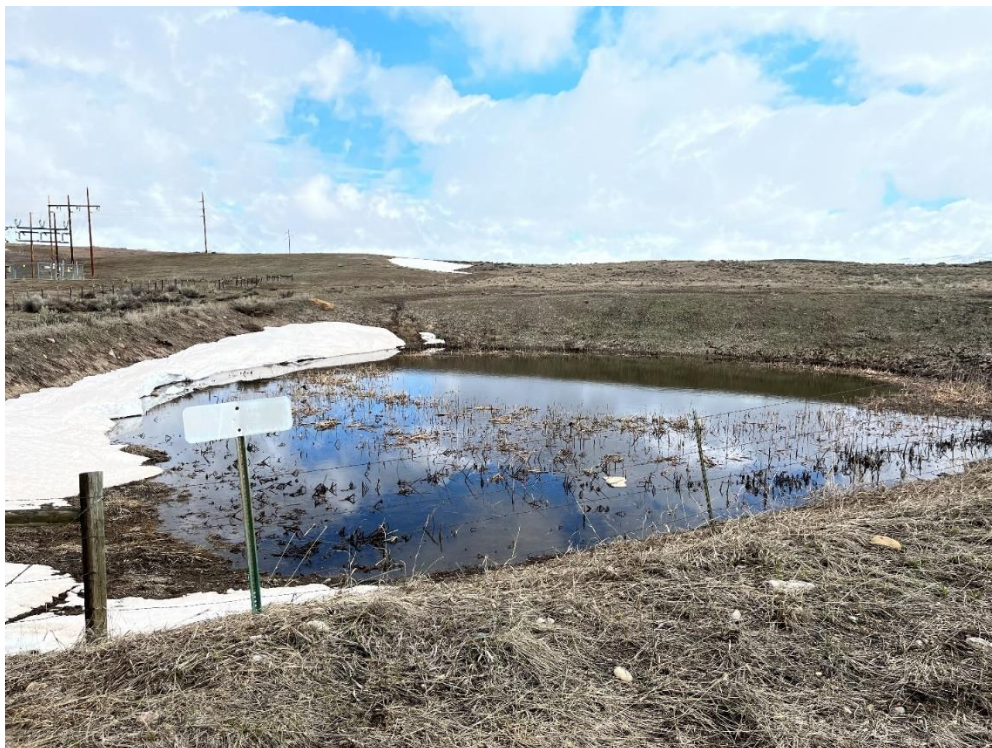
*Photo 6: Truck Loop Pond 001. A faded mine identification sign is present in front of the pond.*

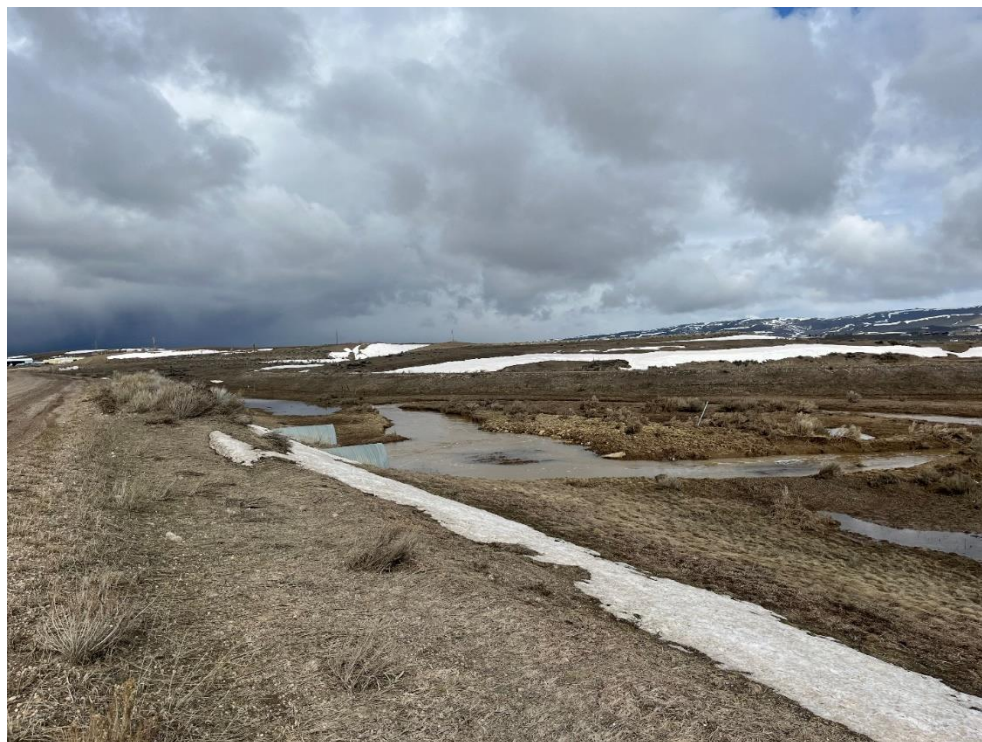
*Photo 7: Culverts were functioning properly in the Tracks-to-Trails area. Rail Loop Pond 002 is located behind the berm located in the foreground.*

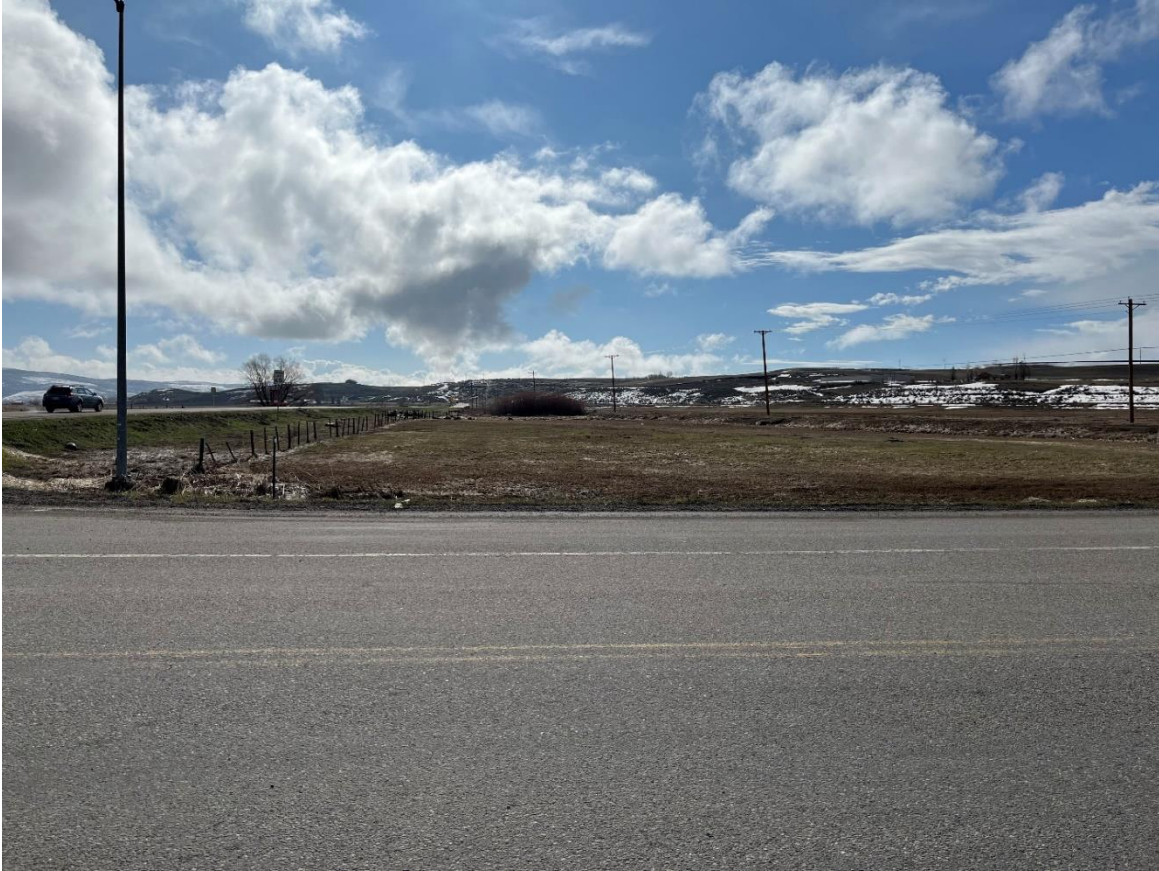
*Photo 8: View east of currently unreleased agricultural use area. Unreleased area begins at the northern entrance to the Sage Creek Trail off Hawthorne St. / CR 37 and extends across Hwy 40, curving to the northeast.*
