MINERALS PROGRAM INSPECTION REPORT
PHONE: (303) 866-3567

MINE NAME: Henderson Mine	MINE/PROSPECTING ID#: M-1977-342	MINERAL: Molybdenum	COUNTY: Clear Creek, Grand
INSPECTION TYPE: Monitoring	WEATHER: Clear	INSP. DATE: April 28, 2023	INSP. TIME: 10:00
OPERATOR: Climax Molybdenum Company	OPERATOR REPRESENTATIVE: Geoff Niggeler	TYPE OF OPERATION: 112d-3 - Designated Mining Operation	
REASON FOR INSPECTION: Normal I&E Program	BOND CALCULATION TYPE: Partial Bond	BOND AMOUNT: \$135,204,778.00	
DATE OF COMPLAINT: NA	POST INSP. CONTACTS: None	JOINT INSP. AGENCY: None	
INSPECTOR(S): Peter Hays Brock Bowles	INSPECTOR'S SIGNATURE:

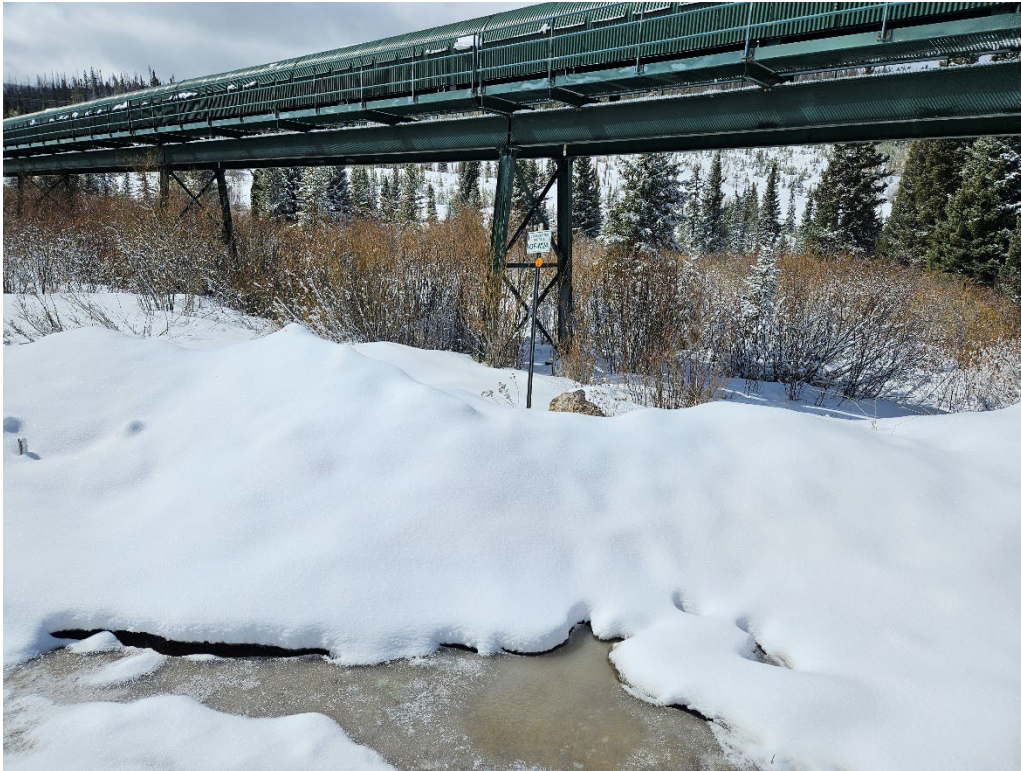
View of OF-M24

OF-M24: the BMP's at this outfall location consist of a rock check dam and straw waddles leading to a rip-rap outfall. The outfall was completely snow covered at the time of the inspection.

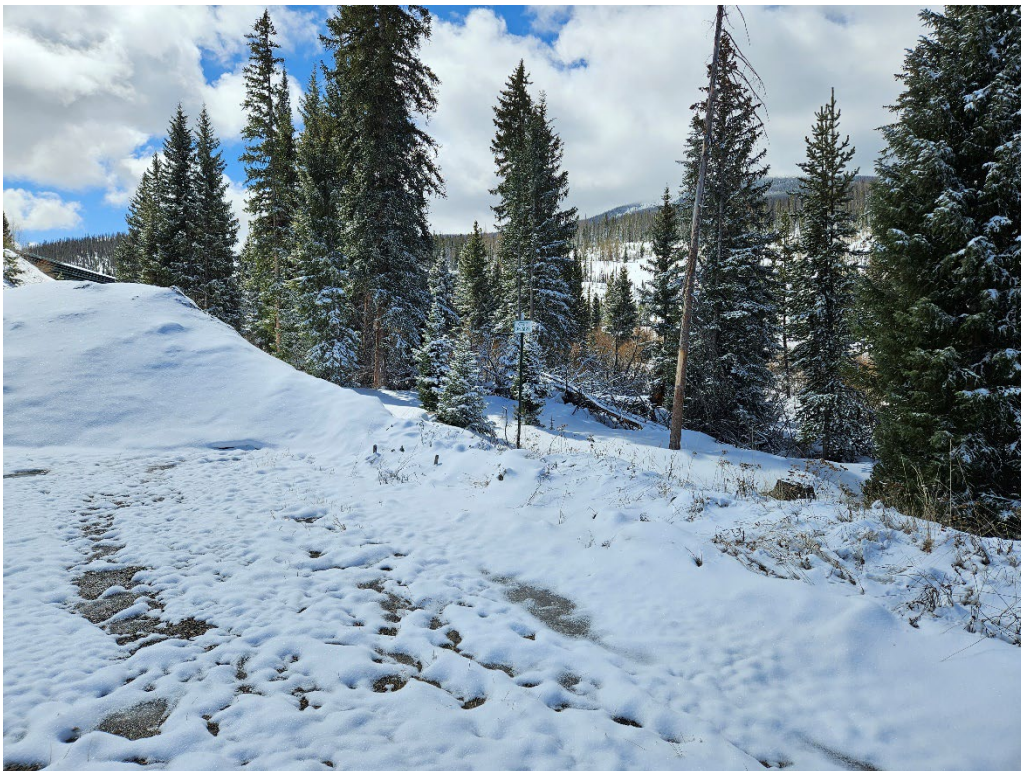
View of OF-M23

OF-M23: the BMP's at this outfall location consist of a rock check dam and straw waddles leading to a rip-rap outfall. The outfall was completely snow covered at the time of the inspection.

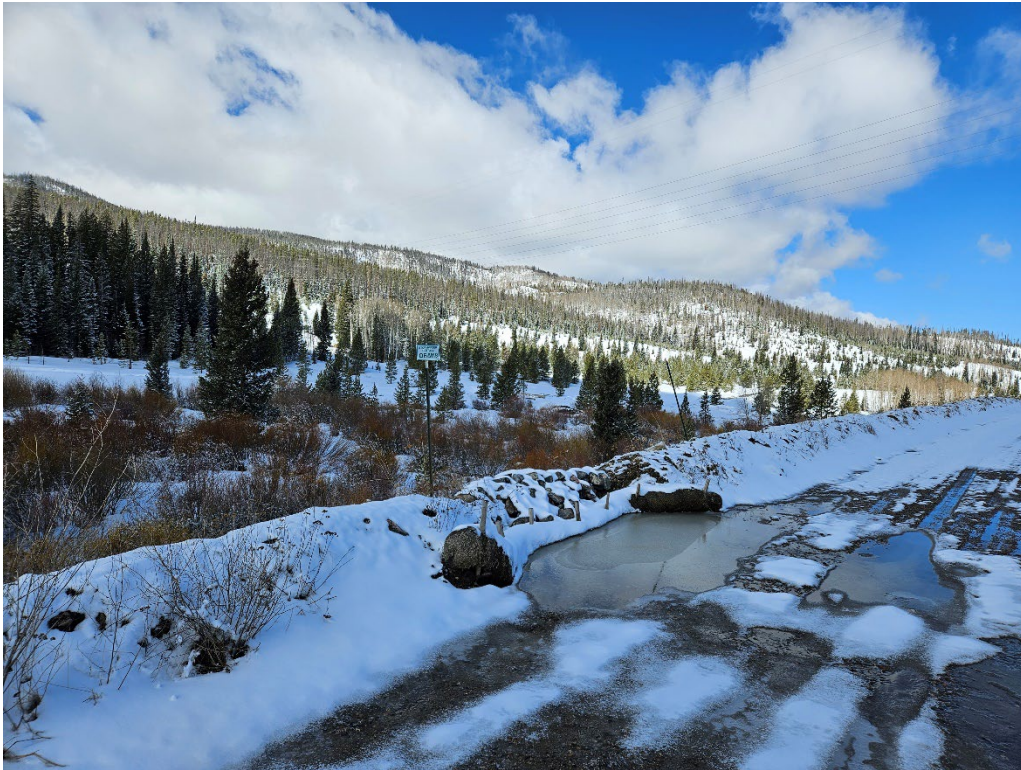
View of OF-M19

OF-M19: the BMP's at this outfall location consist of a rock check dam and straw waddles leading to a rip-rap outfall. The outfall was completely snow covered at the time of the inspection. Stormwater was observed flowing on the road surface towards the outfall. A pool of water was observed upstream of the outfall. Water was observed flowing at the same rate as on the road surface behind the waddles. It appeared the water was able to flow under the waddle due to damage to the waddle by a snowplow. Repairs to the outfall were recommended by the Division during the inspection.

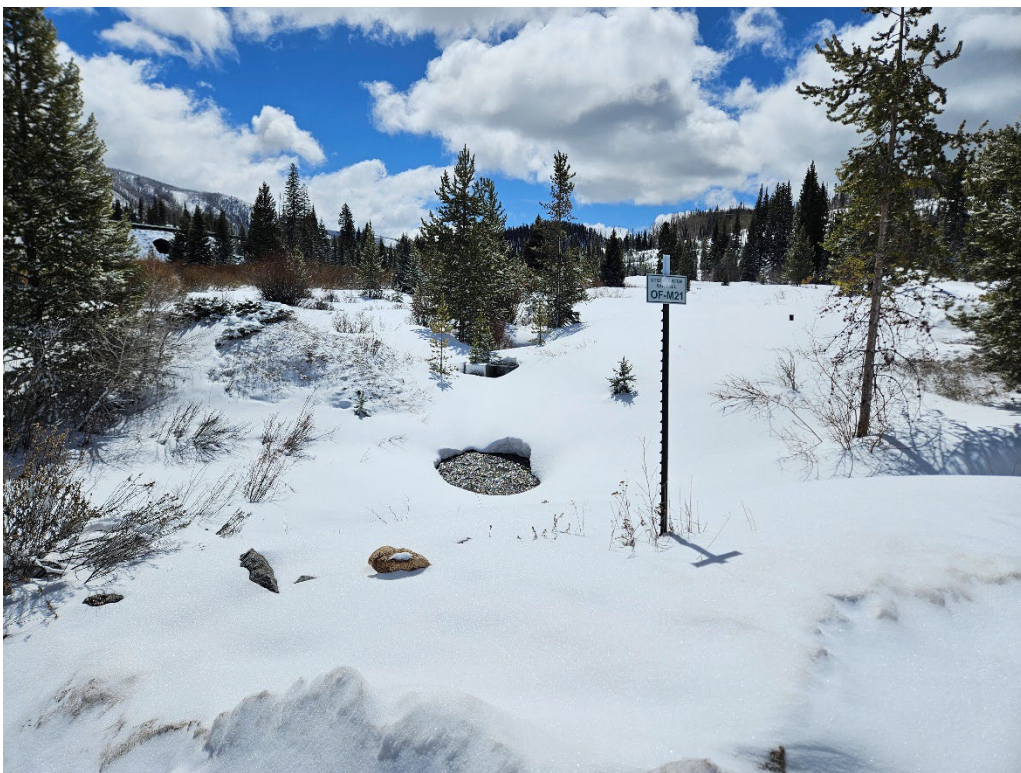
View of OF-M21

OF-M21: the BMP's at this outfall location consist of a rock check dam and straw waddles leading to a rip-rap outfall. The outfall was completely snow covered at the time of the inspection.

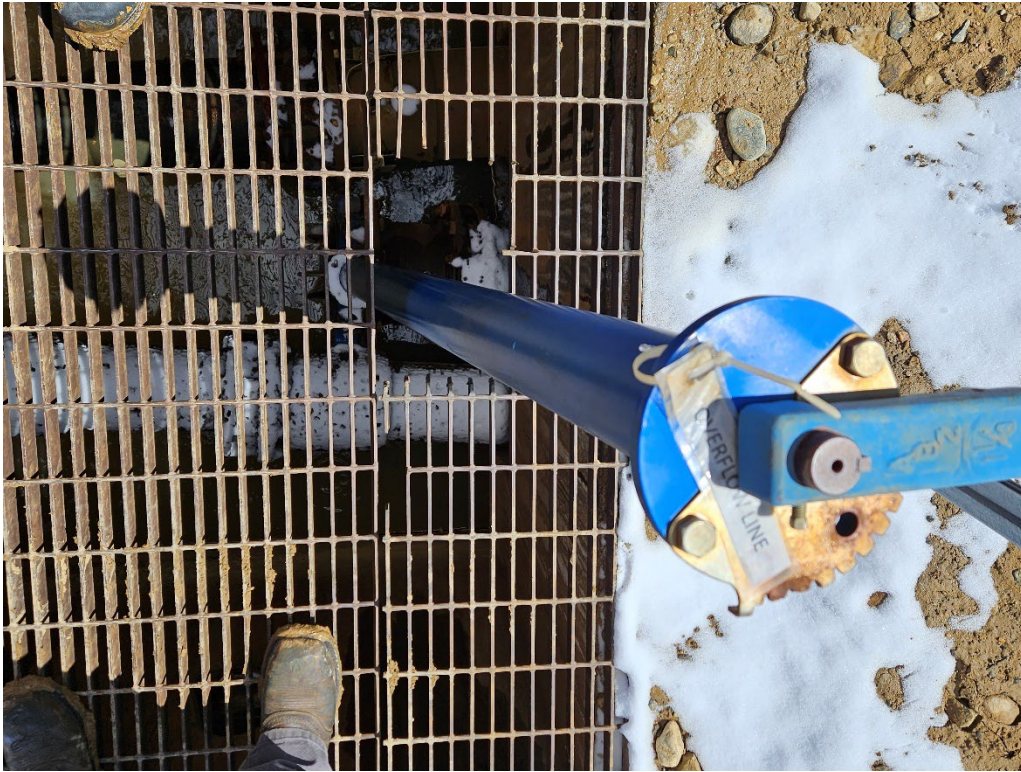
The Operator submitted the 2023 Annual Report for the site on March 8, 2023. In Section 2. Henderson Mill, 2.3.4 – 3-Dam Seepwater Line Leak-Down Test, the Operator reported the backup seepwater line discharge valve leaked at the discharge point below 1-Dam leading to an invalid pressure test. The valve will be replaced and retested in the spring of 2023. The valve was observed during the inspection.

View of the 3-Dam backup seepwater line discharge valve
