Re: Notice of Outstanding Corrective Action, Kirtright Pit, Permit No. M-1986-123

MINERALS PROGRAM INSPECTION REPORT PHONE: (303) 866-3567

MINE NAME:	MINE/PROSPECTING ID#:	MINERAL:	COUNTY:
Kirtright Pit	M-1986-123	Sand and gravel	Larimer
INSPECTION TYPE:	INSPECTOR(S):	INSP. DATE:	INSP. TIME:
Monitoring	Brock Bowles	February 15, 2022	10:30
OPERATOR:	OPERATOR REPRESENTATIVE:	TYPE OF OPERATION:	
Coulson Excavating Company, Inc.	Ken Coulson	112c - Construction Regular Operation

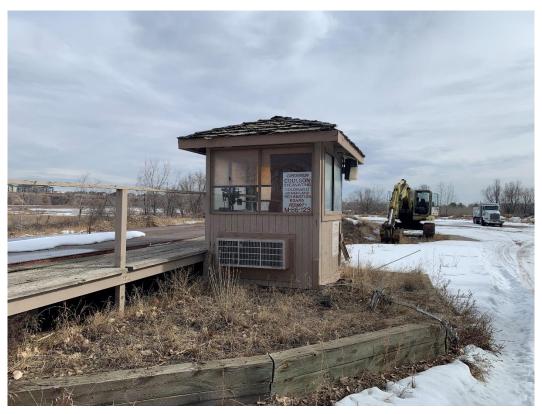
The mine entrance sign was in place on the scale house at the entrance of the mine (photo 1). The site was mostly reclaimed and vegetated with the exception of the scale house and some older equipment near the entrance (photo 1). No mining was taking place, or has taken place for a while. This is evident by the amount and condition of the vegetation on the site (photos 2 & 3). No product stockpiles were remaining.

Photo 1 – Mine entrance sign, scale house and some equipment

According to the 2021 Annual Report, no mining activity has taken place since Dec 2008. The 2010, 2014 and the 2018 inspection reports also state that mining has been completed. As per Rule 3.1.3, all reclamation shall be carried to completion within 5 years from the date the operator has ceased mining. The reclamation of the ponds need to wait until the Augmentation Plan scheduled for water court in 2024 is complete. All other reclamation items, such as removing the scale and scale house, should be completed before the court date.

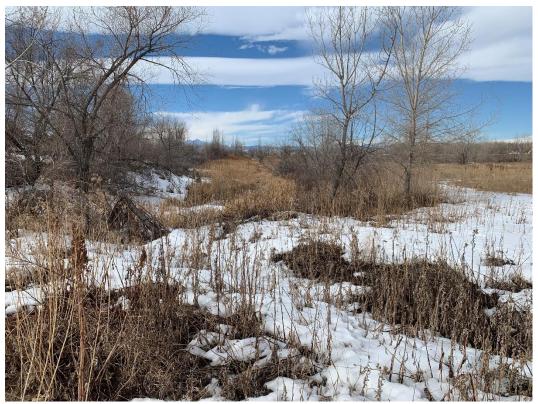
Photo 2 – From the center of the pit area, looking west towards pond 1

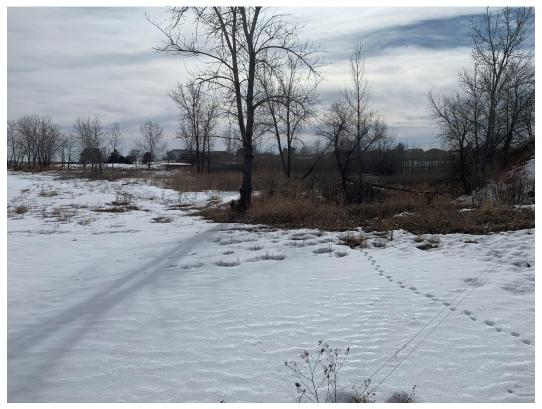
Photo 3- From the center of the pit area, looking east towards ponds 2 and 3

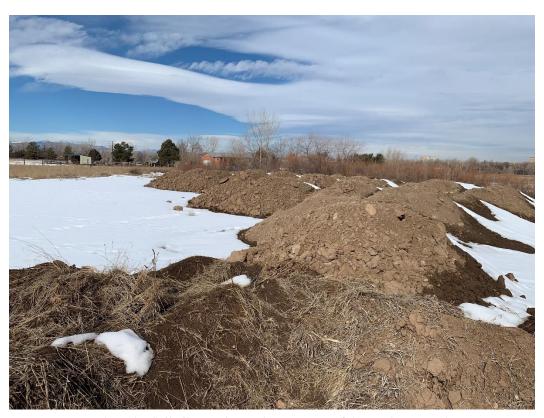
On the southwest corner of the east pond, approximately 25 dump truck loads (piles) of soil have been deposited (photo 4). The soil appears to be topsoil by the amount of grassy vegetation in the soil. The fence and fence posts along Lacy Lane were cut and were placed off to the side giving access to this part of the permit. It is not clear who placed the soil or where it came from. No other disturbances were seen on the site, but it should be noted that the ground was mostly snow covered. The topsoil piles are not consistent with the reclamation plan and need to be addressed. The operator needs to incorporate the soil into the surrounding landscape and revegetate it or remove the piles altogether.

Photo 4 – Soil piles on the southwest corner of the southeast pond
