**MINERALS PROGRAM INSPECTION REPORT**  
**PHONE: (303) 866-3567**

| <b>MINE NAME:</b><br>Mooney 5804 Altura Pit | <b>MINE/PROSPECTING ID#:</b><br>M-2010-012 | <b>MINERAL:</b><br>Sand and gravel | <b>COUNTY:</b><br>Las Animas |
| <b>INSPECTION TYPE:</b><br>Preoperation Inspection | <b>WEATHER:</b> Clear | <b>INSP. DATE:</b><br>April 19, 2023 | <b>INSP. TIME:</b><br>12:00 |

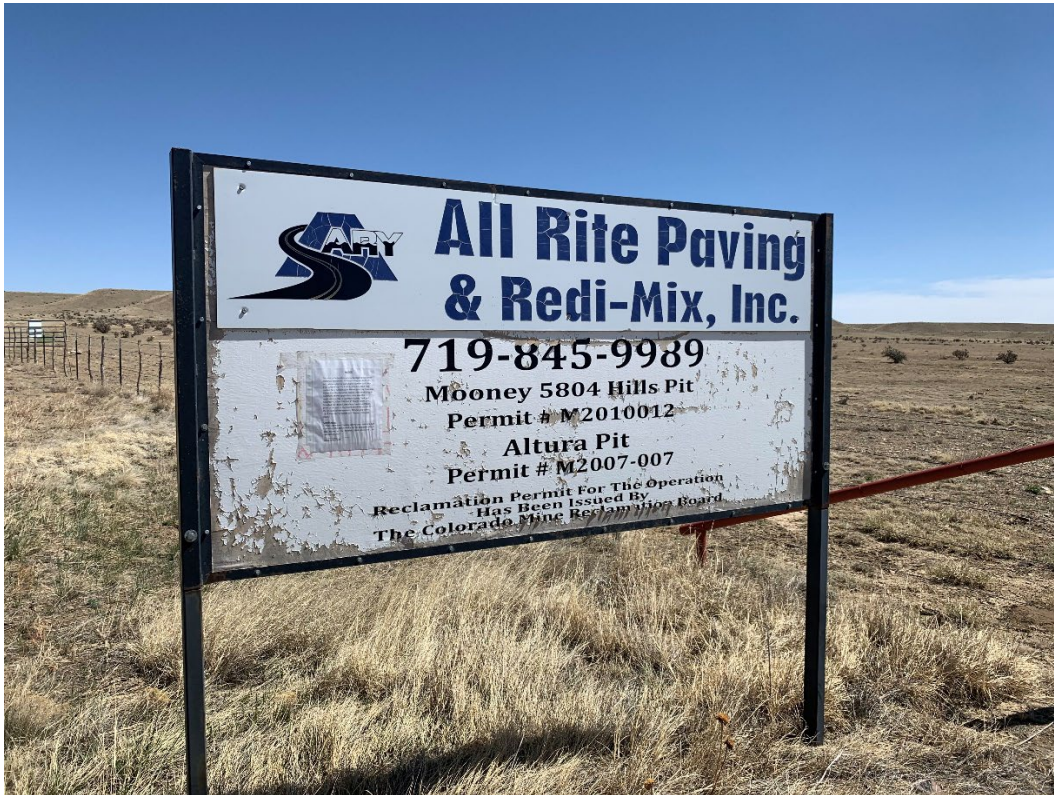
The mine entrance sign was in place at the entrance to the mine. The AM1 application sign required by Rule 1.6.2(1)(b) was in place on the main entrance sign (photo 1). A front end loader and scale were on site, but no mining activity was taking place during the inspection. Several stock piles were located around the site and each was labeled with its product name.

Photo 1 – Mine entrance sign

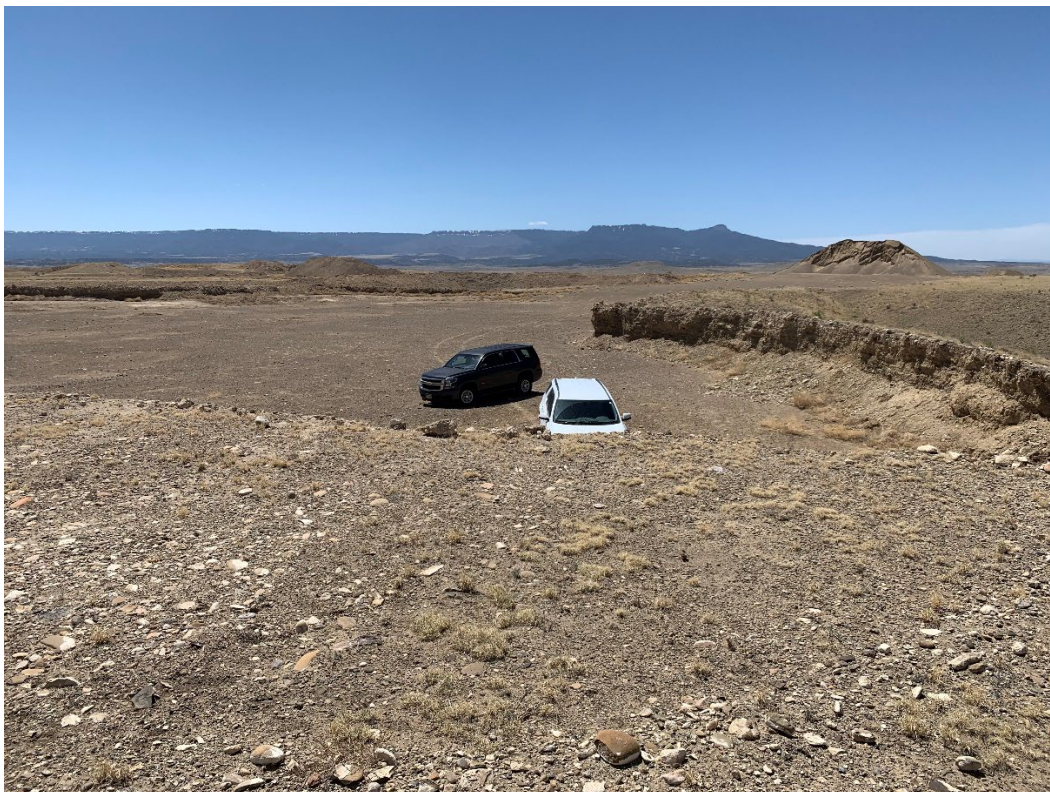
The current mining operation is in top of the plateau (photo 2). Topsoil has been removed in front of the highwall and stored in various places around the working area. The top layer of the plateau is being removed in about 12 foot layers. There is no actual pit that can retain water.

Photo 2 – Mining area in northeast side of pit, facing southwest

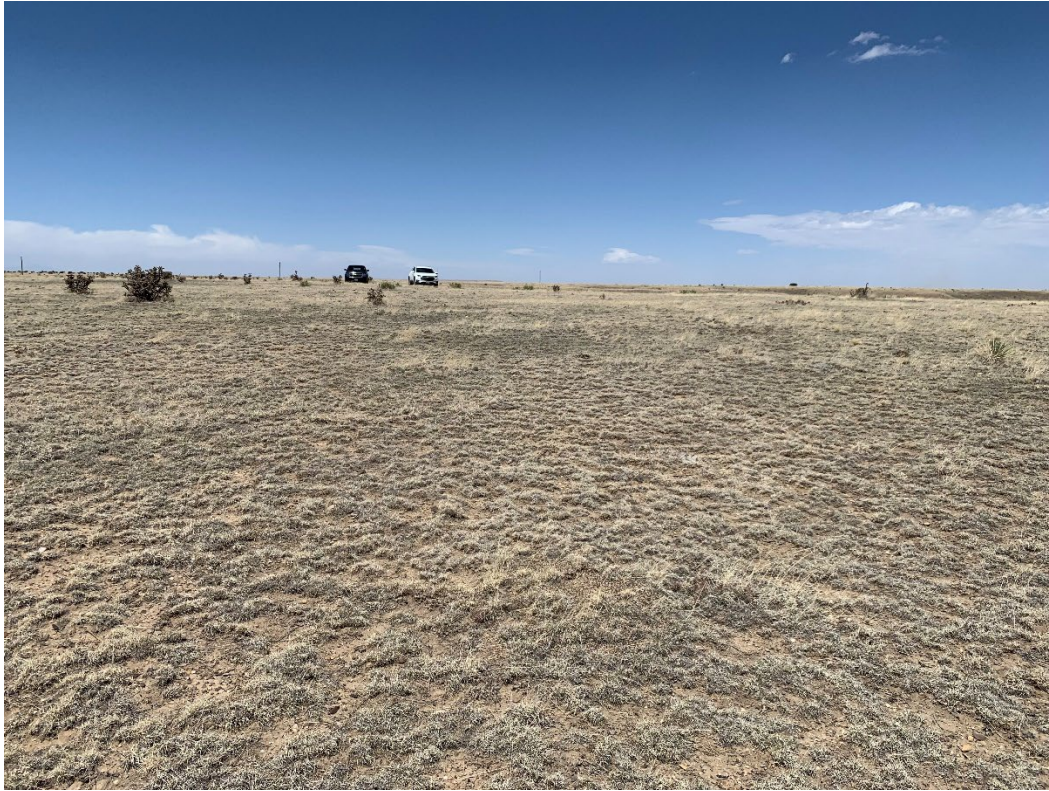
The eastern portion of the proposed expansion area is cattle grazing land. The vegetation contains short grass species with some yucca and cholla plants. The topsoil is thin and naturally has a large percentage of rocks (photo 3). A few small erosion gullies were seen at the edges of the plateau. A large steel water tank (30' diameter x 7' high) with an adjacent water well pump are just east of the current mine entrance road (photo 4). A landowner agreement for the water tank is included with the AM1 application. The application Exhibit C shows an underground pipe connecting the large water tank to a smaller tank north of the of the mine area, beyond the permit boundary. The pipeline was hard to verify on the ground as it was buried. Ms. Schreiber stated there is another pipeline running to the south connected to another water tank. This item is not shown on the map and will have to be verified by the operator. A power line was noted running south to north across the eastern portion of the proposed permit area (photo 5). This power line is not described in the application and will have to be verified/documented by the operator in the AM1 application.

Photo 3 – Eastern side of mining area

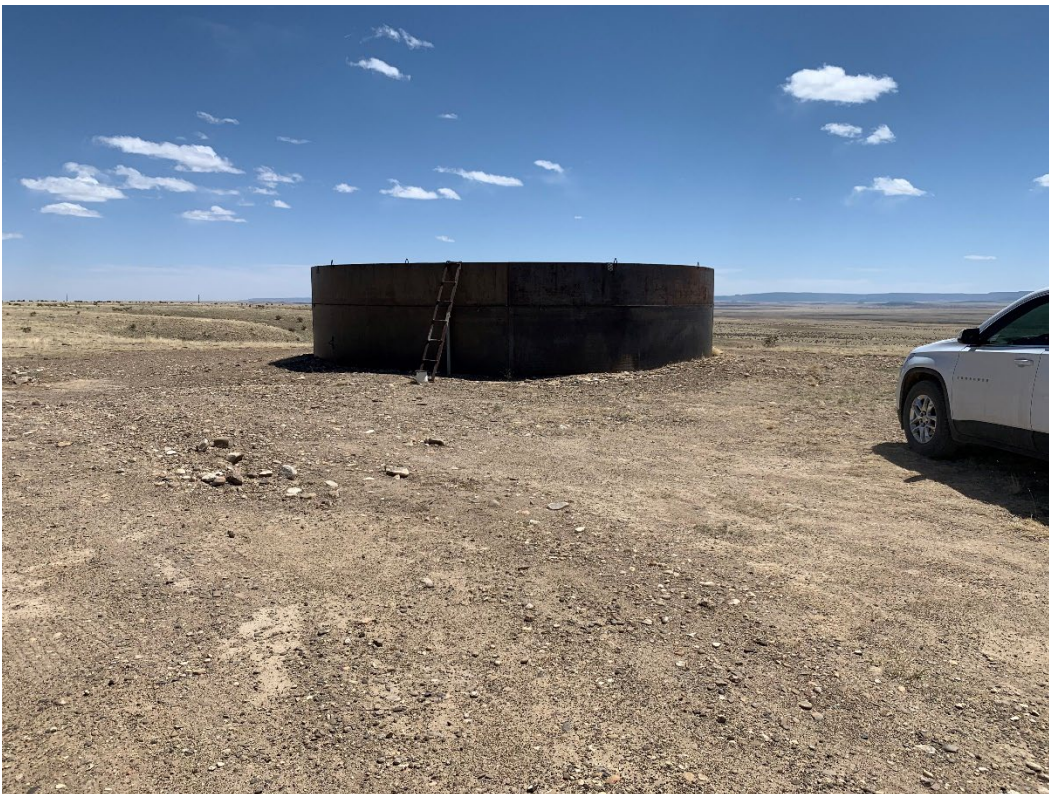
Photo 4 – Water tank in middle of mining area

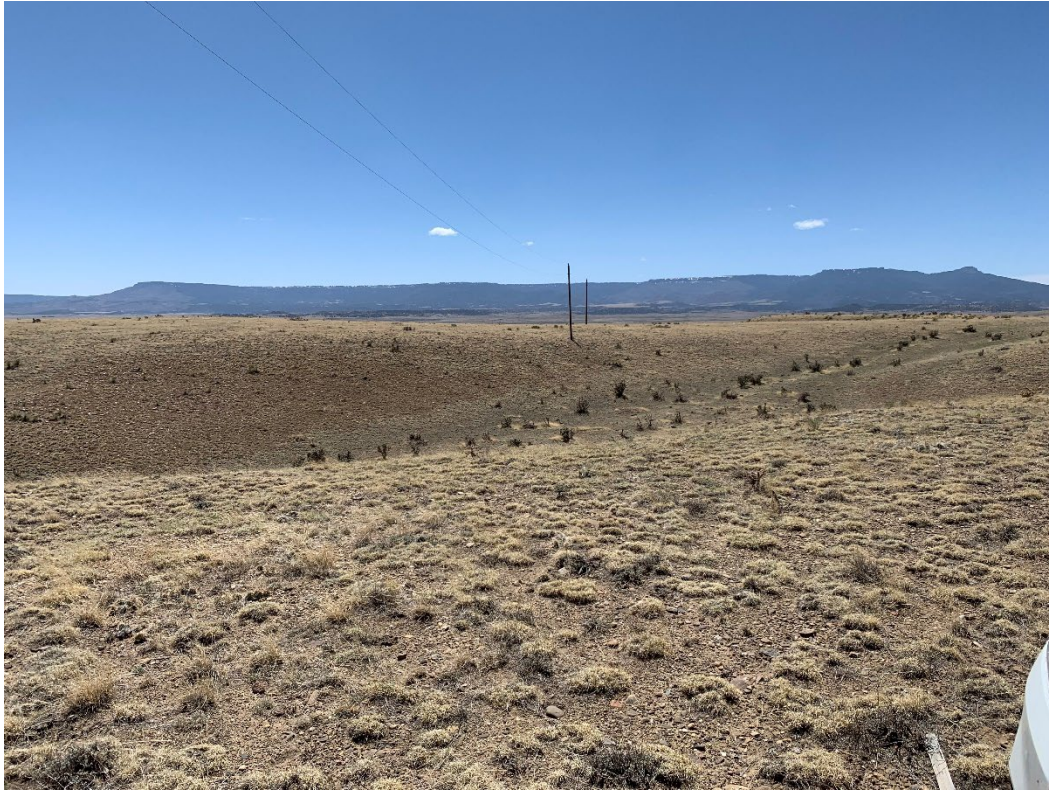
Photo 5 – Power line in the east proposed mine area that are not documented on the map
