**MINERALS PROGRAM INSPECTION REPORT**  
**PHONE: (303) 866-3567**

<b>MINE NAME:</b> Mooney Hills Permit	<b>MINE/PROSPECTING ID#:</b> M-2007-007	<b>MINERAL:</b> Aggregate	<b>COUNTY:</b> Las Animas
<b>INSPECTION TYPE:</b> Monitoring	<b>WEATHER:</b> Clear	<b>INSP. DATE:</b> April 19, 2023	<b>INSP. TIME:</b> 12:00
<b>OPERATOR:</b> All-Rite Paving & Redi-Mix, Inc.	<b>OPERATOR REPRESENTATIVE:</b> Jodi Schreiber	<b>TYPE OF OPERATION:</b> 110c - Construction Limited Impact	
<b>REASON FOR INSPECTION:</b> Normal I&E Program	<b>BOND CALCULATION TYPE:</b> None	<b>BOND AMOUNT:</b> \$25,724.00	
<b>DATE OF COMPLAINT:</b> NA	<b>POST INSP. CONTACTS:</b> None	<b>JOINT INSP. AGENCY:</b> None	
<b>INSPECTOR(S):</b> Brock Bowles	<b>INSPECTOR'S SIGNATURE:</b>

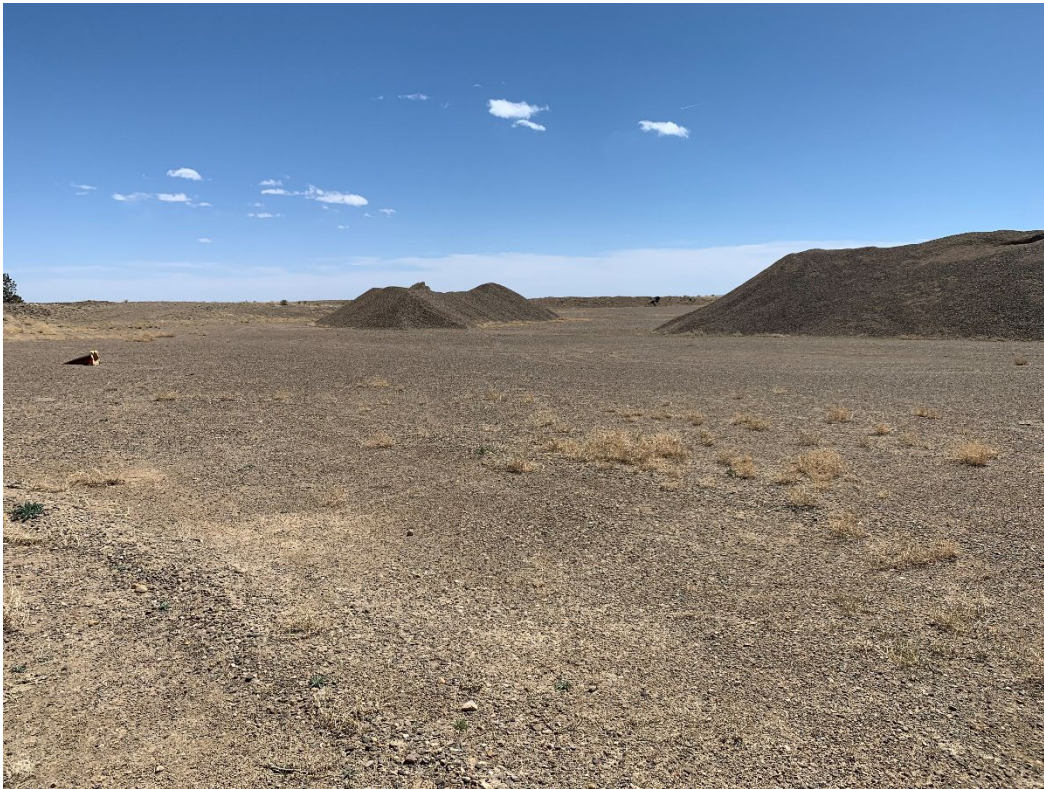
The mine entrance sign was in place at the entrance to the mine. No mining activity was taking place during the inspection. Several stock piles were located around the site and each was labeled with its product name (photo 1).

Photo 1 – Mining area with product stock piles

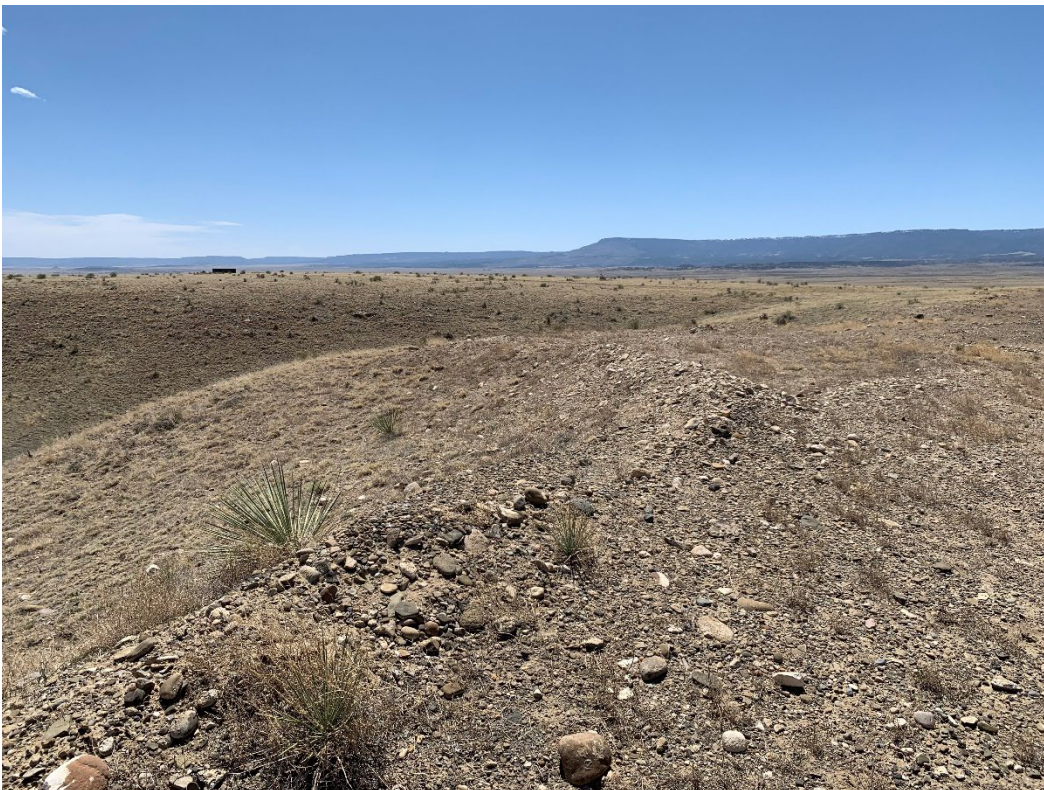
The current mining operation is in top of the plateau. Topsoil has been removed in front of the highwall (photo 2) and stored in various places around the working area. The top layer of the plateau is being removed in about 12 foot layers. There is no actual pit that can retain water.

Photo 2 – Topsoil removed on right side of picture
