## Kagie Pit, M-1979-102, Inspection Report

**MINERALS PROGRAM INSPECTION REPORT**  
**PHONE: (303) 866-3567**

<b>MINE NAME:</b> Kagie Gravel Pit	<b>MINE/PROSPECTING ID#:</b> M-1979-102	<b>MINERAL:</b> Sand and gravel	<b>COUNTY:</b> Routt
<b>INSPECTION TYPE:</b> Monitoring / SO	<b>WEATHER:</b> Cloudy	<b>INSP. DATE:</b> April 26, 2023	<b>INSP. TIME:</b> 09:00
<b>OPERATOR:</b> West Fish Creek Ranch, LLC	<b>OPERATOR REPRESENTATIVE:</b> Kameron DeVincentis	<b>TYPE OF OPERATION:</b> 110c - Construction Limited Impact

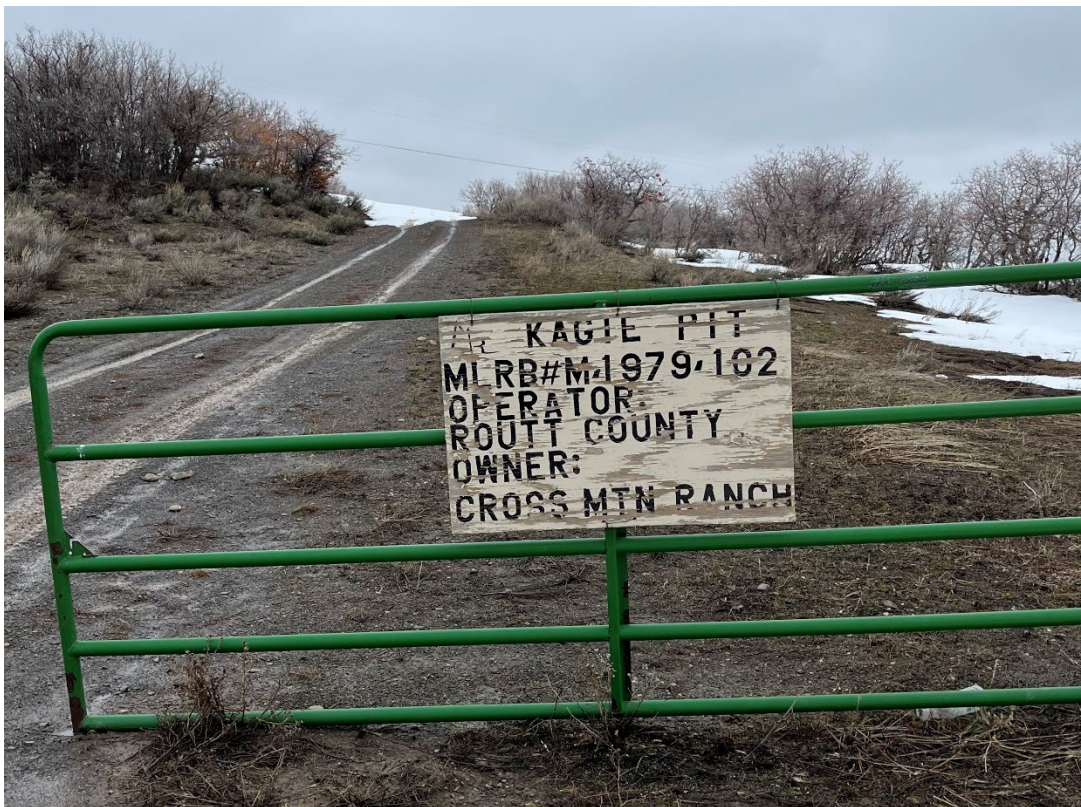
**PROBLEM/POSSIBLE VIOLATION:** Problem: The mine identification sign posted at the entrance of the mine site was inadequate. This is a problem for failure to post a mine identification sign as required by Section 3.1.12(1) of the rule. The Operator shall, at the entrance of the mine site post a sign, which shall be clearly visible from the access road, with a minimum size equaling one hundred and eighty-seven (187) square inches, such as eleven (11) inches in height and seventeen (17) inches in width, with appropriate font size, with the following: the name of the Operator, a statement that a reclamation permit for the operation has been issued by the Colorado Mined Land Reclamation Board; and the permit number.

The site is divided into upper and lower pit sections (Photo 8). The lower pit contains a scale, scale house, as well as an empty ~10,000 gallon tank and grizzly bars (Photos 2 & 3). The Division recommends removing unutilized equipment from the site to reduce liability. The sediment pond located in the northeastern portion of the lower pit was covered in snow. Affected area boundary markers in the form of a fence and metal posts are in place and in compliance with Rule 3.1.12. The mine sign was located at the main entrance from CR 29 (Photo 1). The mine sign was not in compliance with Rule 3.1.12, as the operator name has not been updated to reflect the changes made under SO1. This is cited as a problem. Please send the Division photo documentation that an updated sign has been posted at the mine entrance by the corrective action due date.

**Photo 1: Mine sign posted at the entrance. Needs to be updated to reflect operator changes made under revision SO1.**

**CORRECTIVE ACTIONS:** The operator shall, at the entrance of the mine site, post a sign which shall be clearly visible from the access road with the following: the name of the operator, a statement that a reclamation permit for the operation has been issued by the Colorado Mined Land Reclamation Board; and the permit number. The operator shall submit photo documentation that a proper sign has been posted by the corrective action date.

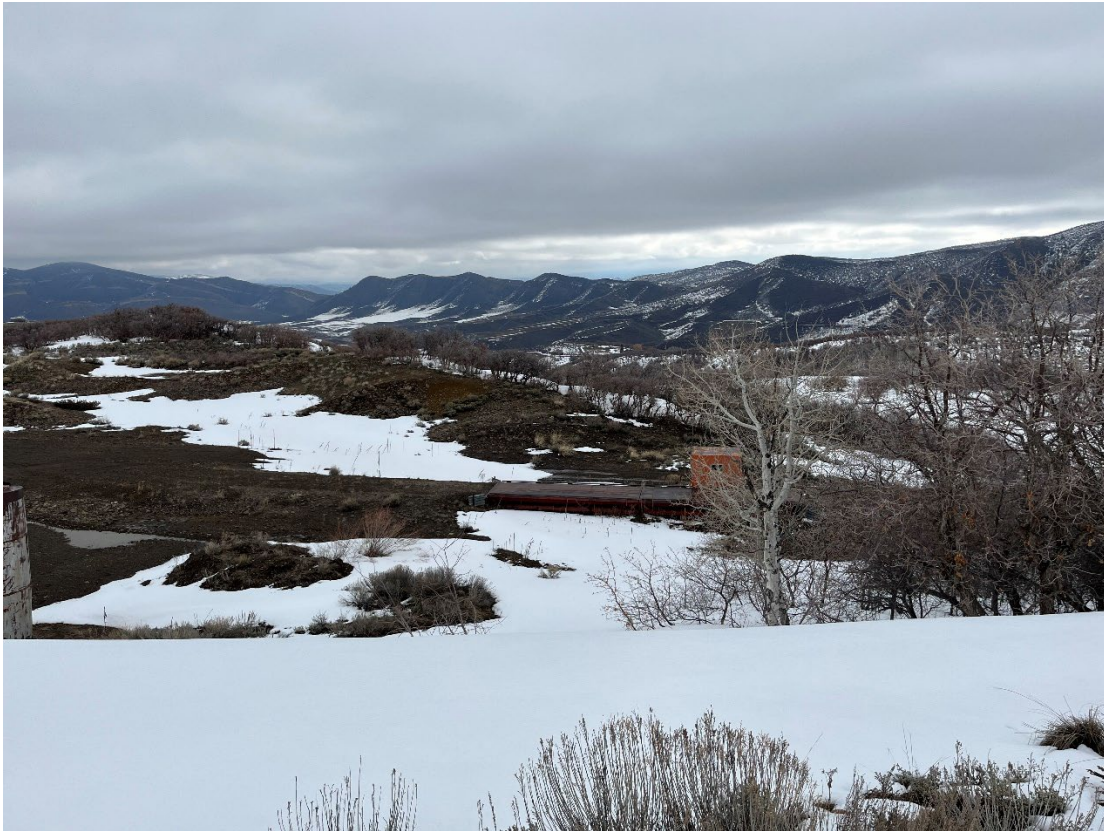
**Photo 2: View of the lower pit from the upper pit area. Scale and scale house are visible.**

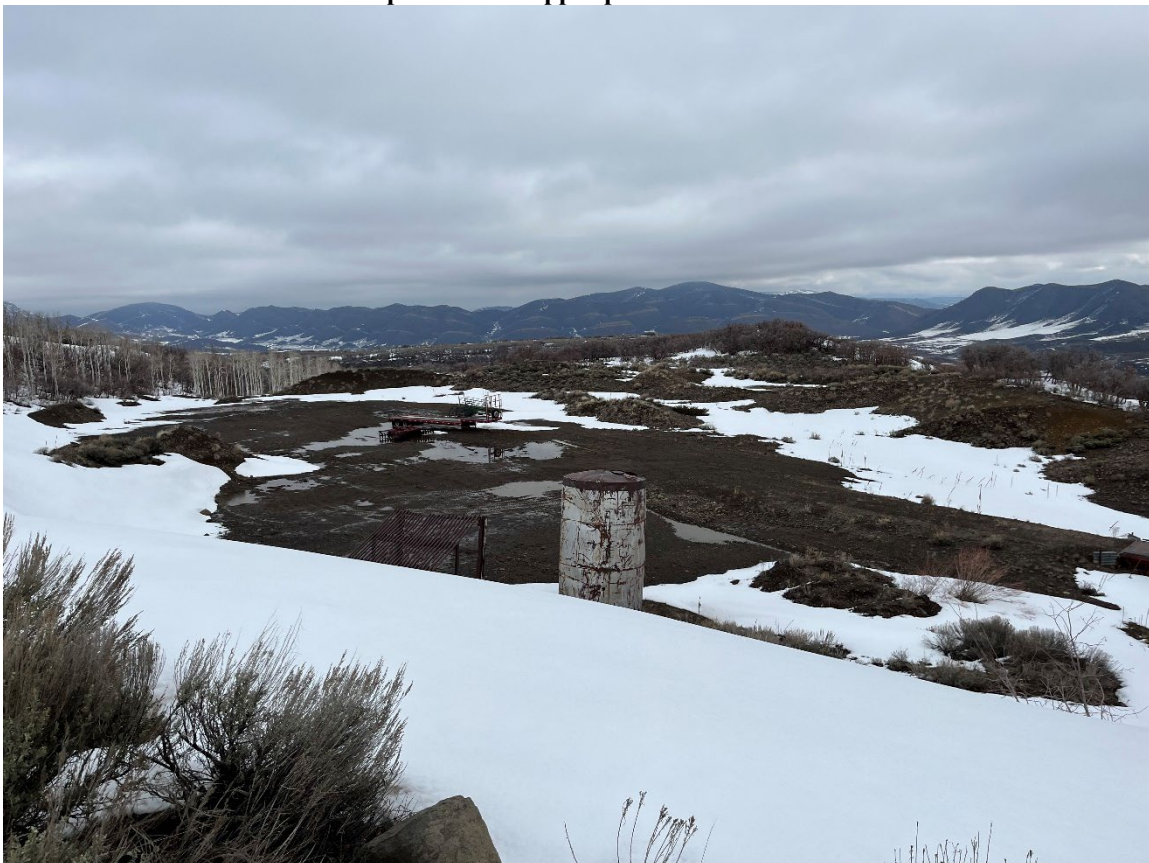
**Photo 3: View north of the empty tank, grizzly bars, and assorted equipment being stored in the lower pit area.**

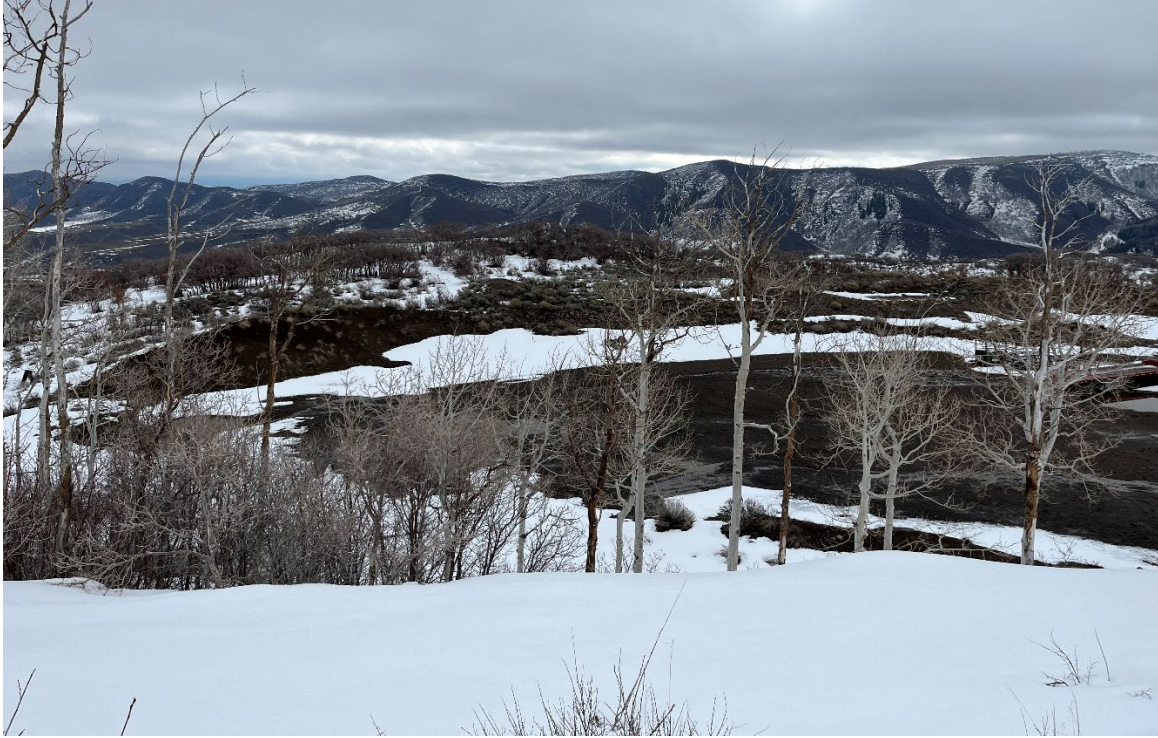
excavation area (Photo 7). There were also two topsoil stockpiles across the site (Photos 4, 5, and 7) which were partially vegetated.

**Photo 4: View east of the lower pit area. A partially vegetated topsoil pile is visible to the north.**

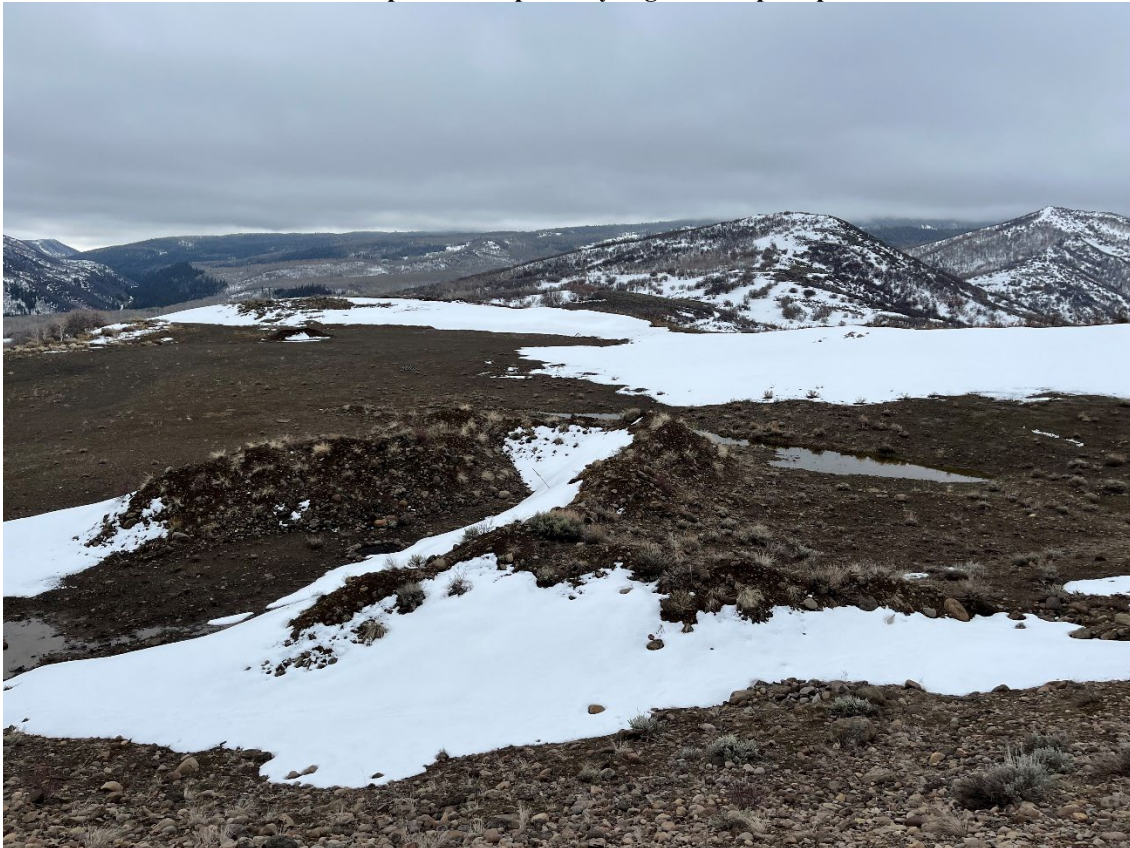
**Photo 5: View southwest of the upper pit taken atop the 'highwall'. A partially vegetated stockpile is visible in the foreground and a small stockpile of pea gravel is visible in the background to the east.**

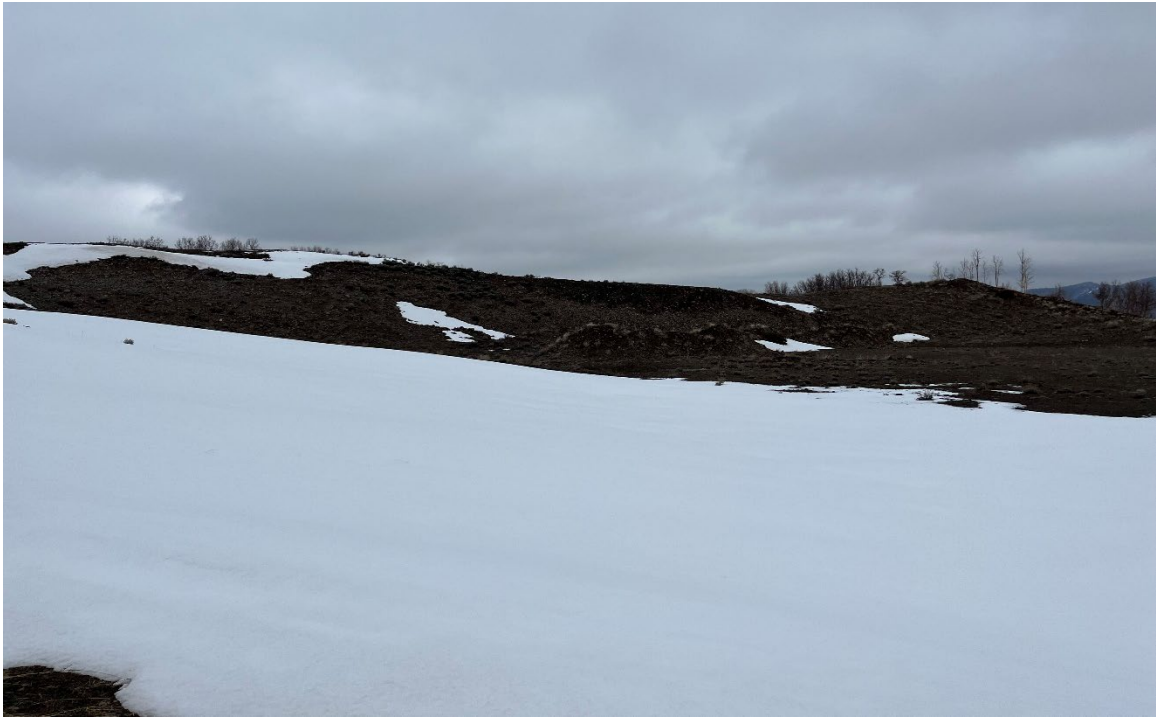
The upper pit entrance leads to the excavation area (Photo 6). There are no true highwalls at this site and all mining slopes exist at an approximately 2H:1V grade. There is a small stockpile of pea gravel in this upper

**Photo 6: View north of the upper pit's 'highwalls'. Slopes were approximately 2:1.**

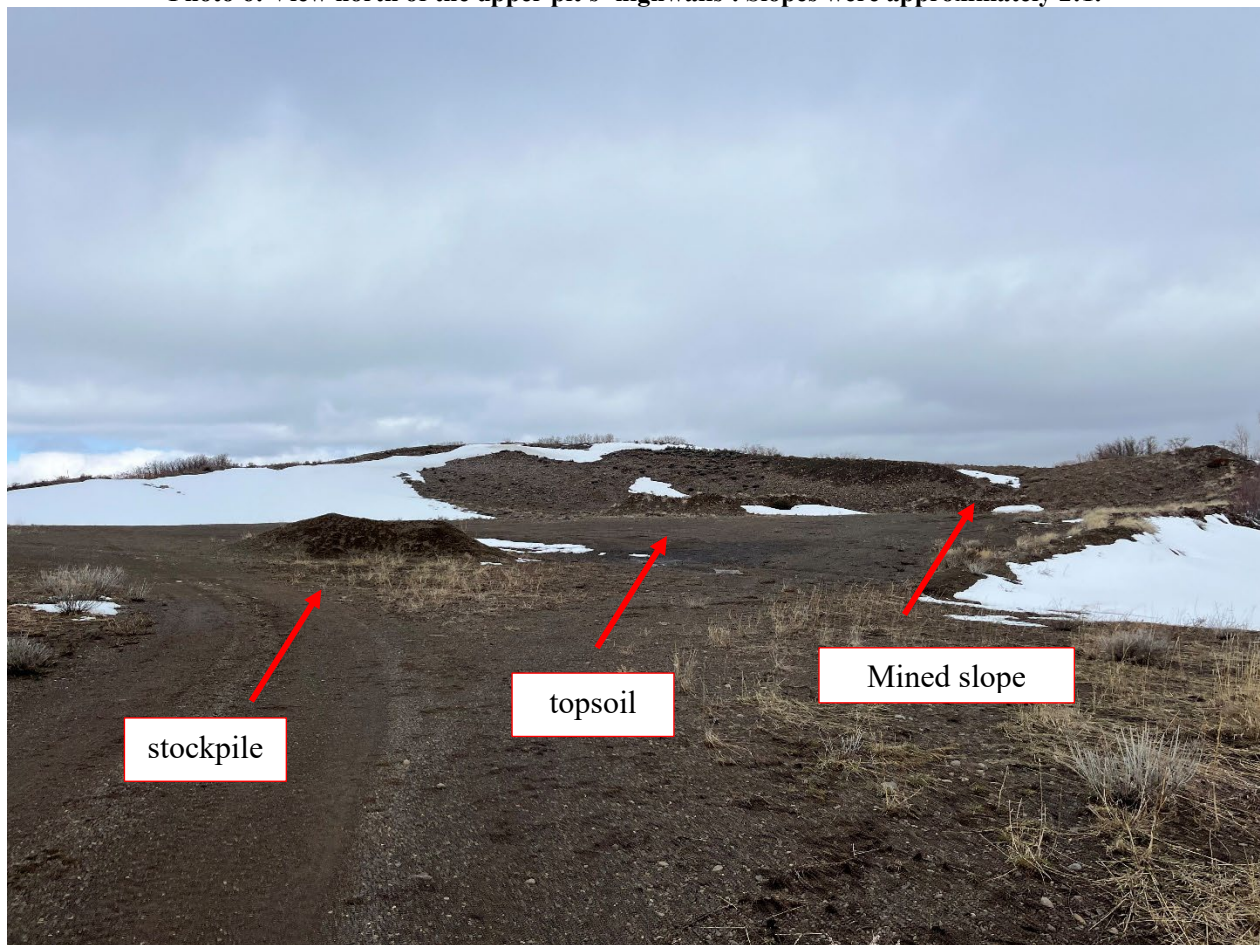
**Photo 7: View north at the entrance to the upper pit. The pea gravel stockpile, mined slopes, and topsoil pile are all visible.**

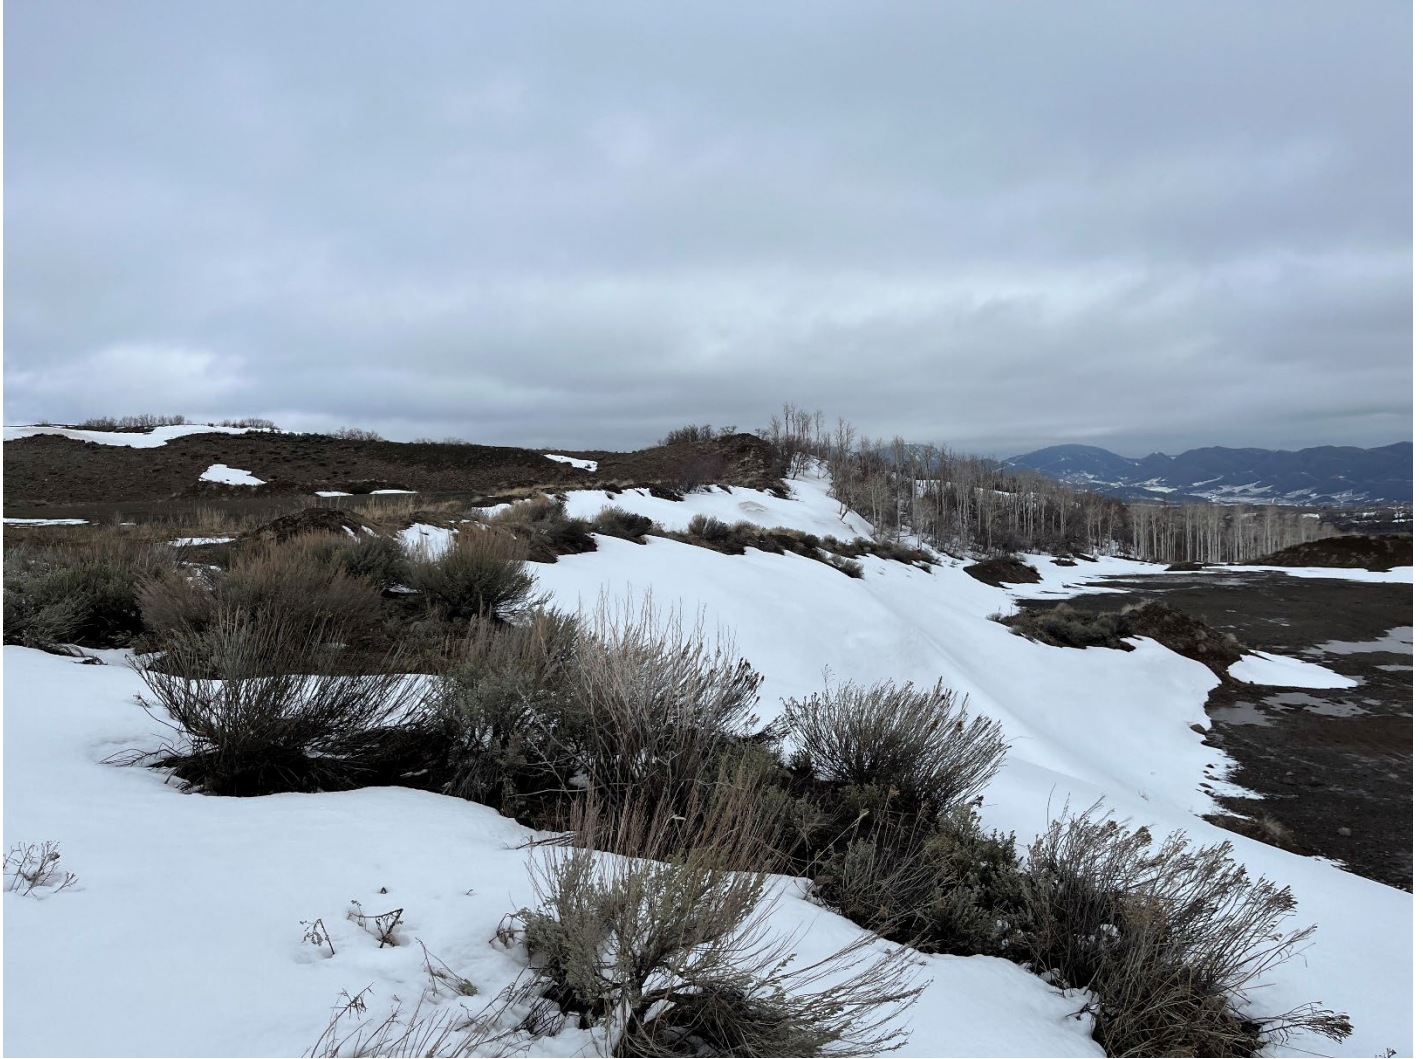
**Photo 8: View north atop the ridge between the upper and lower pit sections. The ridge is undisturbed.**
