**MINERALS PROGRAM INSPECTION REPORT**  
**PHONE: (303) 866-3567**

<b>MINE NAME:</b> Lyle Smith Pit	<b>MINE/PROSPECTING ID#:</b> M-1977-053	<b>MINERAL:</b> Sand and gravel	<b>COUNTY:</b> Costilla
<b>INSPECTION TYPE:</b> Monitoring	<b>WEATHER:</b> Clear	<b>INSP. DATE:</b> April 27, 2023	<b>INSP. TIME:</b> 11:20
<b>OPERATOR:</b> Asphalt Constructors, Inc.	<b>OPERATOR REPRESENTATIVE:</b> Todd Stockebrand	<b>TYPE OF OPERATION:</b> 112c - Construction Regular Operation	
<b>REASON FOR INSPECTION:</b> Normal I&E Program	<b>BOND CALCULATION TYPE:</b>	<b>BOND AMOUNT:</b> \$128,120.82	
<b>DATE OF COMPLAINT:</b> NA	<b>POST INSP. CONTACTS:</b> None	<b>JOINT INSP. AGENCY:</b> None	
<b>INSPECTOR(S):</b> Lucas West Todd Jesse	<b>INSPECTOR'S SIGNATURE:</b>

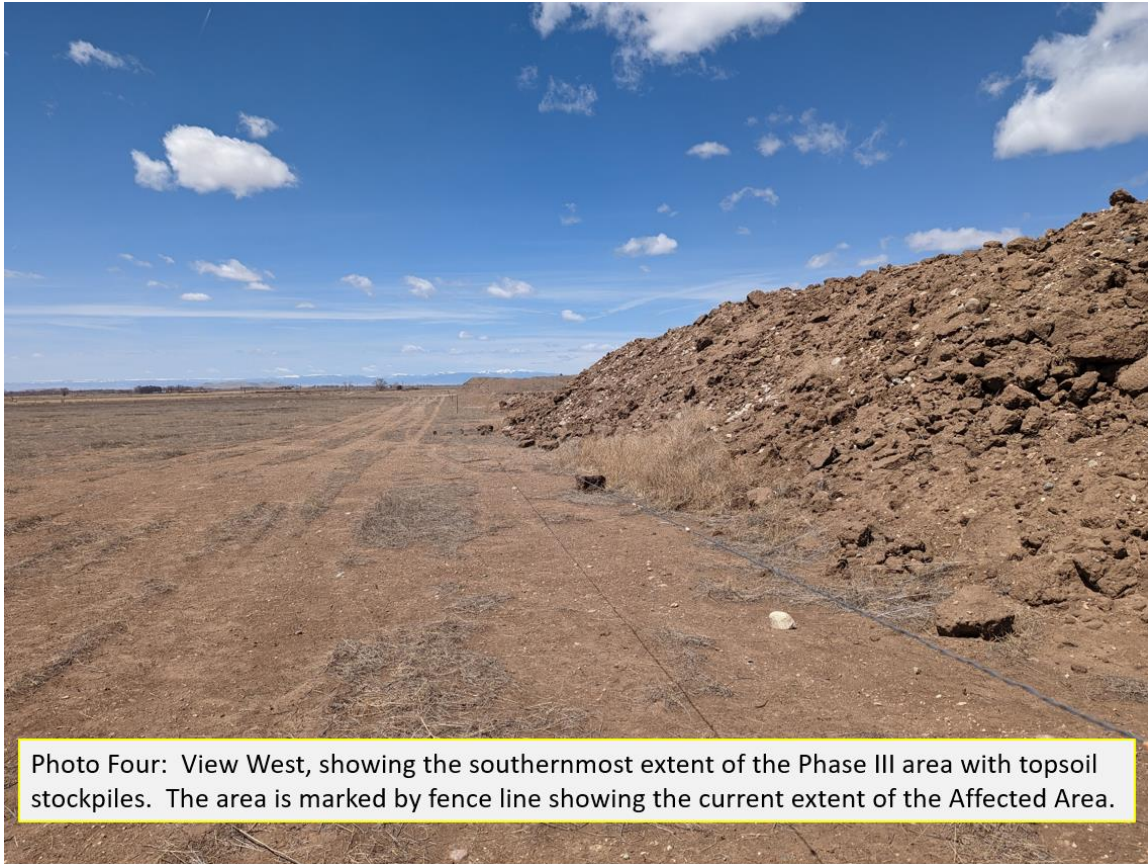
Photo Four: View West, showing the southernmost extent of the Phase III area with topsoil stockpiles. The area is marked by fence line showing the current extent of the Affected Area.

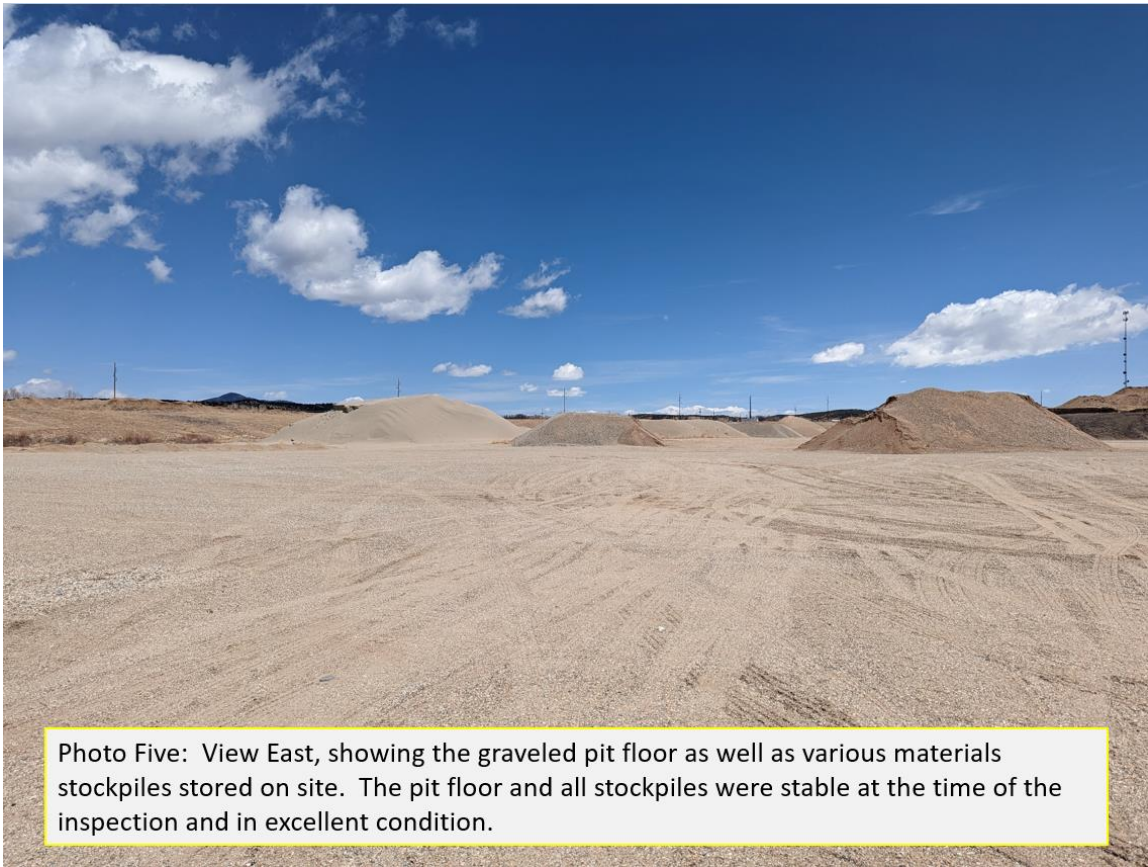
Photo Five: View East, showing the graveled pit floor as well as various materials stockpiles stored on site. The pit floor and all stockpiles were stable at the time of the inspection and in excellent condition.

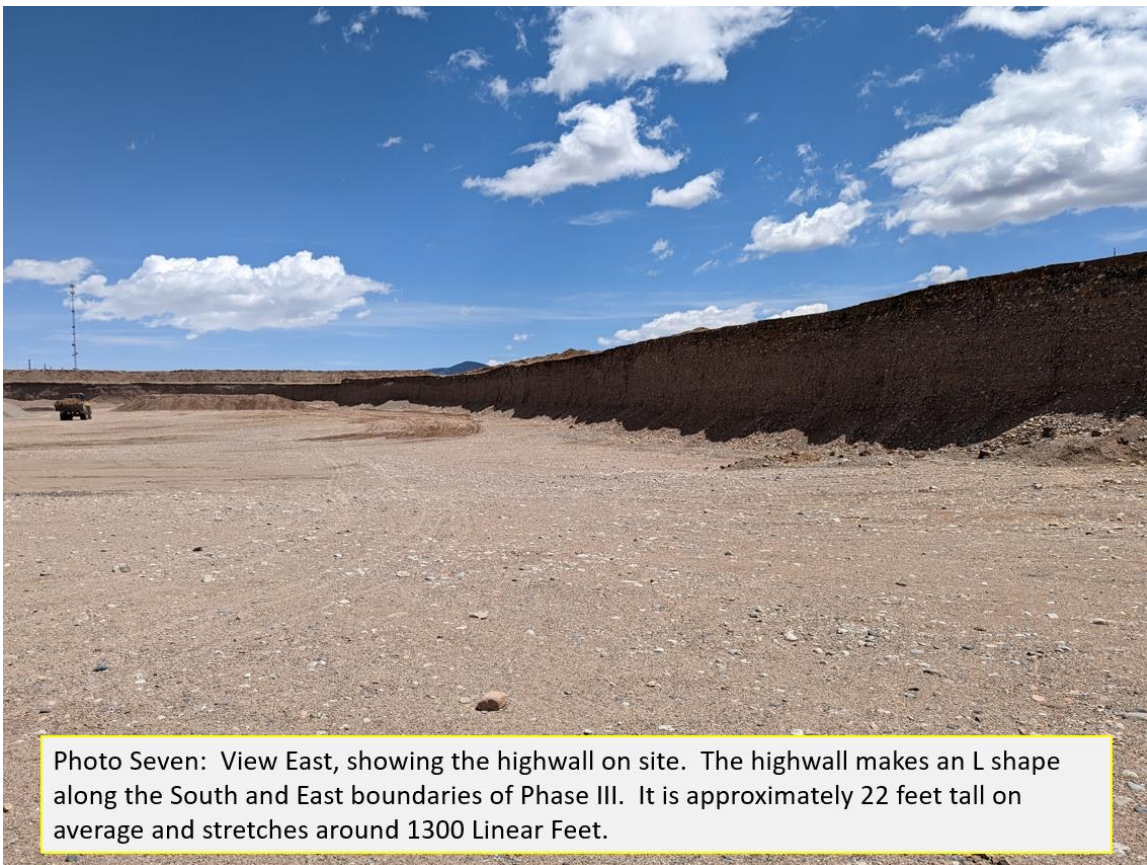
The active mining area was observed, and consists of a highwall that is on average approximately 22 feet tall and approximately 1300 linear feet in length in an L shaped configuration along the south and east sides of Phase III. The highwall can be seen in Photo Seven and appears to be stable with no evidence of sluffing, sliding or erosion noted. The material is removed from the highwall and processed in the crusher adjacent to the highwall and stockpiled on the pit floor. All areas around the highwall and crusher are in good condition. All fuel and potentially hazardous materials are being stored in a mobile trailer with the proper containment devices and observed bulk fuel tanks were verified to be empty.
