**MINERALS PROGRAM INSPECTION REPORT**  
**PHONE: (303) 866-3567**

<b>MINE NAME:</b> Stegner Farms	<b>MINE/PROSPECTING ID#:</b> M-1999-021	<b>MINERAL:</b> Sand and gravel	<b>COUNTY:</b> Larimer
<b>INSPECTION TYPE:</b> Monitoring	<b>WEATHER:</b> Clear	<b>INSP. DATE:</b> April 27, 2023	<b>INSP. TIME:</b> 10:30
<b>OPERATOR:</b> TROLLCO, INC	<b>OPERATOR REPRESENTATIVE:</b> Cody Wooldridge	<b>TYPE OF OPERATION:</b> 112c - Construction Regular Operation	
<b>REASON FOR INSPECTION:</b> Normal I&E Program	<b>BOND CALCULATION TYPE:</b> Complete Bond	<b>BOND AMOUNT:</b> \$65,000.00	
<b>DATE OF COMPLAINT:</b> NA	<b>POST INSP. CONTACTS:</b> None	<b>JOINT INSP. AGENCY:</b> None	
<b>INSPECTOR(S):</b> Patrick Lennberg	<b>INSPECTOR'S SIGNATURE:</b>

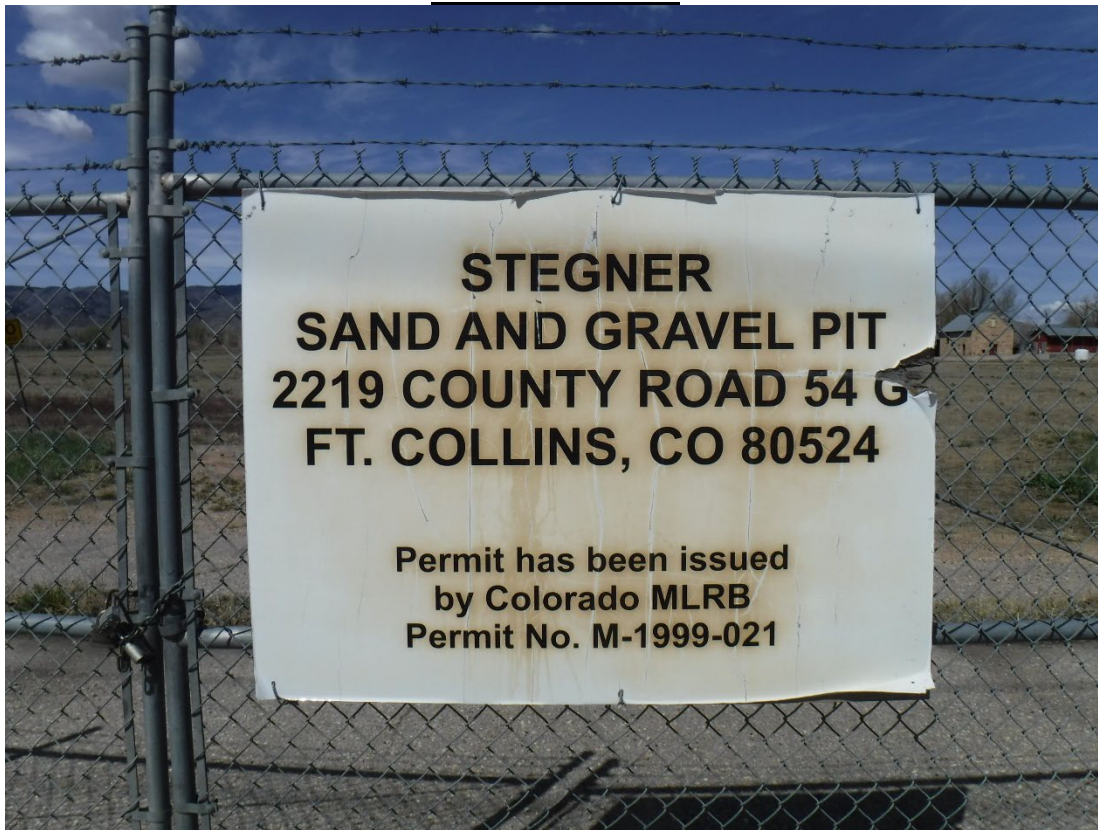
**Photo 1:** Mine sign at the primary mine entrance

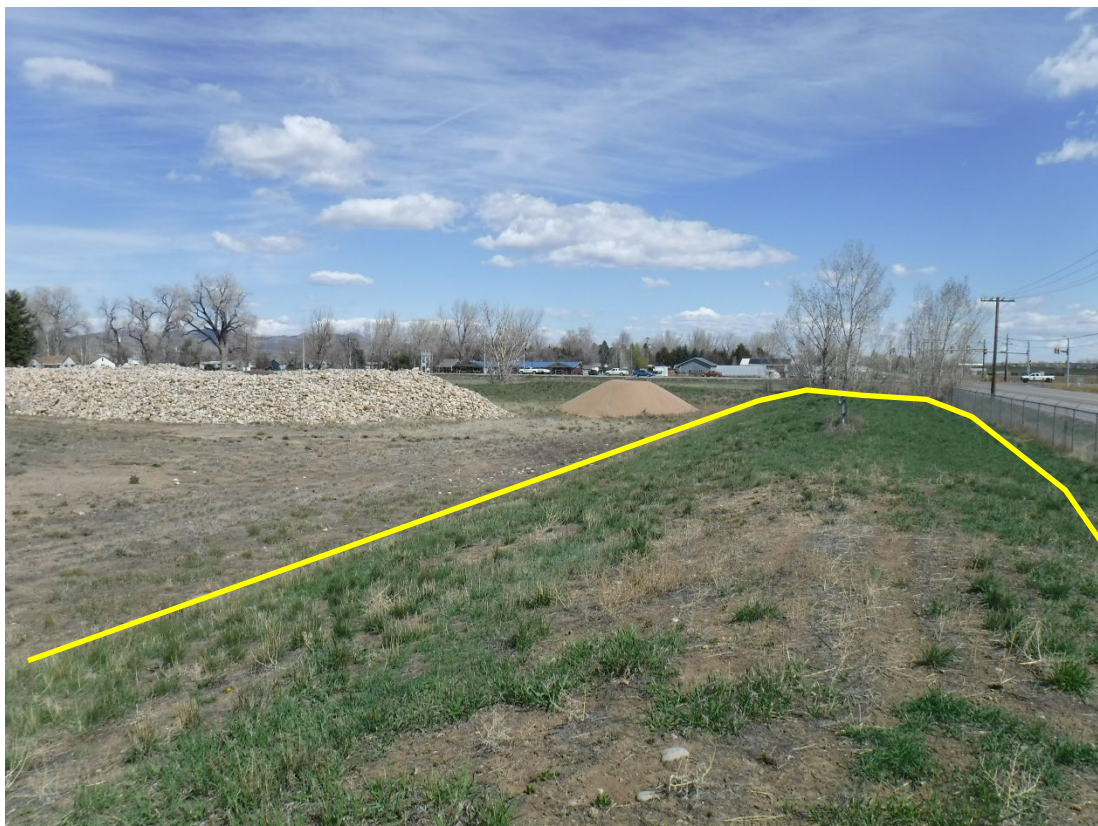
**Photo 2:** Looking north from near the mine entrance along the topsoil berm, yellow outline

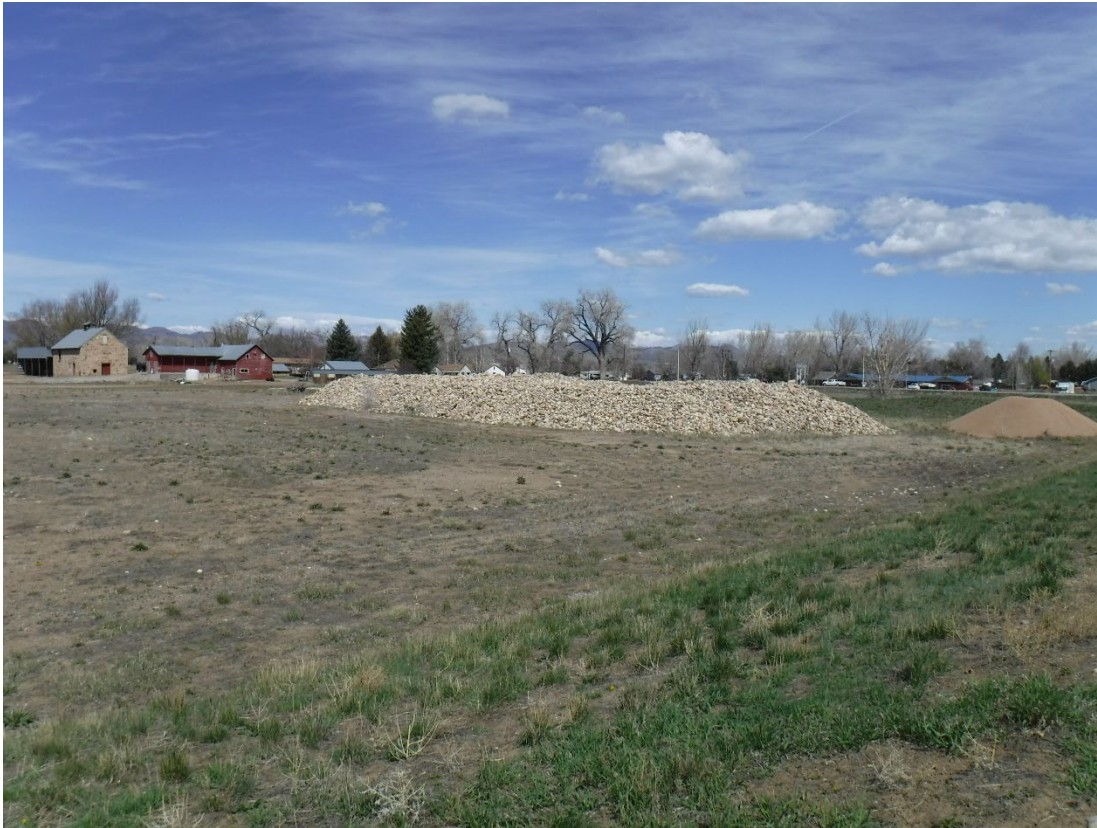
The site was not active at the time of inspection. In 2018 the operator submitted a Technical Revision (TR-7) that updated the Reclamation Plan map to represent the final water surface and define the berms along the eastern boundary of the permit to be used for final reclamation. There still remains a sizable stockpile of cobbles and river rock that the operator is hoping to sell in the near future. Cody did mention that various individuals have been removing small quantities of material from the stockpile of the past couple of years. There is also another small stockpile of fine sand material located adjacent to the cobble stockpile.

The Division estimates there is approximately 11 acres that need topsoil, 1 foot thick, spread over it and then seeded once the stockpiles are removed.

**Photo 3:** Remaining stockpiles of material

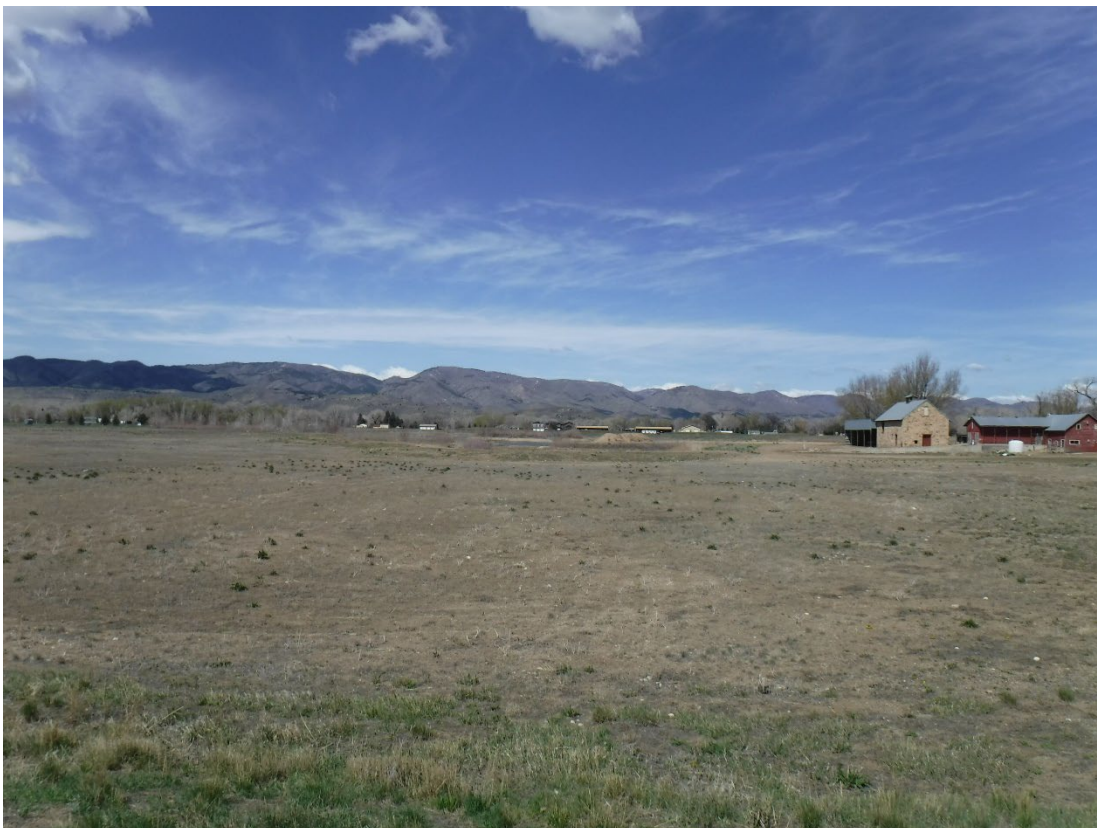
**Photo 4:** Looking west across the eastern permit area towards the reservoir

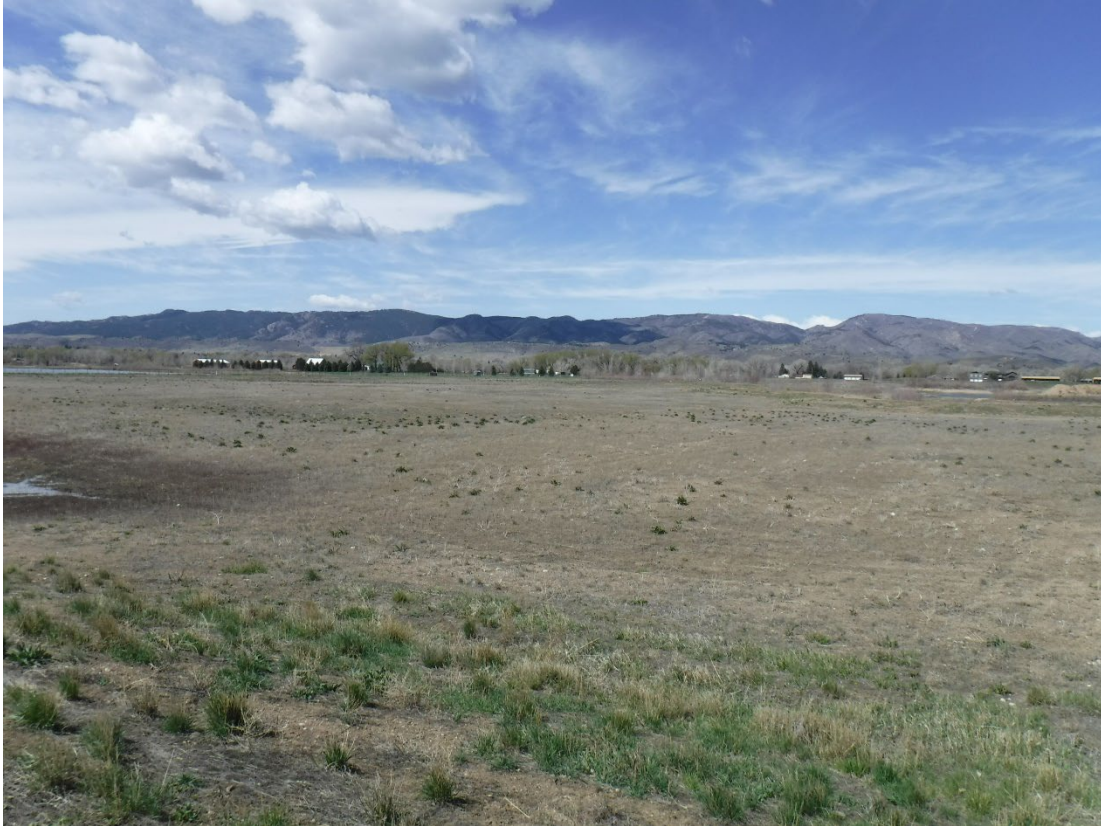
**Photo 5:** Looking southwest across the eastern permit area

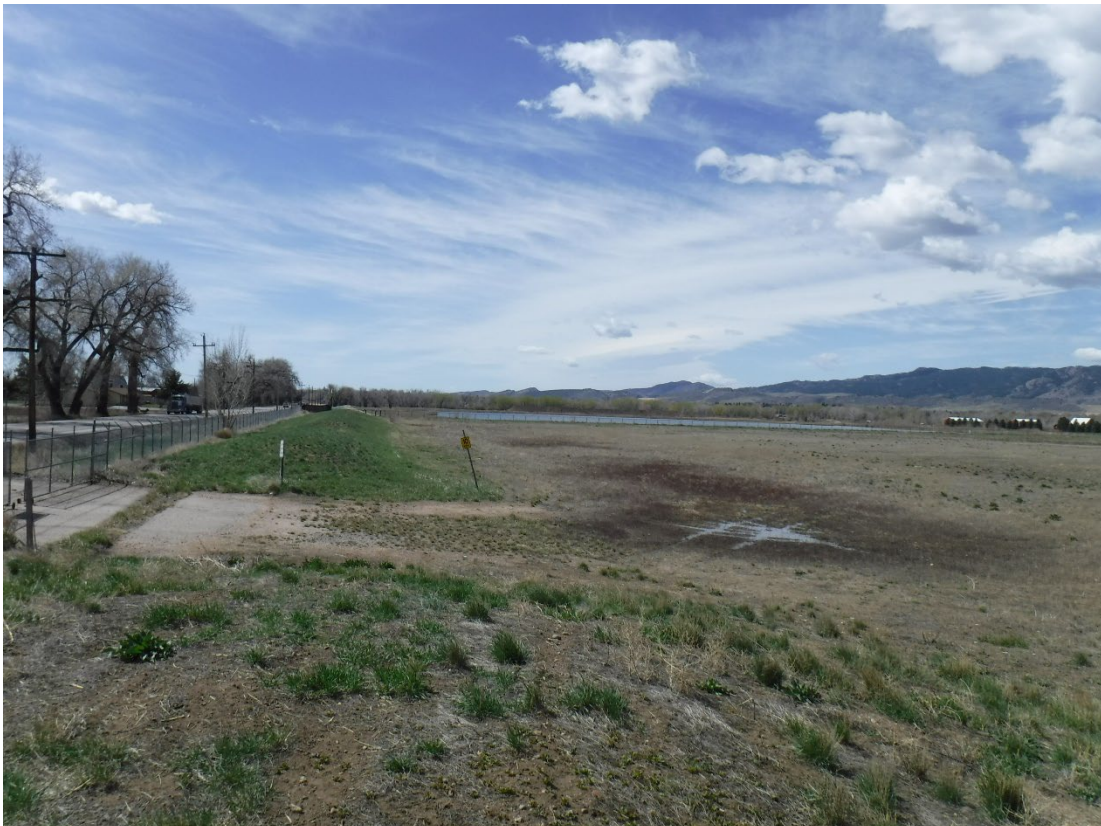
**Photo 6:** Looking south eastern permit boundary, ponded water from rain that fell overnight
