MINERALS PROGRAM INSPECTION REPORT PHONE: (303) 866-3567

MINE NAME:	MINE/PROSPECTING ID#:	MINERAL:	COUNTY:
Ingleside Quarry	M-1980-037-HR	Limestone (general)	Larimer
INSPECTION TYPE:	WEATHER: Clear	INSP. DATE:	INSP. TIME:
Surety-Related Inspection		April 27, 2023	11:30
OPERATOR:	OPERATOR REPRESENTATIVE:	TYPE OF OPERATION:	
Pioneer Sand Company, Inc.	Kurt Thurmann, Jessica Walker	112c - Construction Regular Operation	
REASON FOR INSPECTION:	BOND CALCULATION TYPE:	BOND AMOUNT:	
Surety Related	Complete Bond	\$90,878.51	
DATE OF COMPLAINT:	POST INSP. CONTACTS:	JOINT INSP. AGE	NCY:
NA	None	None	
INSPECTOR(S):	INSPECTOR'S SIGNATURE:	SIGNATURE DAT	E:
Patrick Lennberg	Patrick Stor	May 5, 2023

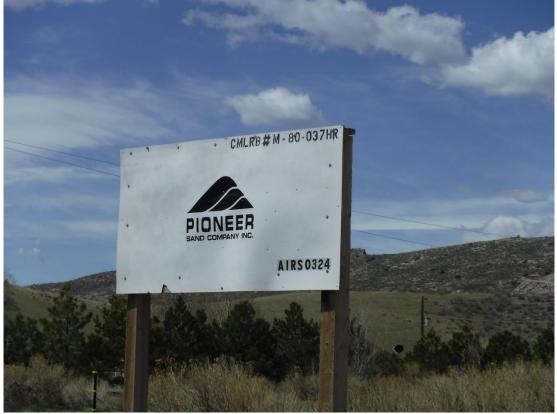
The Ingleside Quarry is located in Larimer County approximately 10.1 miles north of Laporte, Colorado on the west side of US 287. The site is 112c permitted for 86 total acres with 66 acres approved to be affected. The approved post-mining land use is rangeland. A mine sign was observed at the entrance to the mine as required by Rule 3.1.12. It should be noted the mine sign needs to be updated to reflect the new permittee once SO-4 is approved.

Photo 1: Mine sign at entrance to permit

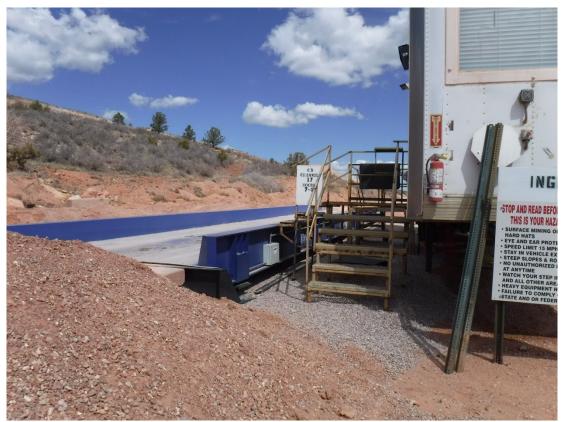
Photo 2: Portable Scale House

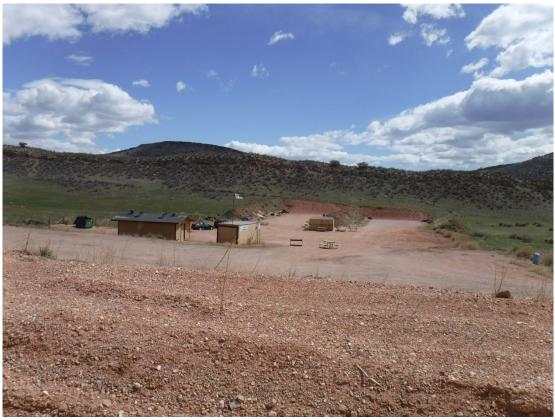
Photo 3: Shooting range adjacent to permit area

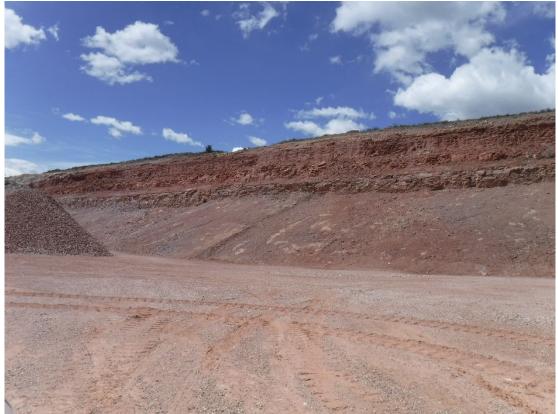
Photo 4: Mined and reclaimed area of the highwall, looking west

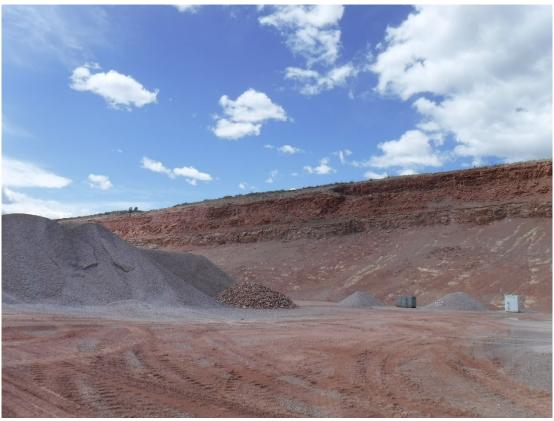
Photo 5: Stockpile area and blasting materials storage containers

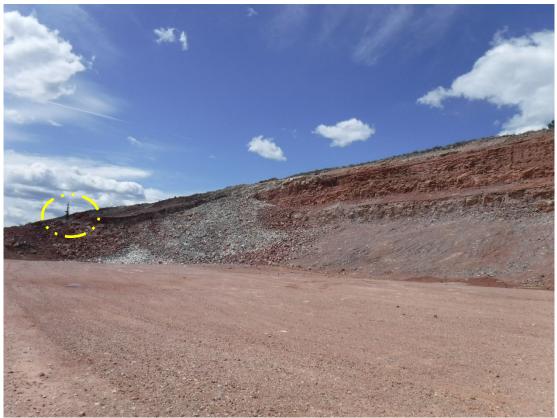
Photo 6: Blasted rock material, drill rig circled in yellow

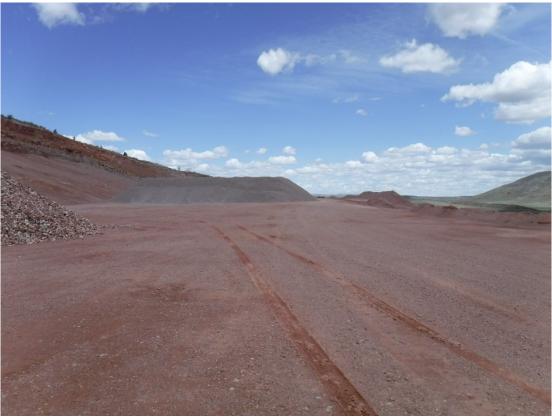
Photo 7: Looking north from the southern end of the affected area

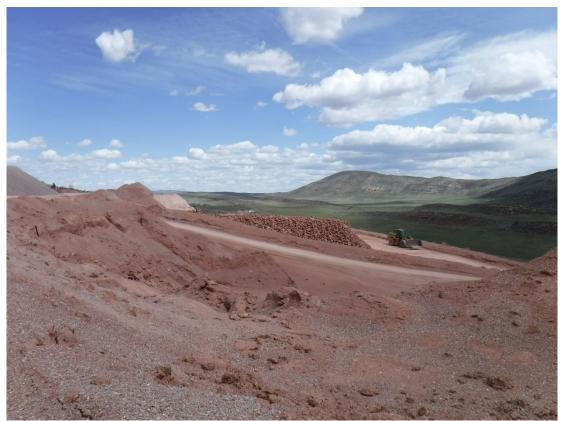
Photo 8: Looking northeast across the lower bench area

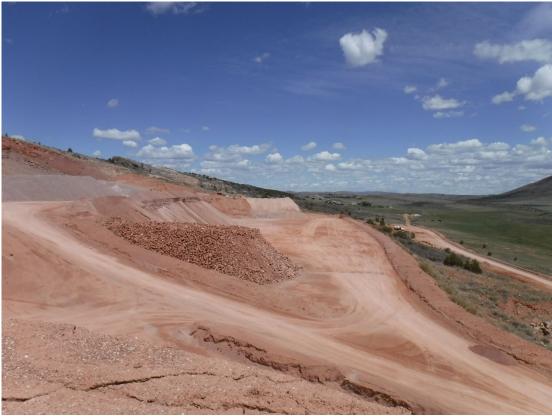
Photo 9: Looking north across the lower bench area

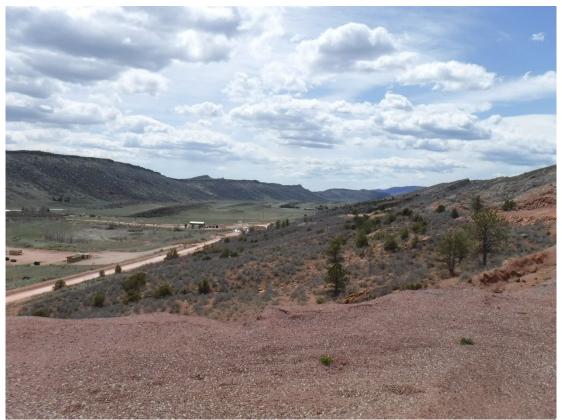
Photo 10: Looking south towards the mine entrance, gun range to the left of photo
