Roadside Mine, C-1981-041, April Partial Inspection Report

PERMIT INFORMATION

Permit Number: C-1981-041 Mine Name: Roadside Portals Operator: Snowcap Coal Company, Inc. Operator Address: MS Tonya Hammond P.O. Box 1430 Palisade, CO 81526	County: Mesa Operation Type: Underground Permit Status: Active Ownership: Private
	Operator Representative Present: Tonya Hammond
Operator Representative Signature: (Field Issuance Only)

Inspection Start Date: April 27, 2023 Inspection Start Time: 10:05 Inspection End Date: April 27, 2023 Inspection End Time: 10:45		Inspection Type: Coal Partial Inspection Inspection Reason: Normal I&E Program Weather: Clear	
Joint Inspection Agency: None		Joint Inspection Contacts: None	
Post Inspection Agency: None		Post Inspection Contacts: None	
Inspector(s): Clayton Wein	Inspector's Signature: <i>Clayton Wein</i>		Signature Date: 5/8/2023

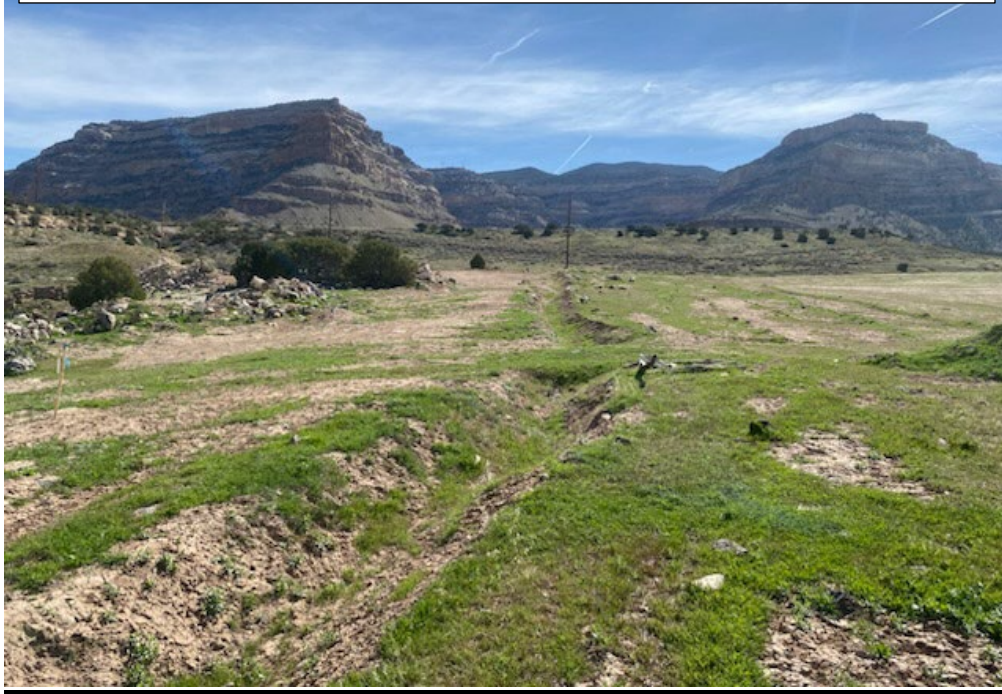
During the inspection the Carey pit was dry. There was no water running from the landowner's buried pipe into the pit. The landowner's trench on tract 71 was also dry. The pipe entering the trench at the east part of Tract 71 was not hooked up. There was no indication of recent flow in the ditch (Photo1). The landowner's middle field, located to the east of Tract 71 was not being irrigated during the inspection (Photo 2). The landowner's trenches on the Tract 70 Mesa were not active at the time of the inspection (Photo 3). None of the riser pipes were observed to be active. There was no evidence of recent flow in the trenches.

Photo 1: The northern portion of the landowner's Tract 71 trench.

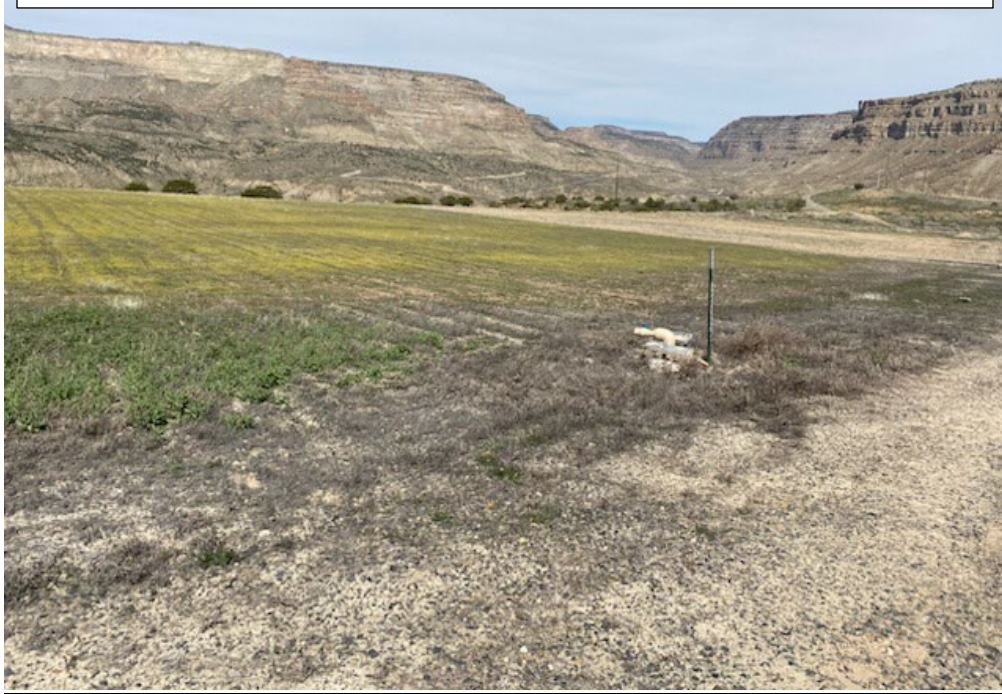
Photo 2: The Landowner's middle field.

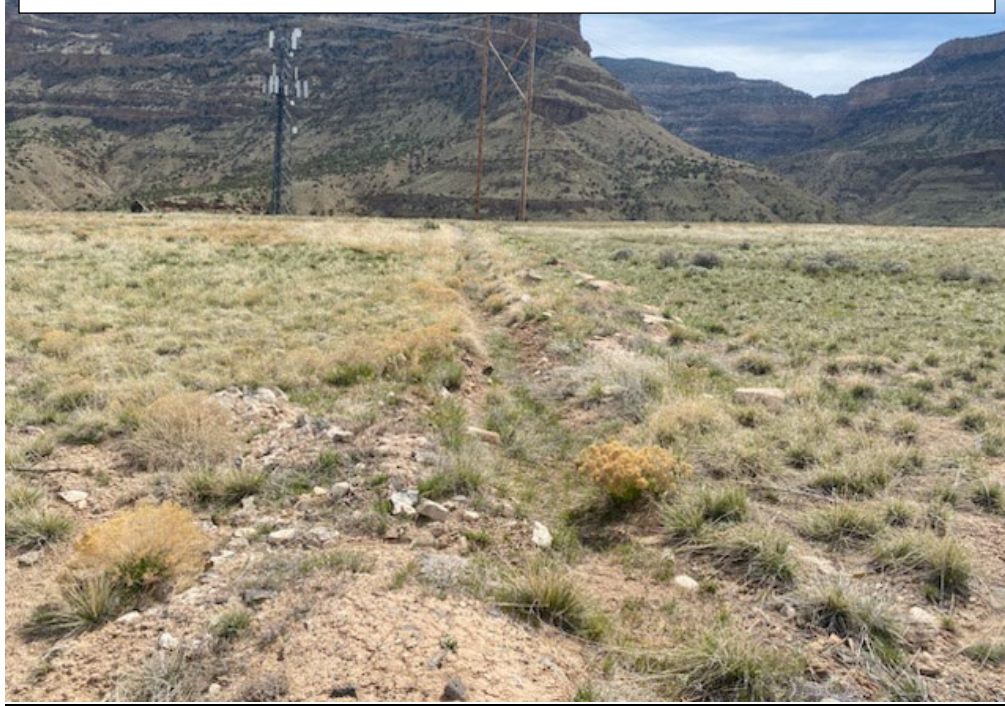
The Landowner's northern trench on the Tract 70 Mesa.

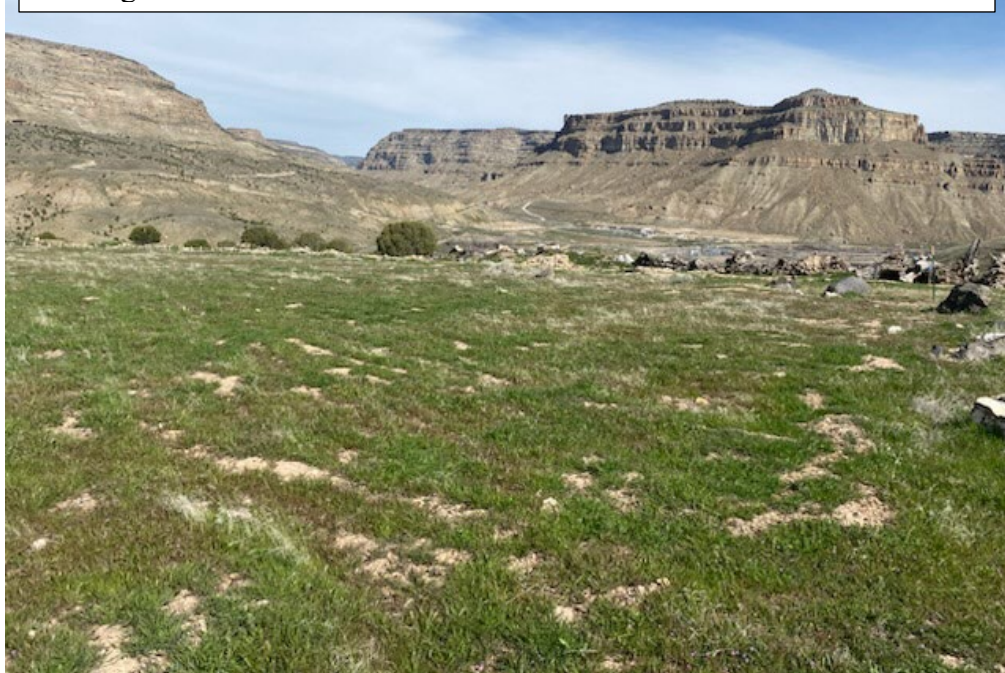
The TR-69 Repair Area is located in the northern part of what is referred to as Tract 71. The repair area is approximately 0.4 acres in size. The area was reclaimed in the fall of 2019 following the completion of work approved under Technical Revision No. 69. During the inspection, the reclaimed area was stable with vegetative cover (Photos 4 and 5). Vegetation was beginning to green and grow in for the spring season. There were no noxious weeds identified. The disturbed boundary markers, represented by T-posts, were in place and properly delineated the disturbed boundary. The straw waddles located on the south and west ends of the disturbed area were in good condition. No off-site impacts were observed. The mine ID sign located on the southern access to

Photo 4: The eastern portion of the TR-69 Repair Area, photo was taken looking to the northwest.

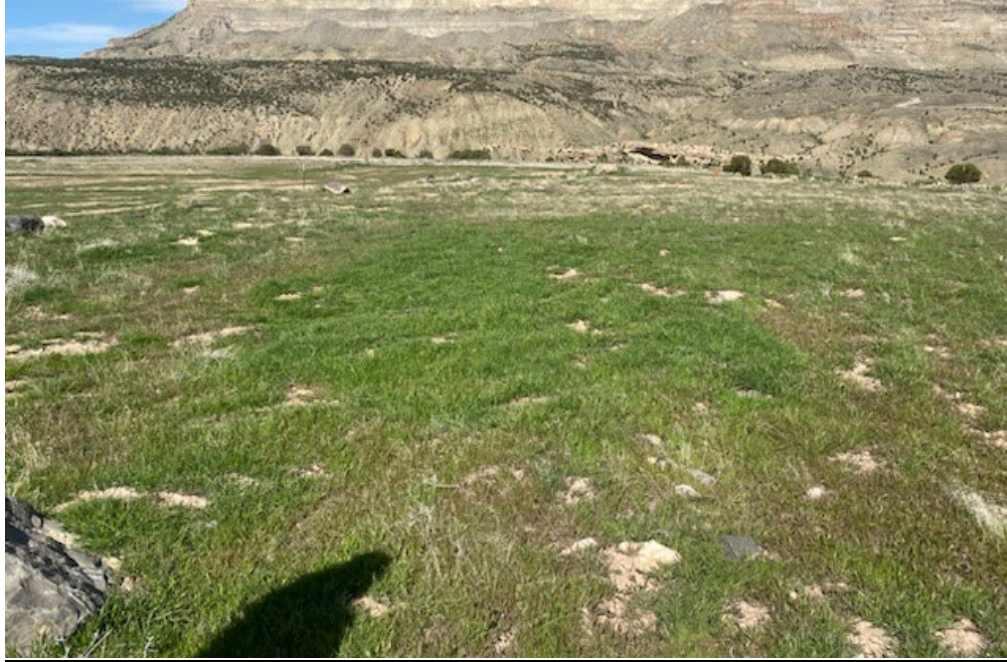
Photo 5: The southwestern portion of the TR-69 Repair Area, the photo was taken looking to the southwest.

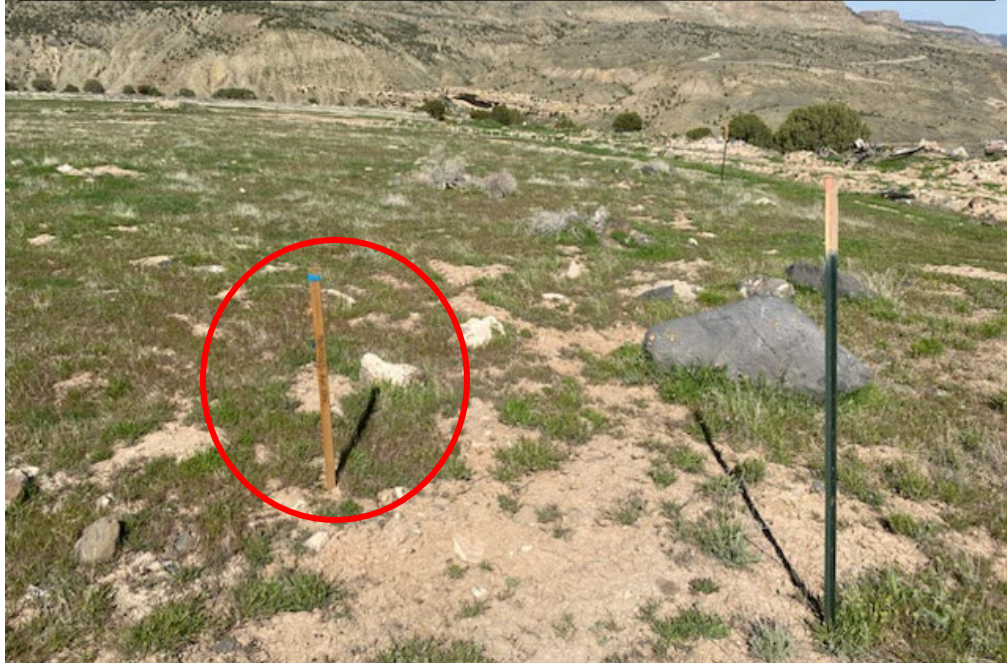
the disturbed area was posted in a clear location on a T-post. During the inspection of the TR-69 Repair Area, a series of wooden stakes with ribbons on them were identified transecting Tract 71. The wooden stakes were labeled "Proposed H2O Easement". These stakes were not placed by the operator and do not have to do with the operator's implementation of their water augmentation plan, as approved by the Division of Water Resources. One of the labeled wooden stake was located within the disturbed boundary of the eastern portion of the TR-69 Repair Area (Photo 6). Discussions with the operator's representative indicated that SCC does not know what the wooden stakes are related to.

Photo 6: The wooden stake identified within the disturbed boundary of the TR-69 Repair Area. The stake was not placed by the Operator.
