MINERALS PROGRAM INSPECTION REPORT
PHONE: (303) 866-3567

MINE NAME: Funk & Hooker Pit	MINE/PROSPECTING ID#: M-1979-058	MINERAL: Sand and gravel	COUNTY: Routt
INSPECTION TYPE: Monitoring	WEATHER: Clear	INSP. DATE: April 25, 2023	INSP. TIME: 10:30
OPERATOR: Routt County	OPERATOR REPRESENTATIVE: Zach Schaffner	TYPE OF OPERATION: 112c - Construction Regular Operation	
REASON FOR INSPECTION: Normal I&E Program	BOND CALCULATION TYPE:	BOND AMOUNT: \$0.00	
DATE OF COMPLAINT: NA	POST INSP. CONTACTS: None	JOINT INSP. AGENCY: None	
INSPECTOR(S): Hunter Ridley	INSPECTOR'S SIGNATURE:

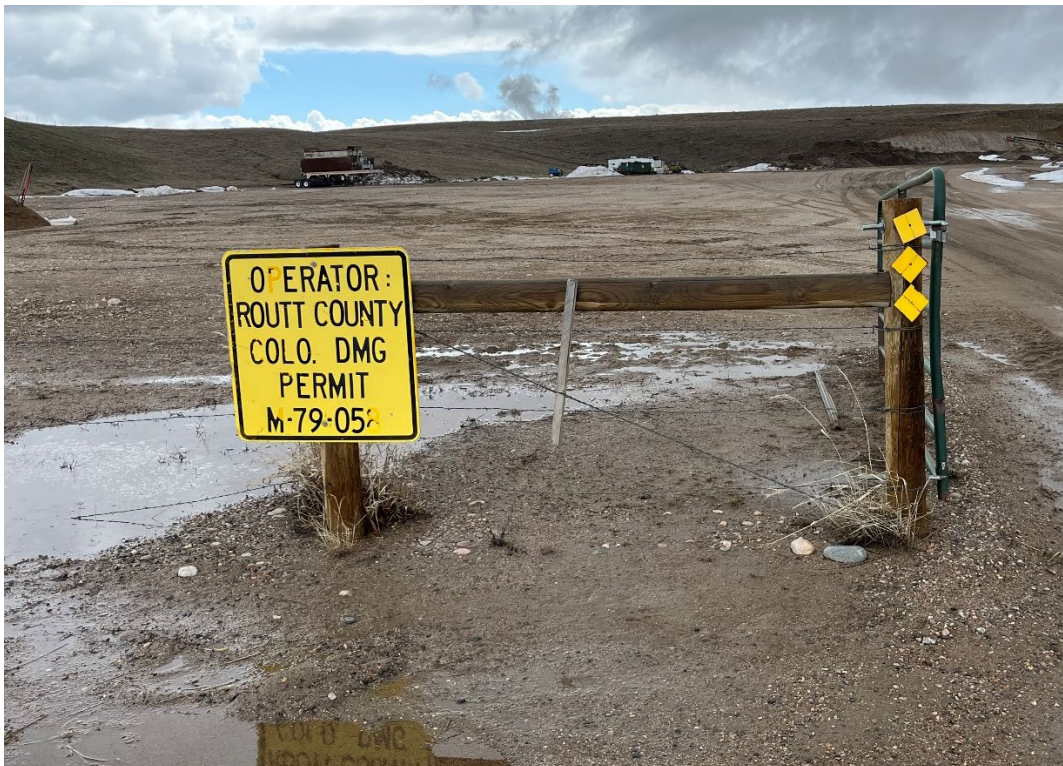
PROBLEM/POSSIBLE VIOLATION: Problem: The mine identification sign posted at the entrance of the mine site was inadequate. This is a problem for failure to post a mine identification sign in conformance with the requirements of Section 3.1.12(1) of the rule. The Operator shall, at the entrance of the mine site post a sign, which shall be clearly visible from the access road, with a minimum size equaling one hundred and eighty-seven (187) square inches, such as eleven (11) inches in height and seventeen (17) inches in width, with appropriate font size, with the following: the name of the Operator, a statement that a reclamation permit for the operation has been issued by the Colorado Mined Land Reclamation Board; and the permit number.

Affected area boundary markers are in place in accordance with Rule 3.1.12, delineated by a wire fence and t-posts. However, the mine sign is peeling and should be amended so that the permit number is fully legible (Photo 1). The Division is citing this as a problem for failure to post a mine identification sign in conformance with the requirements of Section 3.1.12(1). Please send the Division photo documentation that an updated sign has been posted at the mine entrance by the corrective action due date.

Photo 1: Mine sign posted at the entrance to the site, shares an access road with the Hayden Gravel Pit.

CORRECTIVE ACTIONS: The operator shall, at the entrance of the mine site, post a sign which shall be clearly visible from the access road with the following: the name of the operator, a statement that a reclamation permit for the operation has been issued by the Colorado Mined Land Reclamation Board; and the permit number. The operator shall submit photo documentation that a proper sign has been posted by the corrective action date.

CORRECTIVE ACTION DUE DATE: 7/07/23

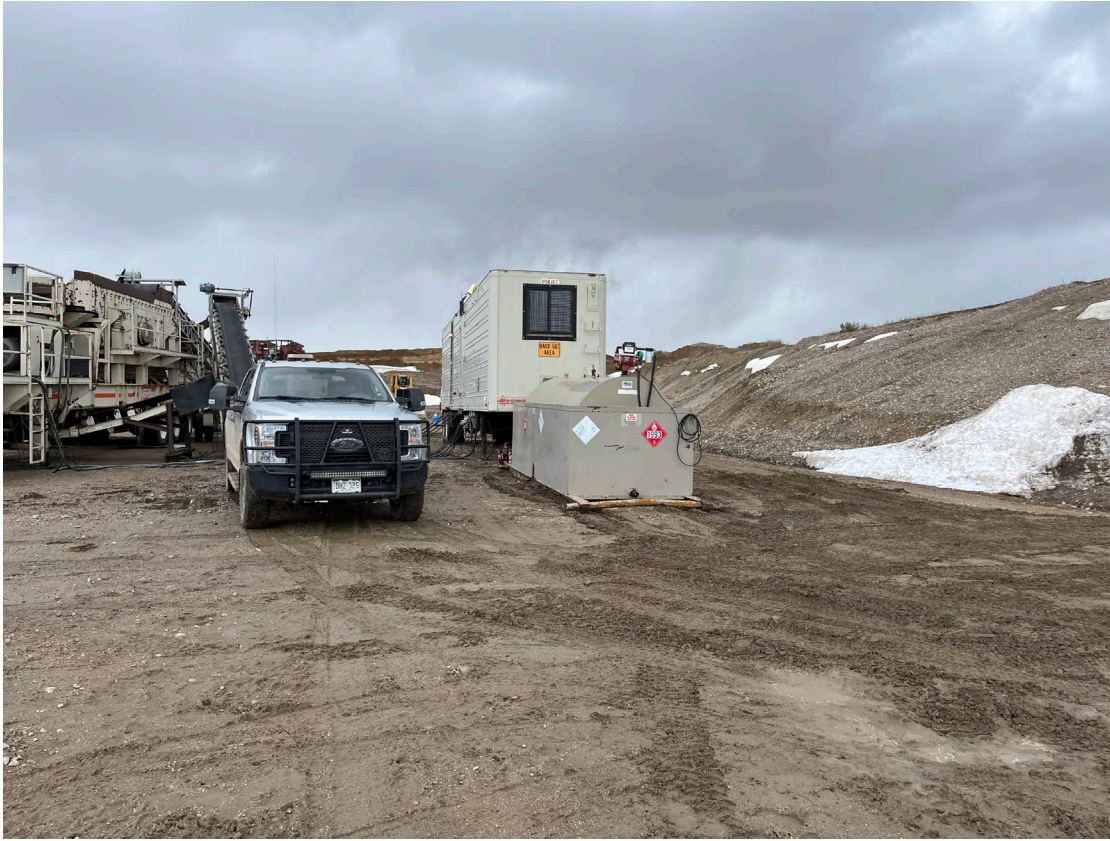
Photo 2: View SE of processing equipment and fuel stored in secondary containment.

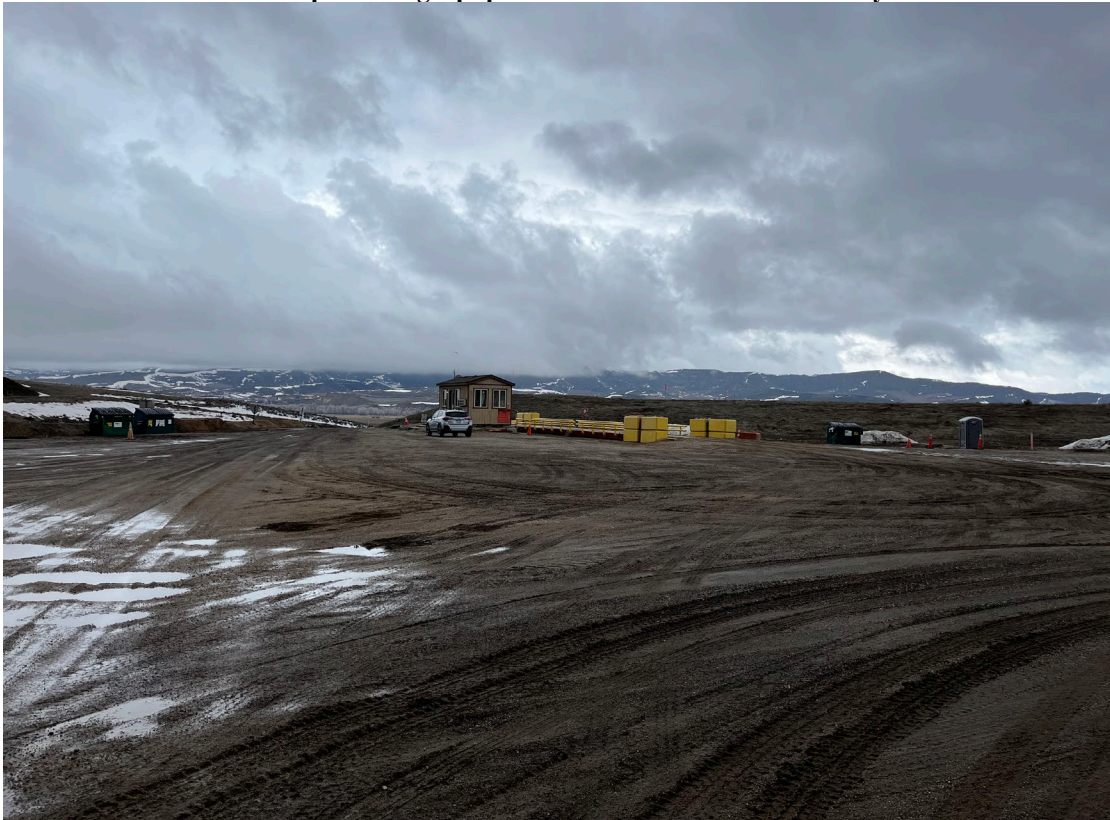
A scale and scale house are located directly north of the mining area and are in shared use with the adjacent Hayden Gravel Pit (Photo 3). As per the mining plan, all mining slopes will be at a 2H:1V grade except the western slope which will daylight. The current mining slopes, located in the southern portion of the permit boundary, are within the required grade and sit at an approximately 15-20ft height (Photos 4 & 5). The operation is currently in Phase 2 of mining. The eastern corner of the pit holds a stockpile of imported material. The operator stated this is shale mixed with pit run (Photo 6). Miscellaneous equipment and portable processing machinery are stored on the northern edge of the permit boundary (Photo 7). The pit floor was dry except for small amounts of snowmelt and no erosion features were observed during the inspection.

Photo 1: View NW of the scale and scale house shared between the Funk & Hooker Pit and the adjacent Hayden Gravel Pit.

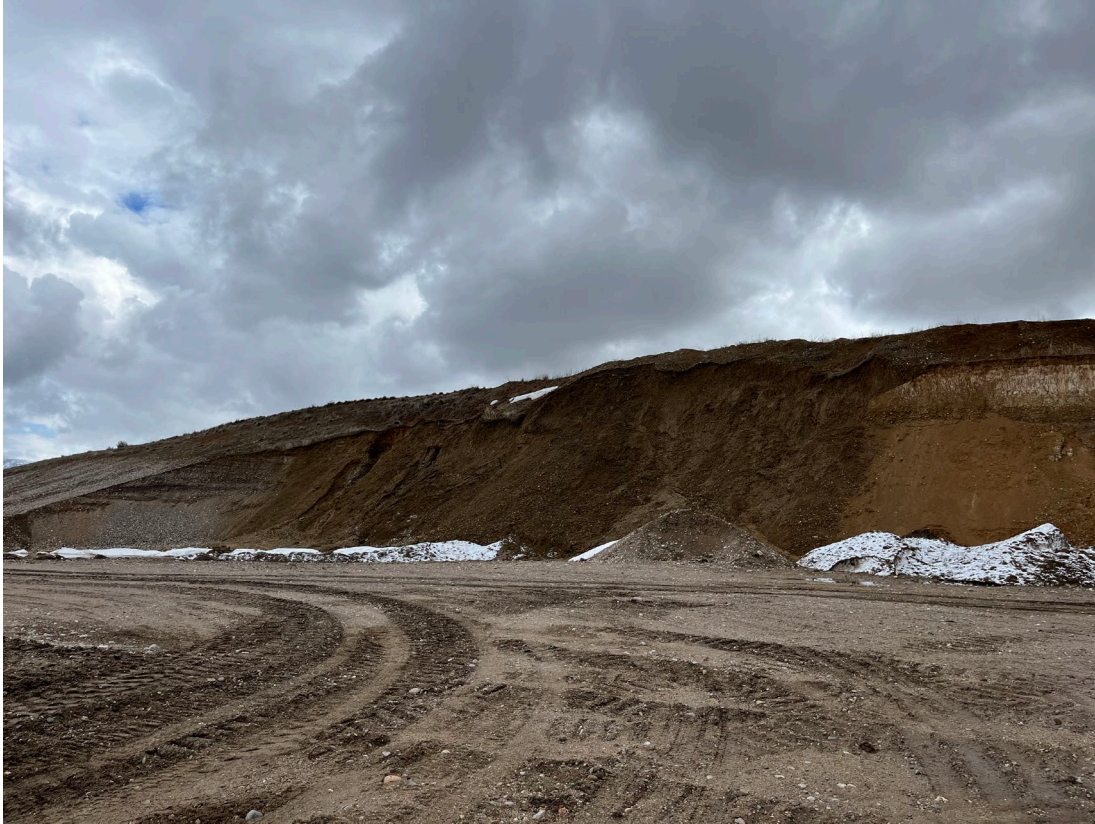
Photo 4: Western boundary of the mining face, will be mined to daylight.

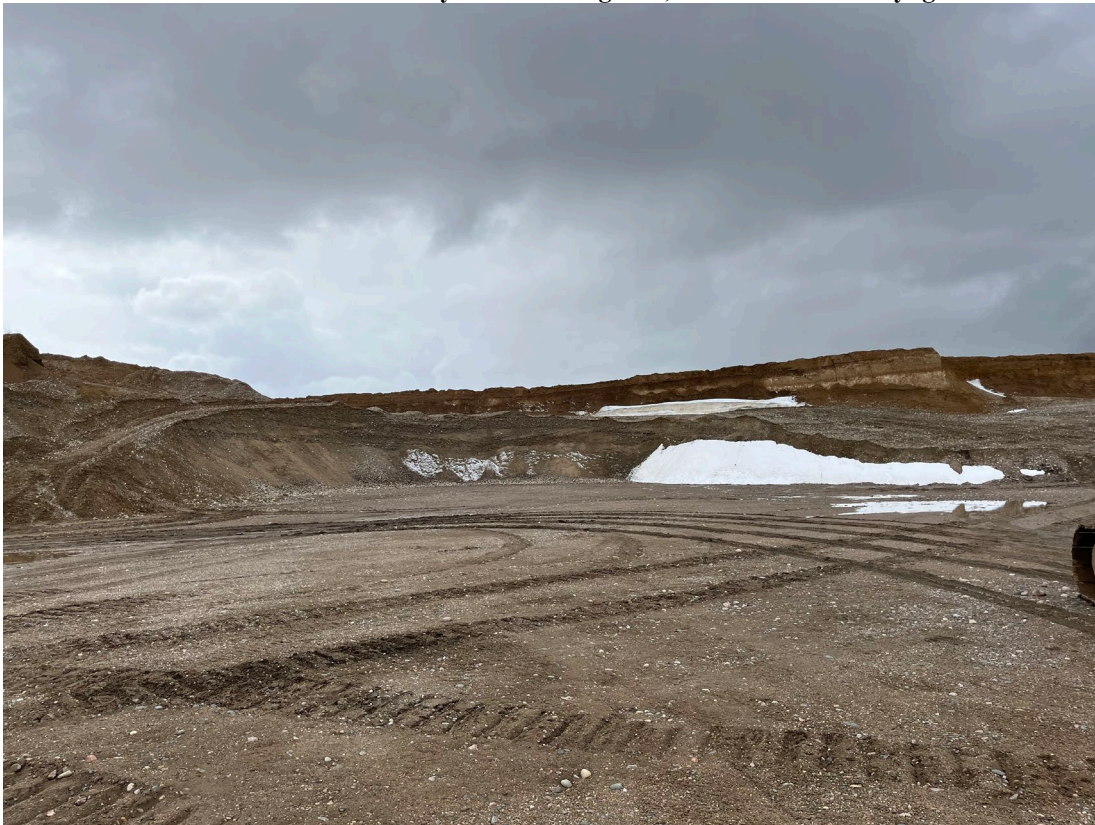
Photo 5: View SE of the existing mining face. Topsoil and overburden piles stored to the N and S of this area were inaccessible due to wet conditions.
