Sage Creek Mine Inspection Report, C-2009-087

PERMIT INFORMATION

INSPECTION INFORMATION

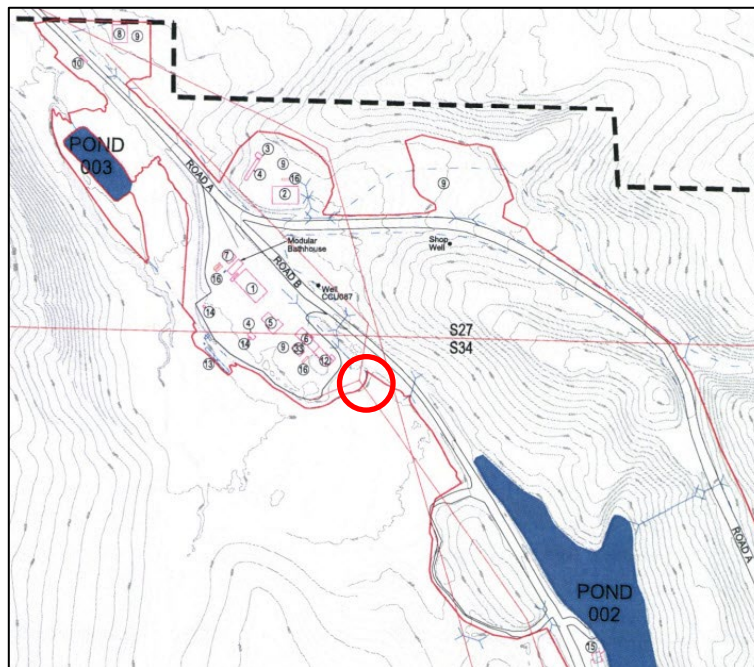
The pipe located below Pond 002, in the previous vehicle wash bay area, was not noted to be leaking at the time of the inspection (Photo 14). Any leakage would report to the same discharge as Pond 002. The operator stated that this pipe is continually checked for maintenance and reinforced to avoid breakage and discharge. Location of pipe is shown on drainage map below.

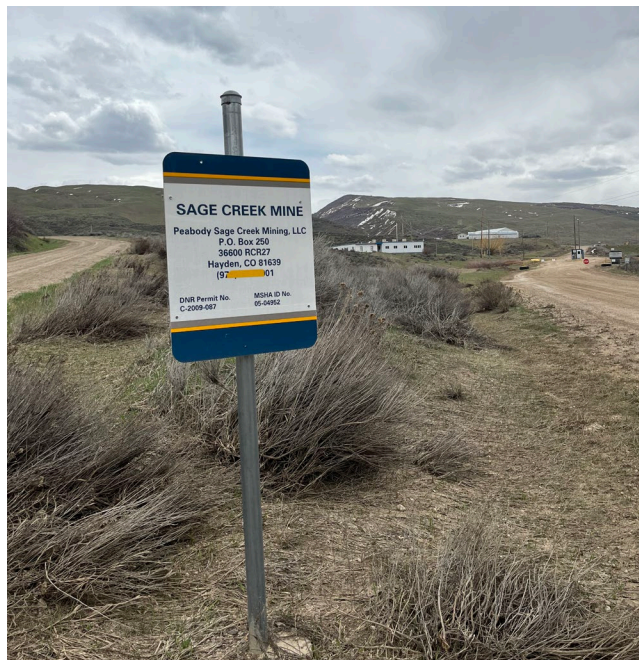
Mine identification markers were observed throughout the site. The required phone number information is currently blocked off from signage (Photo 1). This was discussed with TC representative Miranda Kawcak. Please update the division when signage has been appropriately amended.

Photo 1: Mine sign located at site entrance.

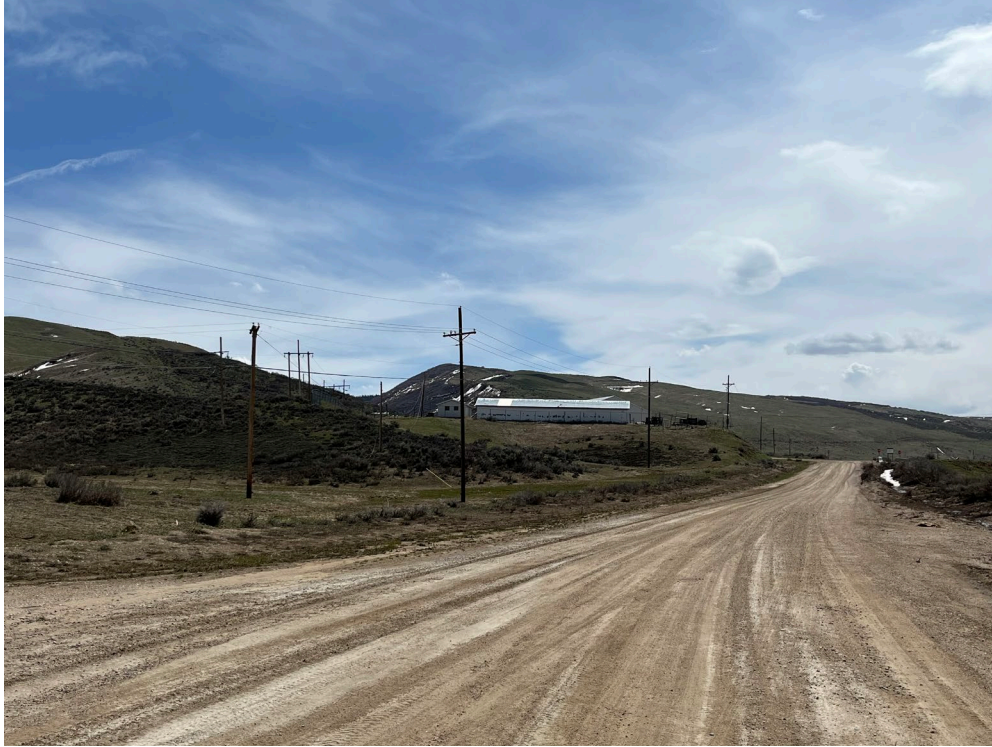
As this site is in temporary cessation, many of the on-site support facilities are unused. This includes storage buildings and a water tank located along Road B (Photo 2) and various buildings in the same area seen in Photo 6.

Photo 2: View SE of Road A and unused storage buildings and water tank.

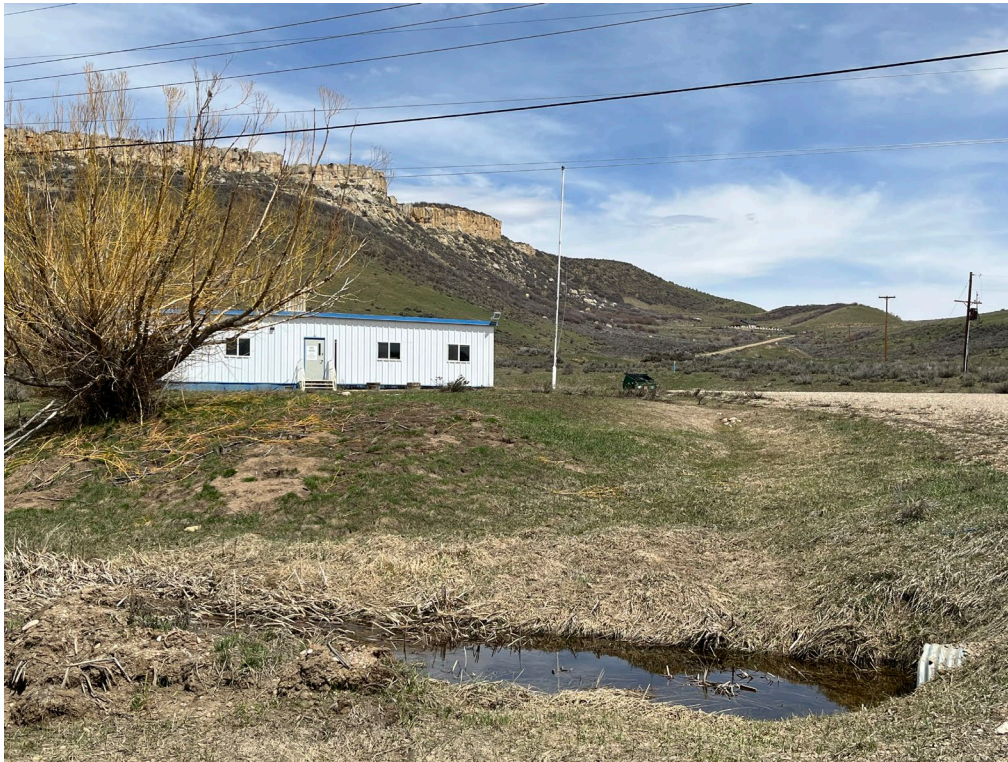
Due to recent heavy snowmelt, all ponds at the site were discharging at the time of inspection (Photos 5, 7, 10, and 11). NPDES #7, located by the site's main office buildings (Photo 3), was also discharging. Recent flooding events have also caused erosional damage to Road B and portal Road F (Photo 8). Repair of these erosional features is listed as an ongoing maintenance item.

Photo 3: View N of the site's office building and parking lots. NPDES Point 7 is located at this culvert and was discharging at the time of inspection.

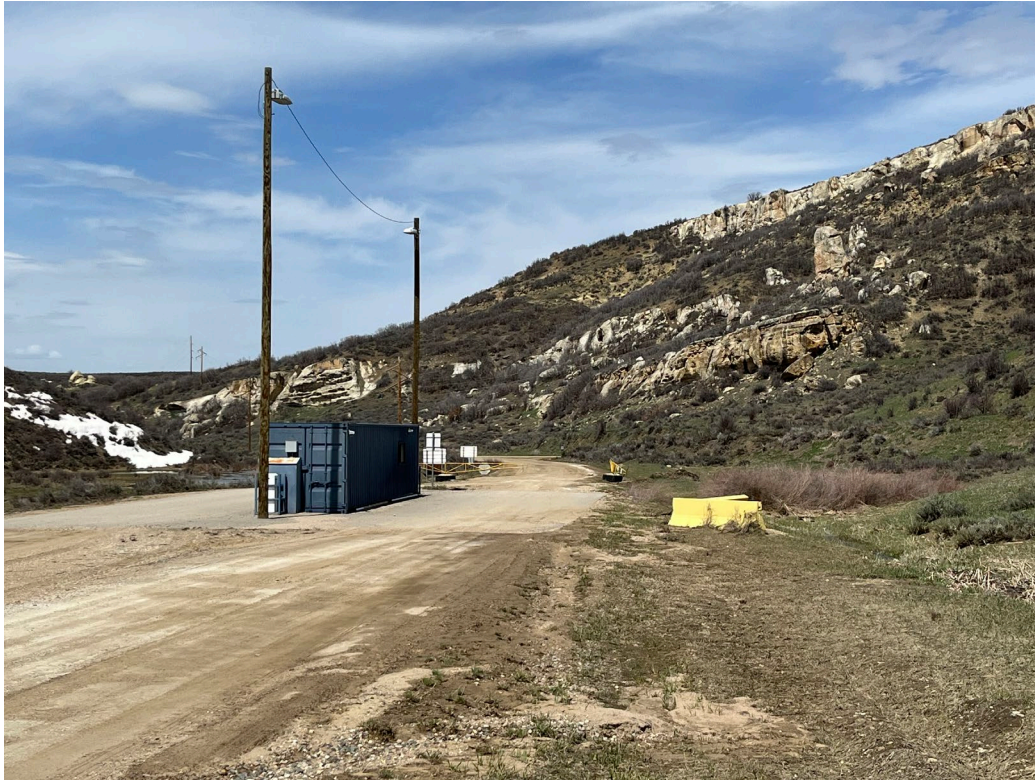
Photo 4: View NW of the scale and scale house located at the entrance to the mine.

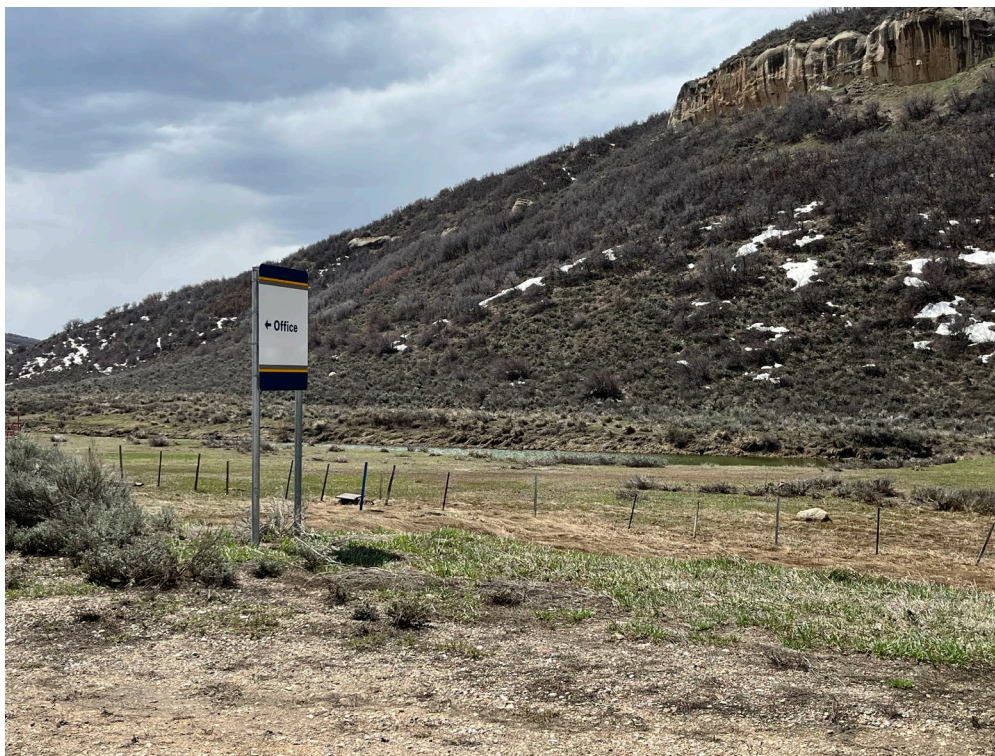
Photo 5: View SW of Pond 003, seasonal grazing occurs in the area surrounding this pond.

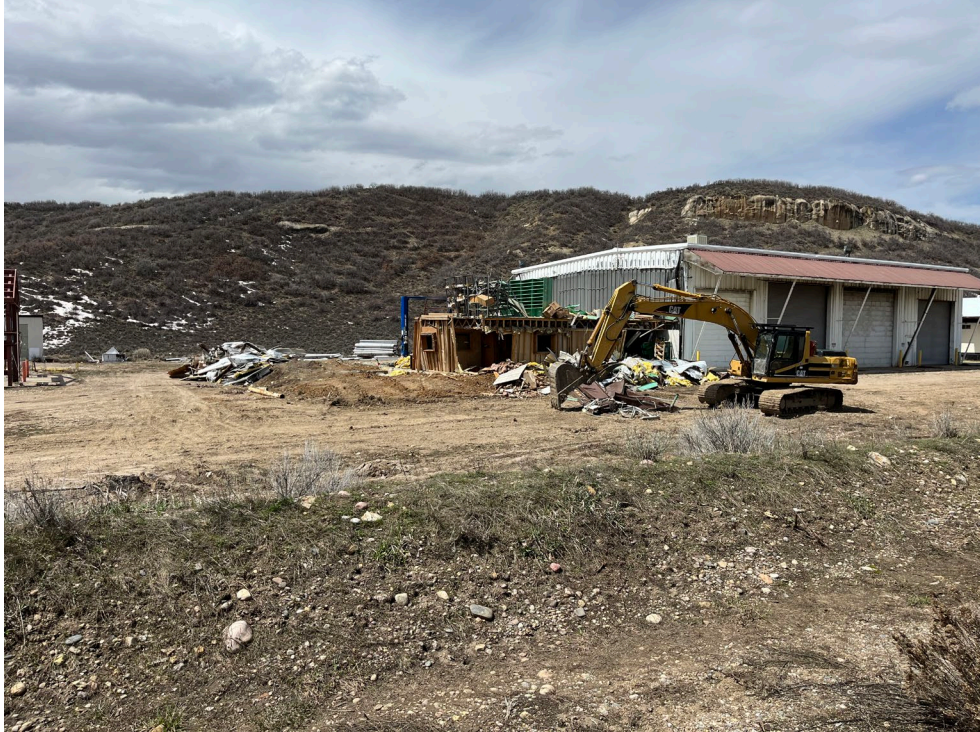
Photo 6: View W of a recently collapsed part of the vehicle maintenance shop, caused by the winter seasons heavy snowfall. Cleanup is currently underway.

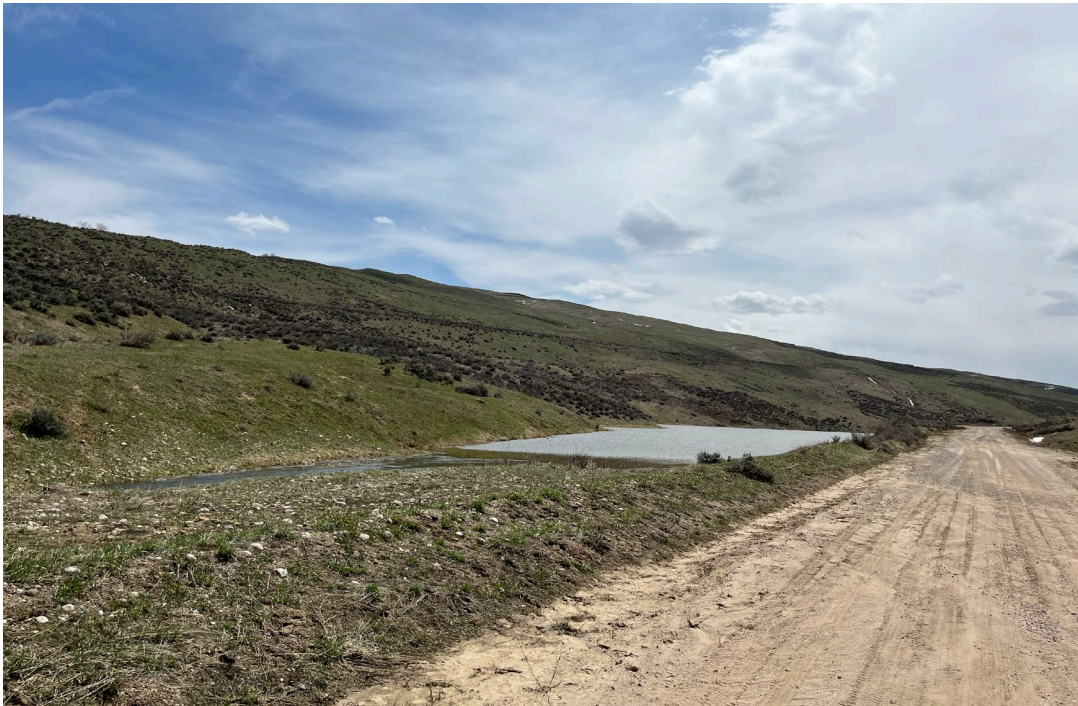
Photo 7: View SE of Pond 002, Grassy Creek connects with Pond 002. Area directly to the east is the old highwall from the previously permitted Seneca II mine.

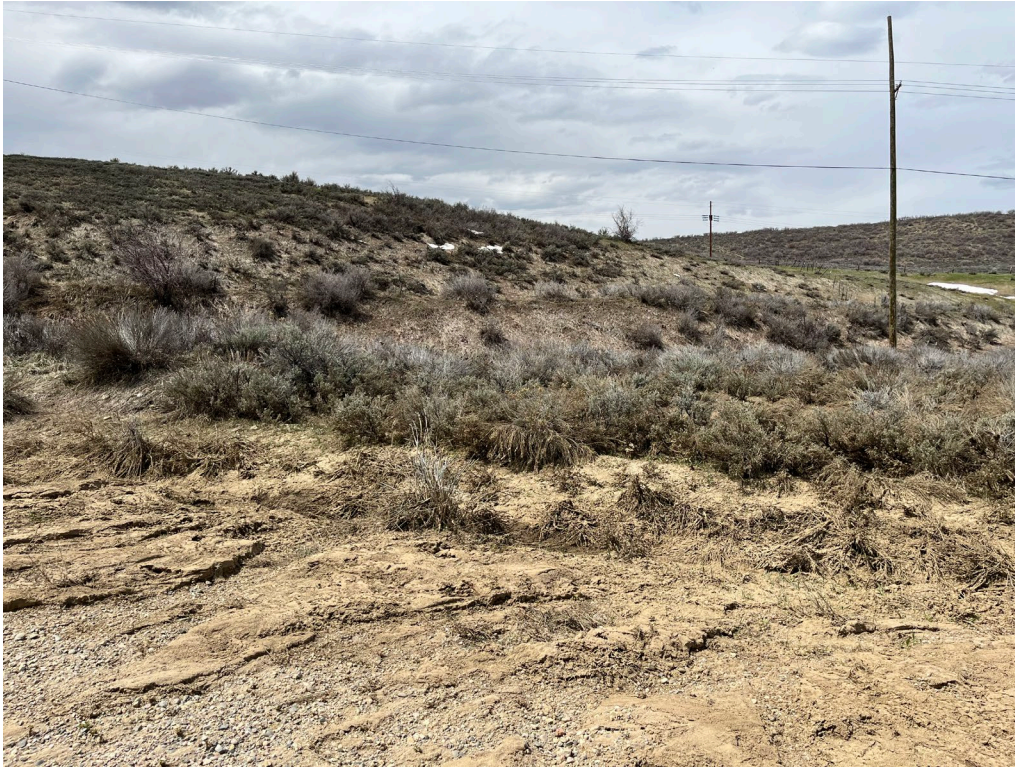
Photo 8: View W from Road B, recent flooding overtopped this road, causing small amounts of erosional damage to the road. See maintenance items.

- The ditch around the portal area needs to be cleared of cattail growth to maintain proper drainage in the area
- Road ditch from the upper tank to the warehouse needs to be repaired and reestablished (Road D, ditch RD-DI).
- Clean ditch across from transformers above portal at seep (photo 2 below)
- Repair erosional features across from upper tank adjacent to the road (top Road D on south side of road)
- Flume repair is needed on Little Grassy Creek as water is undercutting the flume (NPDES 2).
- Erosional features are present on various access roads that require repair (Road B, Road F).
- Additional disturbance markers are recommended.
- Trash screen at Pond 003 needs to be cleared.
- Monitor the pipe below Pond 002 for leakage or blowout.

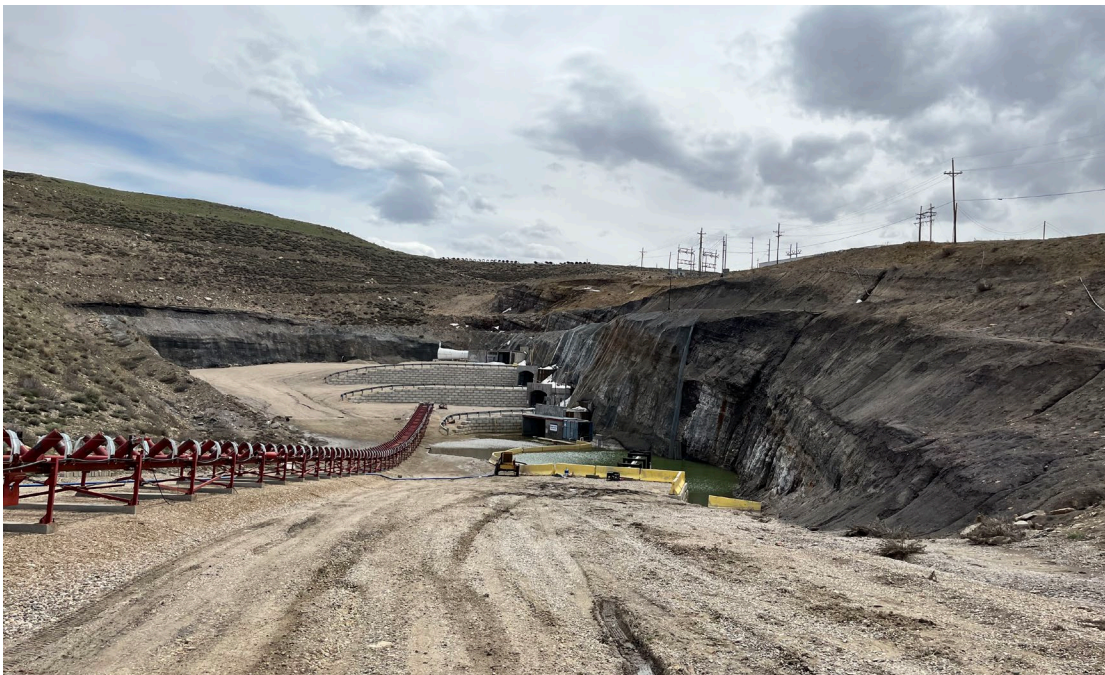
Mine water and snowmelt was being continually pumped at the portal entrance (Photos 9 and 12).

Photo 9: View E of the portal area. Dewatering pumps are continually running to manage snowmelt and mine discharge.

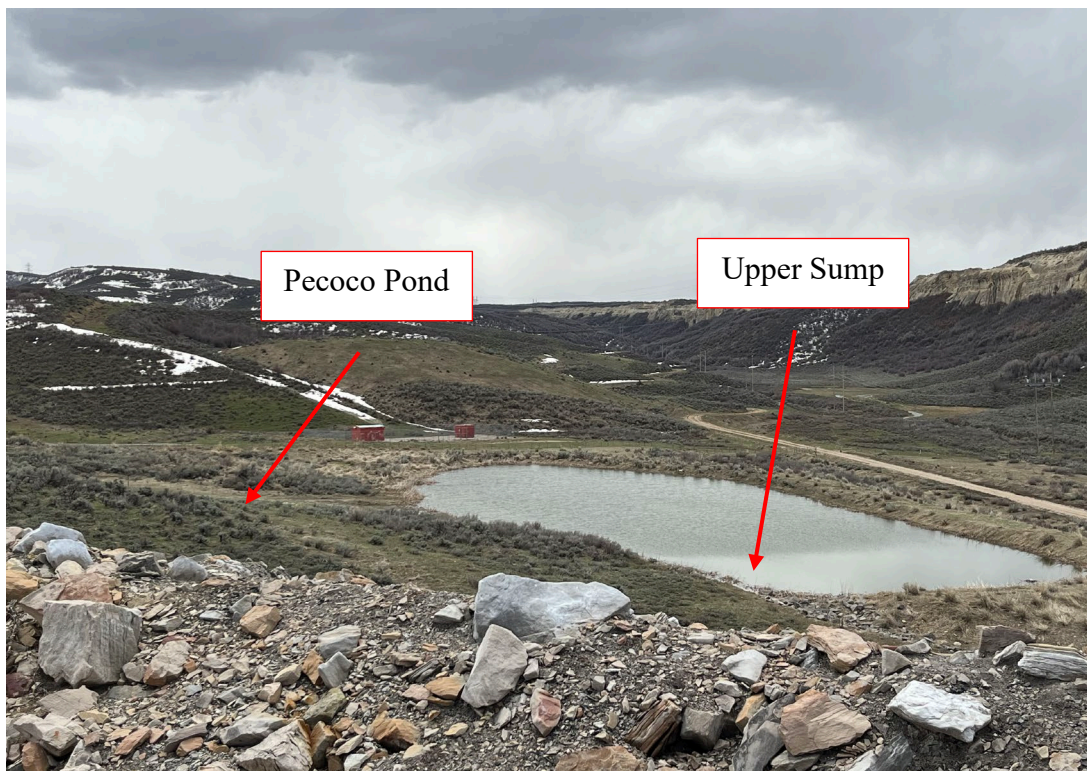
Photo 10: View S of the upper sump pond, directly north of Pecoco Pond.

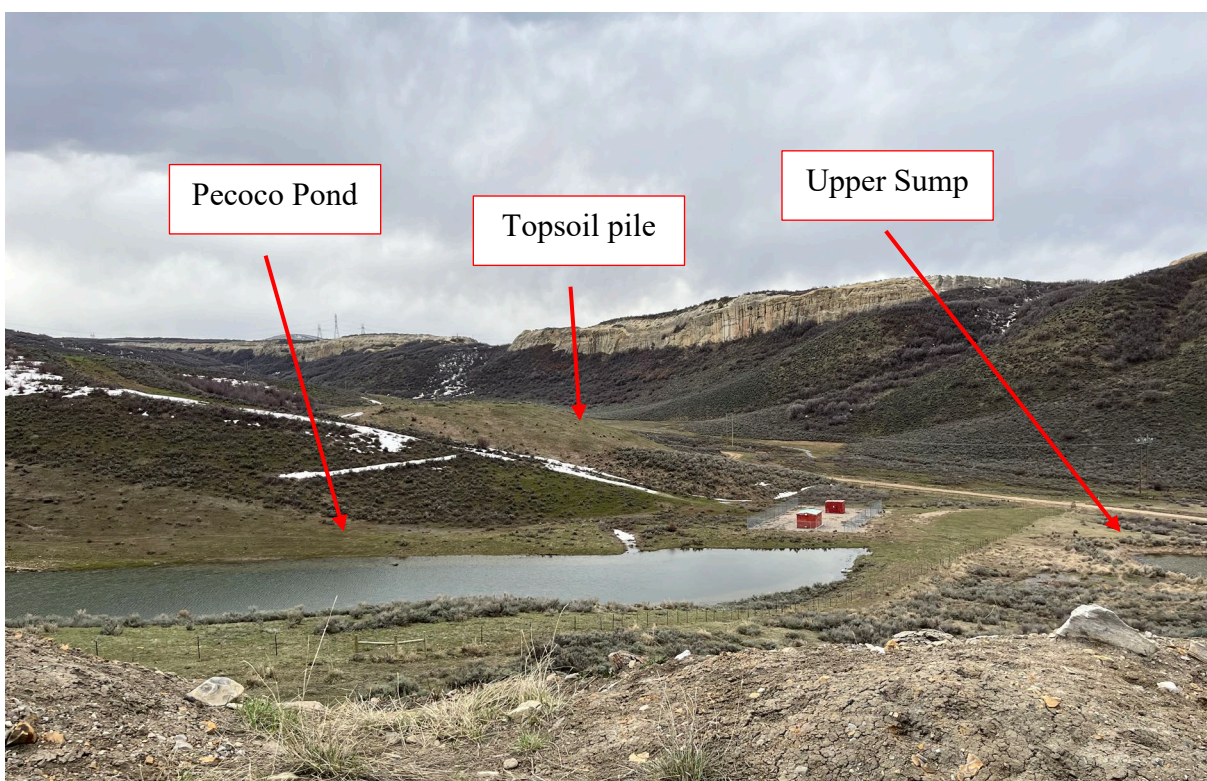
There is one large topsoil pile onsite located adjacent to the Pecoco pond (Photo 11). The pile appears stable, well vegetated and undisturbed.

Photo 11: View S of Pecoco Pond, upper sump is to the north.

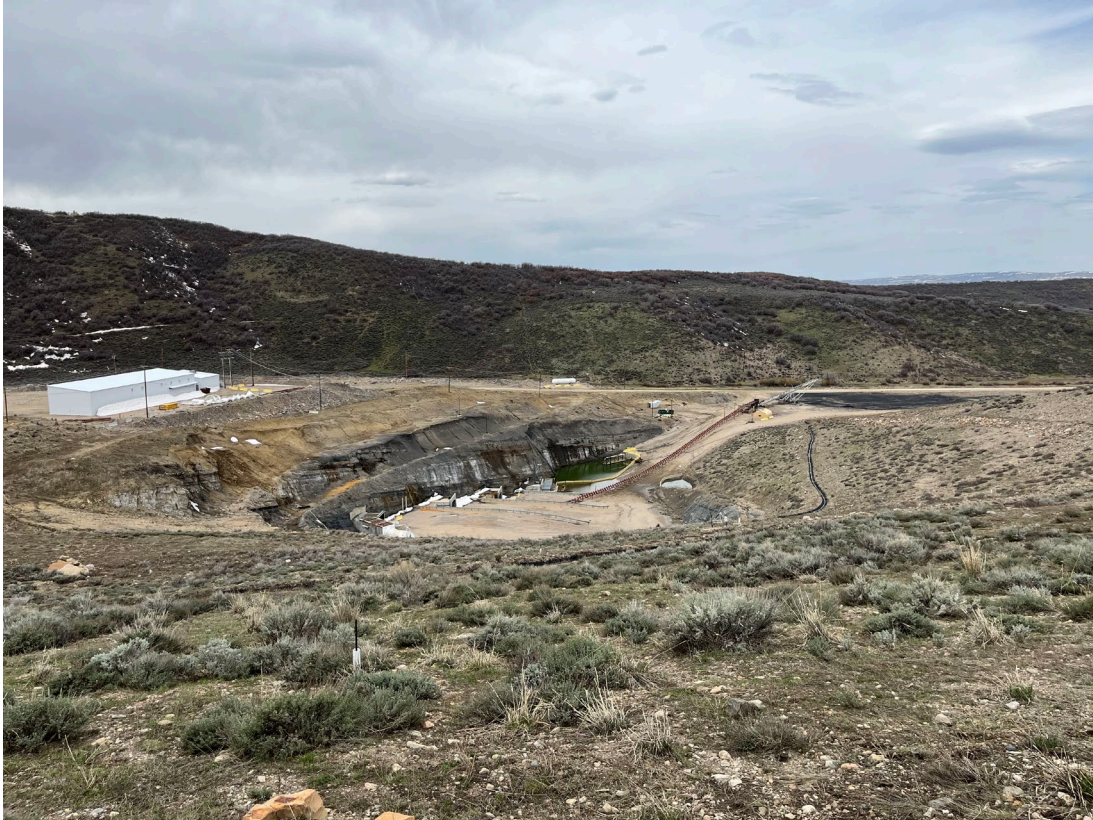
Photo 12: View W, overview of portal area.

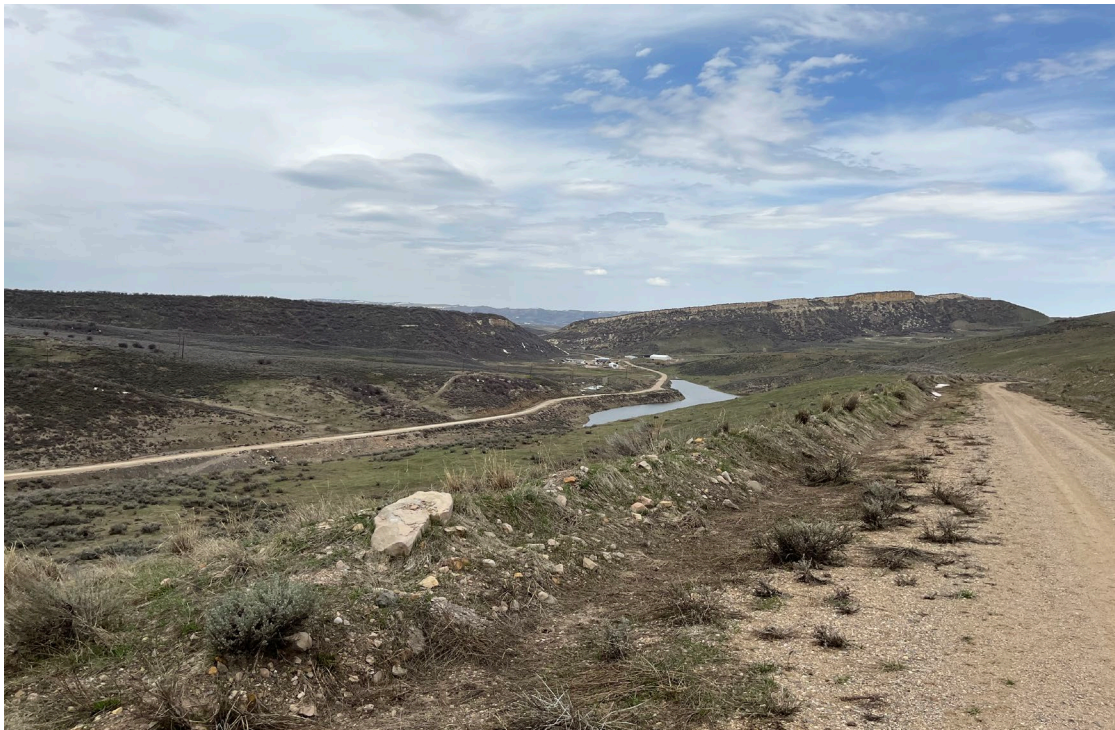
Photo 13: View N from Road A-1, Pond 002 and Road B can be seen in the background.

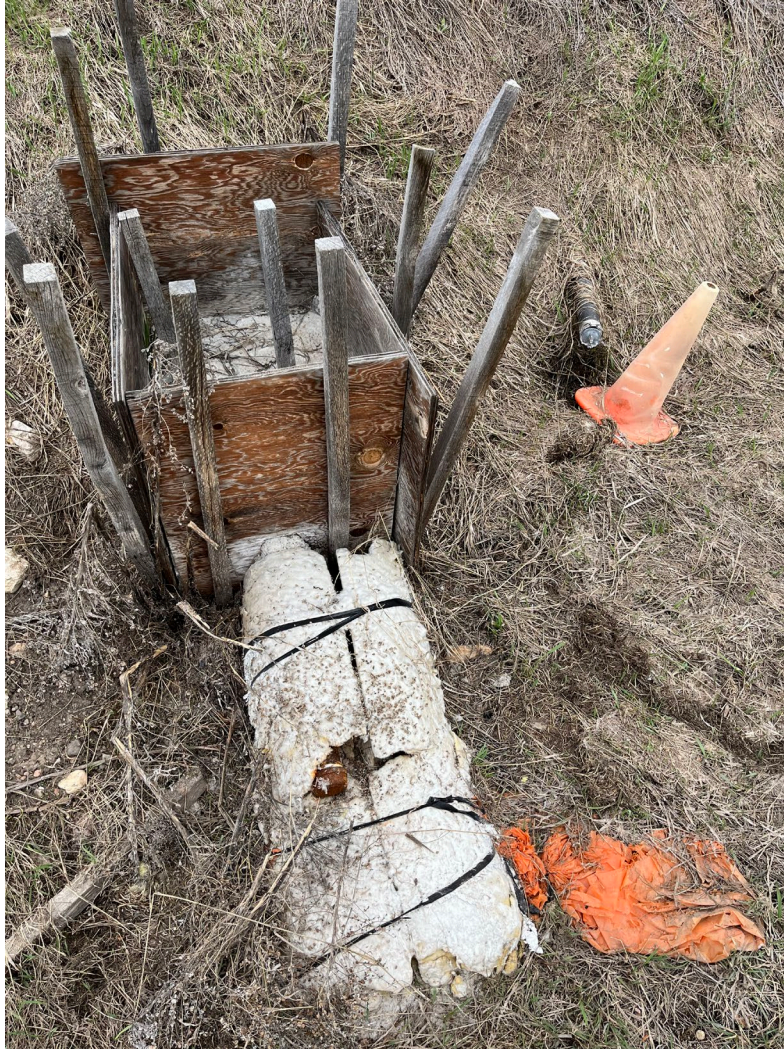
Photo 14: Leaky pipe as noted in previous inspection reports. Efforts have been made to protect pipe from future blowouts.
