Hayden Gulch Loadout Inspection Report, C-1992-081

PERMIT INFORMATION

INSPECTION INFORMATION

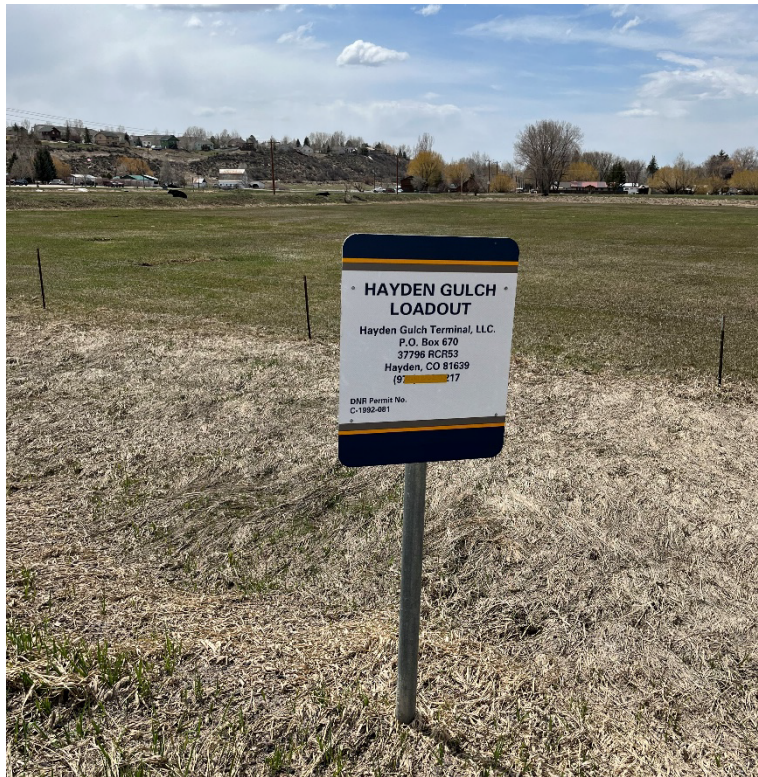
Mine identification markers were observed at the entrance to the unreleased haul road and adjacent to the unreleased agricultural section north and south of Hwy 40. The required phone number information is currently blocked off from signage (Photo 1). This was discussed with TC representative Miranda Kawcak at the Foidel Creek Mine inspection dated May 2, 2023. **Please update the division when signage has been appropriately amended.**

Figure 1: Mine identification sign posted adjacent to unreleased acreage, south of Hwy 40.

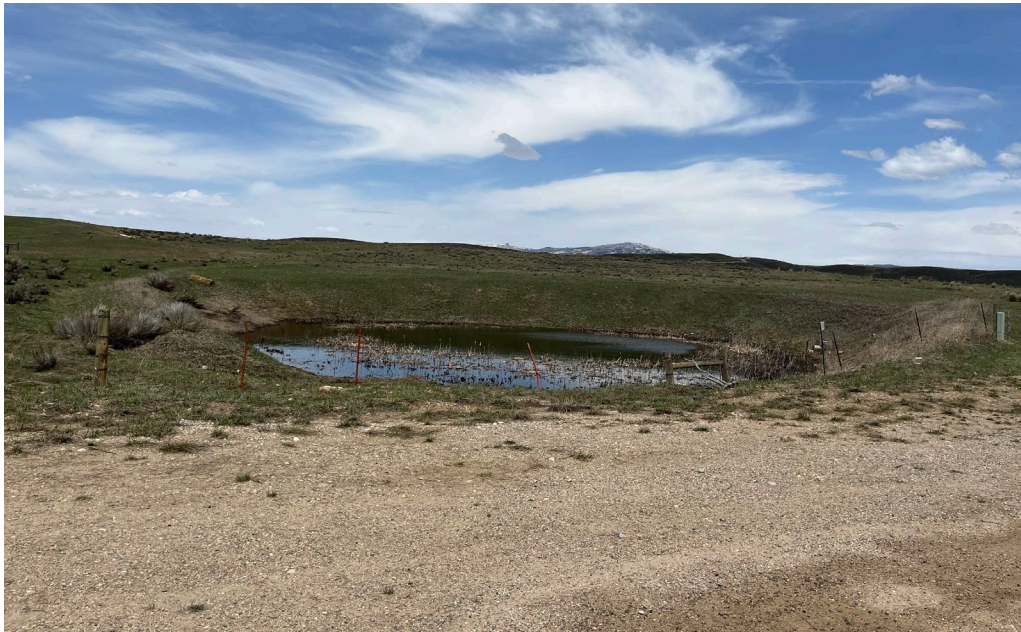
Truck Loop Pond 001 and Rail Loop Pond 002 were full and functioning properly (Photos 2 and 3). Culverts in the Tracks-to-Trails area were flowing and free of blockages (Photo 8).

Figure 2: View N of Truck Loop Pond 001, located along the unreleased haul road.

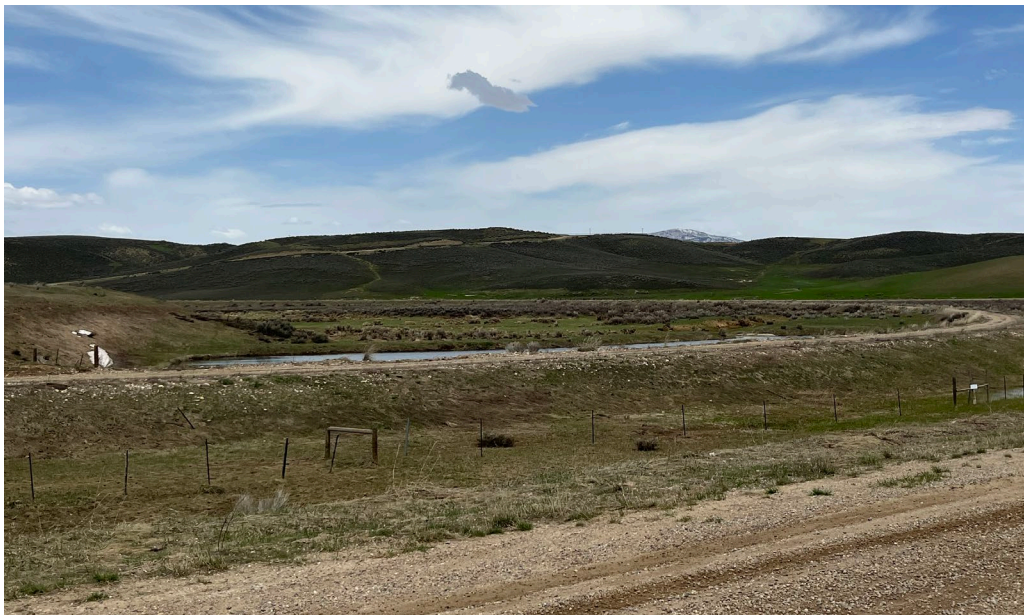
Figure 3: View NE of Rail Loop Pond 002 seen from the unreleased haul road, pond sits within the previously released Tracks-to-Trails area.

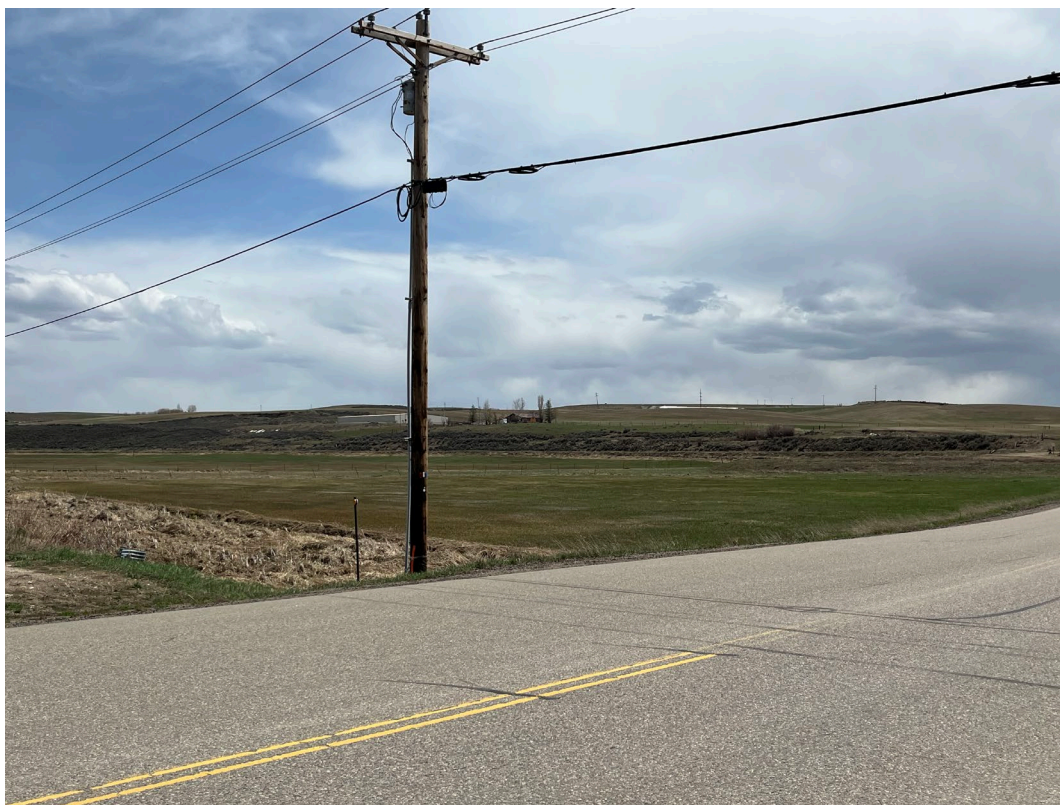
The remaining permit area North of Hwy 40 was well vegetated (Photos 4 & 5). This portion of the permit is planned to be incorporated into adjacent hay fields. Inspection contact stated previously that they are aiming to release this final area in the current year.

Figure 4: View SE of unreleased acreage south of Hwy 40. Hay fields surround this strip of unreleased land.

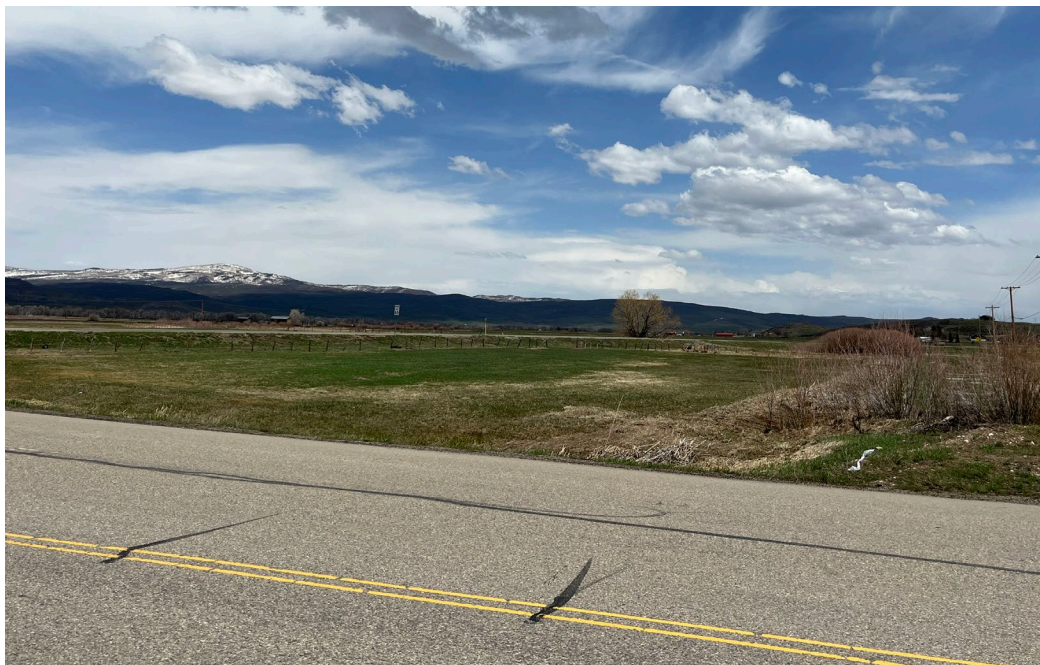
Figure 5: View NE of unreleased acreage south of Hwy 40. Hay fields surround this strip of unreleased land.

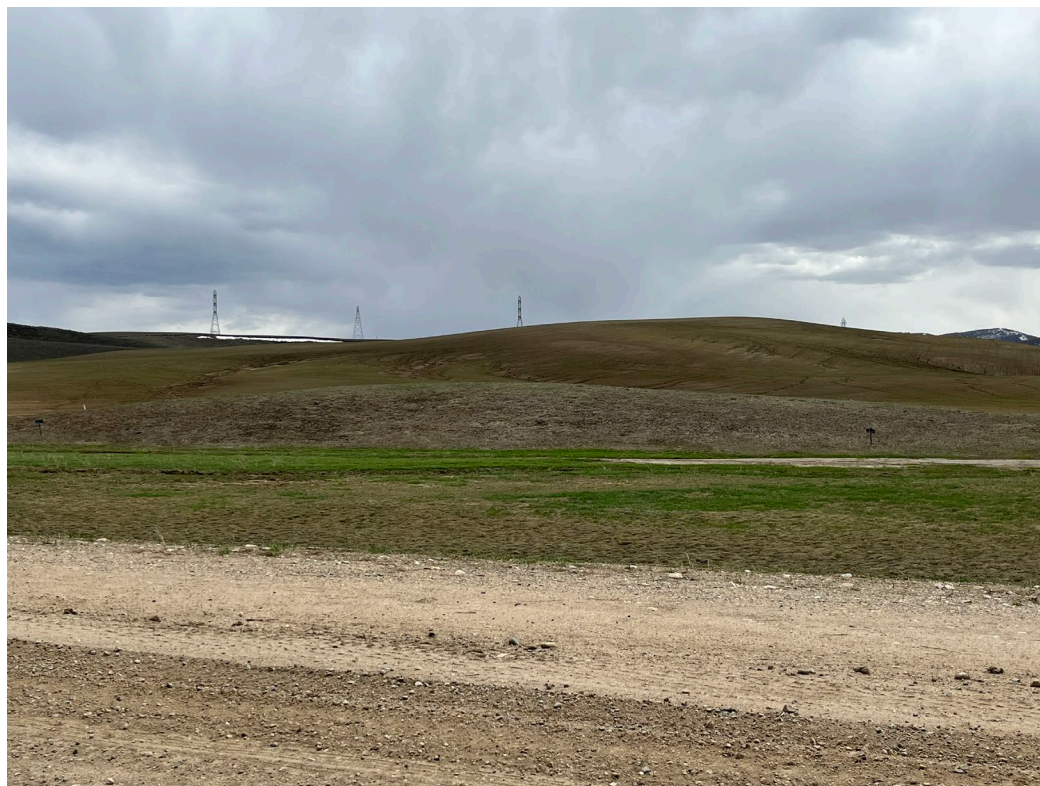
The haul road was well maintained and free of erosional features. The haul road and its associated permanent topsoil pile features (Photos 6 & 7) will be ready for release this year.

Two permanent topsoil piles are located to the east along the currently unreleased haul road / CR37. Both piles are well vegetated and marked by either a sign or a flagged post. (Photos 6 & 7).

Figure 6: View S of one of two permanent topsoil piles located along the unreleased haul road/CR37.

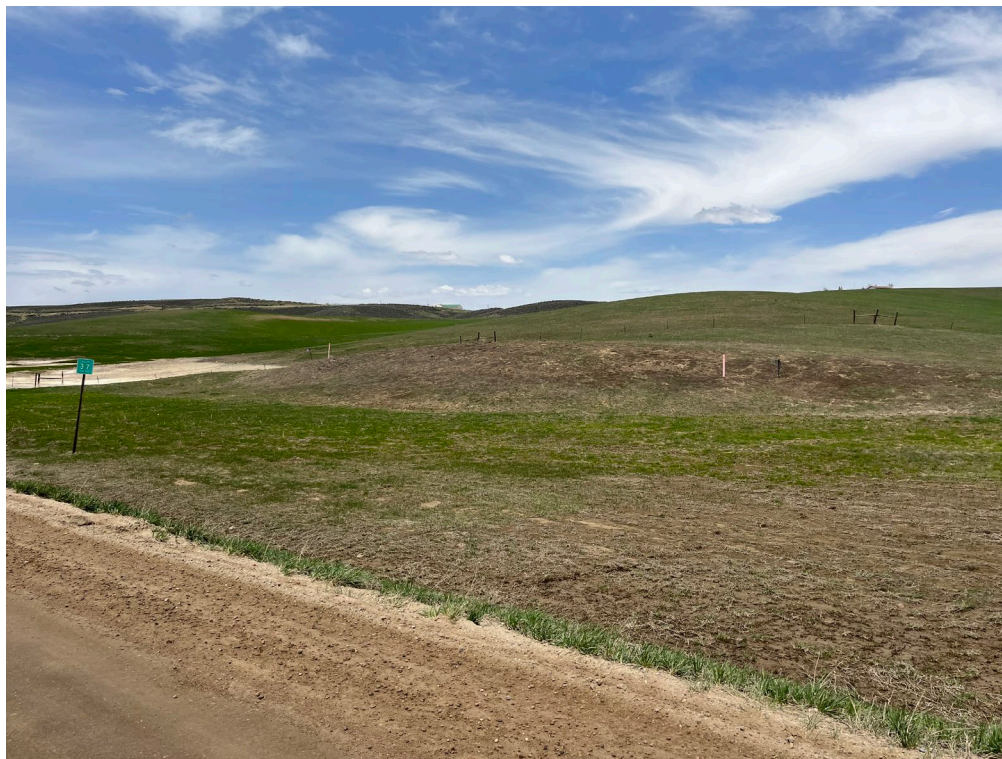
Figure 7: View NE of one of two permanent topsoil piles located along the unreleased haul road/CR37.

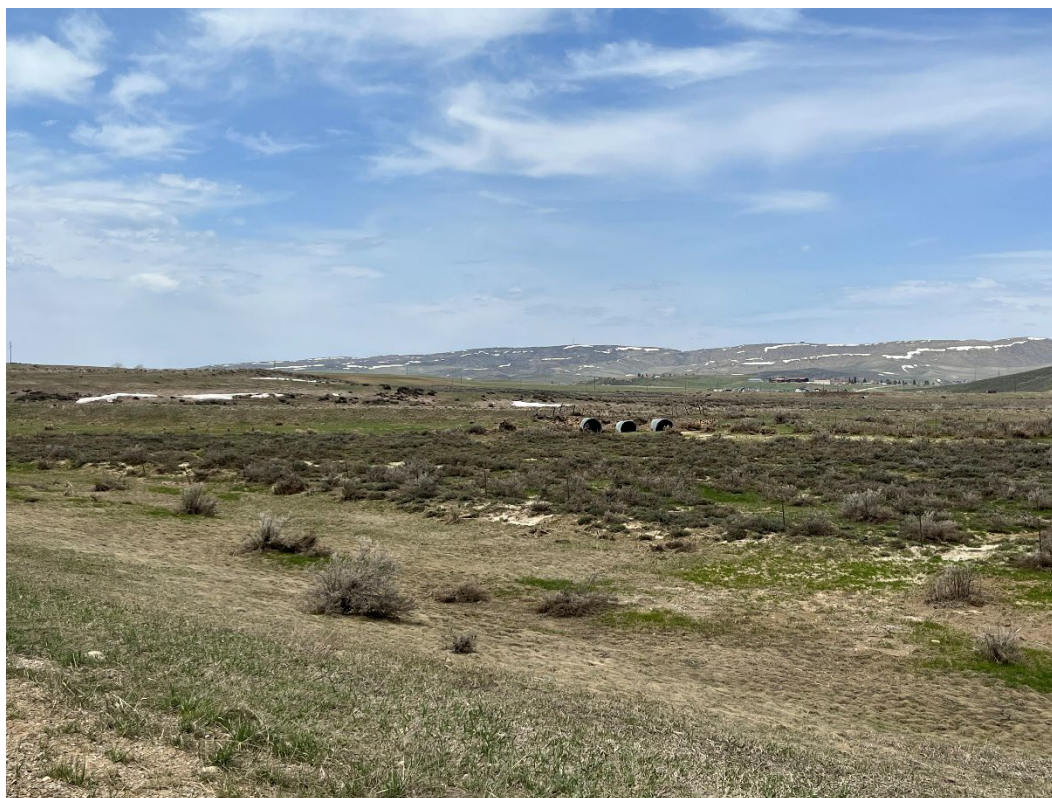
Figure 8: View N of the released Tracks-to-Trails area.
