COLORADO

Division of Reclamation,
Mining and Safety

MINERALS PROGRAM INSPECTION REPORT

MINE NAME: Cresson Project	MINE/PROSPECTING ID#: M-1980-244	MINERAL: Gold and silver	COUNTY: Teller
INSPECTION TYPE: Monitoring	WEATHER: Clear	INSP. DATE: April 20, 2023	INSP. TIME: 09:30
OPERATOR: Cripple Creek & Victor Gold Mining Company	OPERATOR REPRESENTATIVE: Tony Matarrese & Josh Adams	TYPE OF OPERATION: 112d-3 - Designated Mining Operation

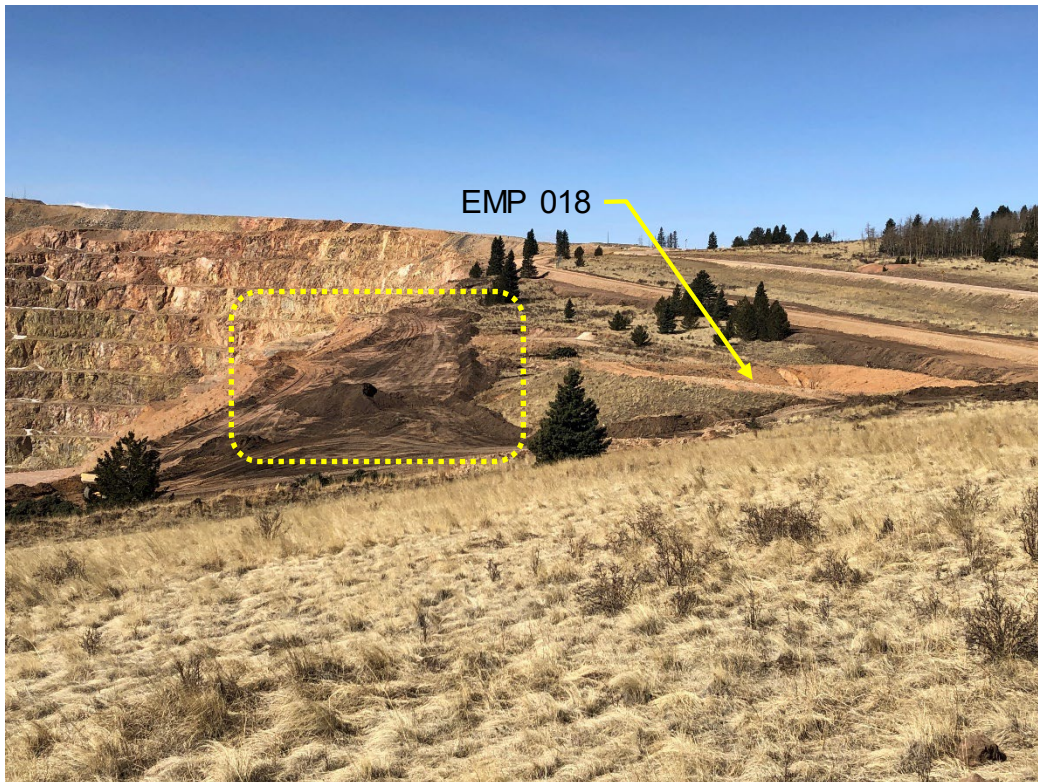
WHEX Clay Borrow Source: Messrs. Matarrese and Adams accompanied the DRMS to the WHEX Clay Borrow Source, where Jeff Gaul (CC&V). Mr. Gaul stated they had moved roughly 1,000 cubic yards to the staging area near the VLF 2 phase III construction area and that the mine expects to be finished with excavations in this borrow area in early June. He also pointed out the excavation of the clay material is limited to the area south of the toe of EMP 17 (see **Photo 1**). CC&V is installing a fence to delineate the northern extent of the clay borrow area.

Photo 1. WHEX Clay Borrow Area (Excavation ends at toe of EMP 018, looking SSW)

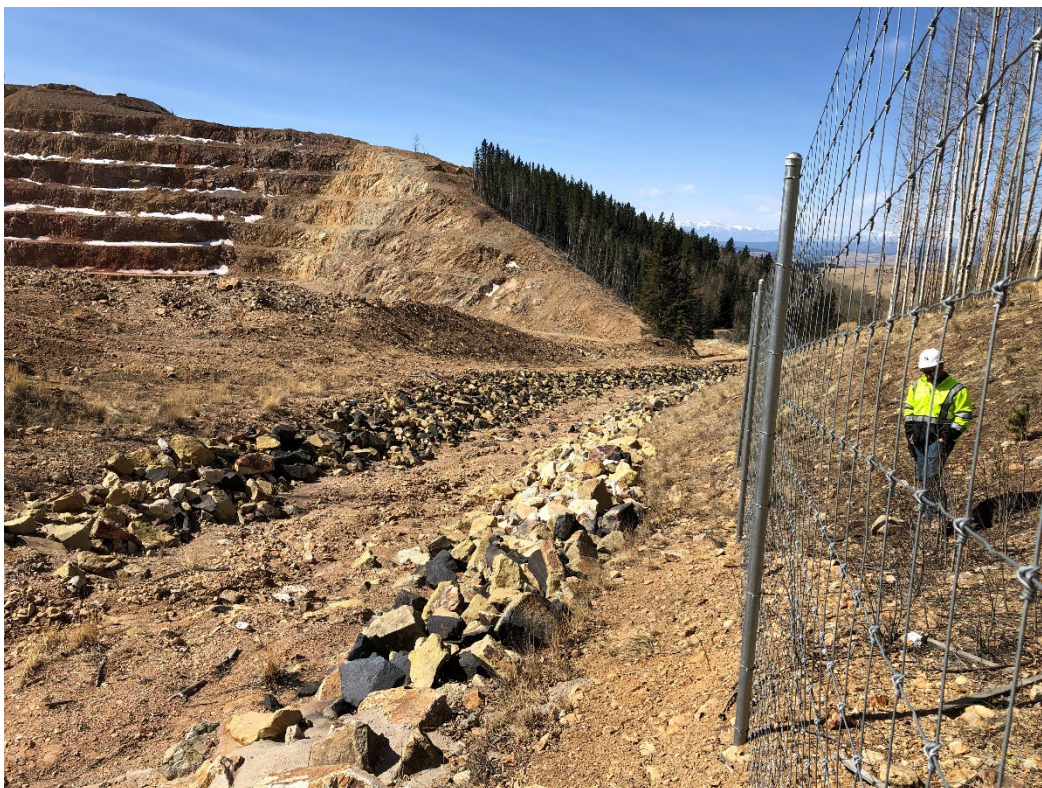
PROBLEM/POSSIBLE VIOLATION: Problem: The Globe Hill diversion channel was observed to have accumulated a significant amount of sediment and some of the paler stone showed signs of significant weathering after being in place for about six years. This is a problem at this time for failure to protect the affected land from erosion and siltation pursuant to C.R.S. 34-32-116 (7) and Rule 3.1.5(3); and demonstrates some of the riprap used in construction did not meet the approved engineering specifications.

Globe Hill Diversion Channel: The Globe Hill diversion channel was constructed in October 2017 after the approval of TR-86. The channel was inspected to determine if any maintenance was needed. Subsequent to the diversion channel construction, the 8-foot wildlife protection fence was installed immediately north of the channel (see **Photo 2**). As the Globe Hill pit is on the south side and there are no gates in the fence, maintenance access to the diversion channel is currently problematic. The grouted upper reach (inlet section) appeared to be in relatively good condition (see **Photo 3**), although a few cracks were observed in the grout on the side closest to the fence (see **Photo 4**). A side channel was armored with riprap as a field fit during the 2017 construction (see **Photo 5**). Much of the paler stone showed considerable signs of weathering (see **Photo 6**). Based on the approved riprap specifications (02271.0 Riprap, dated 4/25/2017) at the time the diversion channel was constructed: "Rip rap shall consist of hard, dense, and durable stone, angular in shape, and resistant to weathering." (reference paragraph 2.1.1 Riprap). In addition, sediment has accumulated in a significant section of the diversion channel, which also requires maintenance attention (see **Photo 2**). **The weathered paler stone does not meet the specifications, and the accumulated sediment are cited as a combined problem on p. 1 of this report related to controlling erosion and siltation.**

Photo 2. Globe Hill Diversion Channel (looking SSW, note fence on right and sediment in riprap channel).

CORRECTIVE ACTIONS: The operator shall submit a Maintenance Plan to provide procedures for monitoring and maintaining stormwater channels, especially armored sections (e.g., riprap and grouted riprap channels) and a schedule for replacing weathered riprap by the corrective action date.

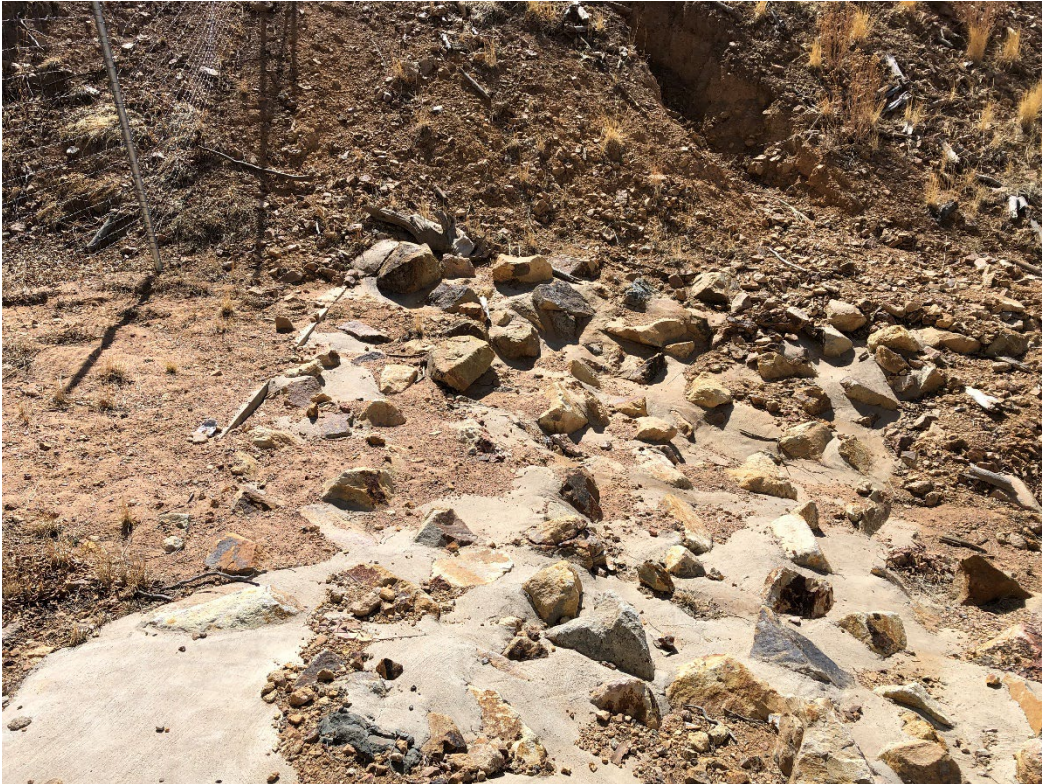
Photo 3. Grouted riprap section of Globe Hill Diversion Channel (looking SE, note fence on left).

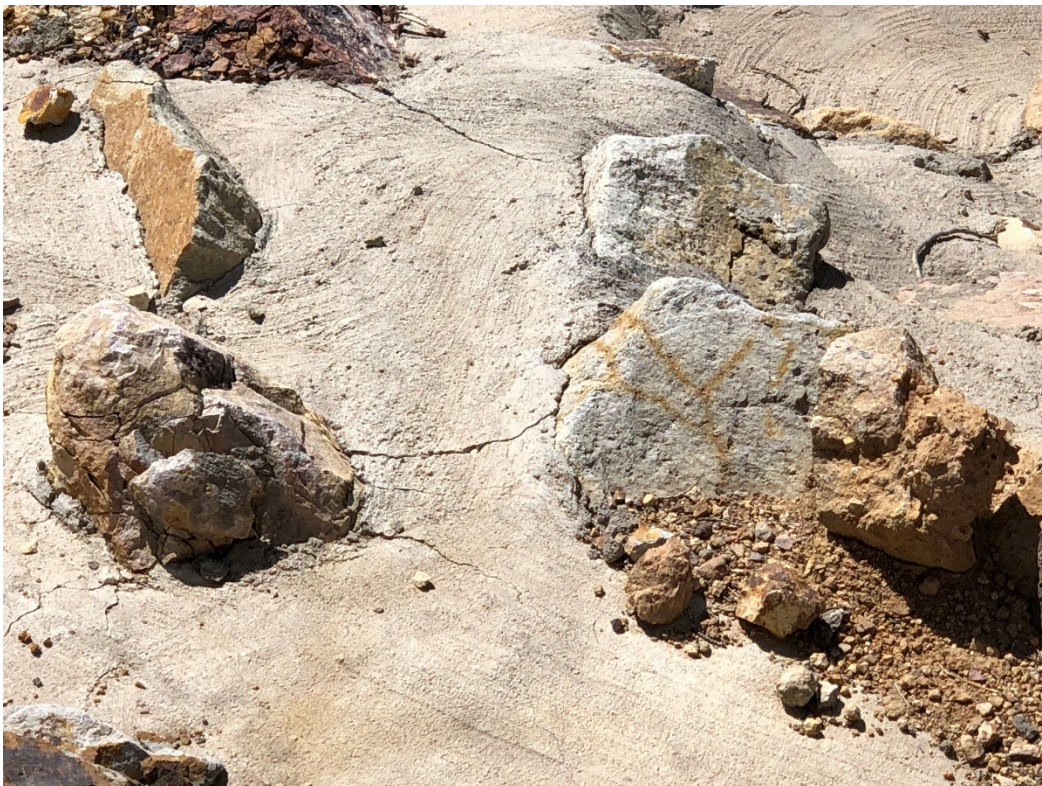
Photo 4. Cracked grout (minor) in grouted riprap section of Globe Hill Diversion Channel.

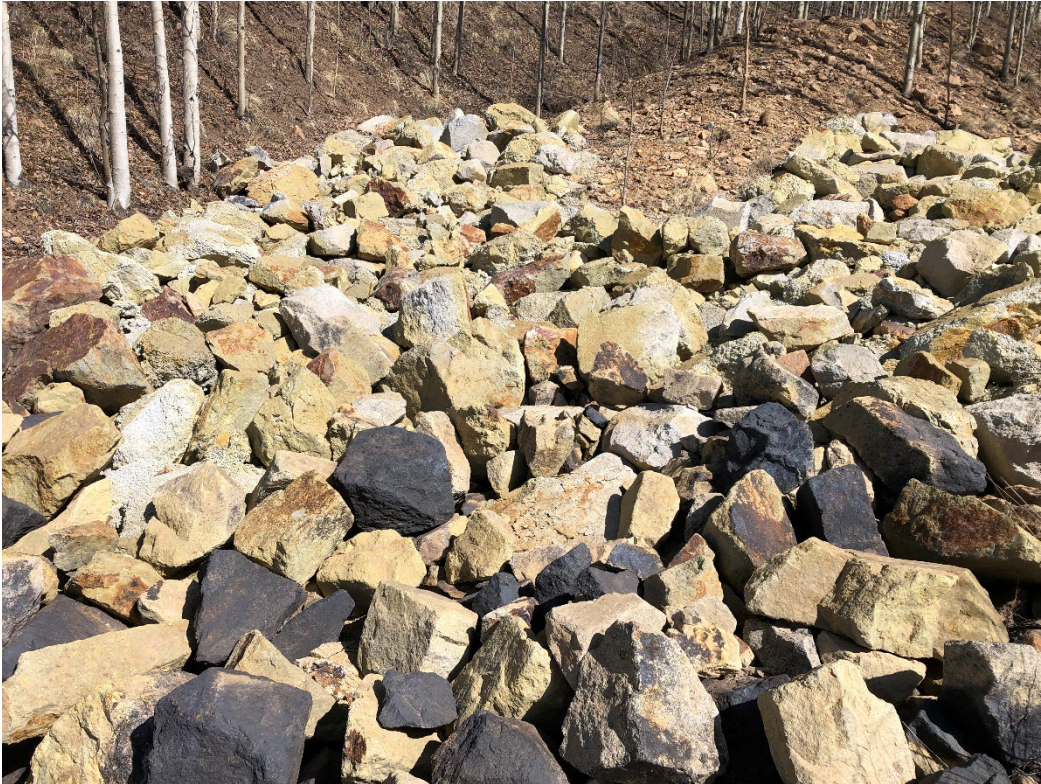
Photo 5. Globe Hill Diversion side channel (looking north from upper end of diversion).

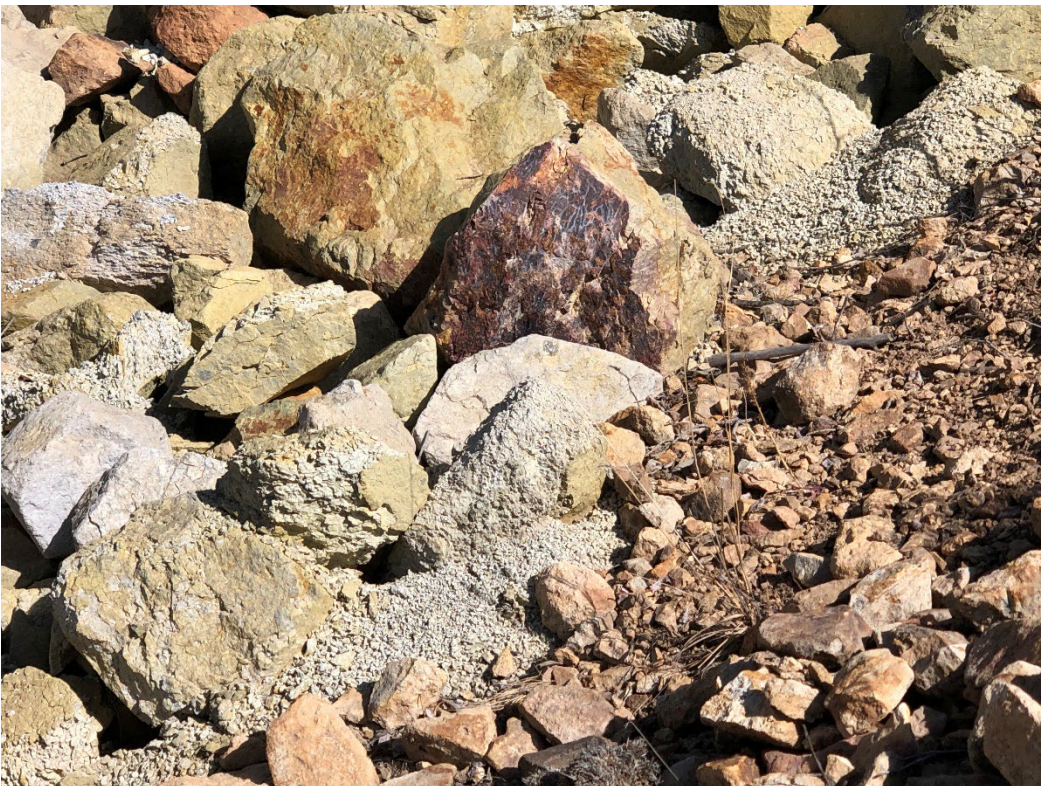
Photo 6. Weathered riprap in Globe Hill Diversion side channel (pale rock weathering).

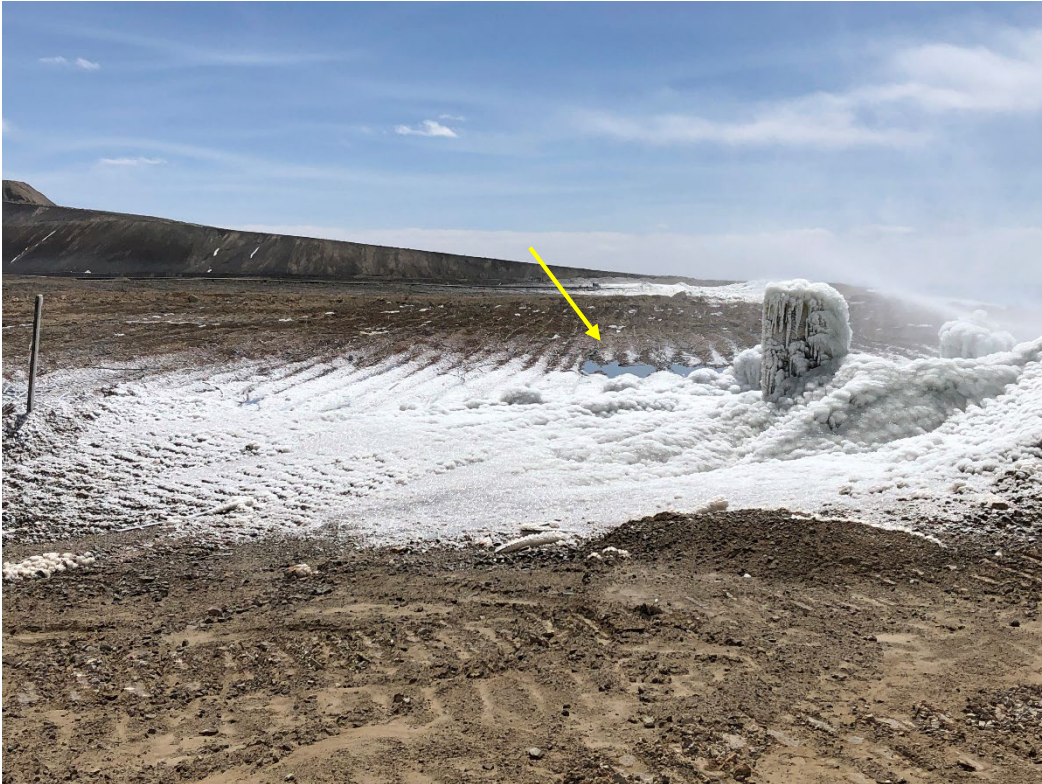
VLF 1 Overlook: CC&V representatives accompanied the DRMS to the top of VLF 1 for the primary purpose of inspecting the surface for ponded solution. Ponded solution close to or exceeding the approved wildlife protection plan limit of 3 feet by 3 feet was observed on the north 10,200 (see **Photo 7**), south 10,200 (see **Photo 8**) and the 10,400 (see **Photo 9**) levels. CC&V stated there is a challenge preventing ponded solution this time of year when solution freezes overnight and melts during the day. CC&V committed to correcting the

Photo 7. Solution ponding on VLF 1, north 10,200 level (looking south, note frozen solution).

problem by the end of the day and provided the DRMS with photographic evidence on April 21st of having ripped the areas where ponding was observed to reestablish solution infiltration.

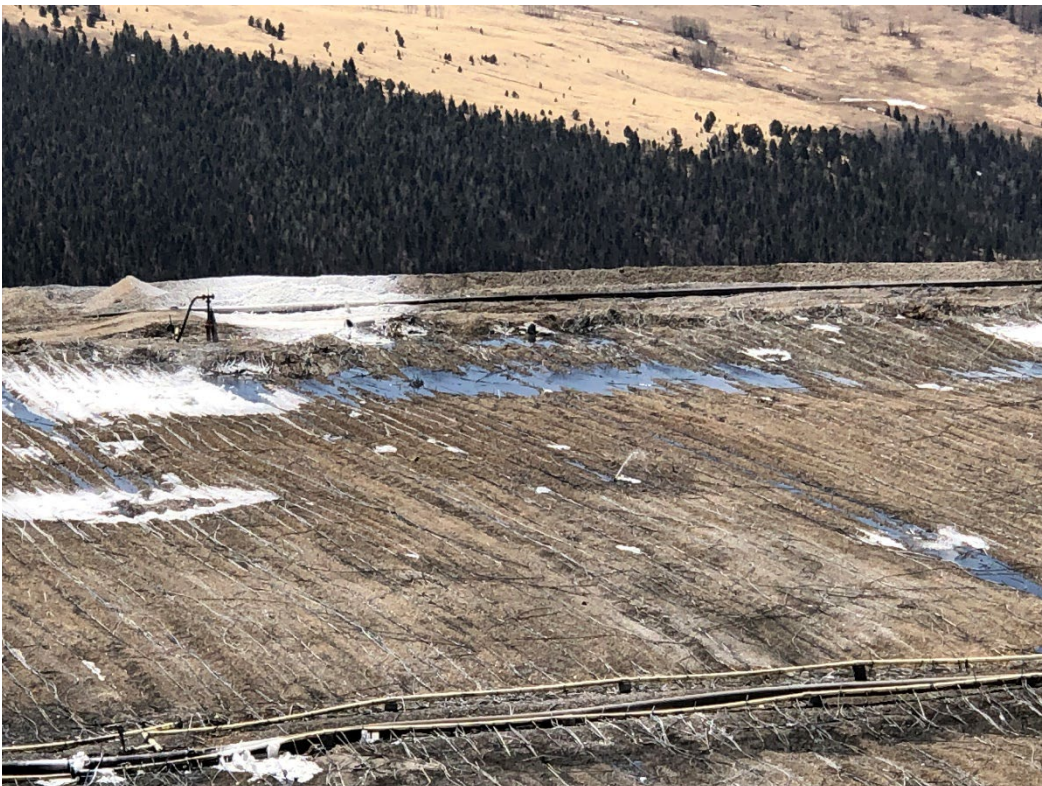
Photo 8. Solution ponding on VLF 1, south 10,200 level (looking south).

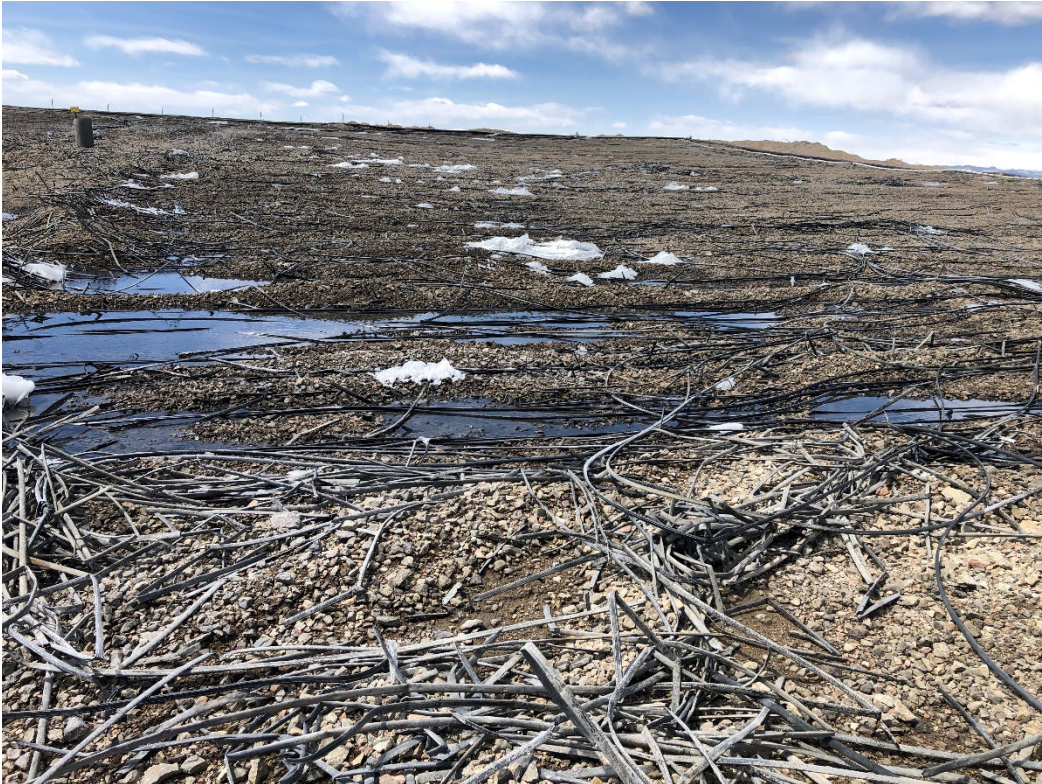
Photo 9. Solution ponding on VLF 1, 10,400 level (looking west).

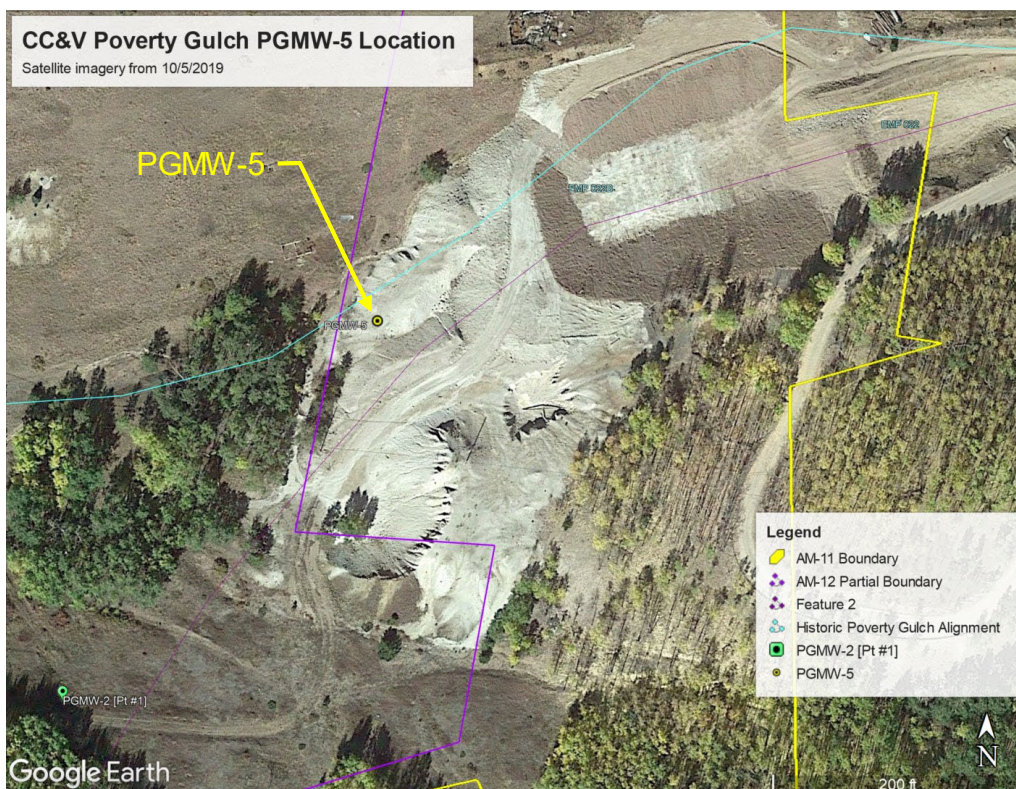
PGMW-5: A quick trip to the newly installed PGMW-5 monitoring well was requested by the DRMS to observe its location (see **Photo 10**). The location was obtained using this inspector's iPhone to provide an approximate location (38.746069°, -105.168222°). Mr. Matarrese stated the water in the well was muddy and he was continuing to develop it. The well ID was welded onto the casing (see **Photo 11**).

Photo 10. PGMW-5 location – west of EMP 022B.

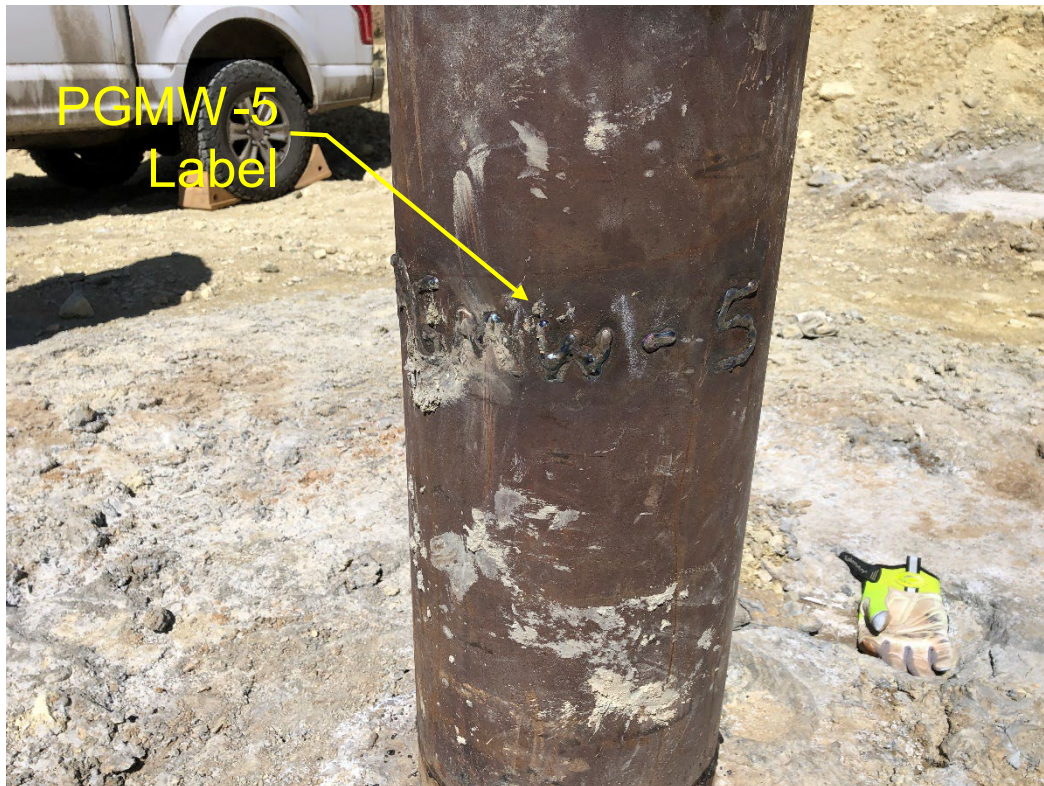
Photo 11. Poverty Gulch monitoring well PGMW-5 casing.

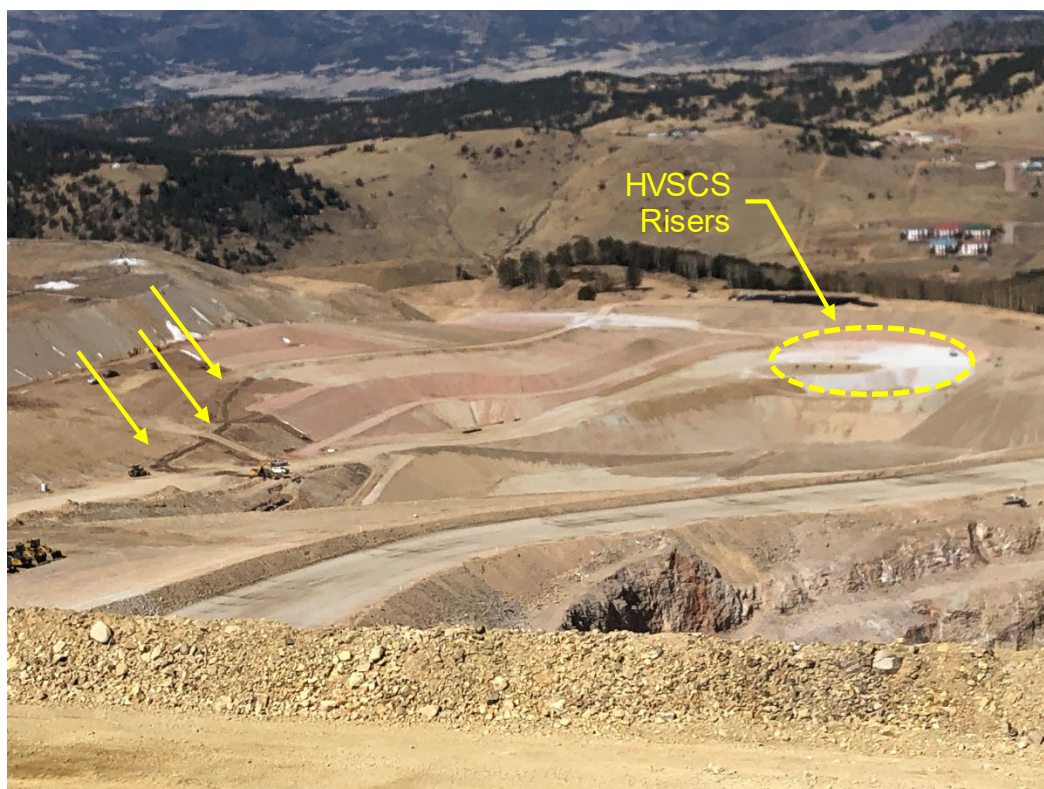
VLF 2 Phase III construction: Mr. Jeff Gaul was present for the overview and status update for the Phase III construction in the Schist Island pit. Mr. Gaul stated they were installing a leak detection trench (see **Photo 12**).

Photo 12. VLF 2, Phase III leak detection system trench (left arrows) construction (looking WSW).
