MINERALS PROGRAM INSPECTION REPORT

MINE NAME: D Road Gravel Pit	MINE/PROSPECTING ID#: M-2002-046	MINERAL: Sand and gravel	COUNTY: Mesa
INSPECTION TYPE: Monitoring	WEATHER: Cloudy	INSP. DATE: May 2, 2023	INSP. TIME: 10:00
OPERATOR: Ephemeral Resources, LLC	OPERATOR REPRESENTATIVE: Mark Gardner	TYPE OF OPERATION: 112c - Construction Regular Operation	
REASON FOR INSPECTION: Normal I&E Program	BOND CALCULATION TYPE: Complete Bond	BOND AMOUNT: \$162,289.00	
DATE OF COMPLAINT: NA	POST INSP. CONTACTS: DRMS	JOINT INSP. AGENCY: None	
INSPECTOR(S): Amy Yeldell	INSPECTOR'S SIGNATURE:

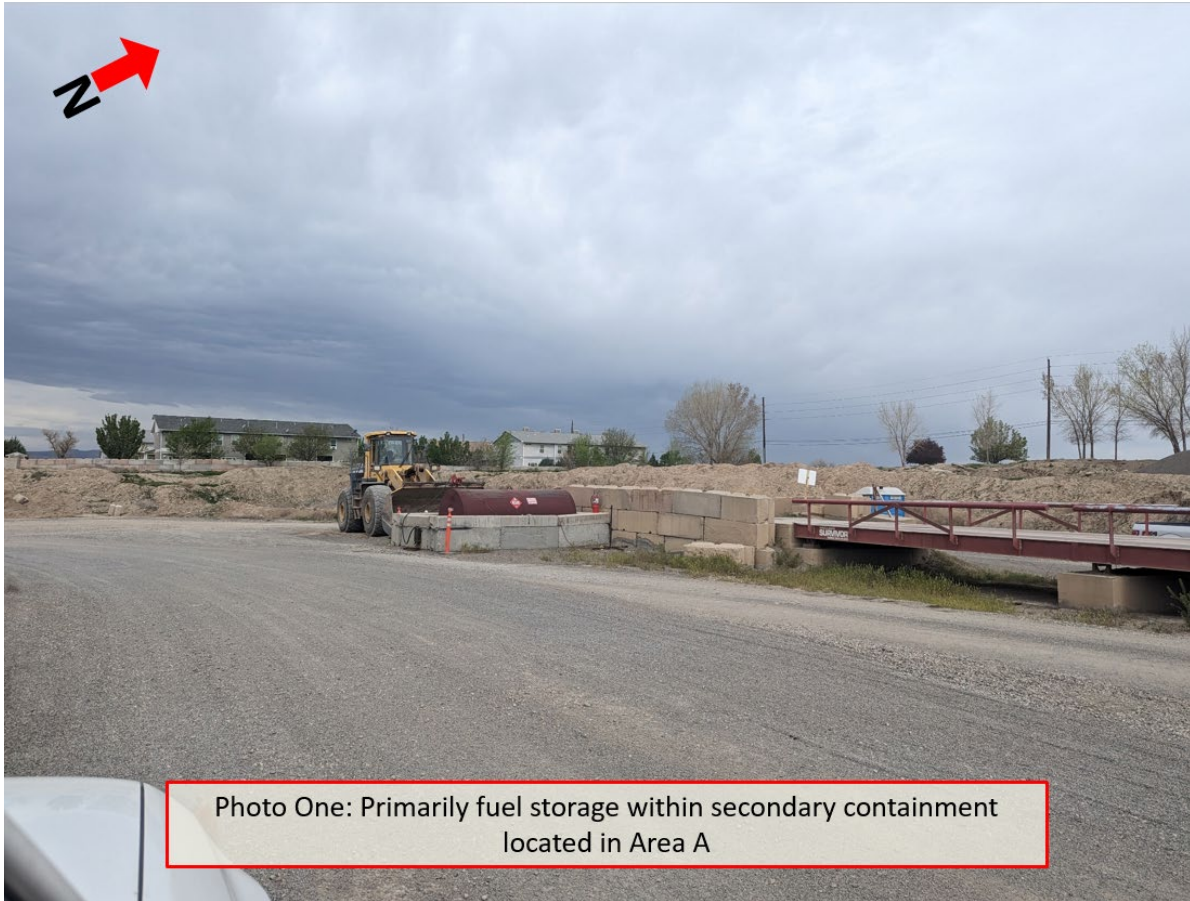
All fuel is stored within secondary containment. The primary fuel storage is located in Area A adjacent to the

scale (Photo One). A small secondary fuel tank is stored within Area E. No other hazardous or toxic materials were observed on site.

Photo One: Primarily fuel storage within secondary containment located in Area A

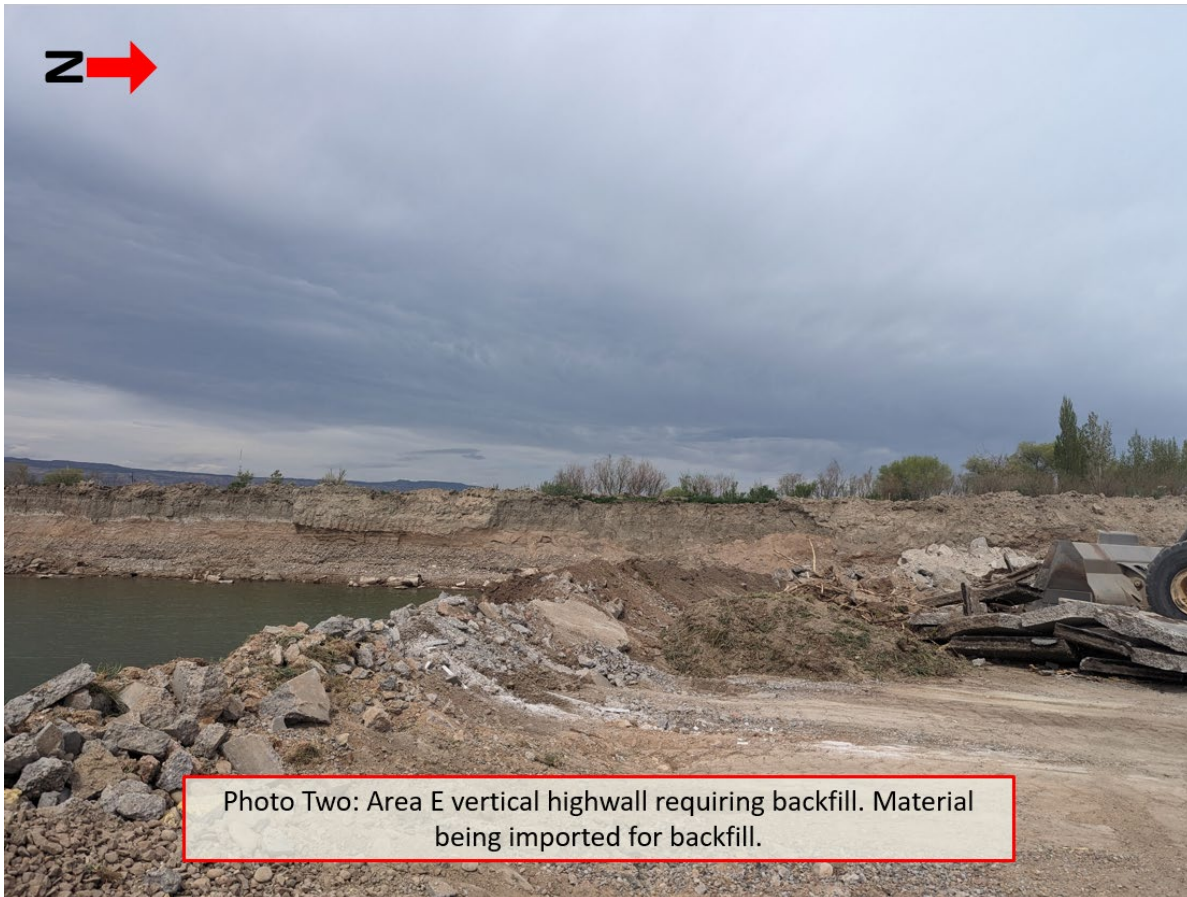
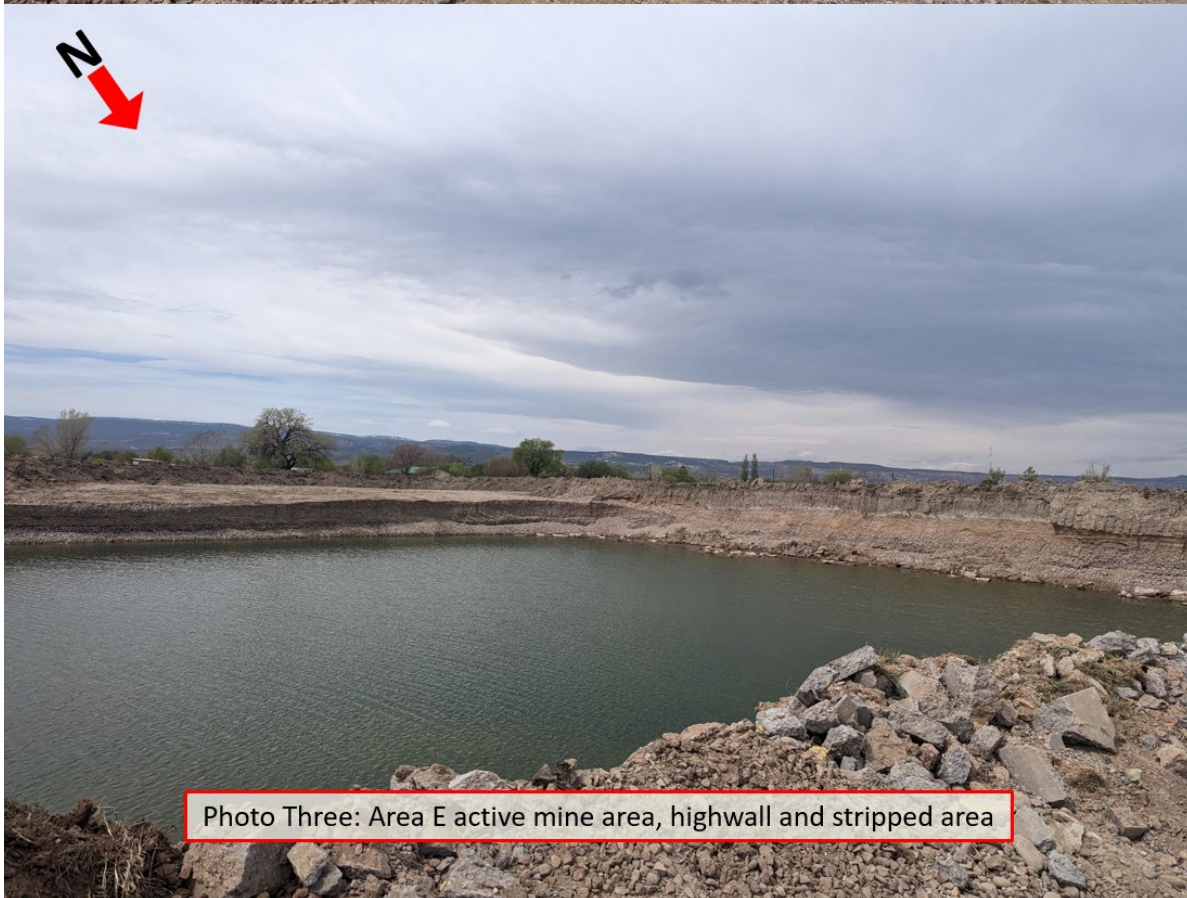
Area E has an active vertical highwall adjacent to the permit boundary which will require backfill to reduce the grade (Photos Two and Three). Interior highwalls may be graded with cut/fill (Phot Four). The northern permit boundary highwall has been sufficiently graded to a 3H: 1V. Approximately 6 acres which has previously been mined is backfilled.

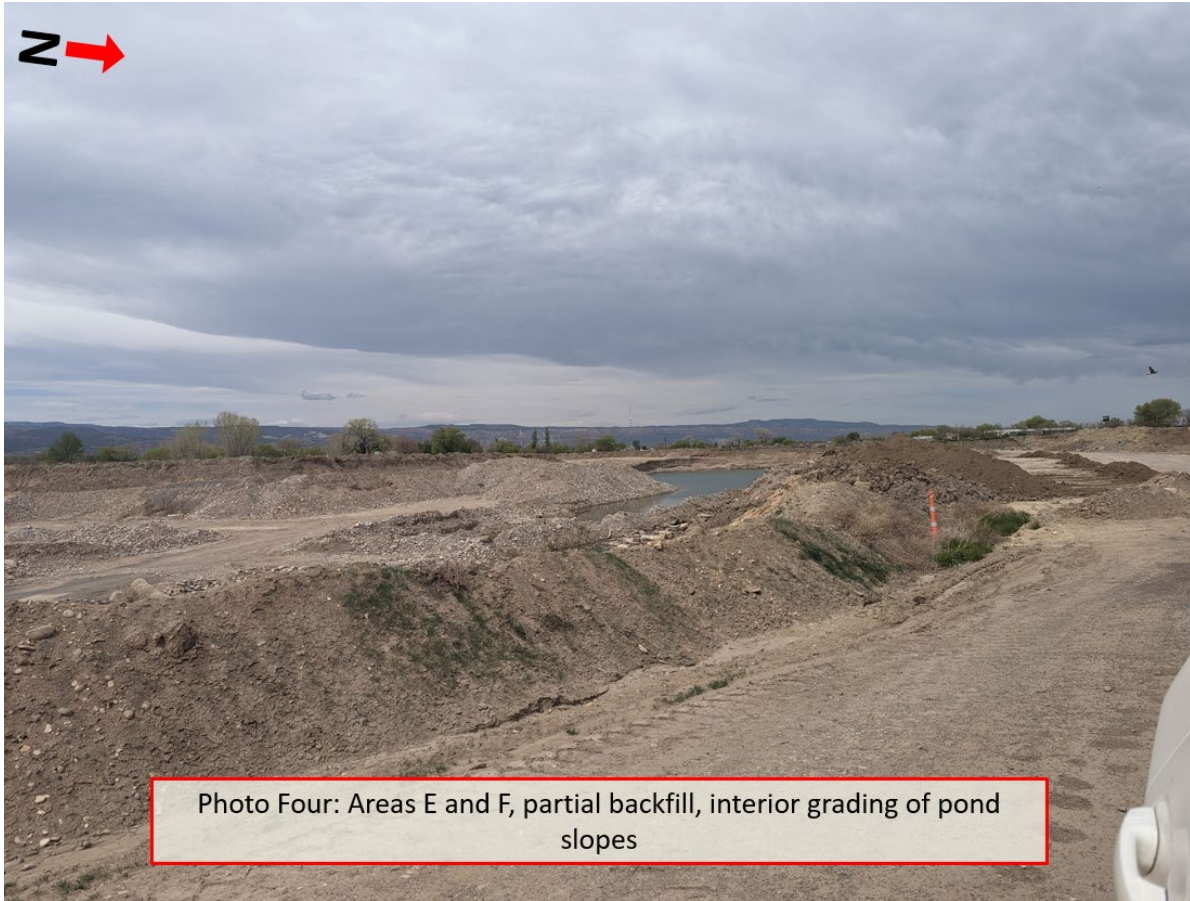
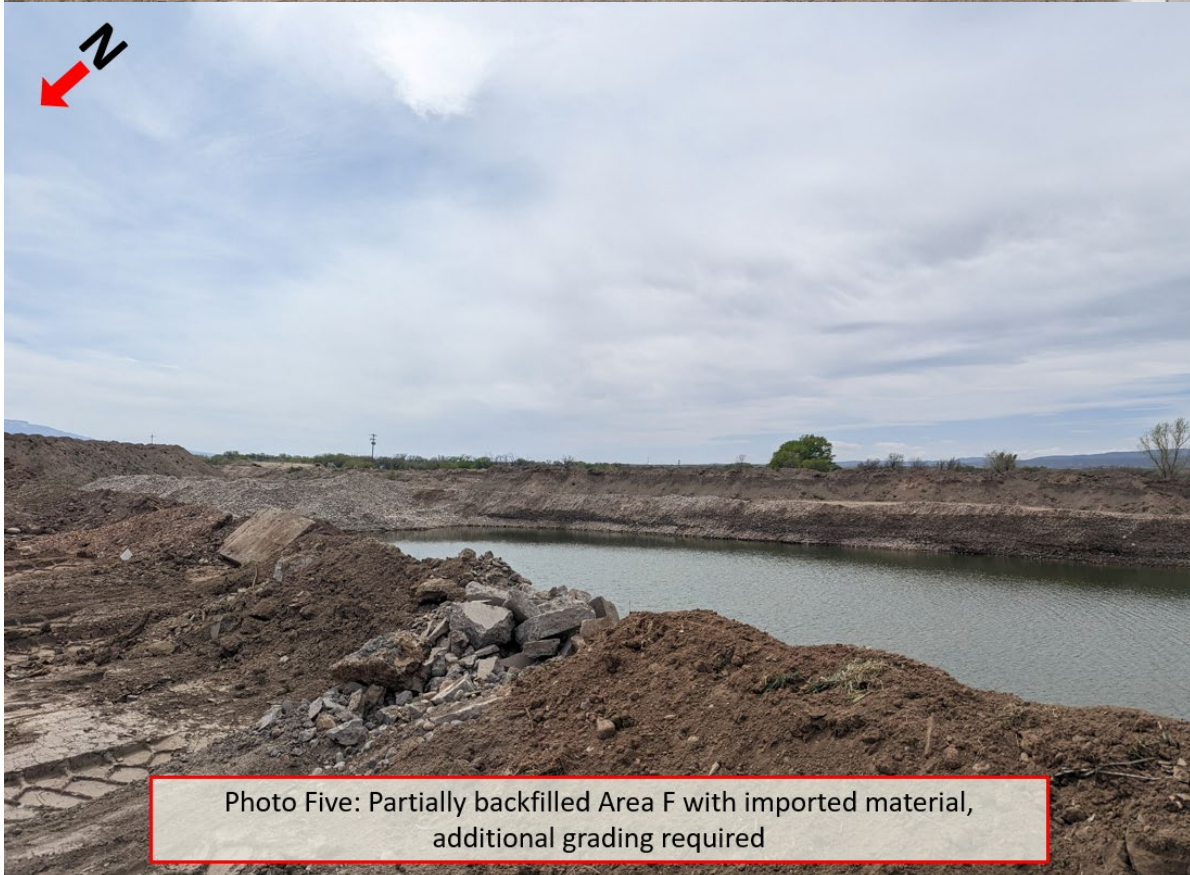
Area F is completely mined out and has mostly been backfilled (approx. 6.2 ac). A small excavated portion remains in the southwest corner of this phase. These slopes may be graded with cut/fill (Photos Four, Five and Six).

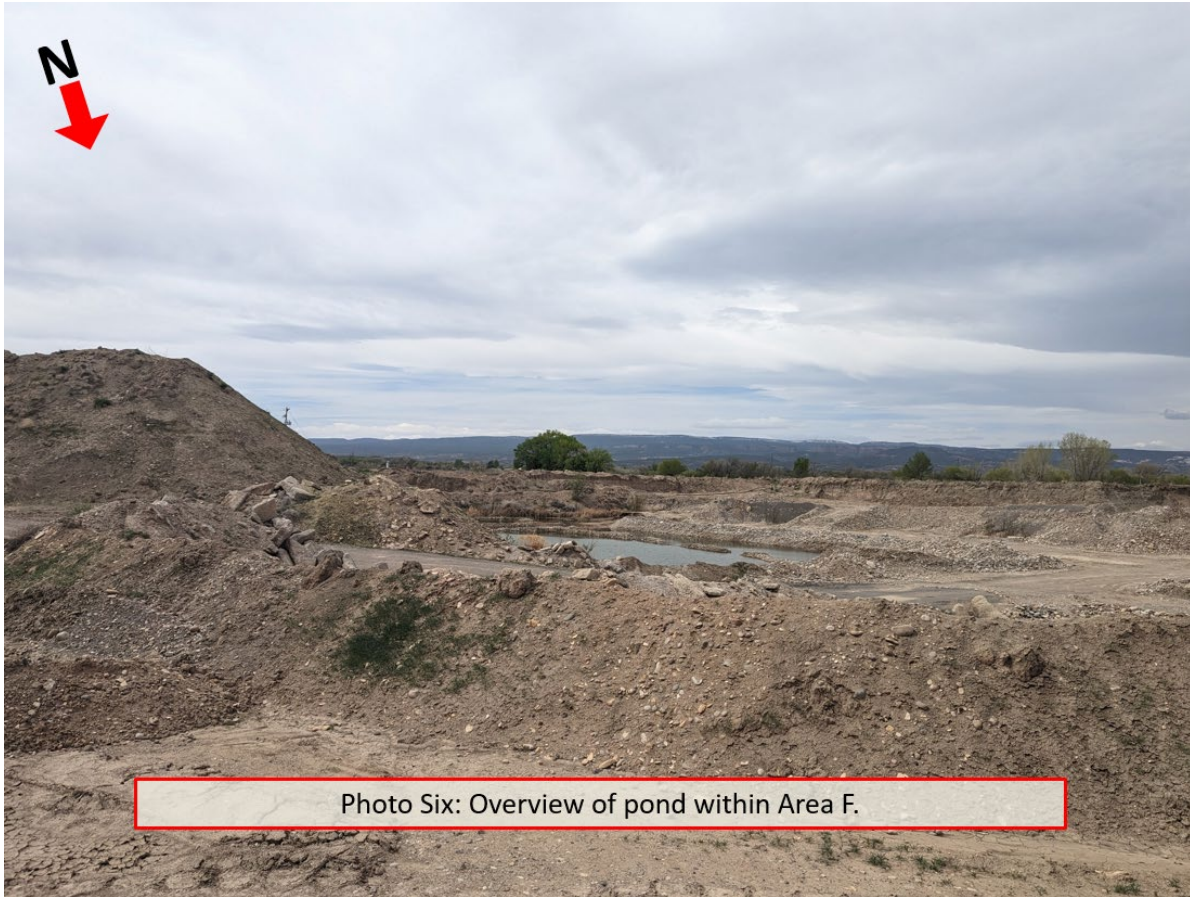
Photo Six: Overview of pond within Area F.

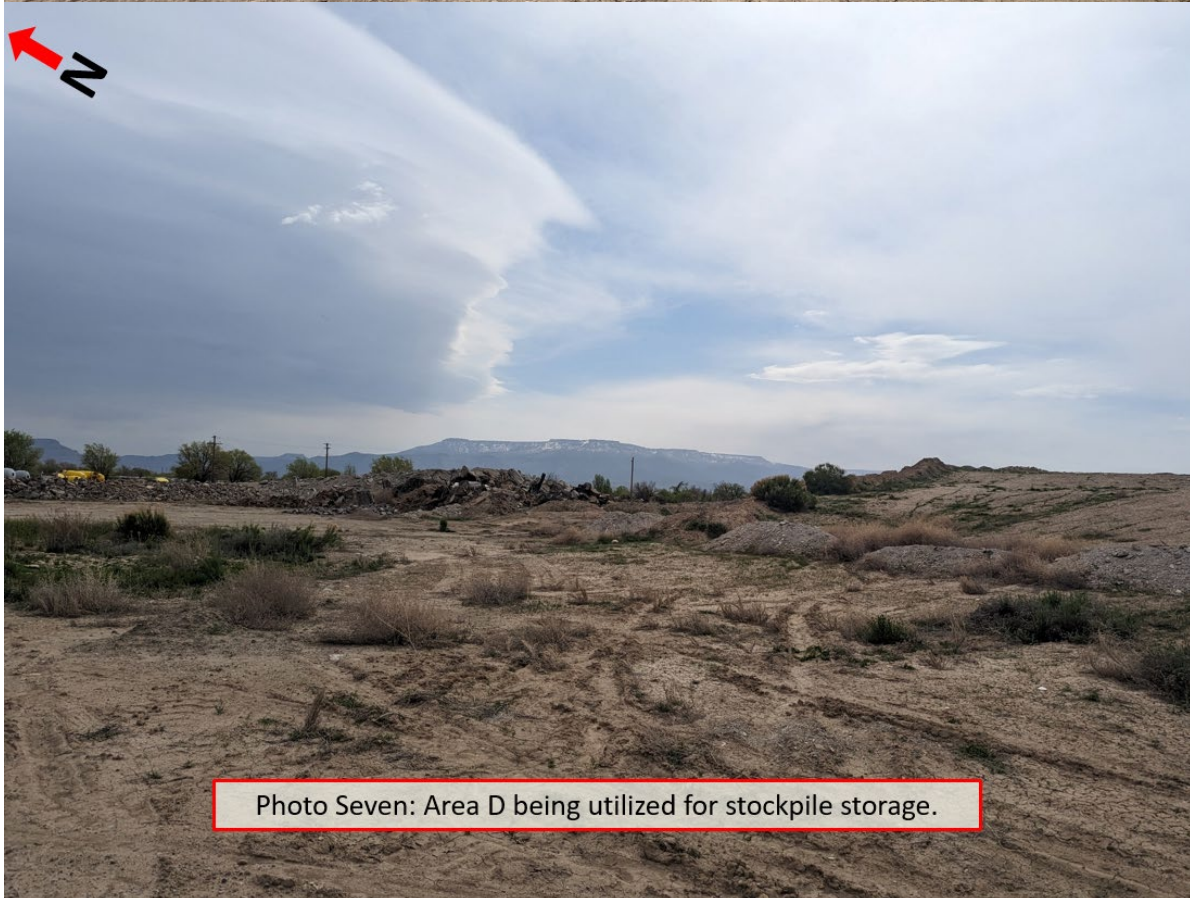
Most stockpiles are located within Area A. Area B is in final reclamation. Area C is undisturbed and being used for agricultural purposes. Area D is partially affected, with undisturbed areas remaining in agricultural use. Within Area D approximately 6.6 acres is being utilized for stockpile storage (Photo Seven). No excavations have occurred in this phase. Areas E and F are the active mining phases. Approximately 11 of the 13 acres within Area E have been affected to date. 6 acres have been backfilled, 2 acres is stripped and a 3 acre excavation (or pond) is present. All of Area F has been affected. Approximately 6.2 acres of Area F has been backfilled, the southwest portion remains open (pond).

Area D is currently being used for stockpile storage. The topsoil was not stripped/salvaged prior to placement of stockpiles in this area. In the future, all topsoil needs to be removed and salvaged for reclamation prior to utilizing an area for mining pursuant to Rule 3.1.9. Additionally any stockpiled topsoil that will not be replaced within a short enough time (180 days), shall be revegetated to avoid deterioration. The operator is encouraged to save any imported topsoil for future reclamation use. If additional areas will be backfilled rather than becoming a lake, additional topsoil will be required for reclamation.

Photo Seven: Area D being utilized for stockpile storage.

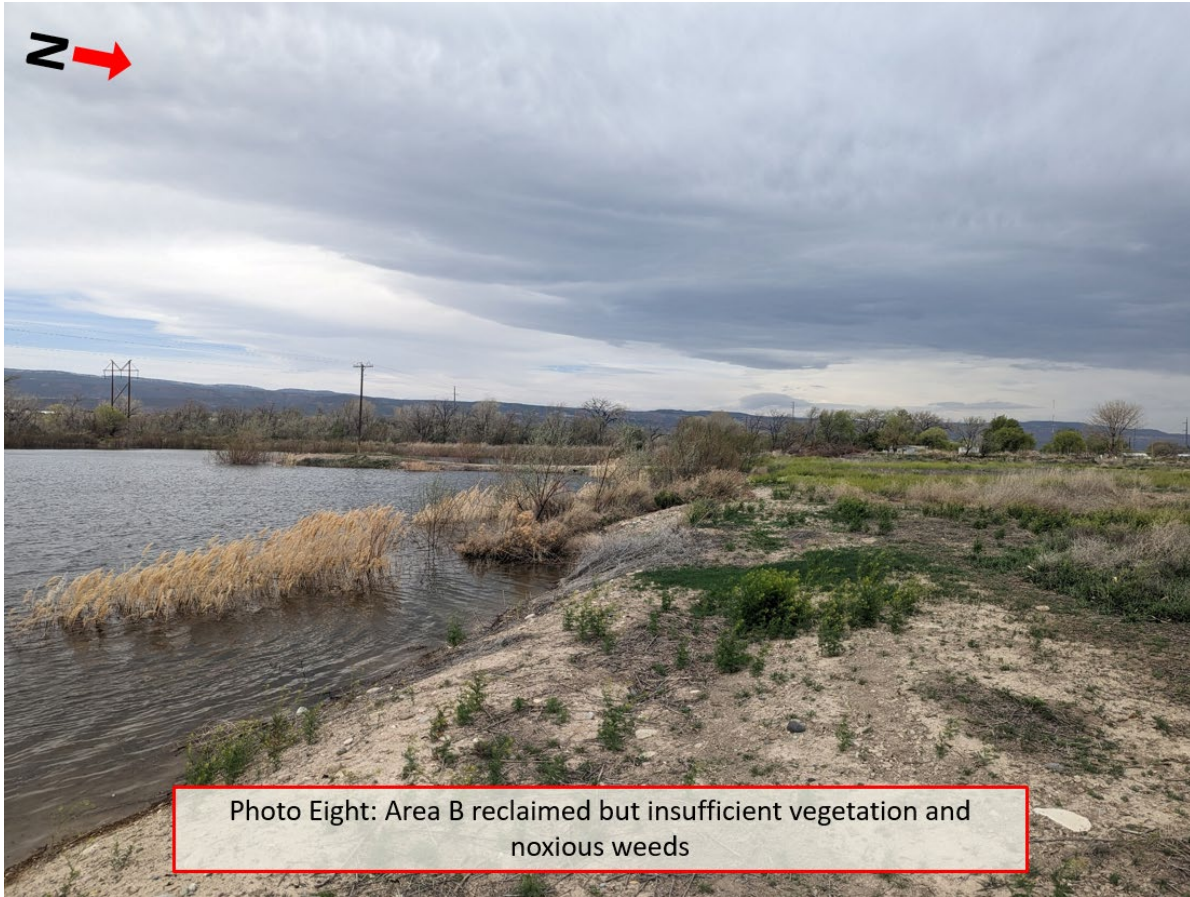
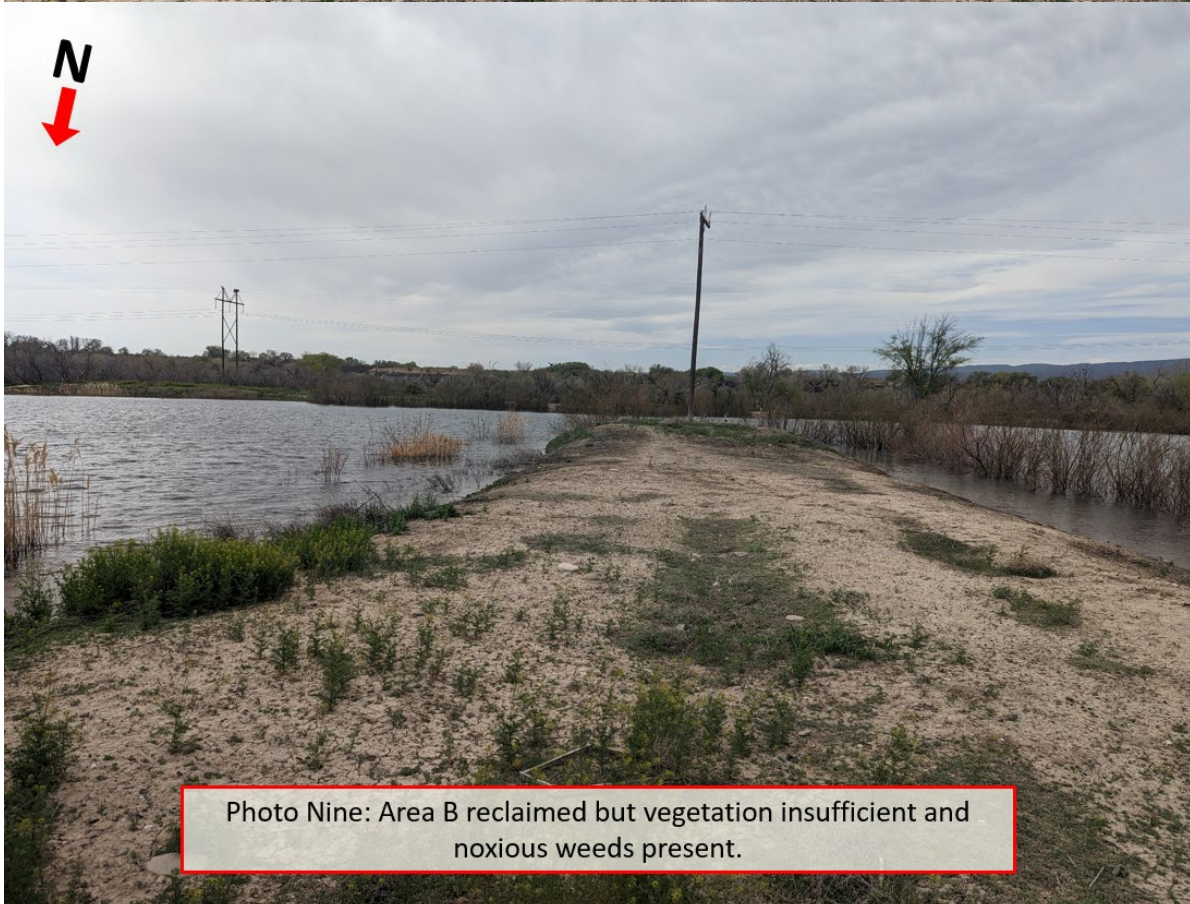
Area B is completely mined out and has been reclaimed. Revegetation has not been successfully established throughout this phase. According to Mr. Gardner the ponds water level have come up significantly, inundating lots of the grasses that had established. Upper banks and surrounding areas within Area B are extremely sparse or lacking desirable species (Photos Eight and Nine). Additional revegetation efforts are likely necessary.

The perimeter berms of Area A have been revegetated. No other areas aside from B have been reclaimed to date. Noxious weeds were established throughout the reclaimed areas (Area B). The operator is encouraged to aggressively manage noxious weeds in reclaimed areas to avoid delays in reclamation success and permit release. Also if areas void of vegetation or sparse in desirable species do not germinate in the next few weeks additional seeding efforts are recommended. Tamarisk and Russian Olive shall be managed pursuant to Rule 3.1.10(6).

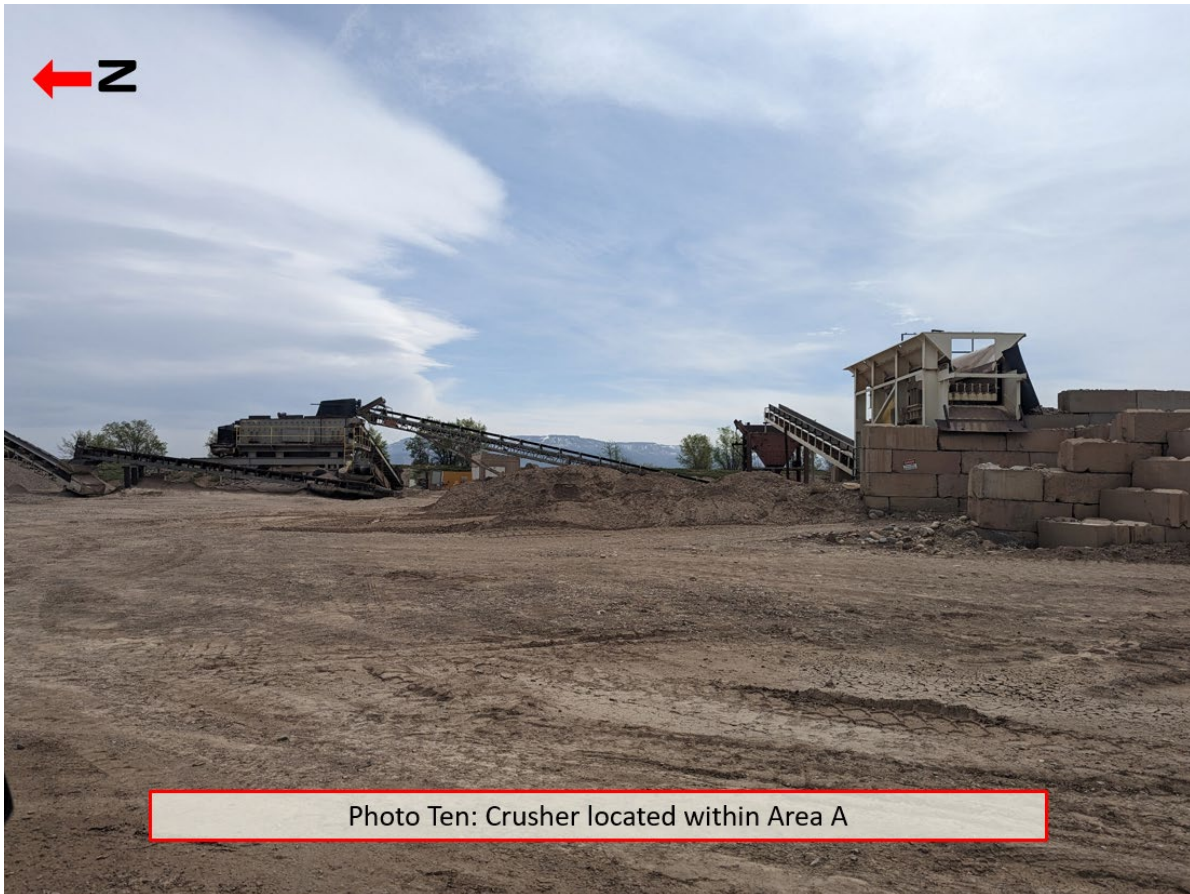
Area A is the operations area for the mine. This includes the scale, office, primary fuel storage and crusher plant (Photo Ten). No other buildings are located within the permit.

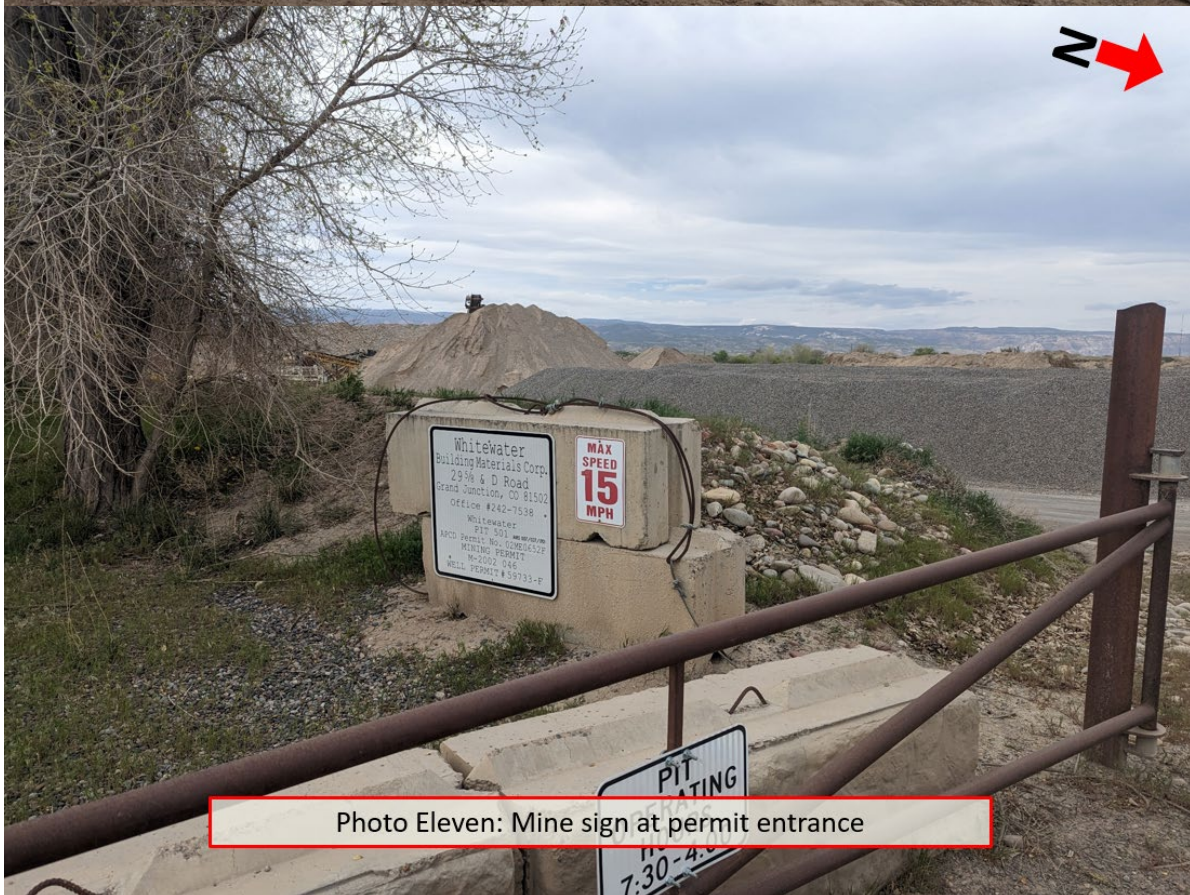
A mine sign was posted at the entrance to the mine site as required by Rule 3.1.12(1). The information depicted was correct/ up to date and the sign was of sufficient size (Photo Eleven). The permit boundary of the affected land was clearly delineated primarily by a wire fence pursuant to Rule 3.1.12(2).
