McClane Canyon Mine, C-1980-004, April 2023 Complete Inspection and OSMRE Oversight Inspection Report

PERMIT INFORMATION

Permit Number: C-1980-004 Mine Name: McClane Canyon Mine Operator: ARC McClane Canyon, LLC Operator Address: Joe Brinton 652 Peony Dr Grand Junction, CO 81507	County: Garfield Operation Type: Underground Permit Status: Temporary Cessation Ownership: Private
	Operator Representative Present: Chuck Silengo
Operator Representative Signature: (Field Issuance Only)

INSPECTION INFORMATION

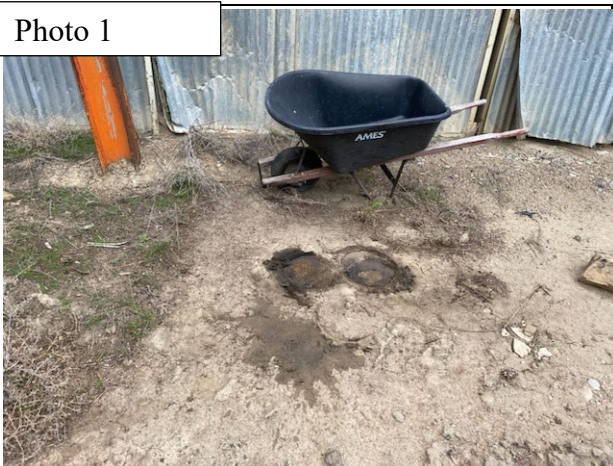
Photo 1

1. Clean up contaminated soil on the east side of the shop and dispose of in accordance with the approved Spill Prevention Control and Countermeasures Plan/SPCC (Photo 1).

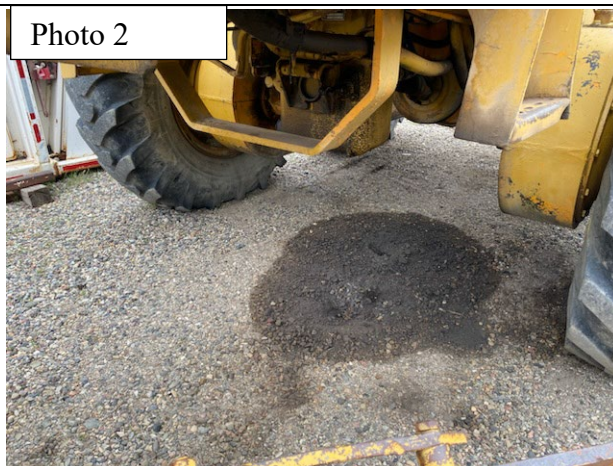
Photo 2

2. Clean up the contaminated soils beneath the grader parked on the west side of the mine office and dispose of the contaminated material in accordance with the SPCC (Photo 2)

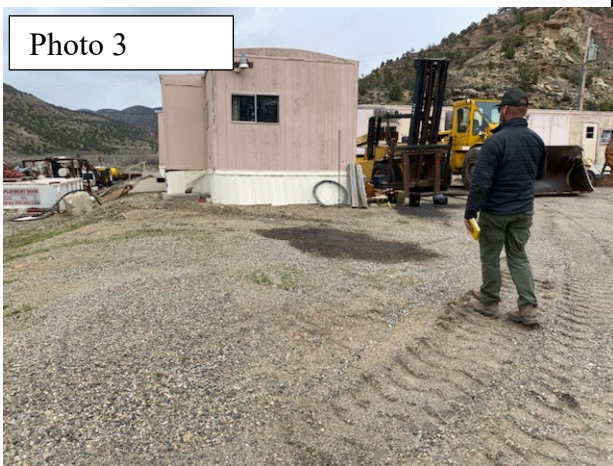
Photo 3

3. Clean up the contaminated soils located at the back/south side of the mine office and dispose of the contaminated soils in accordance with the SPCC (Photos 3 and 4)

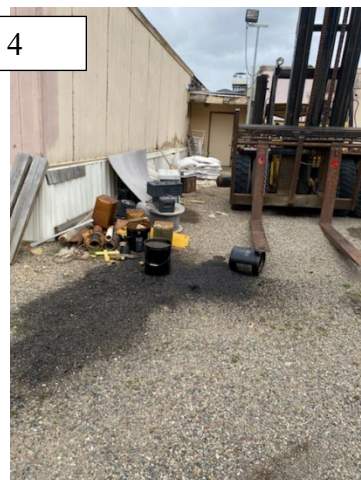
Photo 4

4. Remove old barrels from behind the south side of the shop. The barrels must be removed from the site in accordance with the approved SPCC. (Photos 4 and 5).

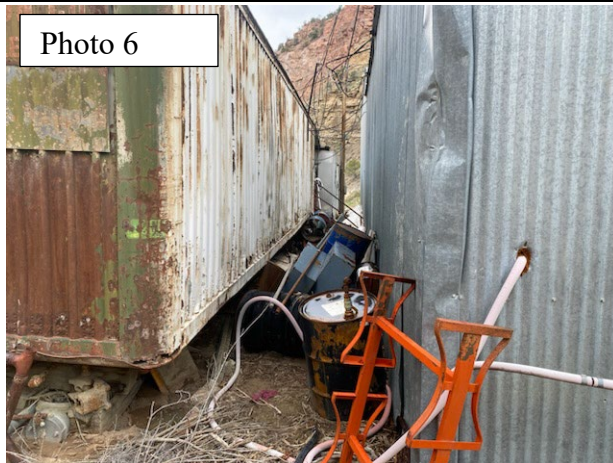
Photo 6

5. Remove old barrels located behind the shop and dispose of in accordance with the approved SPCC. (Photo 6)
6. Remove old barrels and filters from within the filter shed and dispose of in accordance with the approved SPCC (Photo 7).

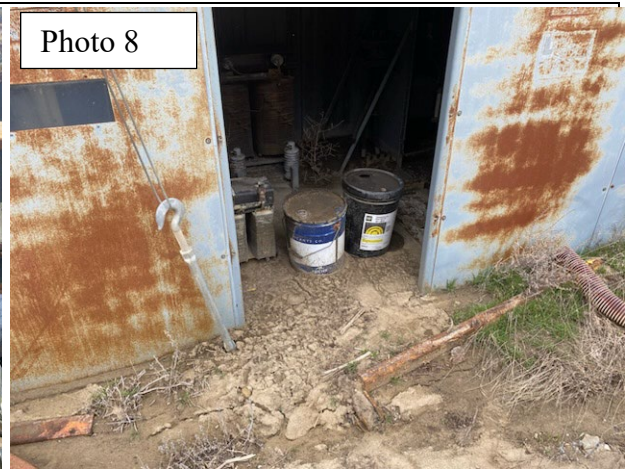
7. Remove old barrels from within the transformer building and dispose of in accordance with the approved SPCC (Photo 8).
8. Remove the barrels from beneath the conveyor building and dispose of in accordance with the approved SPCC (Photo 9).

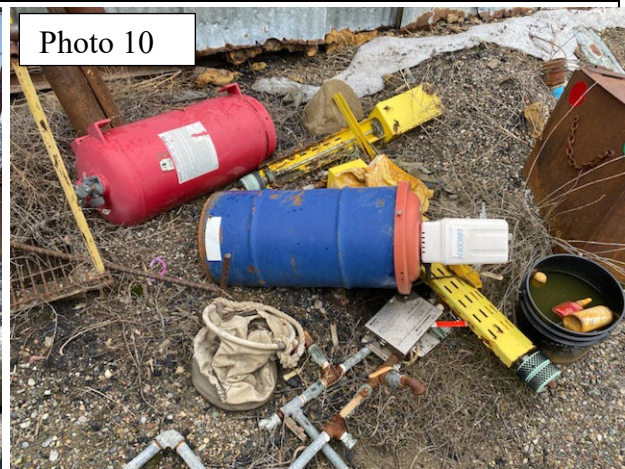
9. Remove all barrels containing fluids located on the north side of the shop and dispose of

- in accordance with the approved SPCC (Photo 10).
10. Remove all barrels of liquids from the laydown area located on the bench below and to the north of the shop. Dispose of the liquids in accordance with the approved SPCC (Photo 11).

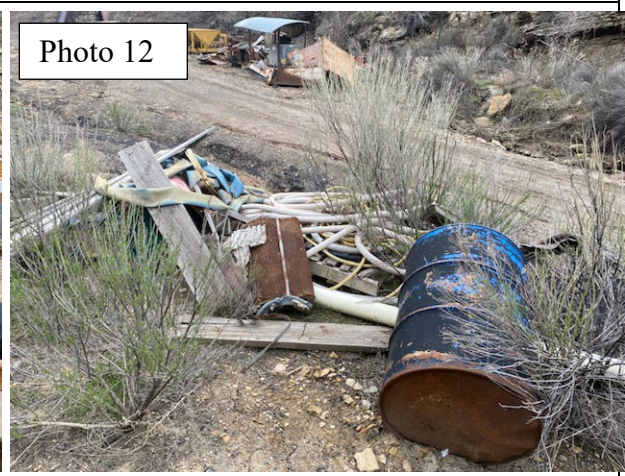
11. Please remove the barrels located across the haul road from Item # 10. Dispose of the barrels in accordance with the SPCC (Photo 12).
 12. Please relocate the large red fuel tank located just east of Sump I to a location with a containment berm as outlined in the approved SPCC (Photo 13).

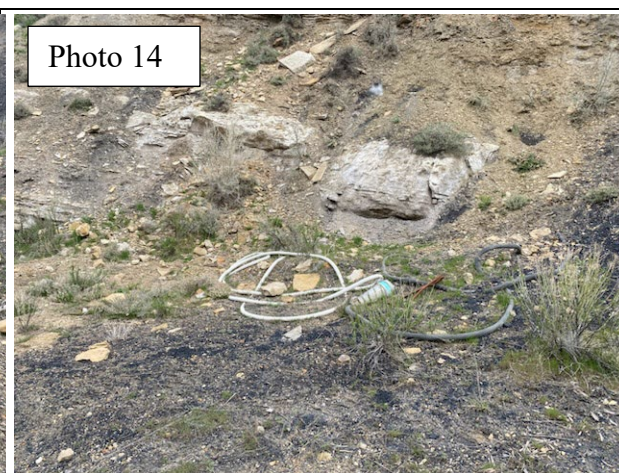
13. Please pick up the hoses located near the fuel tank described in Task no. 12 and store in an approved location such as the shop or dispose of in accordance with the approved SPCC (Photo 14).

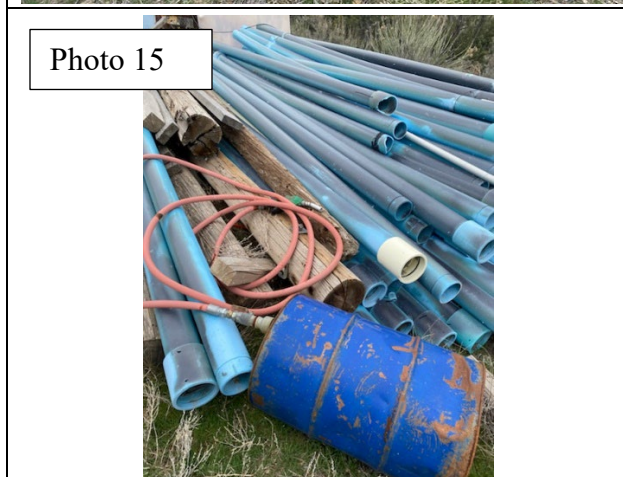
14. Remove all barrels and any containers with liquids from the equipment laydown area north across the haul road from the sediment pond. Dispose of the barrels and containers with liquids in accordance with the approved SPCC (Photo 15).

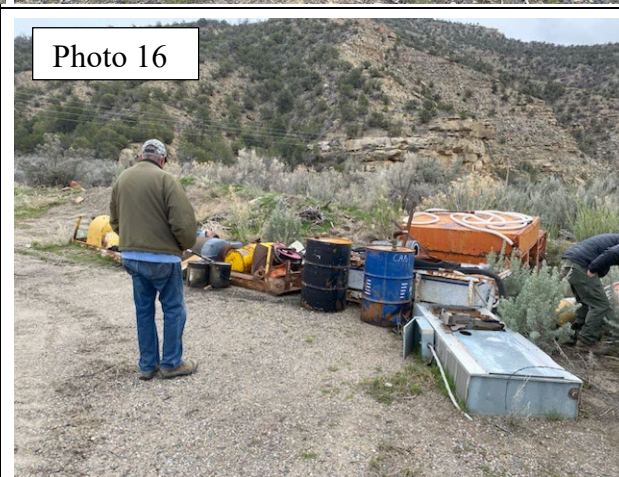
15. Remove all barrels and containers with liquids from the mine office pad. Dispose of the barrels and any containers with liquids in accordance with the approved SPCC (Photo 16).

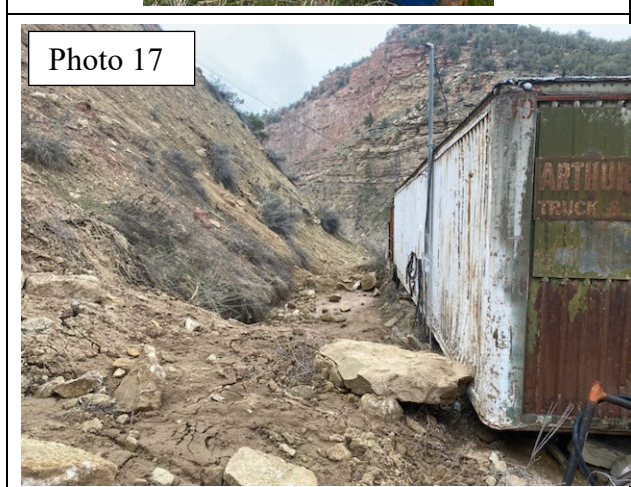
16. The clearwater diversion ditch, D-2, located behind the south side of the shop needs to be cleaned out and reestablished to ensure proper conveyance of water from undisturbed areas around the disturbed areas of the Portals Bench (Photo 17).

clearwater ditch already diverts Clearwater from the portals bench on the southern side of the bench. The D-2 Ditch was observed to be filled with sediment and sloughage from the adjacent hillside. The D-2 ditch must be cleaned to ensure clearwater does not enter the disturbed area of the portals bench. The inlet to the B culvert was observed to be clear from blockages (Photo 34). Several rills were identified on the start of the haul road adjacent to the shop. The rills need to be patched to prevent further enlargement (Photo 35).

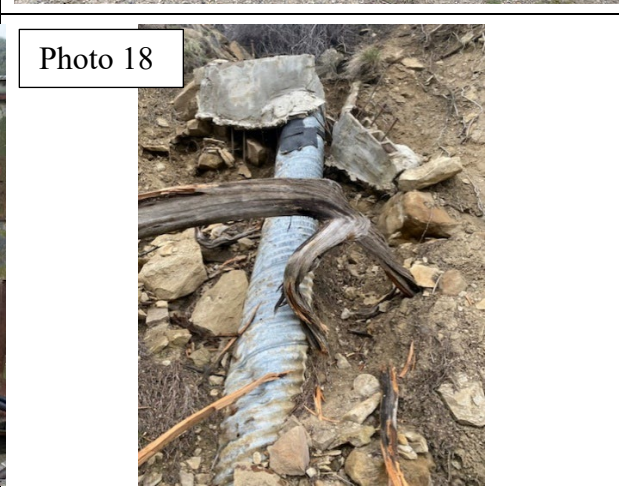
17. A revision needs to be submitted to the Division to repair the functionality of surface water features for clearwater drainages D-5 (Photo 18) and E (Photo 19). Both Clearwater culvers are completely plugged. The revision could alter these features to surface ditches that would connect to Ditch D-2.
