MINERALS PROGRAM INSPECTION REPORT
PHONE: (303) 866-3567

MINE NAME: Cortner Pit	MINE/PROSPECTING ID#: M-1986-159	MINERAL: Sand and gravel	COUNTY: Pueblo
INSPECTION TYPE: Illegal(Unpermitted Operation)	WEATHER: Clear	INSP. DATE: April 5, 2023	INSP. TIME: 09:30
OPERATOR: Martin Marietta Materials, Inc.	OPERATOR REPRESENTATIVE: Julie Mikulas	TYPE OF OPERATION: 112c - Construction Regular Operation	
REASON FOR INSPECTION: Normal I&E Program		BOND CALCULATION TYPE: Complete Bond	BOND AMOUNT: \$73,556.00
DATE OF COMPLAINT: NA		POST INSP. CONTACTS: None	JOINT INSP. AGENCY: None
INSPECTOR(S): Amber Michels	INSPECTOR'S SIGNATURE:

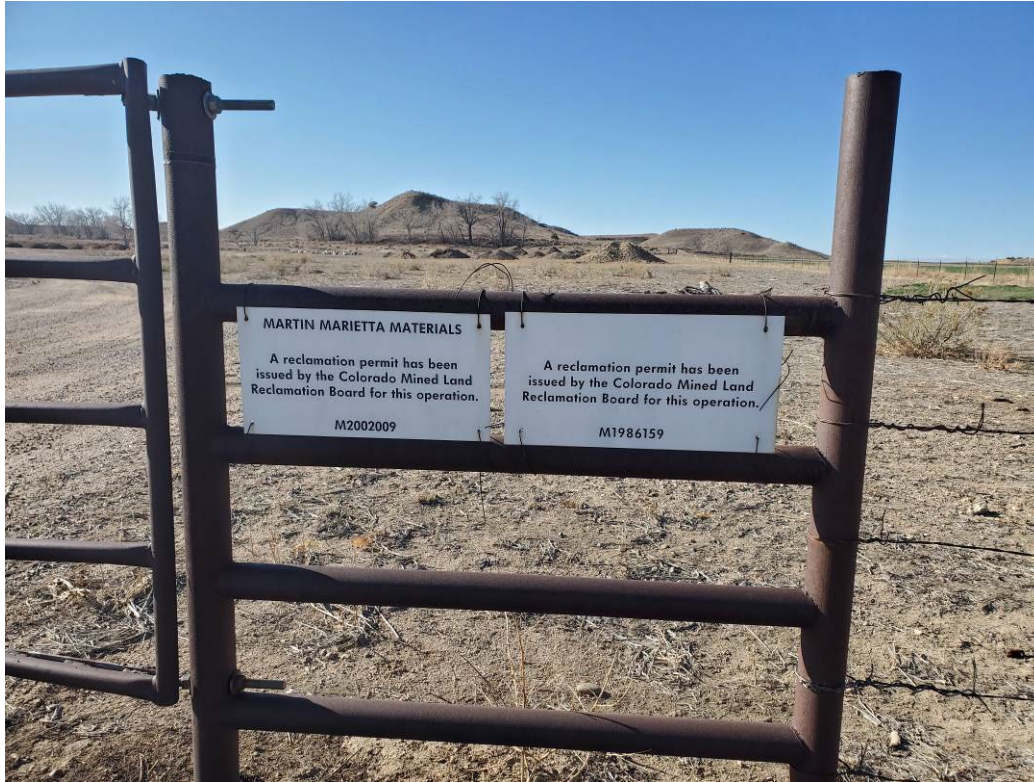
A mine sign was posted on the entrance gate located east of Cortner Road alongside the sign for the Operator's adjacent Beeman Pit #1 (Photos 1 and 2). The mine sign posted for the Cortner Pit complies with Rule 3.1.12(1).

Photo 1: Looking east at the mine sign posted at the entrance to the Cortner Pit (right) on the east side of Cortner Road. The mine sign for the Operator's adjacent pit, Beeman Pit #1, is posted to the left.

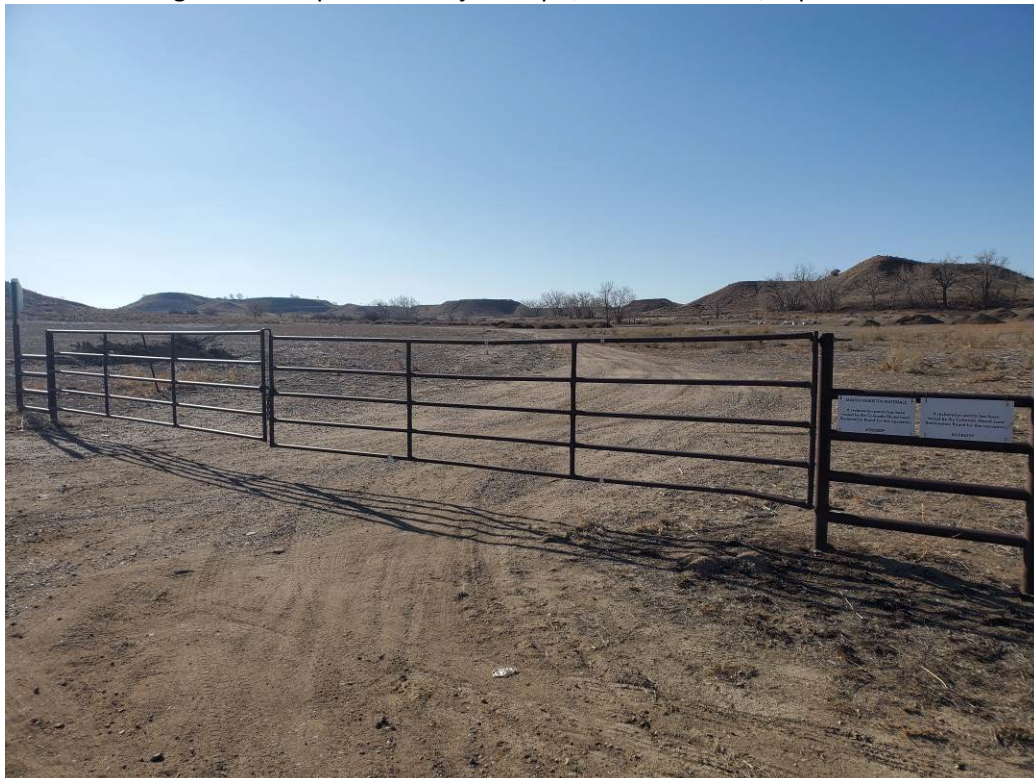
Photo 2: Looking east at the mine sign posted at the entrance to the Cortner Pit on the east side of Cortner Road.

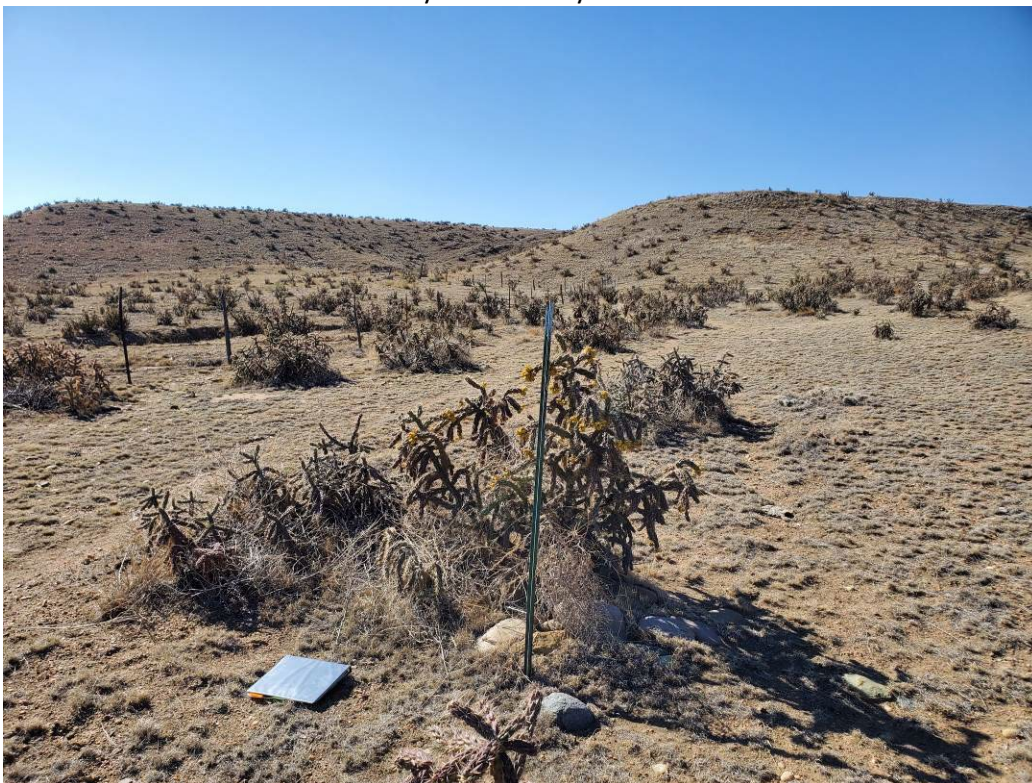
No boundary markers were observed onsite, except one located in the north-east corner (Photo 6). The Operator stated that this is due to the discrepancy in the permitted acreage and the 86.12 acres that the approved permit boundary reflects. They stated that they have had a survey done and intended to ask the Division about this before verifying their markers prior to requesting a release of the southern Phase V area. The Division took GPS points around the site using Esri Field Maps to find approximately where the permit boundary should be (Map 3), as well as to link photos taken around the pit to show the land from the various directions georeferenced in Map 1. A **problem** was cited above for failure to maintain boundary markers. The Operator will need to provide evidence that this has been abated and that the boundary markers reflect the approved affected acreage by the corrective action date.

Photo 6: Looking south at the approximate northwest corner of the permit boundary indicated by the binder and remaining boundary marker.

CORRECTIVE ACTIONS: The Operator shall conduct a survey and replace the boundary markers in the correct location(s). The Operator shall provide photo evidence to the Division that this has been done by the corrective action date.

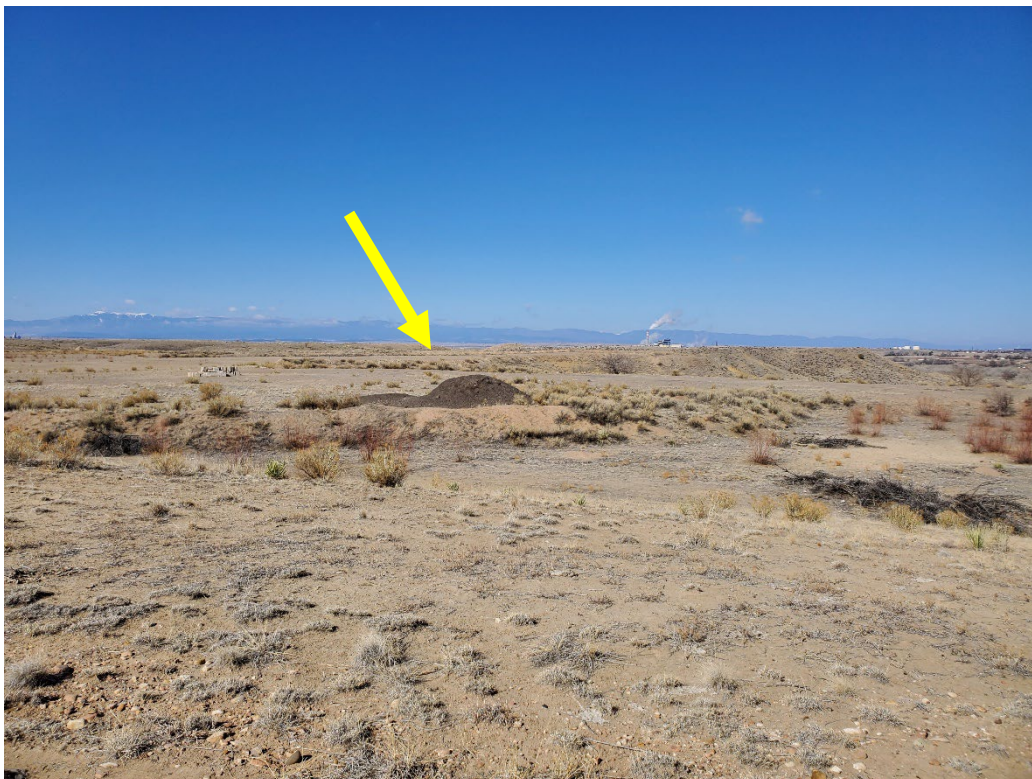
Photo 12 shows a stockpile observed onsite. When asked what this pile consisted of, the Operator stated that it was asphalt used for ice management on the roads. The pile appears to be stable.

Photo 12: Looking west at the asphalt stockpile (indicated by the yellow arrow) used for ice control on the access and haul roads. Also pictured beyond the stockpile to the west are the reclaimed slopes daylighting north in the Phase I area.

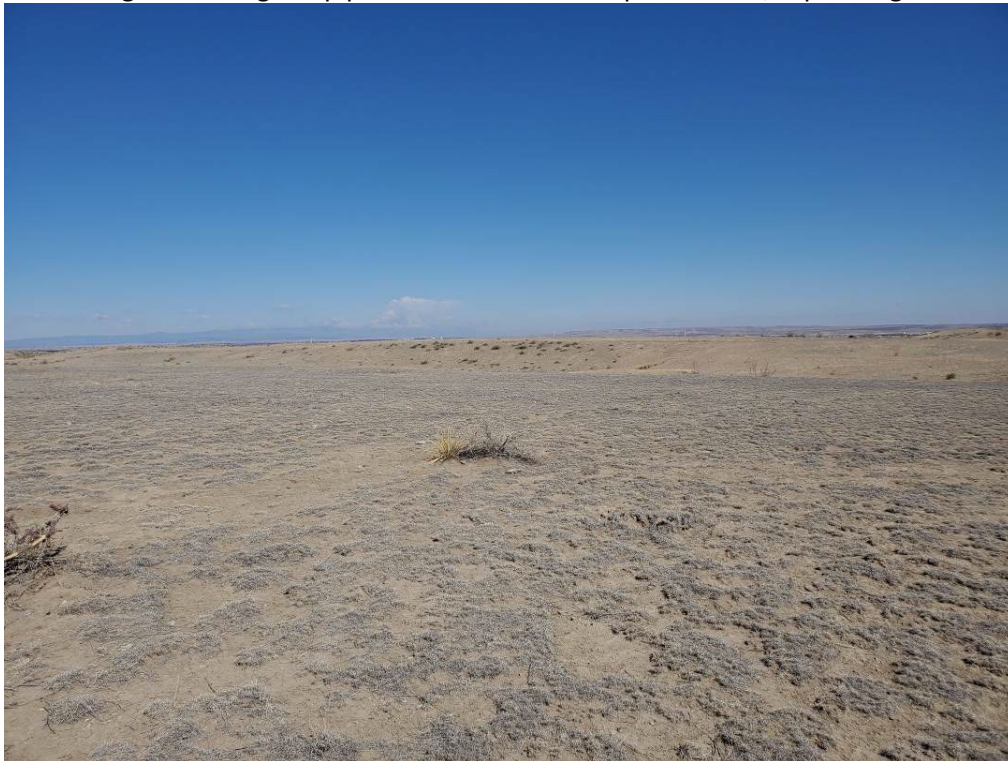
Photo 14: Looking north at the reclaimed south side of the Phase III permit area. The reclaimed slopes appear stable with no erosional features.

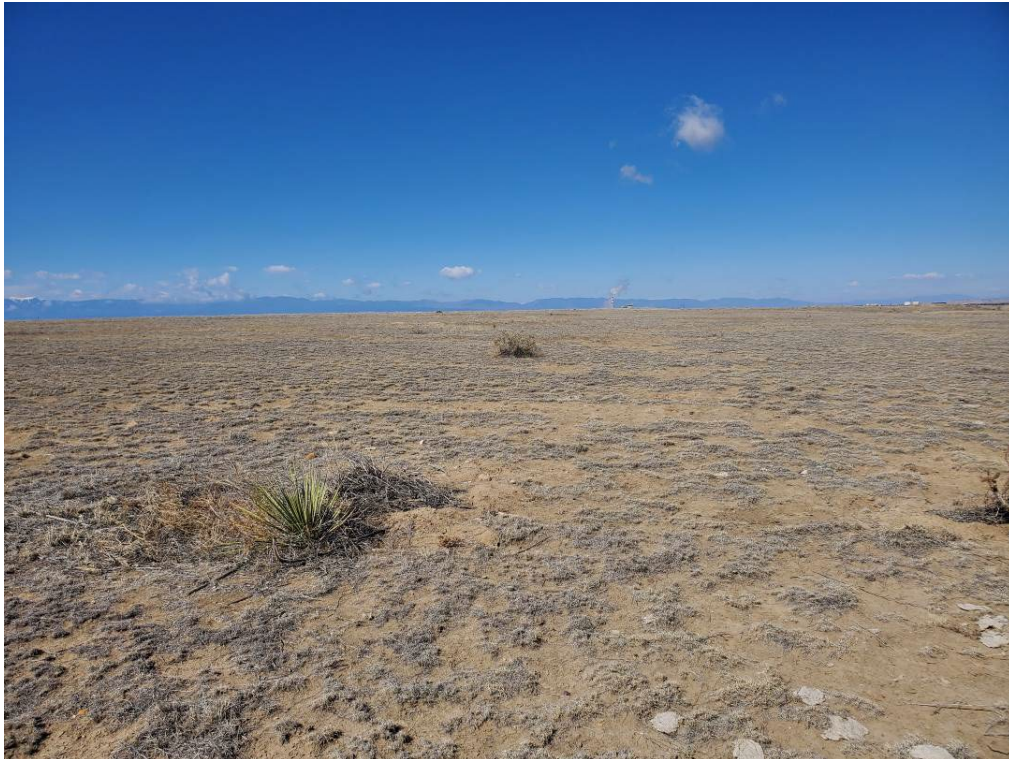
The Cortner Pit is currently approved to affect a maximum of 49 acres of land at any one time. The 2022 annual report and annual report map submitted by the Operator indicate that 58.5 acres have been affected at this time. A **problem** has been cited above for this issue. The Operator has been instructed to either submit a technical revision (TR) to request an increase in approved affected acreage, or submit an acreage reduction and/or surety reduction to release the reclaimed areas or reduce the reclamation liability. During the inspection, the Operator stated that they plan to request a release for the southern portion of the site (Phase V—see Photo 16) that was never mined.

Photo 16: Looking south-west into the un-mined Phase V area.

CORRECTIVE ACTIONS: The Operator shall submit a Technical Revision, with the required \$216 revision fee, to update and clarify the current approved mine plan to reflect existing and proposed activities or they shall submit an Acreage Reduction by the corrective action date.

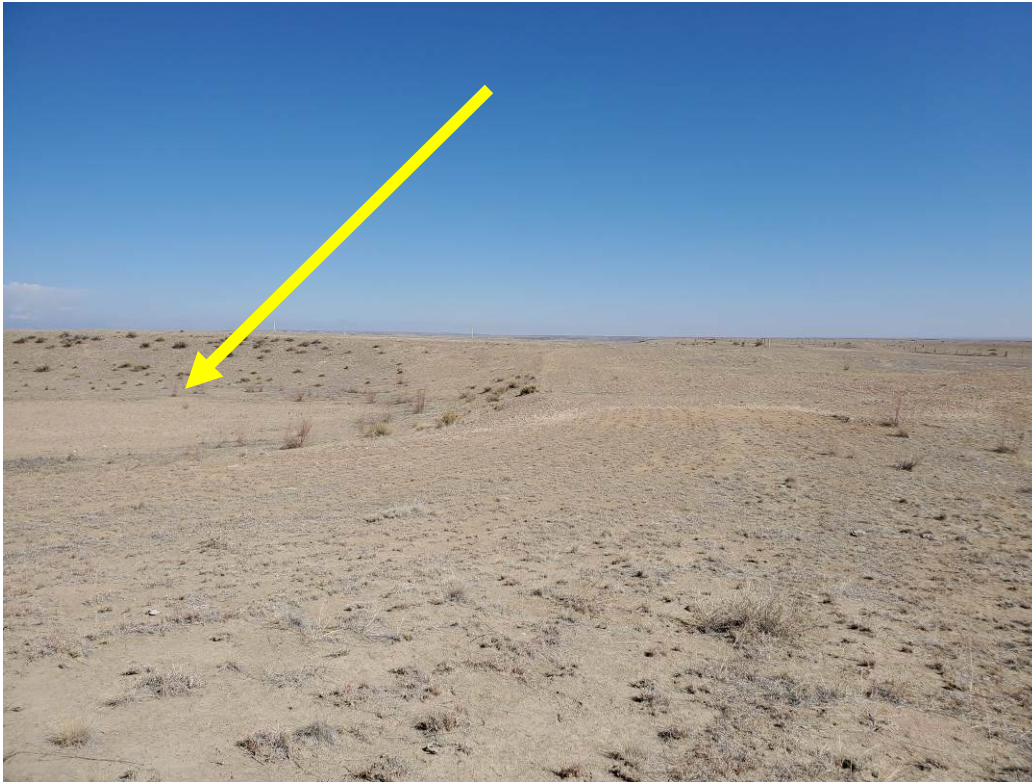
Photo 17: Looking north at the reclaimed slopes in the Phase III area that daylight to the south. The yellow arrow indicates the flat area that has been unable to sustain vegetation.

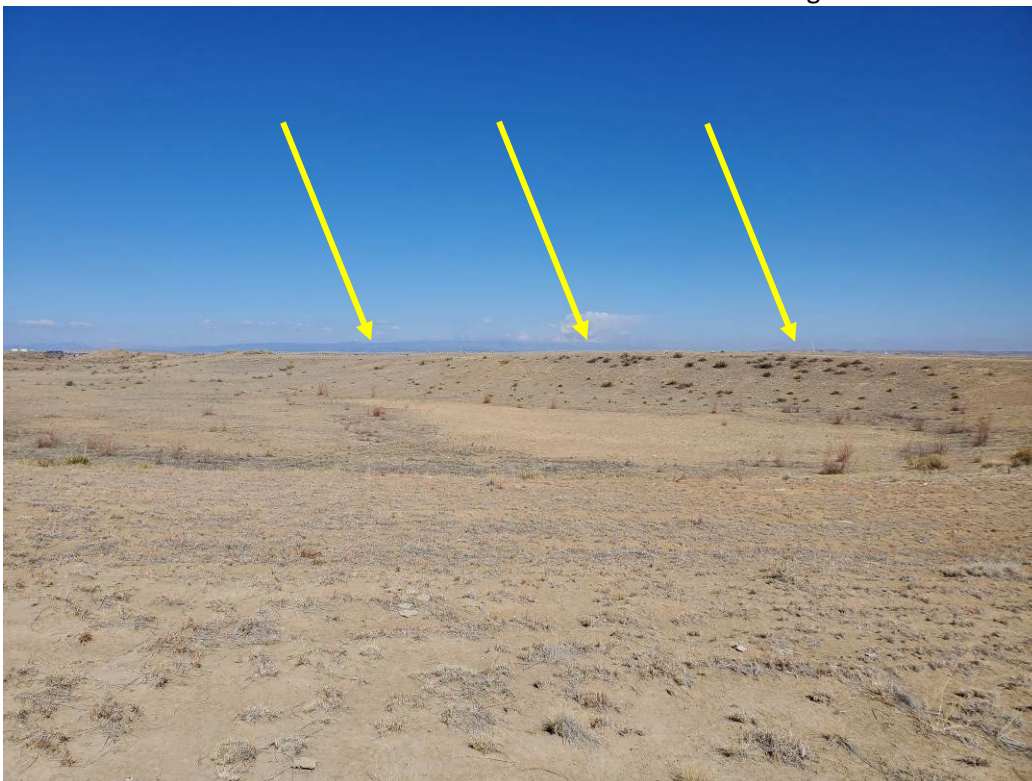
Photo 18: Looking north-west at the reclaimed slopes in the Phase III area that daylight to the south (yellow arrows). The flat area has been unable to sustain vegetation.

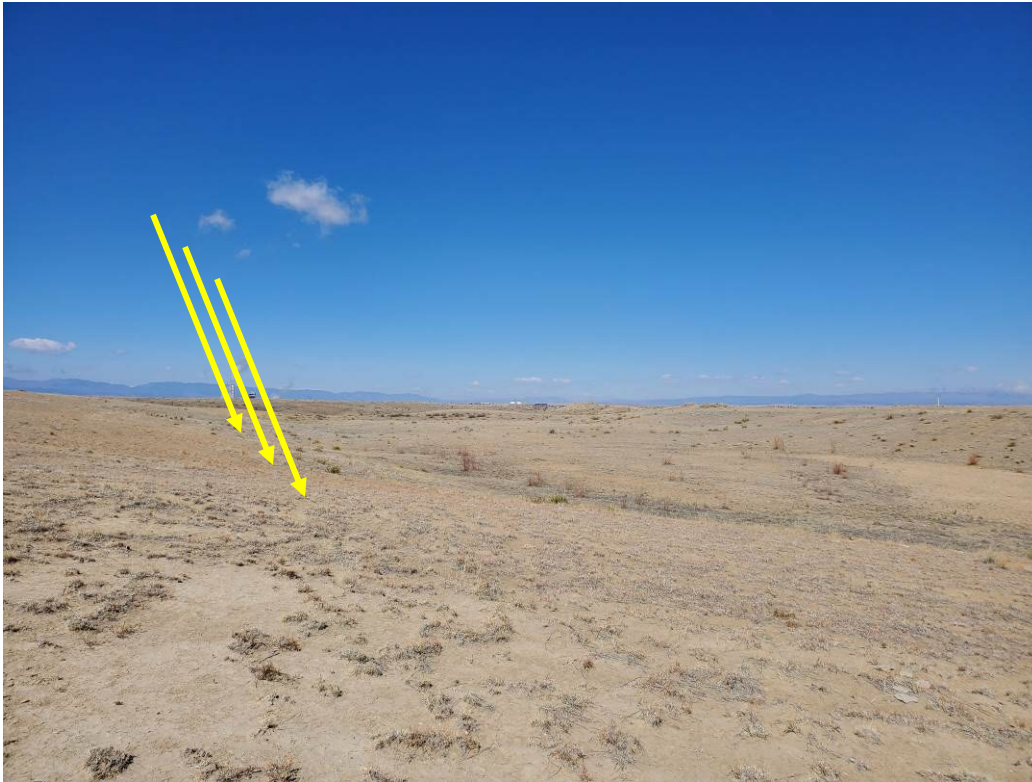
Photo 19: Looking west at the reclaimed slopes in the Phase III area that daylight to the north (yellow arrows). The slopes look stable and are at a 3H:1V slope or shallower.

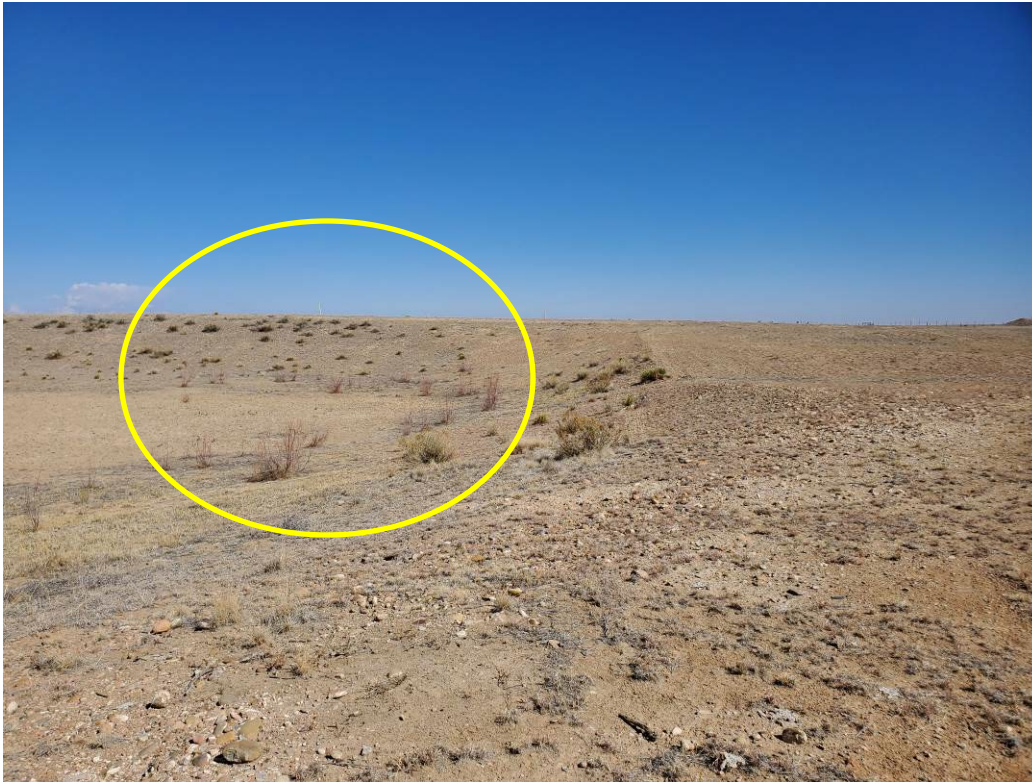
PROBLEM: Tamarisk (salt cedar) trees are present within or have volunteered into the permit area and are becoming established. This is a problem for failure to employ weed control methods for a state listed noxious weed species within the permitted area, and to reduce the spread of weeds to nearby areas as required by Section 3.1.10 (6) of the rule.

Photo 21: Looking north at the re-establishment of tamarisk plants (circled in yellow) within the flat area.

CORRECTIVE ACTIONS: The Operator shall implement the existing weed control plan and provide photo evidence to the Division that indicates that this problem has been abated by the corrective action date.

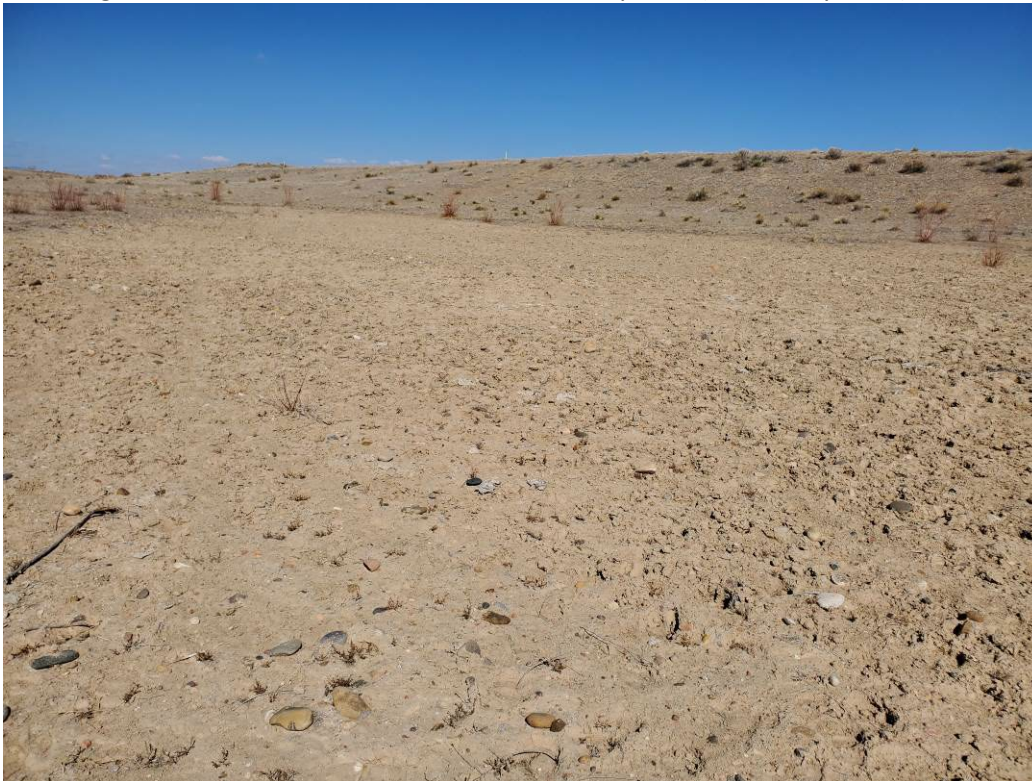
Photo 22: Looking north-west across the flat area that has been unable to sustain vegetation. Cattle prints were observed throughout the area, as well as the re-establishment of tamarisk around its borders.

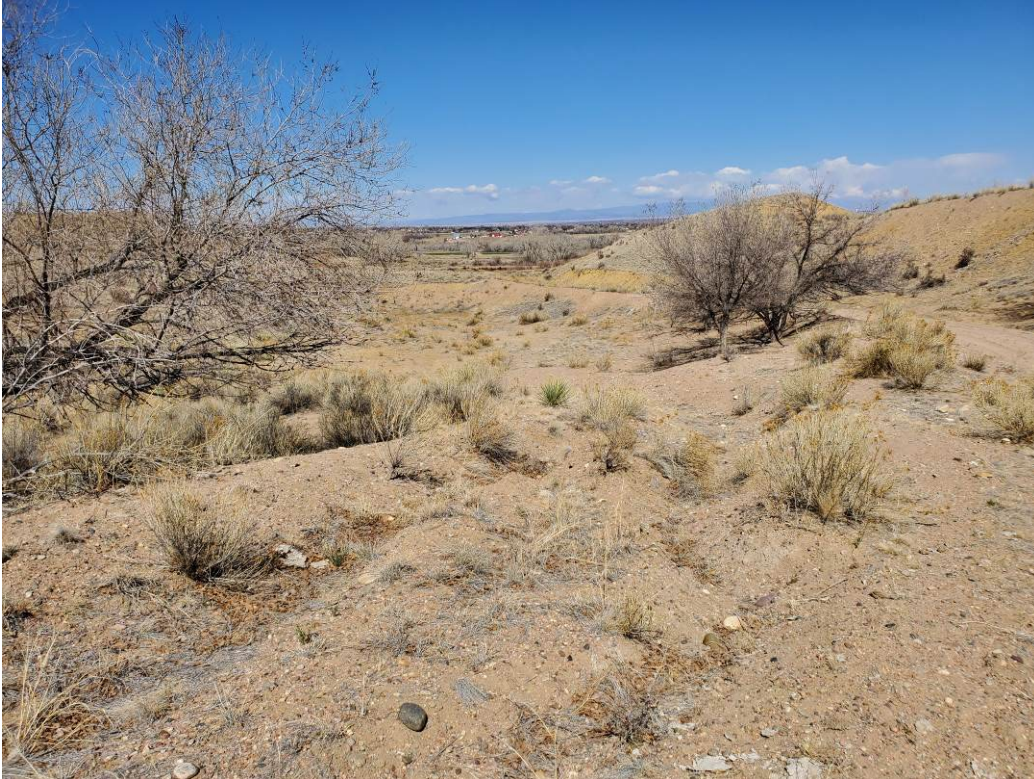
erosion that occurred from run-off on the access/haul road. The check dams in this area have since been reclaimed and re-vegetated (Photos 28 and 29). West of this area, seemingly outside of the permit boundary, check dams and an earthen dam beyond them are still in place (Photos 30 through 33). When the Division stated the presence of these may be a problem, the Operator insisted that they were instructed to install these by the Division as a result of a previous inspection. The Division's 2012 inspection instructed the Operators to correct the erosion observed to the west of the Phase III area, as well as stabilize the areas adjacent to the haul roads, therefore, this appears to have been complied with as instructed. The remaining check dams and earthen dam appear to be stable, and no additional erosion was observed on or adjacent to the haul road.

Photo 28: Looking north at the reclaimed erosional area cited in the Division's 2012 inspection.

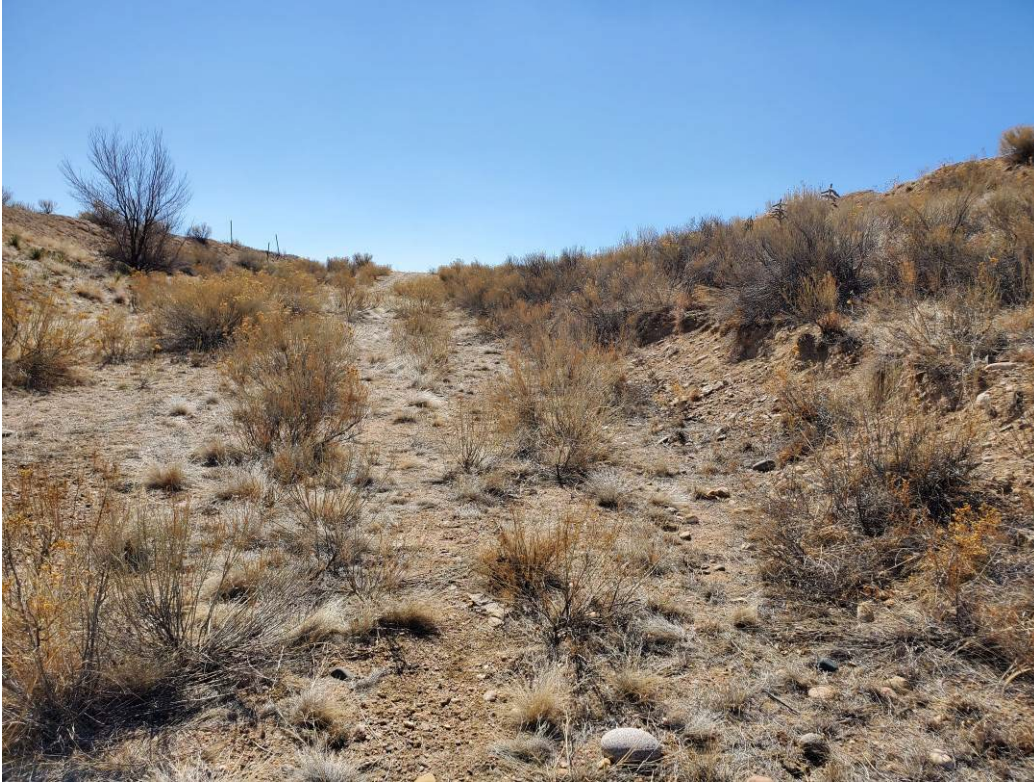
Photo 29: Looking south at the reclaimed erosional area cited in the Division's 2012 inspection.

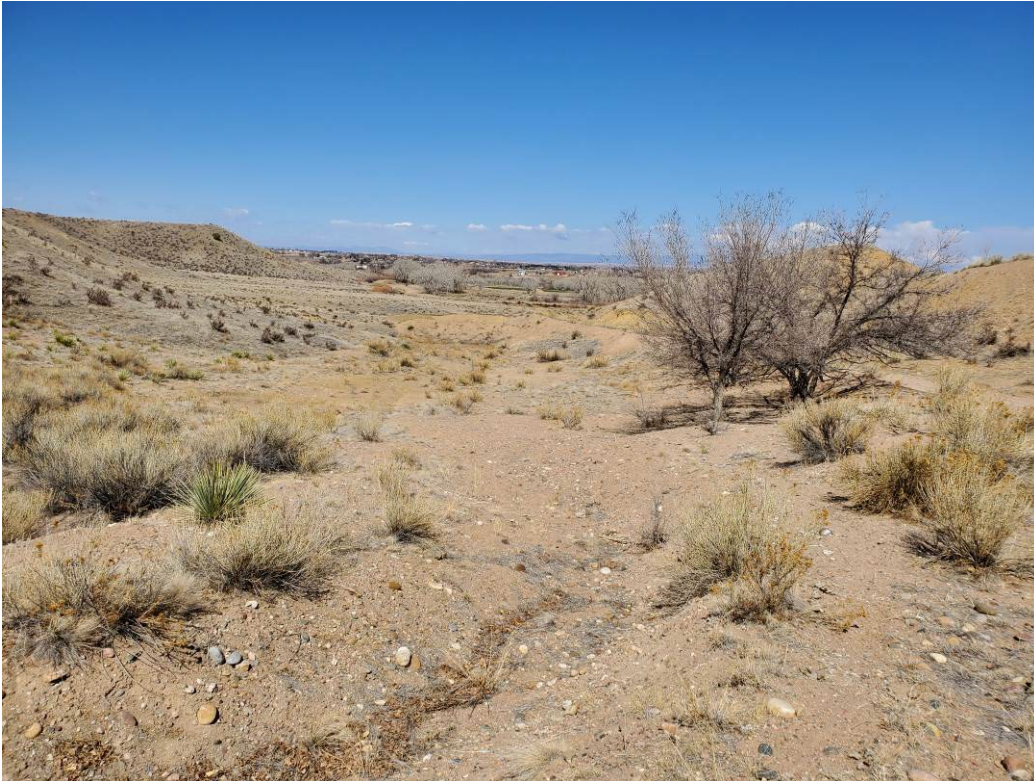
Photo 30: Looking north outside of the permit area to the west of the haul road at the check dams created as a result of an inspection citation during the Division's 2012 inspection.

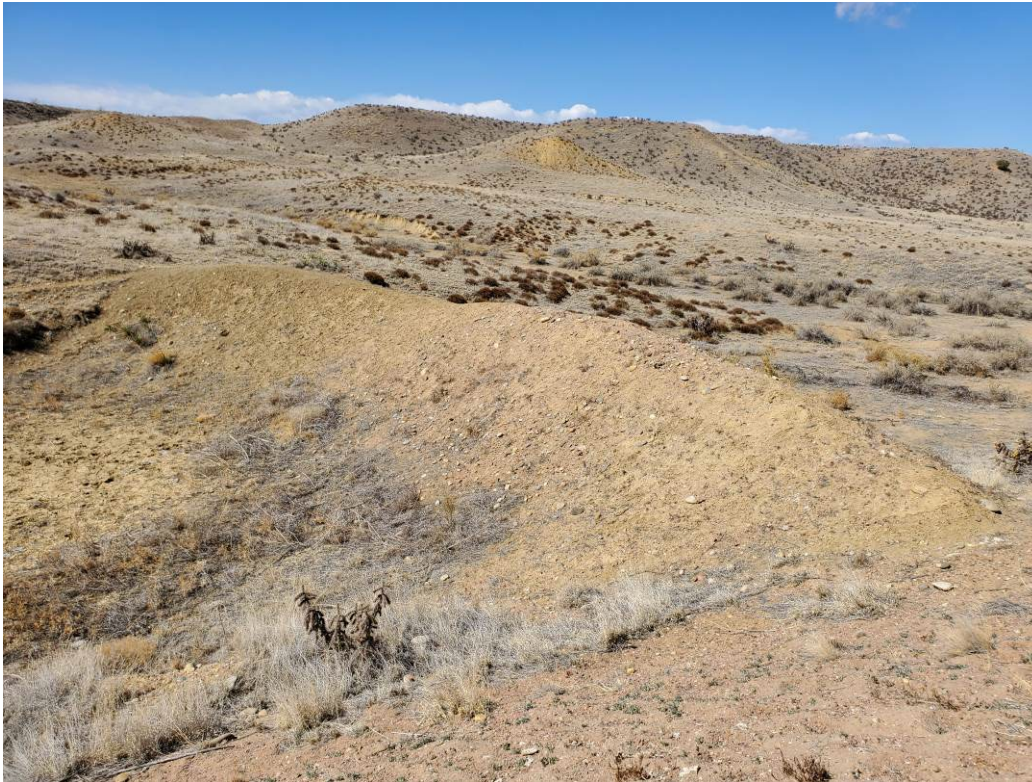
Photo 31: Looking west outside of the permit area to the west of the haul road at the earthen dam located at the extent of the check dams created as a result of an inspection citation during the Division's 2012 inspection.

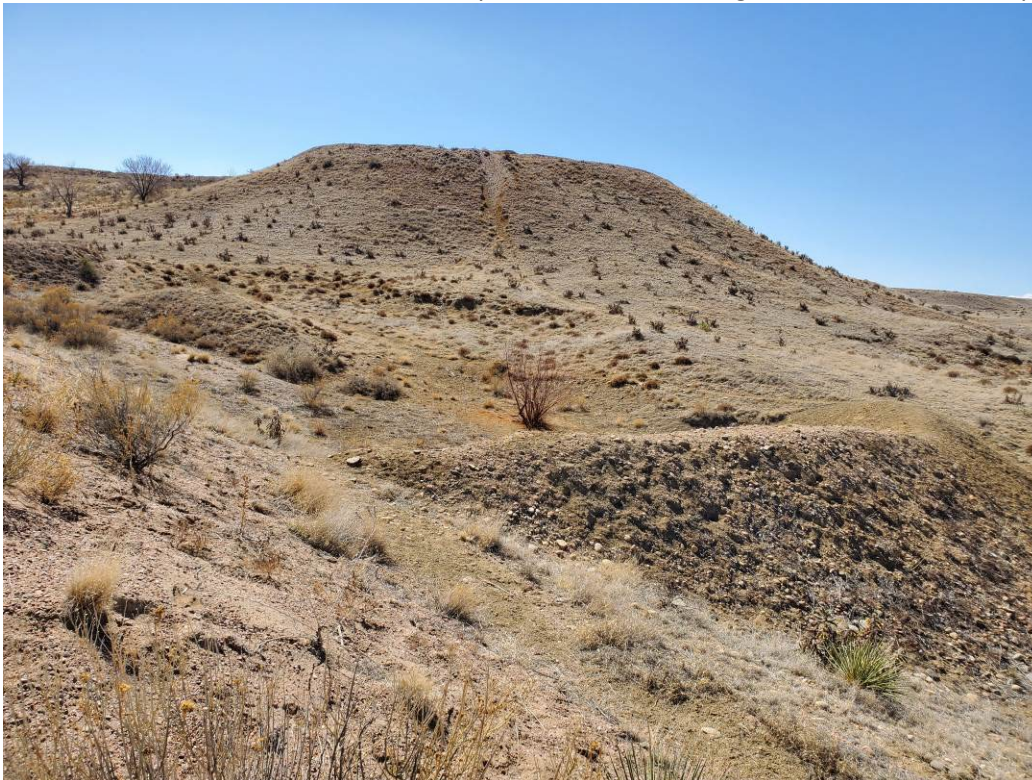
Photo 32: Looking south outside of the permit area to the west of the haul road at the check dams created as a result of an inspection citation during the Division's 2012 inspection.

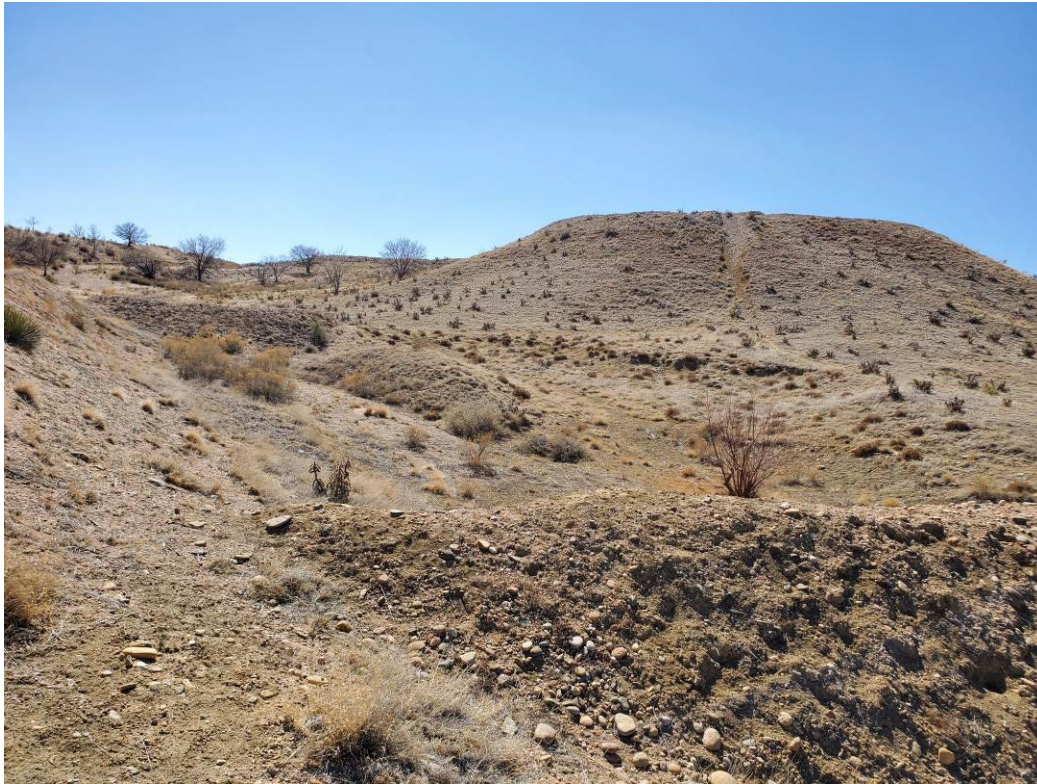
Photo 33: Looking south-east outside of the permit area to the west of the haul road at the check dams created as a result of an inspection citation during the Division's 2012 inspection.

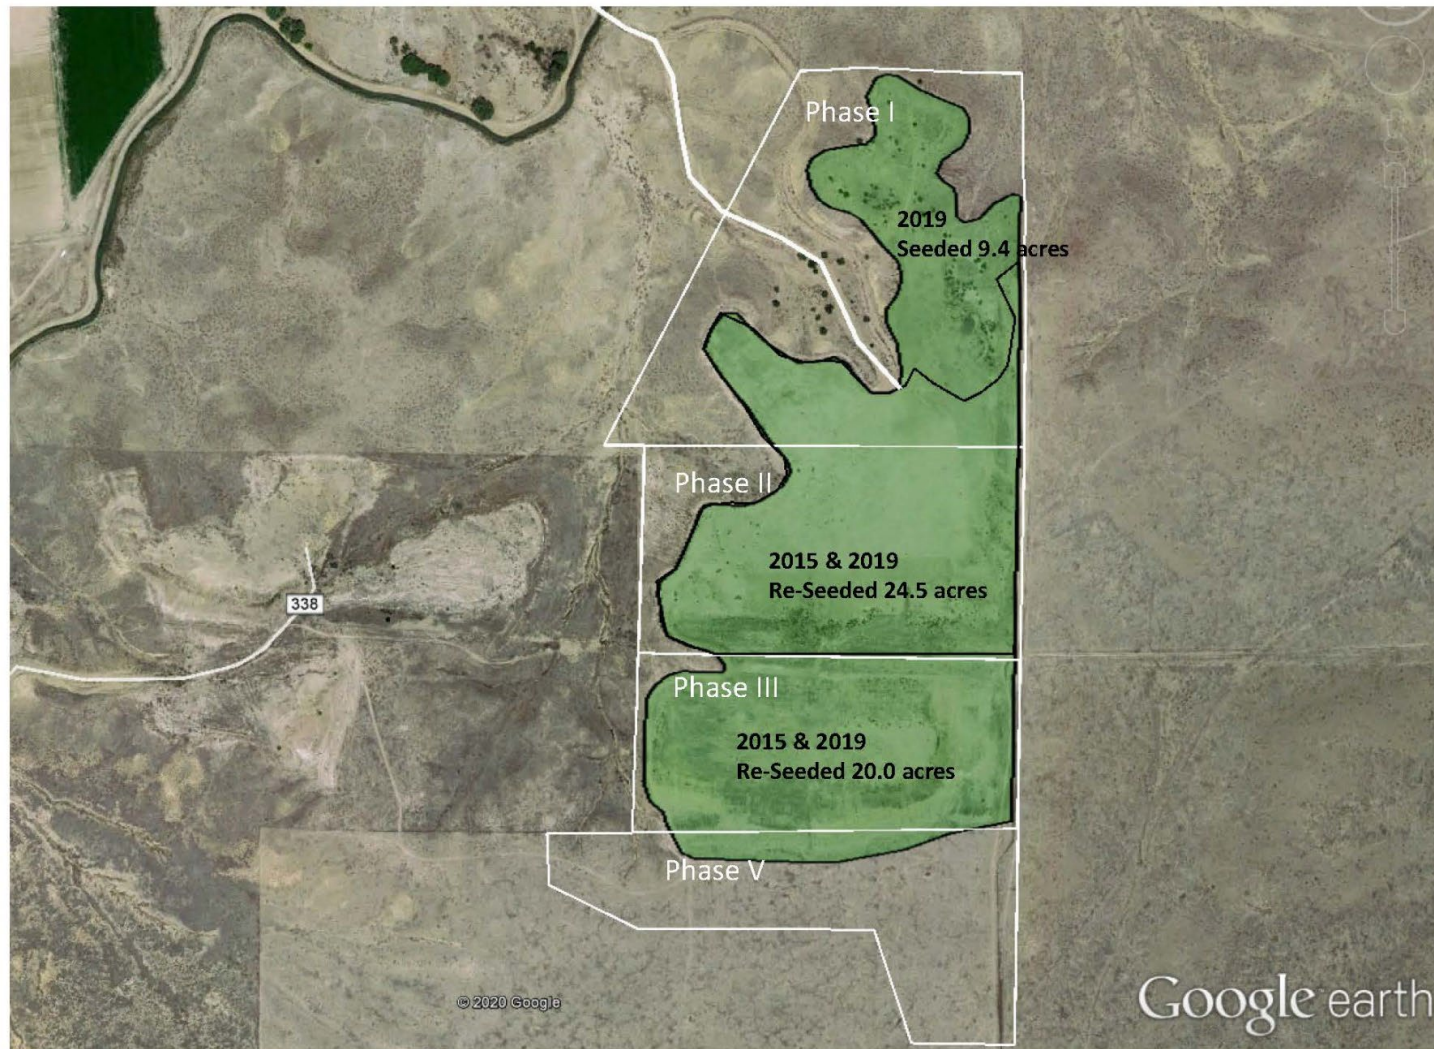
The previously mined areas have been partially to completely reclaimed. The 2022 annual report and report map submitted by the Operator indicate that 53.9 acres have had topsoil replaced and have been seeded (Map 2). However, the report also states that 58.5 acres have been reclaimed to date. When asked about the 4.6 acre discrepancy, the Operator stated that that may be a typo, or that it may be the area along the access road within the permit boundary where check dams were installed, reclaimed, and reseeded. The Operator will need to correct this discrepancy on the next annual report and report map for clarification.

Map 2: Map edited from the Operator's 2022 annual report map used to indicate the reported location of the 53.9 acres of seeded and topsoiled areas. *The Division's edits are the Phase labels.
