Deserado Mine, C-1981-018, April 2023 Partial Inspection Report

Division of Reclamation,
Mining and Safety

Permit Number: C-1981-018 Mine Name: Deserado Mine Operator: Blue Mountain Energy, Inc Operator Address: Mr Kurtis Blunt 3607 County Road 65 Rangely, CO, 81648	County: Moffat, Rio Blanco Operation Type: Underground Permit Status: Active Ownership: Private
	Operator Representative Present: Kurtis Blunt
Operator Representative Signature: (Field Issuance Only)

Inspection Start Date: April 26, 2023 Inspection Start Time: 10:00 Inspection End Date: April 26, 2023 Inspection End Time: 12:00		Inspection Type: Coal Partial Inspection Inspection Reason: Normal I&E Program Weather: Clear	
Joint Inspection Agency: None		Joint Inspection Contacts: None	
Post Inspection Agency: None		Post Inspection Contacts: None	
Inspector(s): Todd Jesse	Inspector's Signature:

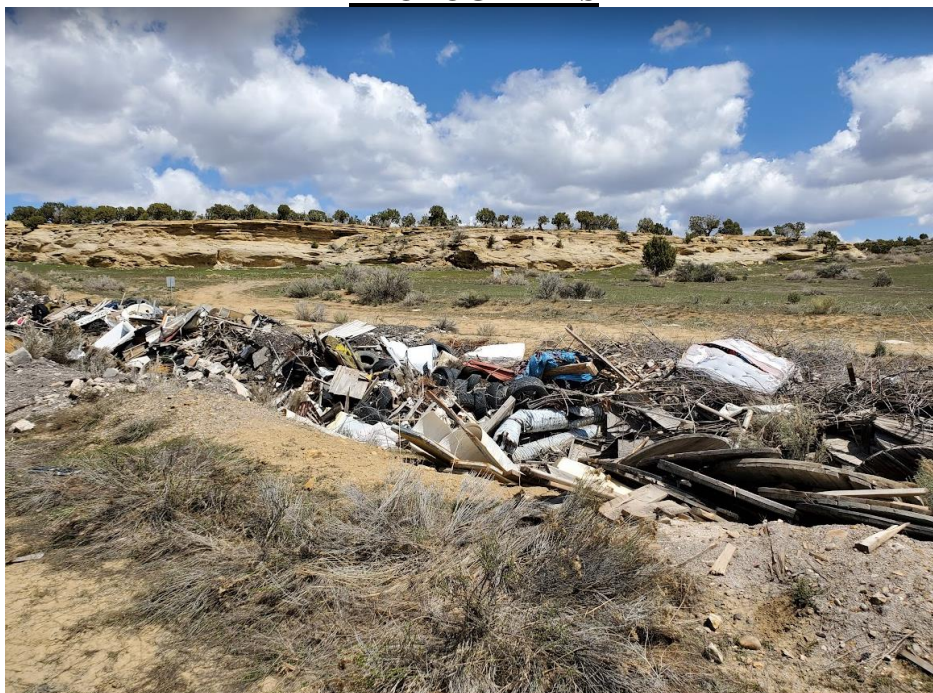
The Halandras Landfill (Photo 1) is located on the west side of County Road 65 (CR-65), north of the main facilities area. **The landfill has a small amount of debris that has blown out of the landfill and has landed in areas adjacent to the pit. Please return debris to the landfill.** There were no indications of offsite impacts or erosional features.

Photo 1: View to the northeast of landfill area. Small amount of trash outside pit.

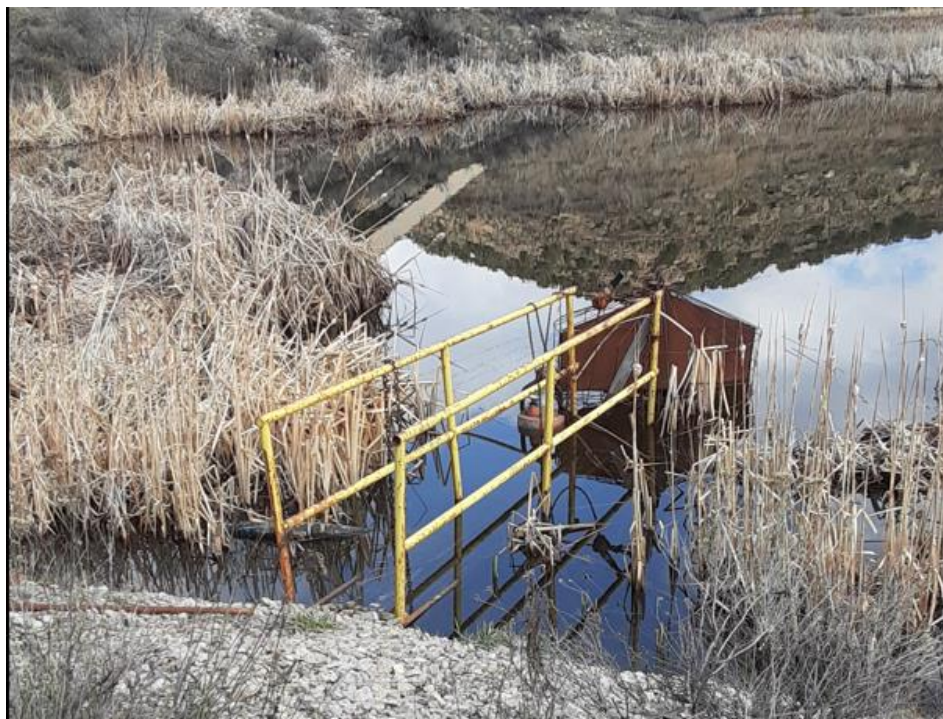
The DP-1 pond and PP-2 pond are both within the facilities area of the mine site. DP-1 was discharging water (Photo 2). The embankments of the pond were covered with vegetation and there were no indications of instability or erosion. The outfall was free of obstructions. PP-2 (photo 3) was holding water during the inspection. No discharge was observed at PP-2. The embankment was stable with no erosional concerns identified.

Photo 2: View to the northwest of Pond DP-1 outlet discharging.

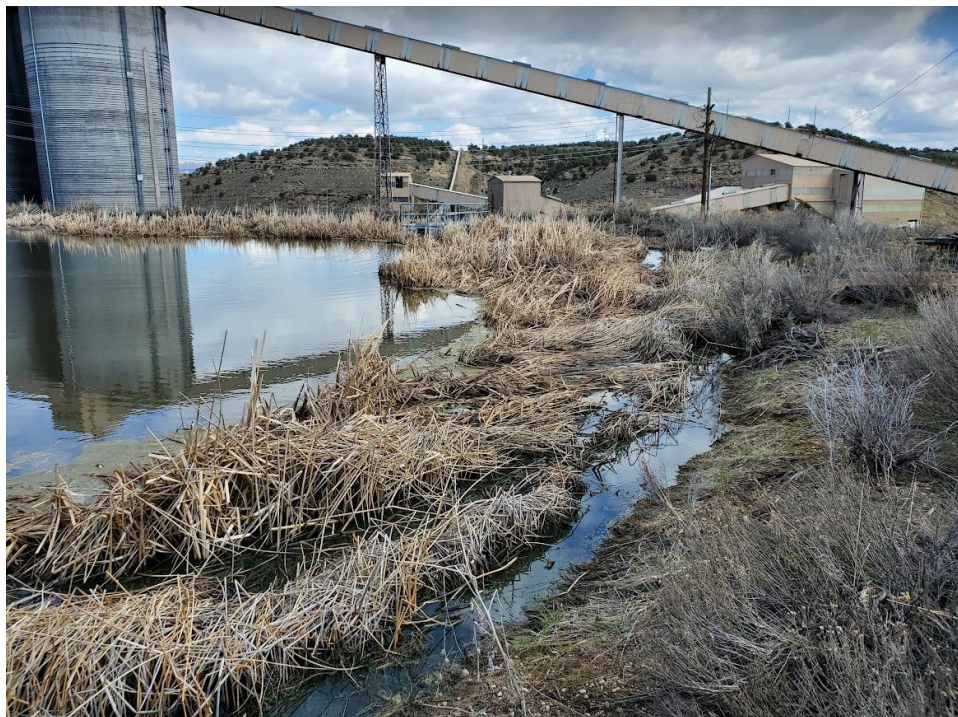
Photo 3: View to the north of PP-2 embankment.

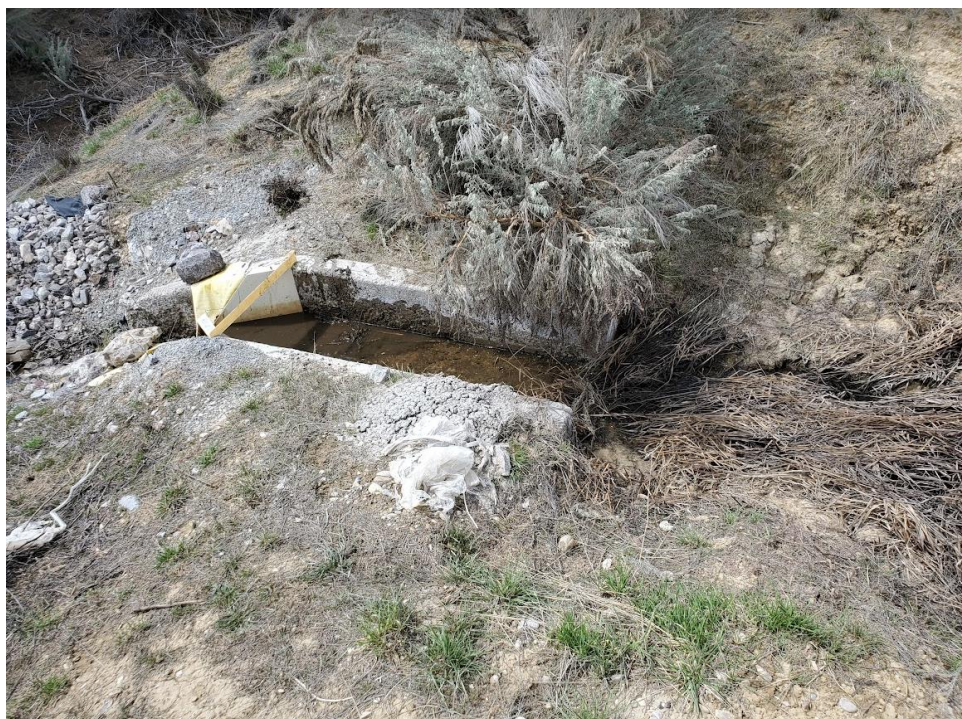
The Last Chance Pond (Photo 4) is part of the dewatering system that allows miners to work underground. The pond is part of a passive water treatment system that improves water quality before it is discharged into the environment. At the time of the inspection the pond was discharging water. The embankment of the pond is stable with no burrows or erosional concerns.

Photo 4: Last Chance Pond discharge

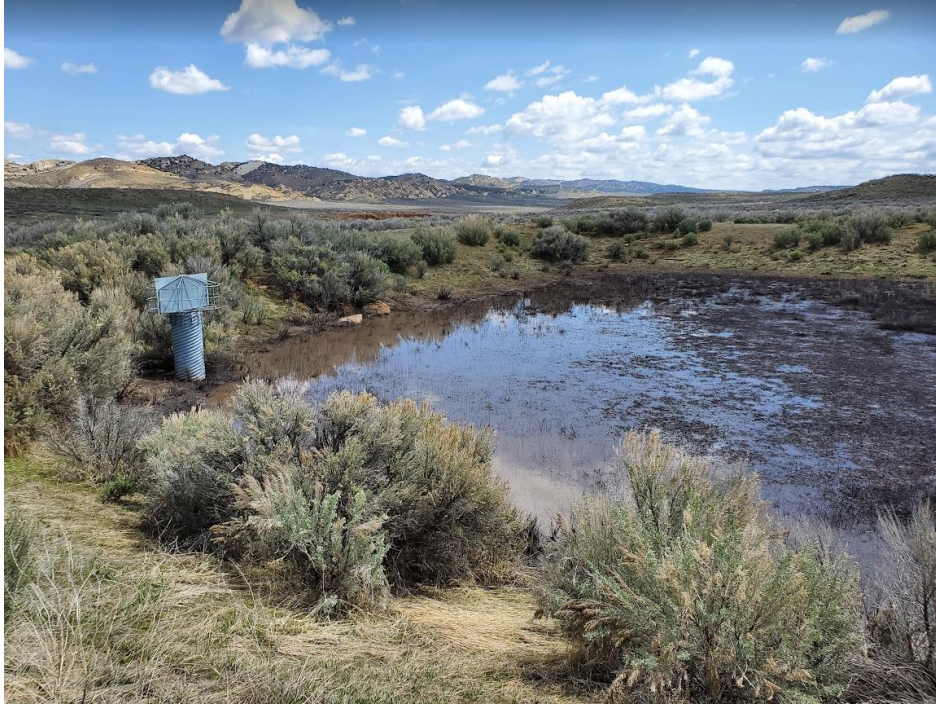
Ponds RP1, RP2/3, RP4, and RP5 are located in the refuse pile area of the permit. RP1 (Photo 5), RP2/3, RP4, and RP5 are all holding water, but no discharge was observed at any of these ponds. The embankments of these ponds are vegetated. No erosion, slumping or animal burrows were observed at any of the refuse pile ponds. However, there were a number of frogs in RP2/3.

Photo 5: Pond RP1 with water. View to the east

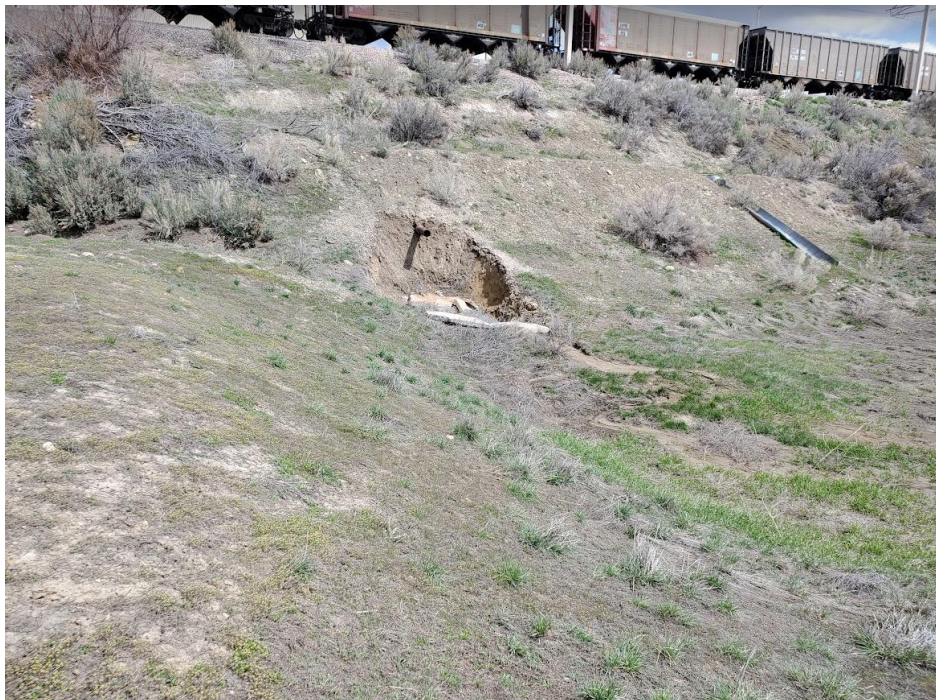
The Rail Loop Sump and Pond are part of the hydrologic controls around the rail loop area. The sump was not holding water, but a small amount of water was seen dripping in and filtering into the ground. No erosion concerns were identified at the sump. The Rail Loop Pond (Photo 6) was not holding water. Signs of erosion are found along the northern embankment of the pond, but when compared to photos of previous inspections the erosional scar does seem stable and has not increased in size.

Photo 6: Erosion scar on Rail Loop Pond. View to the north.

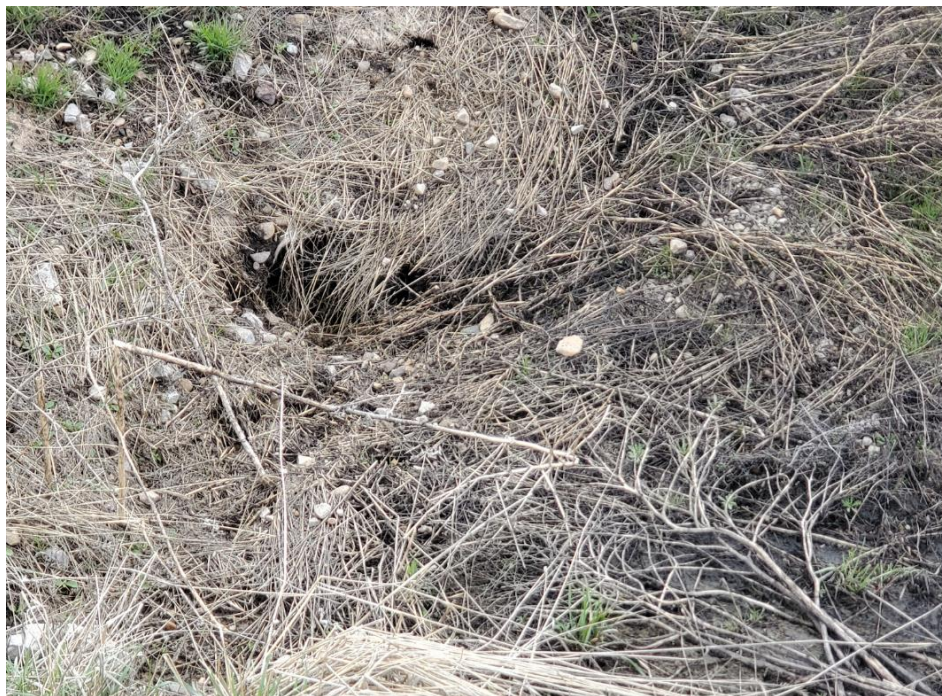
There are a couple culverts in the slot storage area and around the nitrogen plants. These culverts were observed to be partially filled with sediment. The culvert near the Nitrogen Plant (Photo 7) is especially clogged. **Please clean out the culverts and associated ditches or excess sediment. The current ground conditions were too soft to complete these items. The operator has the culverts on the list of items that require maintenance when ground conditions allow.**

Photo 7: Plugged culvert near the Nitrogen Plant. View to the northeast

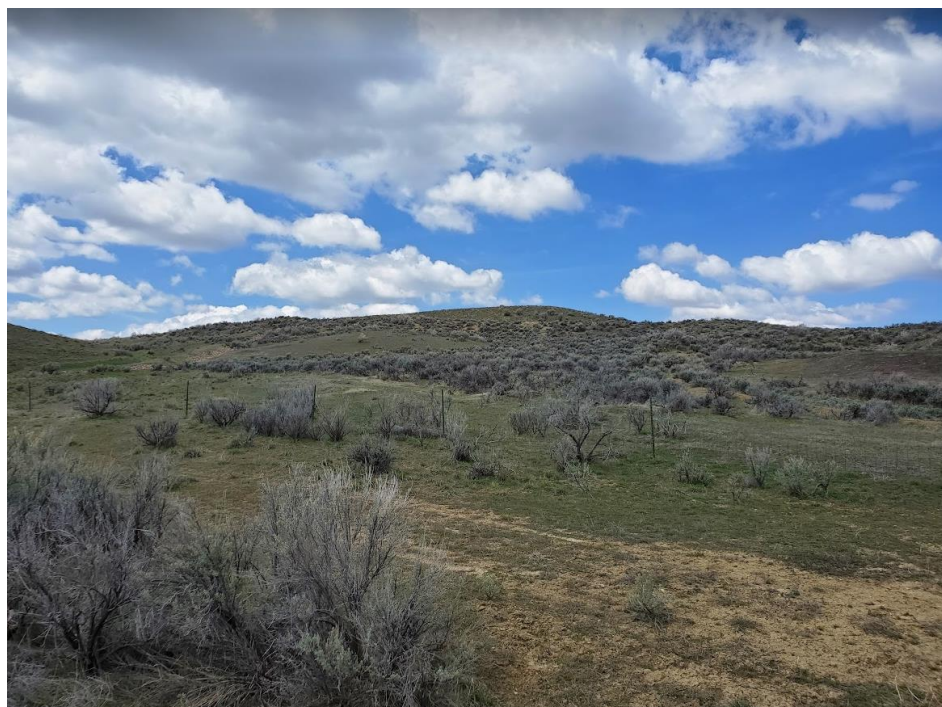
Refuse Pile RP-1 (Photo 8) has stable banks and no signs of erosion or slumping. Vegetation is well established and blends with surrounding undisturbed areas. Diversion ditches around the refuse pile are free of obstructions and convey water. The slopes of the pile appear stable with no erosional concerns identified.

Photo 8: Refuse Pile RP1. View to the southwest

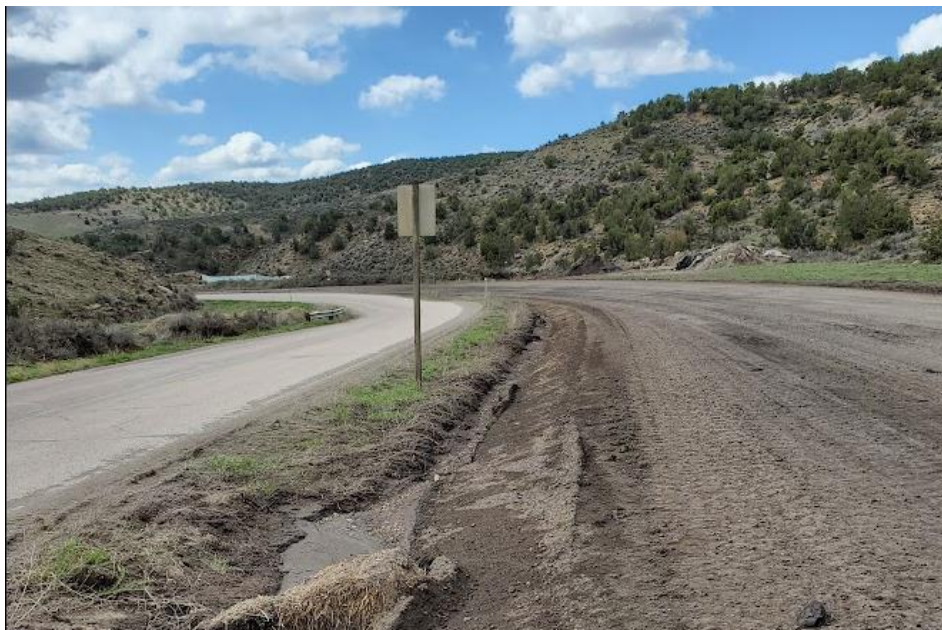
The haul road at the Deserado Mine was well maintained and dry. The road was stable with no erosional concerns. However, portions of the ditch are not completely dried after the snowmelt and recent rainstorms. Crews have begun to blade the road and ditch as part of the spring site cleanup in some areas (Photo 9). In other areas, the ditches are too soft and equipment sinks in the mud. As conditions continue to dry out the surface crews will continue to clean ditches and replace bales as needed.

Photo 9: View to the south. Ditch that has been pulled along haul road

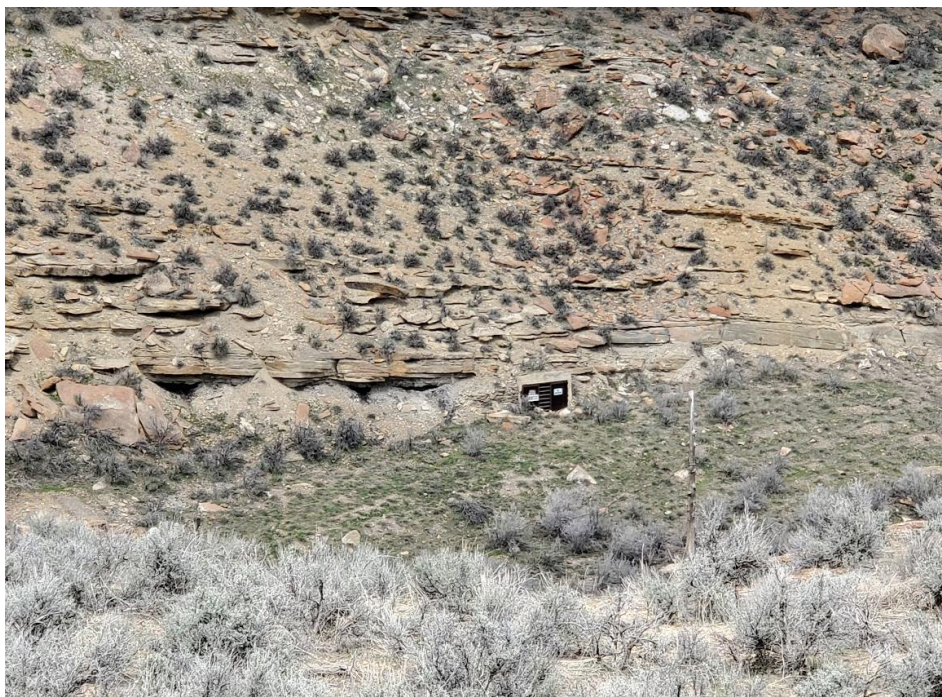
The Stanley Gordon Portals (Photo 10) are secured with a bat gate. Warning signs are attached to the gate to discourage unauthorized entry. Vegetation is well established and blends with surrounding vegetation. No signs of erosion or slumping was observed.

Photo 10: View to the north of the Stanley Gordon Portal reclamation.

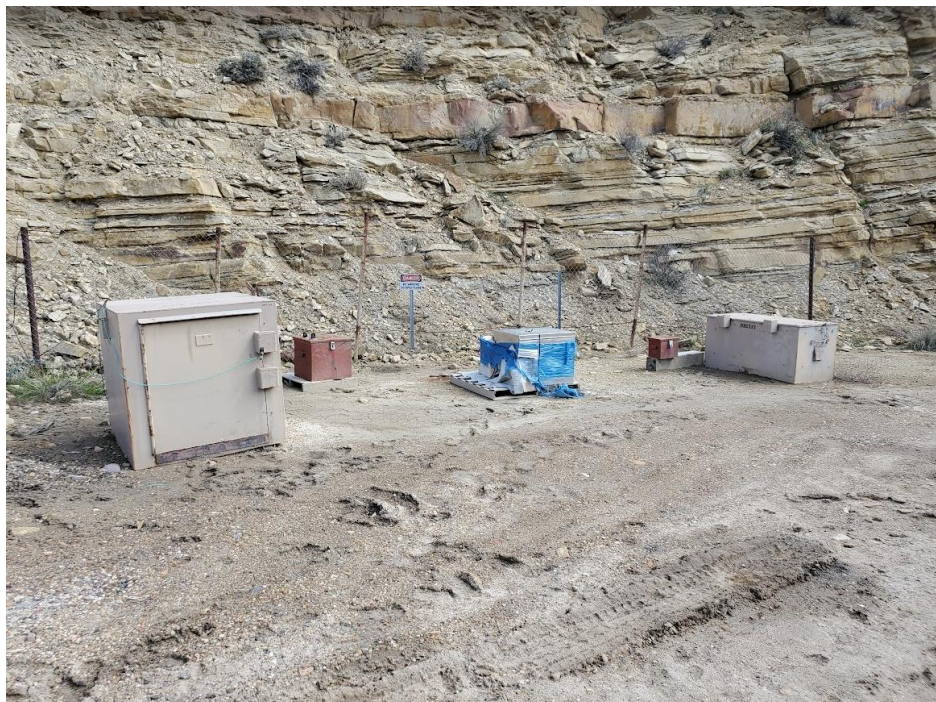
Photo 11: View to the northeast of Explosives Pad

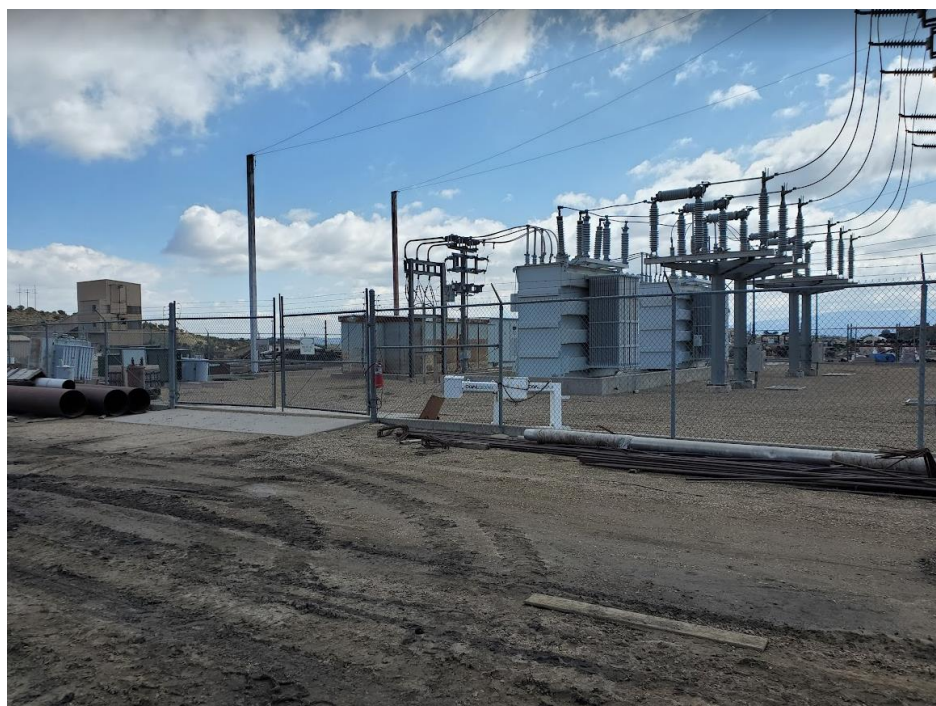
Photo 12: View to the east of electric substation.

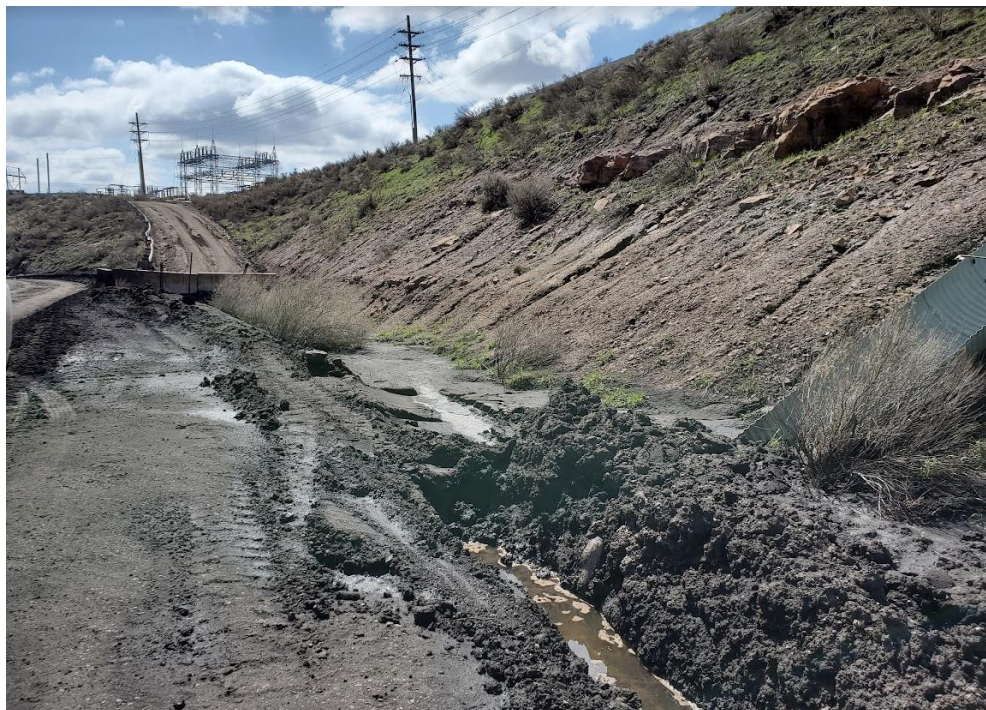
as the snow melts. The Explosives Pad (Photo 11) has good housekeeping. No signs of erosion or settling on the pad. The Electric Substation (Photo 12) on the top bench of the portal facilities has good housekeeping. The electric area is secured with fencing that has warning signs. There is also a fire extinguisher that is readily accessible. Electric equipment appears in good working order and there are no indications of erosion. The roads to access the benches in the support facility are in good condition, but **some ditches (Photo 13) are partly filled in with sediment. Please clean facility/portals area ditches when ground conditions allow.**

Photo 13: View to the southeast of ditch in facility area. Crews attempted to pull the ditch and sunk in the mud.

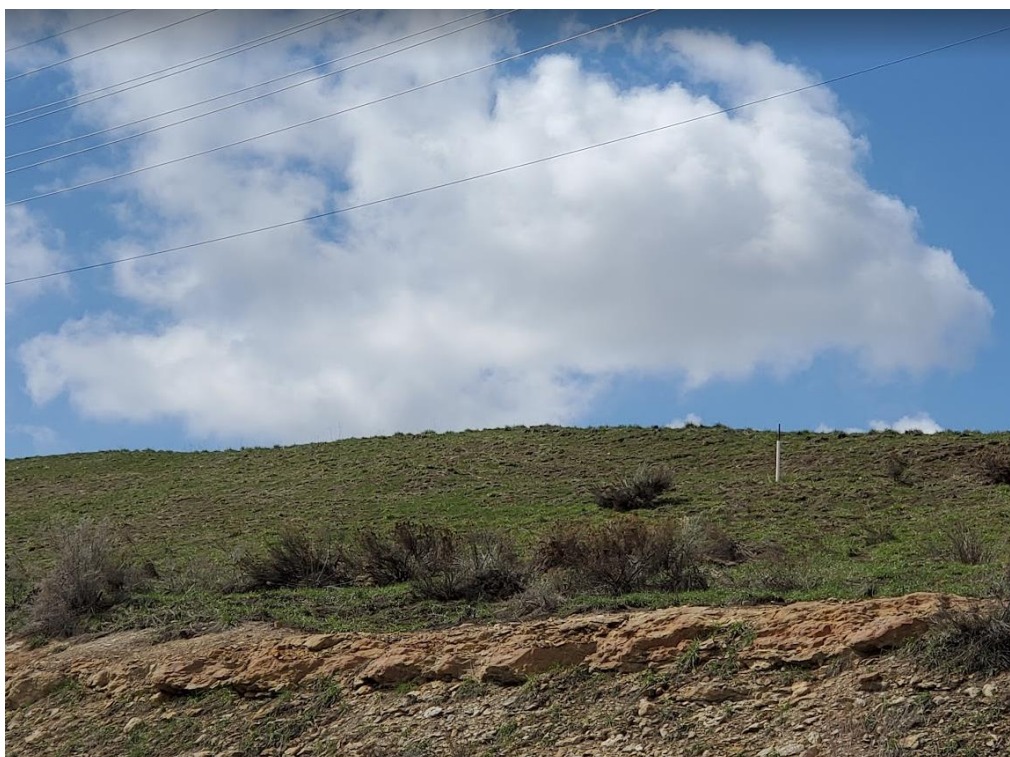
The D Portal topsoil pile (Photo 14) is located in the main facilities area. A topsoil marker was seen on top of the pile. The topsoil pile marker was a T-post covered with white PVC. The topsoil pile was covered in established vegetation. There were no indications of erosion or instability observed on the stockpile.

Photo 14: View to the south of the D Portal Topsoil Pile.
