Inspection Report, Foidel Creek Mine, C-1982-056

PERMIT INFORMATION

INSPECTION INFORMATION

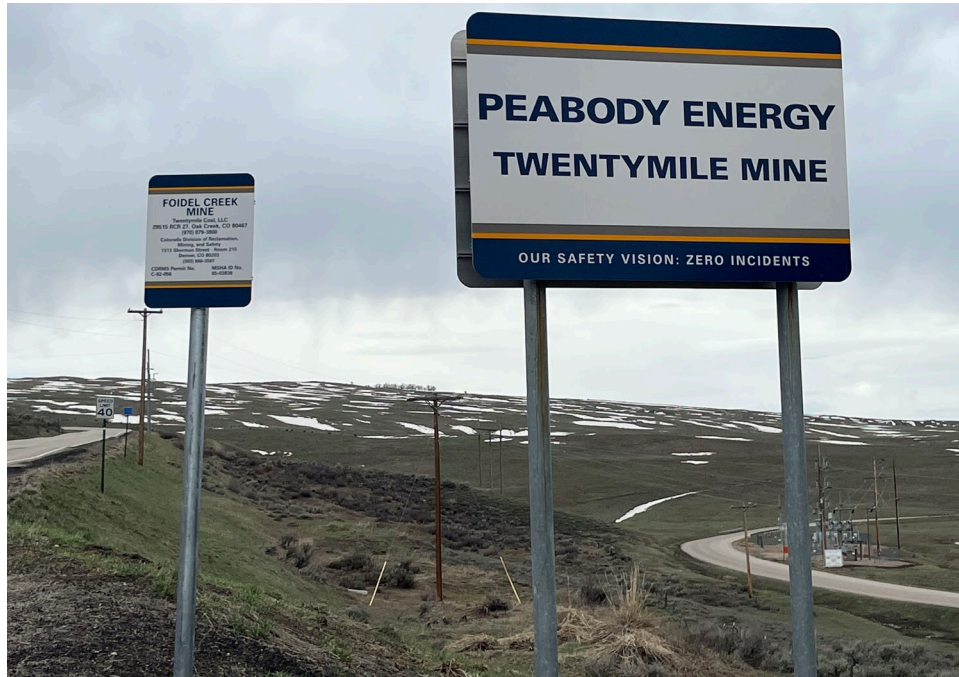
Mine identification markers were observed throughout the site (Photo 1). All information for compliance was present. The missing phone number information on mine signs for HG Loadout and Peabody Sage Creek Mine (see related inspection reports dated March 30, 2023, April 25, 2023 and May 2, 2023) was discussed with the TC representative. **Please update the division when signage has been appropriately amended.**

Photo 1: Mine sign posted at site entrance.

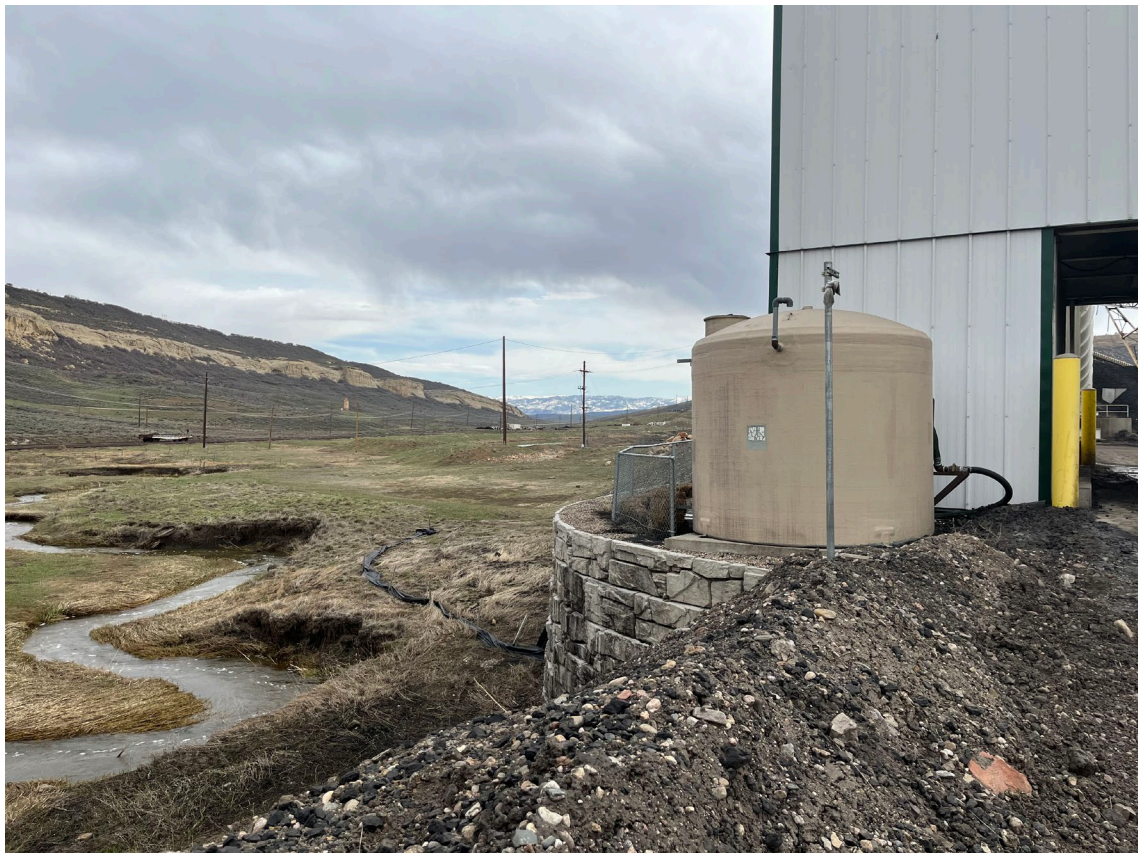
Photo 2: View NE of the back of the stoker coal loadout facility, Foidel Creek is directly below. A silt fence has been installed to protect Foidel Creek from sediment / runoff from this building.

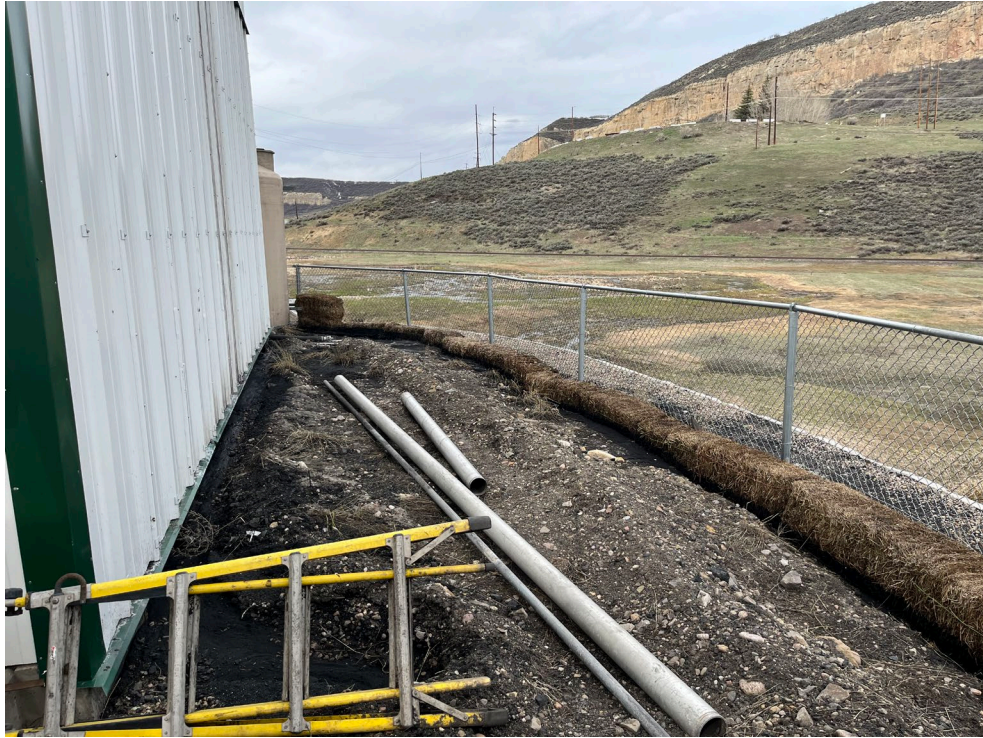
A partial function of the stoker coal loadout facility is washing coal product. Last Fall, DMRS noted that this wash plant facility was leaking water behind the building (Photo 5). The building is scheduled for sealing in the spring of this year. In the meantime, the Operator has been using straw bales (Photo 3) and a silt fence (Photo 2 and 4) behind the building to protect Foidel Creek from drainage and sediment from this facility. Currently, water is being pumped from the flooded building to a small pump house to the northeast, where it is eventually discharged

Photo 3: View S, behind stoker coal loadout building which shows the straw bales put in place to slow the drainage of water from the stoker loadout building to Foidel Creek below.

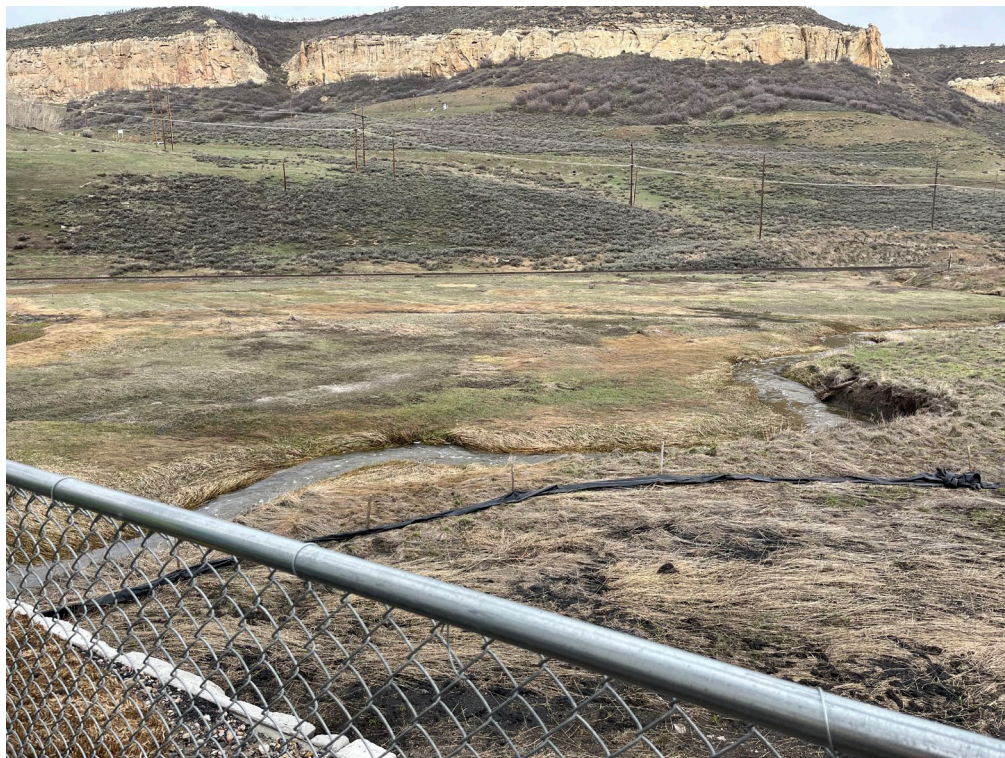
Photo 4: A silt fence is installed below the stoker loadout building.

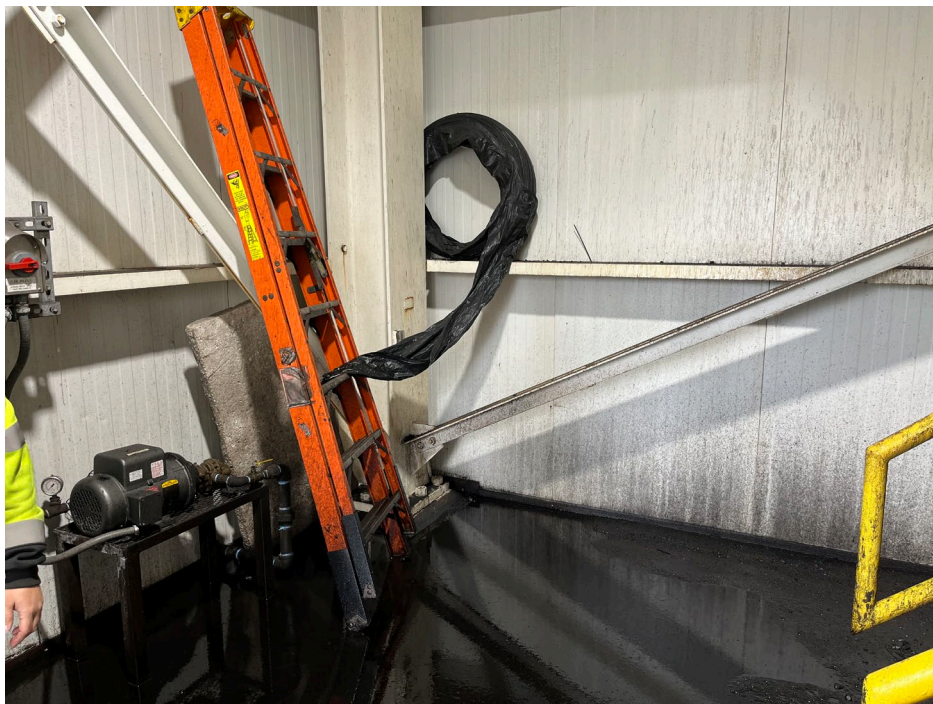
to Pond E. This pump house is heated so as to avoid winter freezing issues. After sealing the building, water will continue to report to Pond E through this pump system.

Photo 3: Inside of the stoker loadout facility, building will be sealed in the spring season to prevent seepage. Facility drainage will be directed to the adjacent pump house.

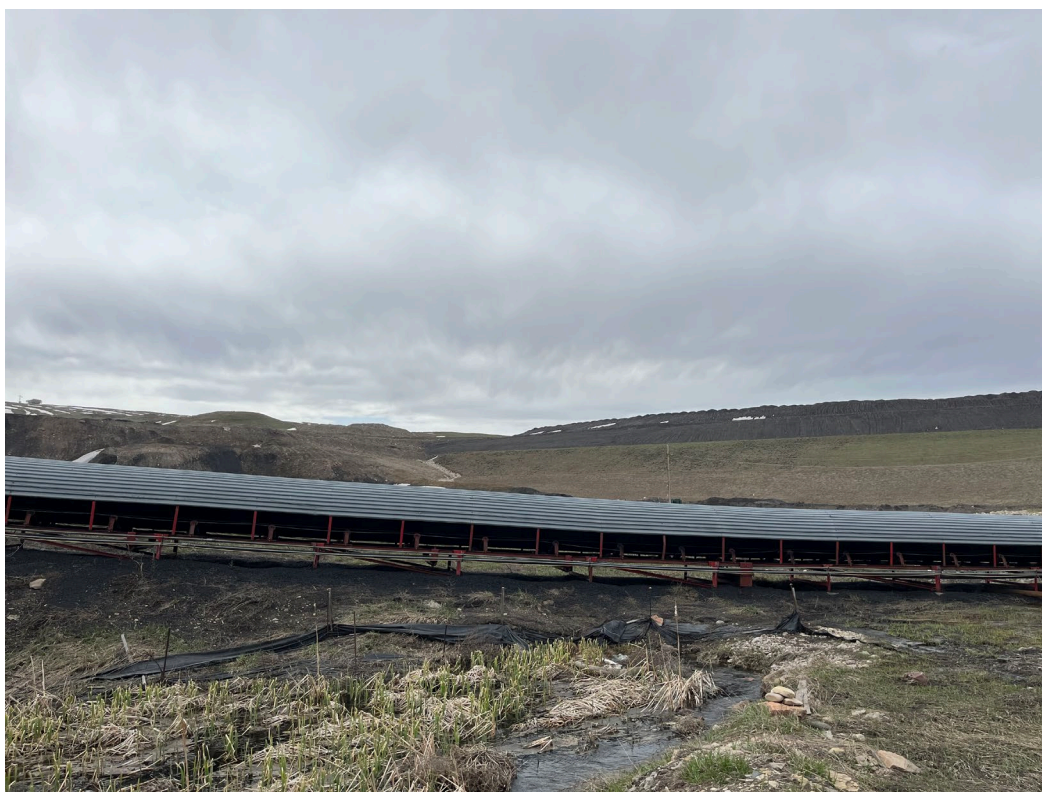
Photo 4: View SE of conveyor, refuse pile, and Pond D discharge point.

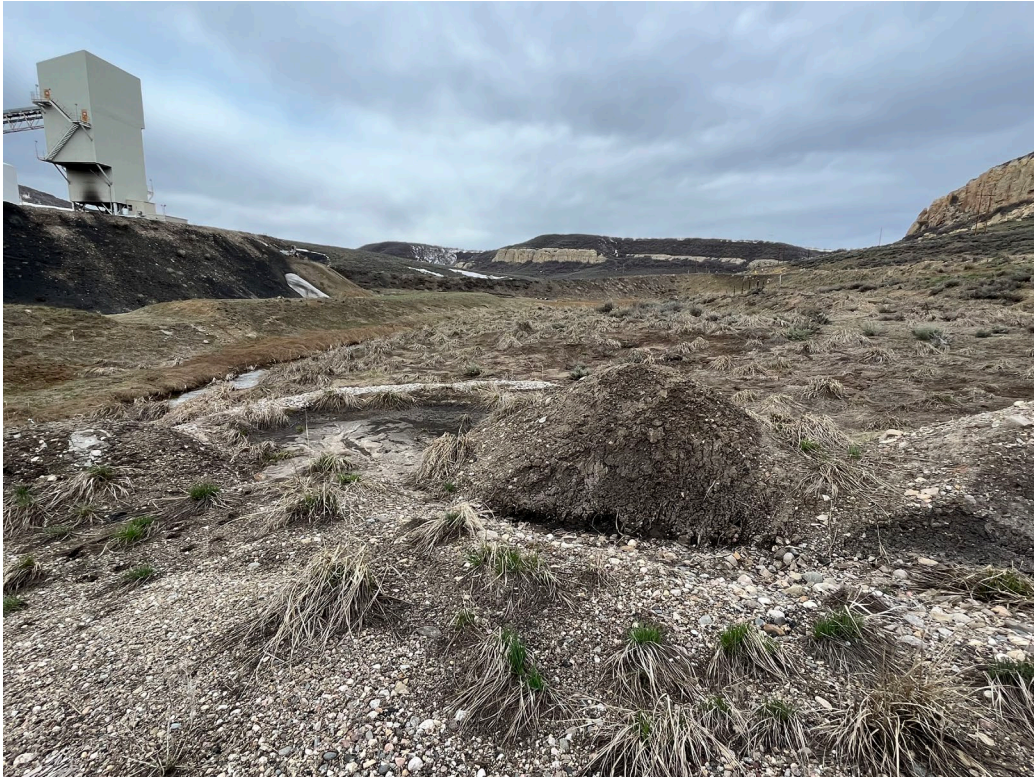
All ponds across the site are scheduled for cleanup in response to the heavy flood events seen in recent weeks. Photo 7 shows a designed ‘sump’ feature, located above Pond B which acts as a preliminary catchment for sediment before it enters its assigned pond. There are several other ‘sump’ areas around the site.

Photo 5: View SW of designed 'sump' feature, located near Pond B

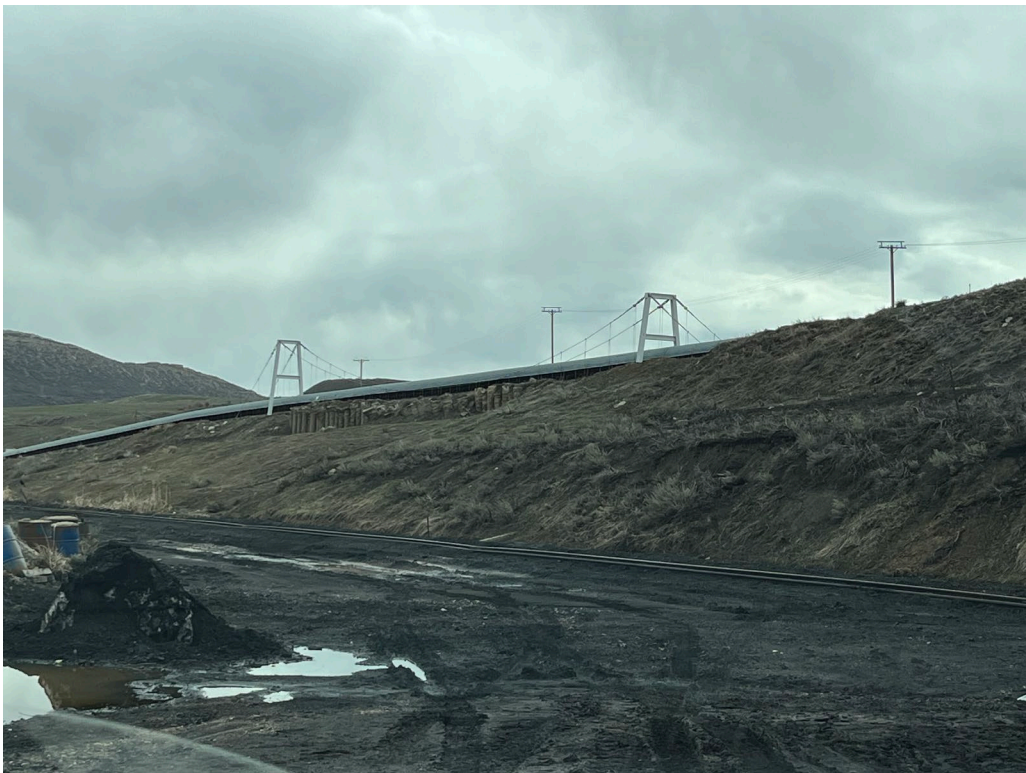
Eroded out pylons are seen under the conveyor system to the south of the train loadout (Photo 8). Shallow bedrock in the area is prone to slippage and erosion. MR317 addressed this issue in 2020 by constructing a suspension bridge for 200 feet of the overland conveyor system in this area.

Photo 6: View E of pylon structures and suspended conveyor

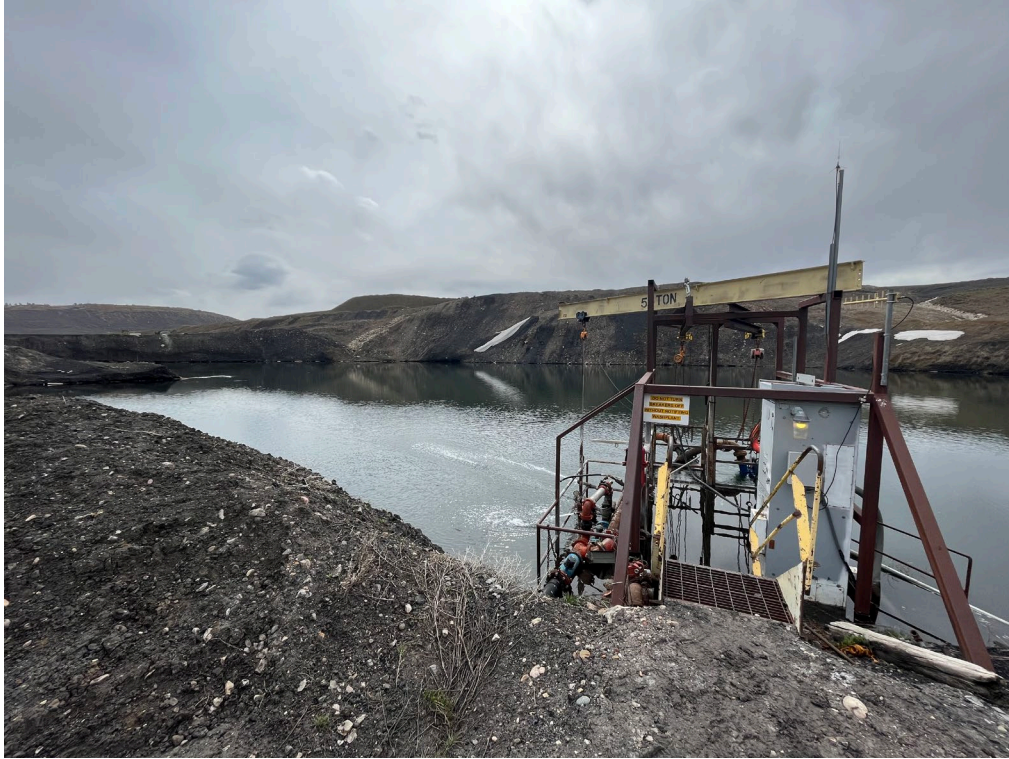
Photo 7: View E of Pit Pond, adjacent to Pond D, discharging at the time of inspection

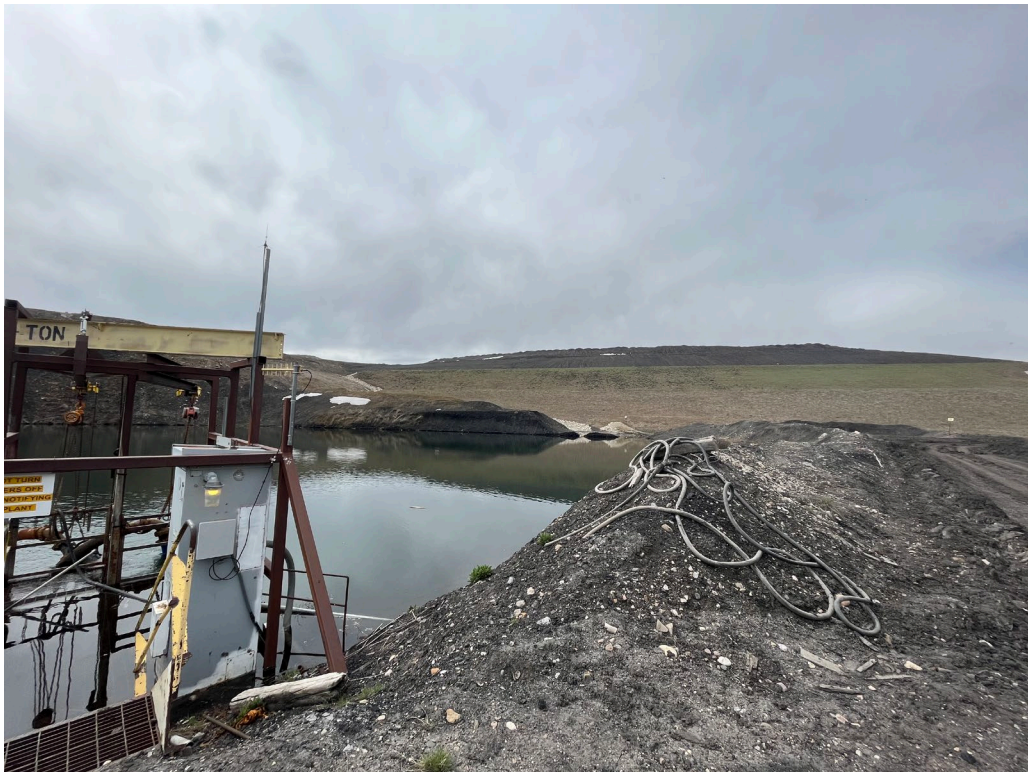
Photo 8: View S of refuse pile, drainage reports to Pond D

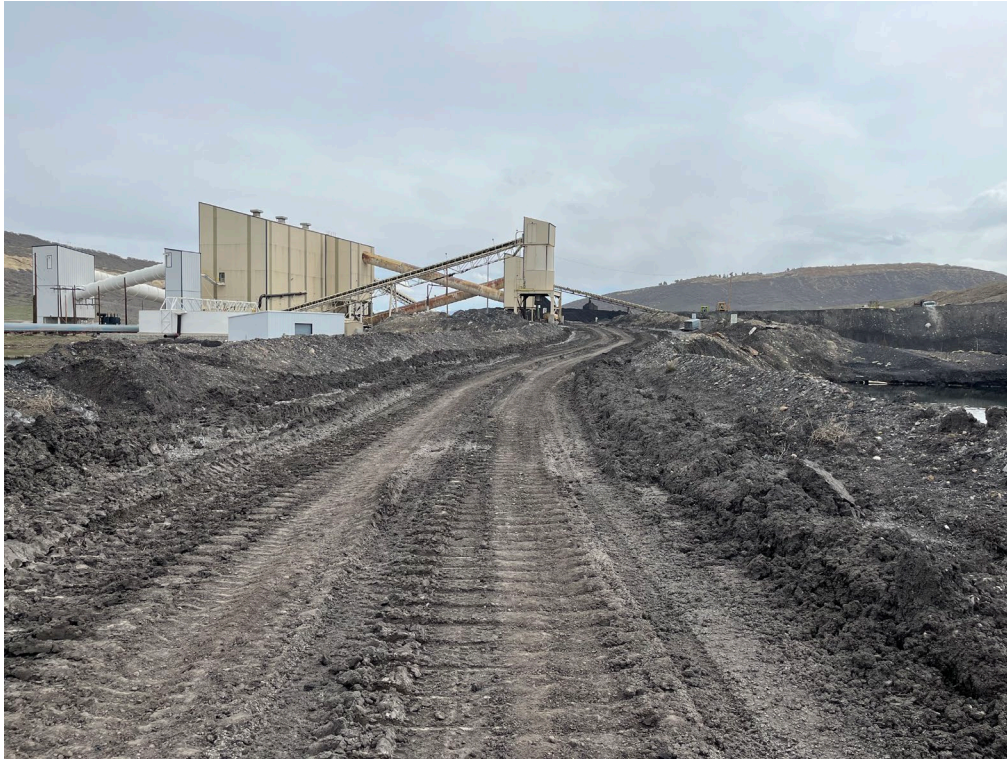
Within the main surface facilities area, Pond D, the Pit Pond (Photos 9 and 10), and Pond G are currently discharging (Photo 13). Due to recent heavy snowmelt, Pond D is nearly consumed by runoff, as opposed to its main use for mine water. Drainage from the refuse pile also reports to Pond D (Photo 6). The roads in this area are scheduled to be regraded once conditions have dried out from spring snowmelt and flooding (Photo 11). Berms in this area are still in place and functioning properly, but will also receive maintenance once conditions dry out.

Photo 9: View N of road between Pit Pond and Pond D, will be regraded once conditions dry out

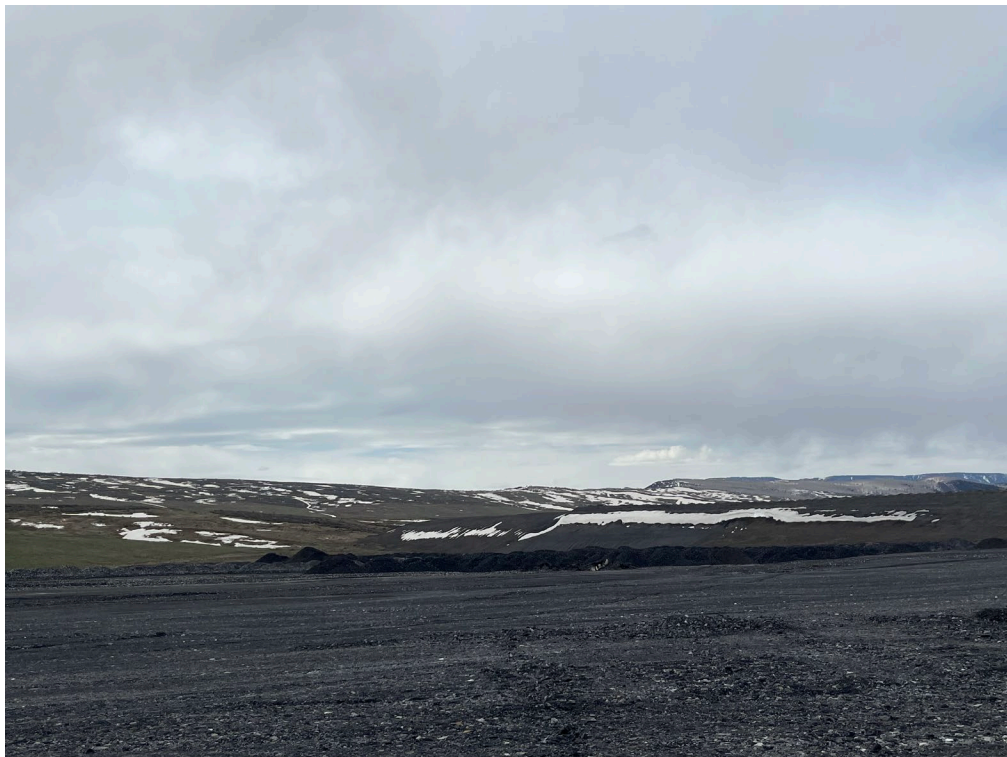
Compaction of refuse material piled throughout the winter is set to begin in the upcoming weeks. Drainage is functioning properly in this area with no standing water atop the pit (Photo 12).

Photo 12: View S of refuse pile, currently working on 3rd and 4th lift, over burden pile used to reclaim refuse area is located to the east.

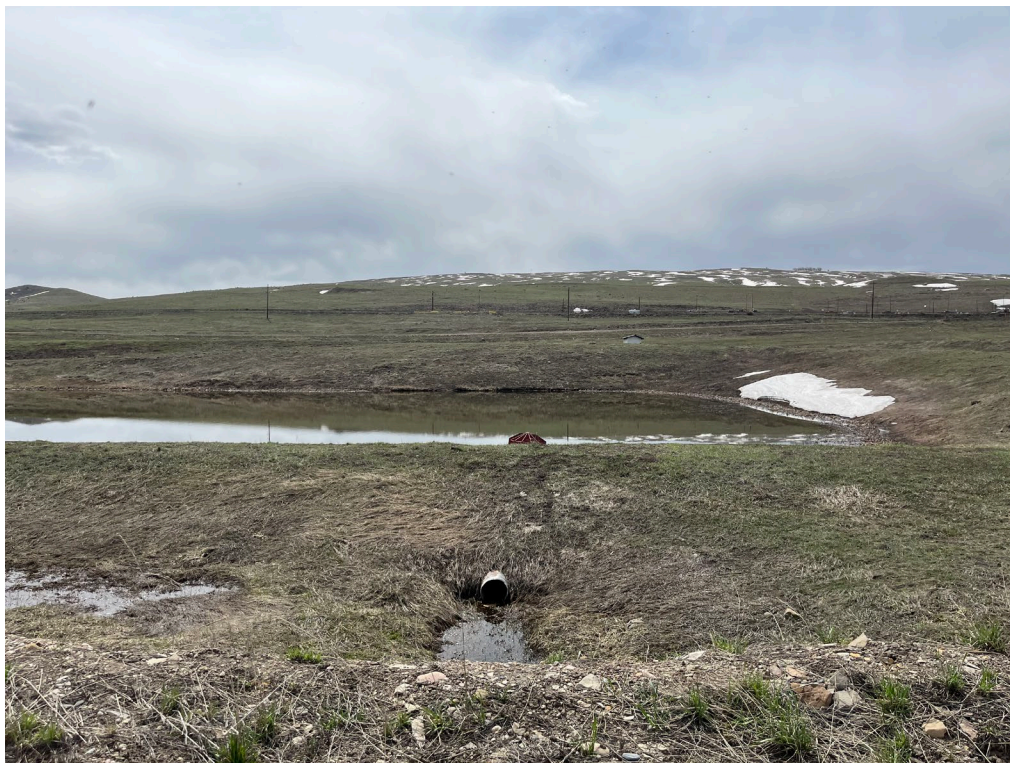
Photo 13: View E, Pond G, discharging, culvert is clean and functioning properly

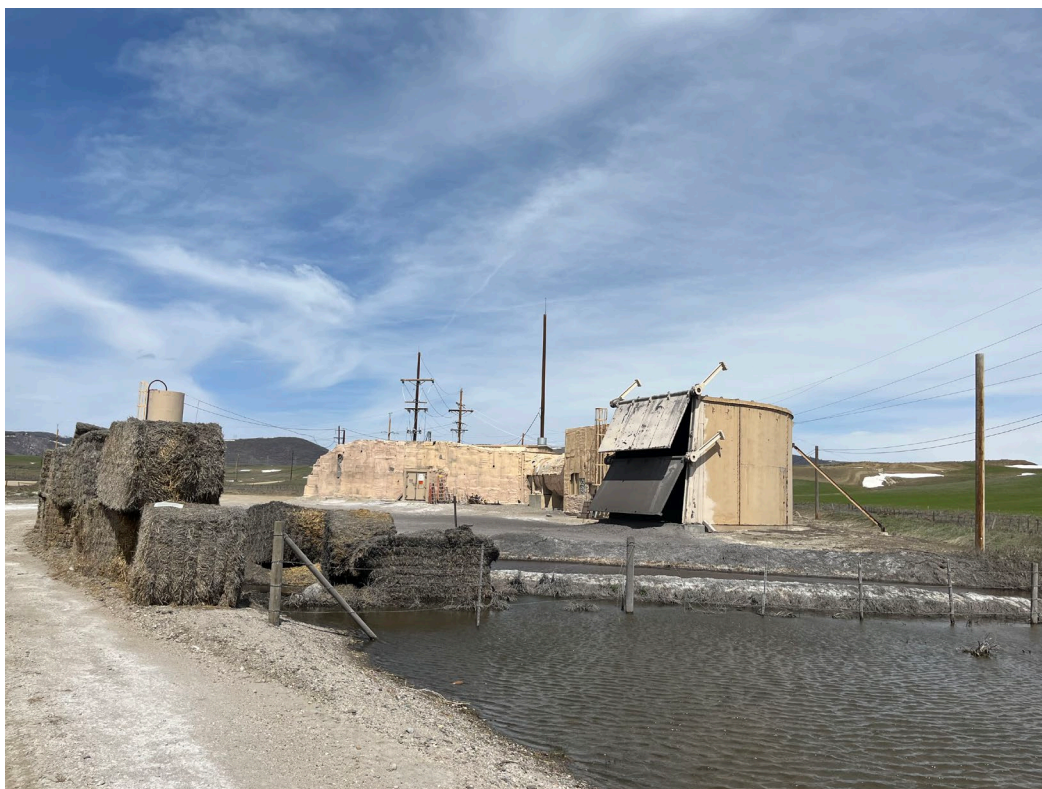
Wetlands in the 6MN area were not accessible due to muddy conditions, however the main facilities in this area were accessible (Photo 16). The sediment pond in this area was functioning properly (Photo 15). Water from this sediment pond reports to the million gallon tank and is used for dust control measures underground. The 6MN area experienced heavy flooding in recent weeks. The Operator stated that emergency repairs were done to the 6MN access road as a result. Once flooding subsides, construction of the new road approved by MR322 will begin in this area (Photo 14).

Figure 14: View N of 6MN ventilation area, MR322 road will be rerouted here when flooding subsides

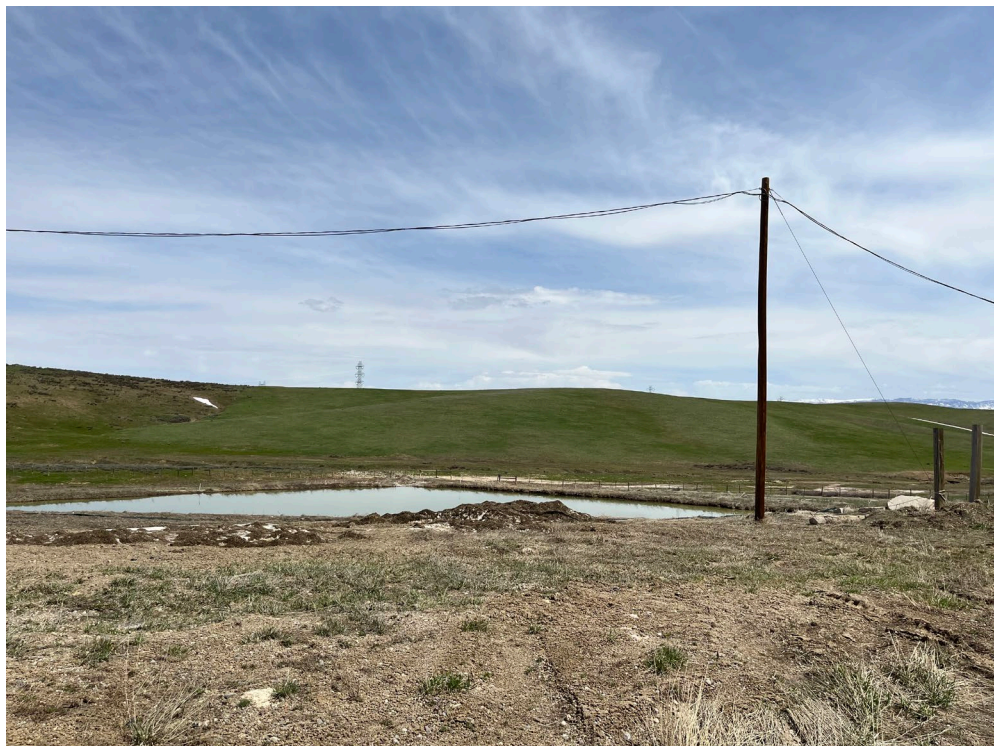
Figure 15: View N of 6MN sediment pond

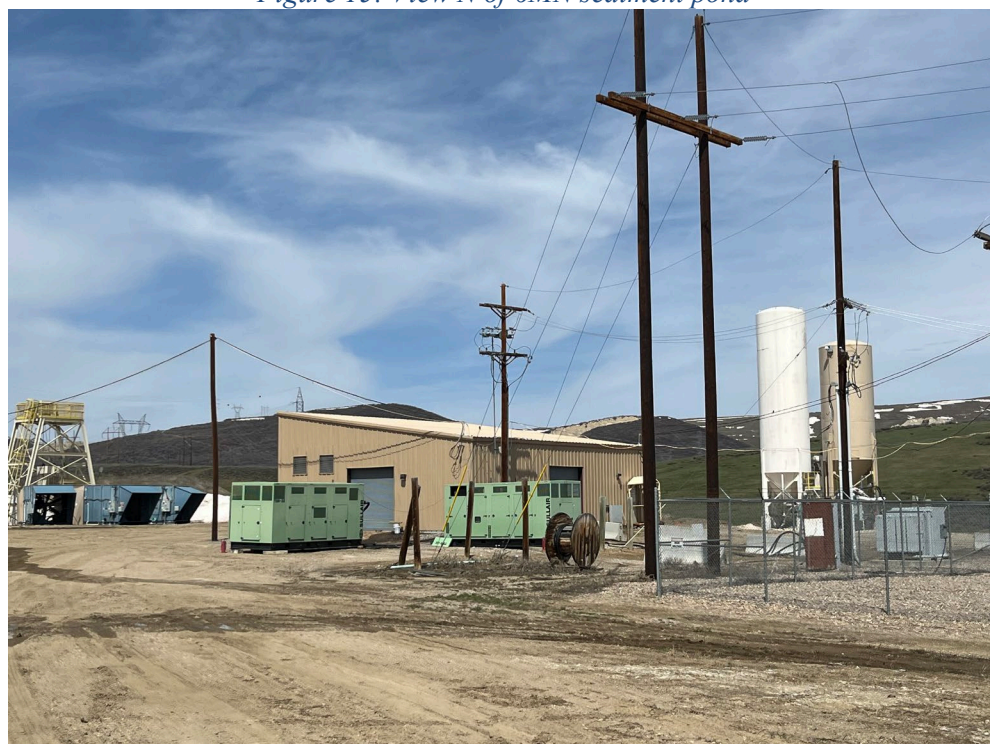
Figure 16: View N of 6MN facilities including 6MN intake shaft, emergency escape, rock dust containment, and electrical substation
