### MINERALS PROGRAM INSPECTION REPORT

<b>MINE NAME:</b> Brownstone Quarry	<b>MINE/PROSPECTING ID#:</b> M-1997-065	<b>MINERAL:</b> Dimension stone	<b>COUNTY:</b> Larimer
<b>INSPECTION TYPE:</b> Monitoring	<b>WEATHER:</b> Clear	<b>INSP. DATE:</b> April 27, 2023	<b>INSP. TIME:</b> 09:30
<b>OPERATOR:</b> LJS, LLC	<b>OPERATOR REPRESENTATIVE:</b> Justyn Hamilton	<b>TYPE OF OPERATION:</b> 112c - Construction Regular Operation

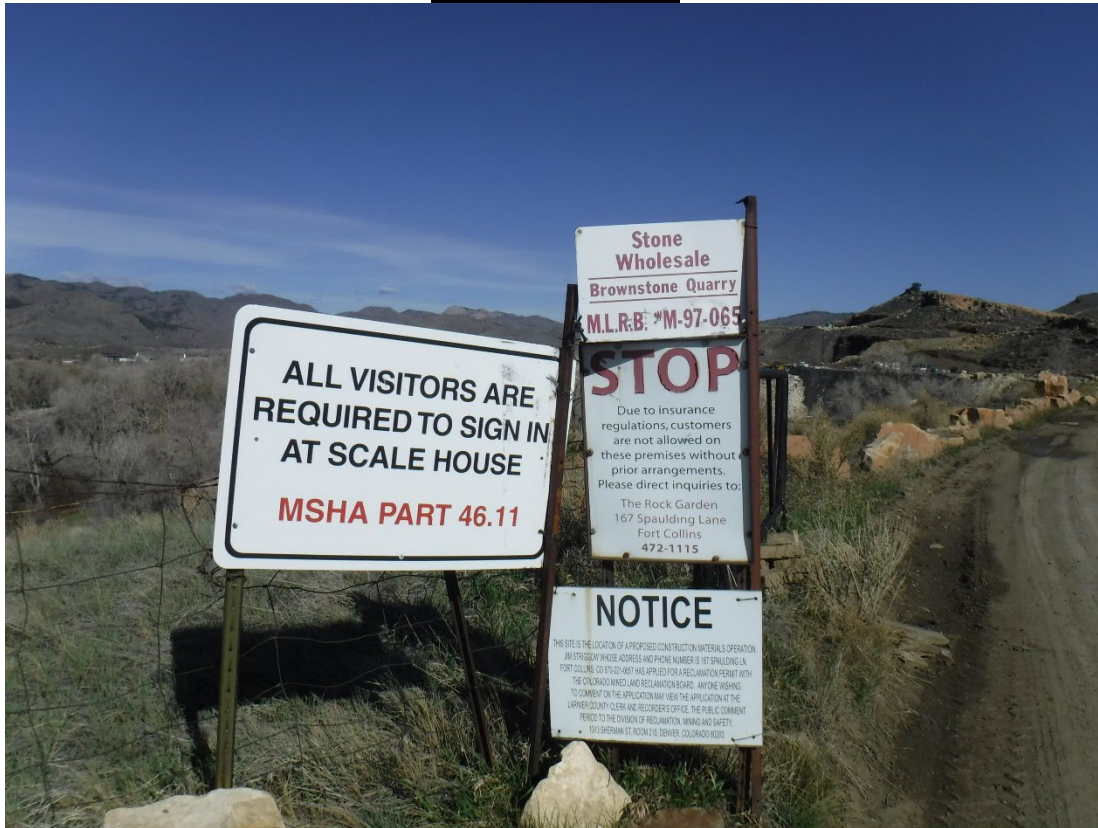
The Brownstone Quarry permit is located in Larimer County approximately 2.8 miles northwest of Laporte, CO off of US 287. The permit is located on land owned by LJS, LLC which is the current Permittee. The approved permit is a 112c operation for 66.2 acres. The approved post mining land use is pastureland. A mine sign was observed at the entrance to the mine as required by Rule 3.1.12.

Photo 1: Mine sign at entrance

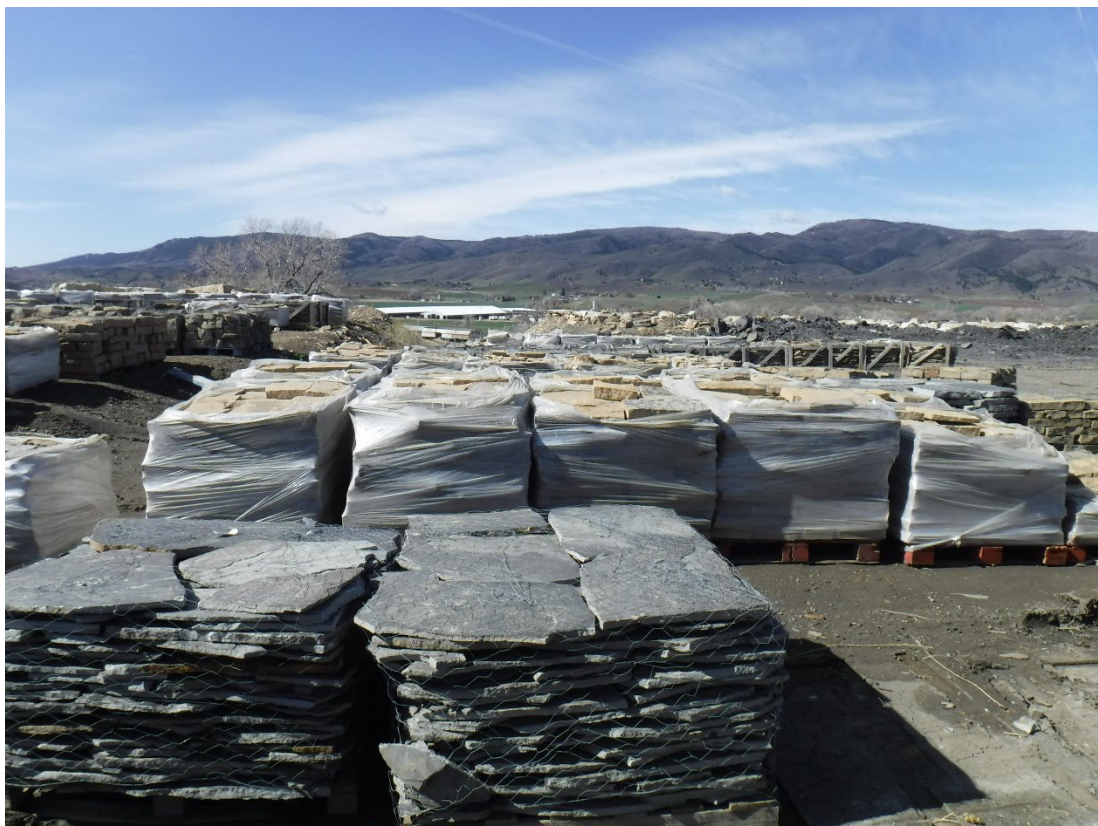
Photo 2: Staged and processed and to be processed material

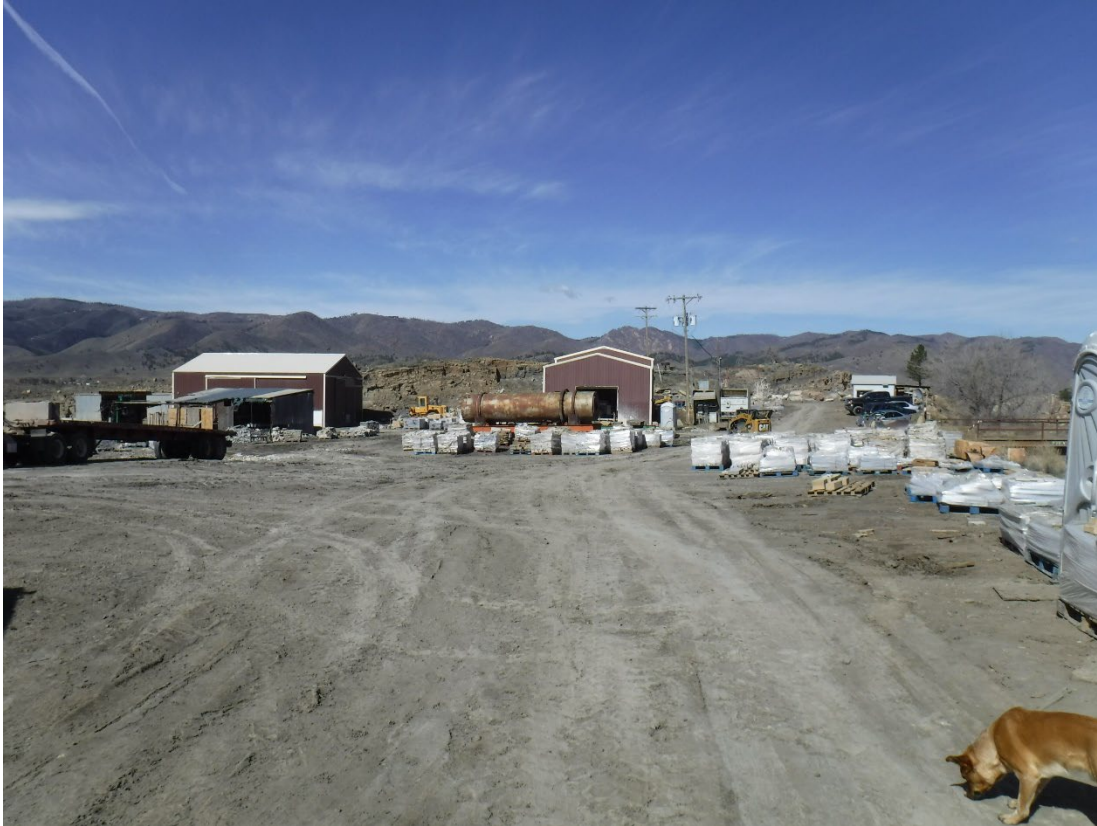
**Photo 3:** Wire saw building and other material processing buildings

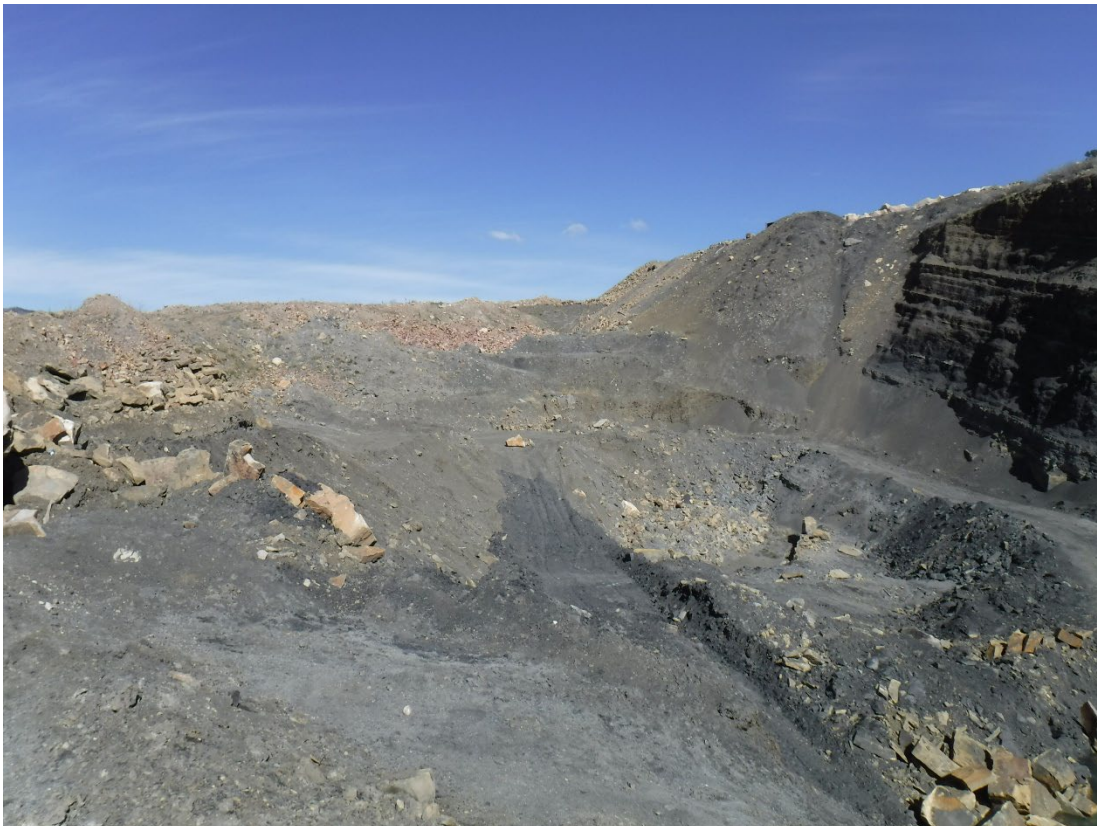
**Photo 4:** Overburden stockpile of material adjacent to pit

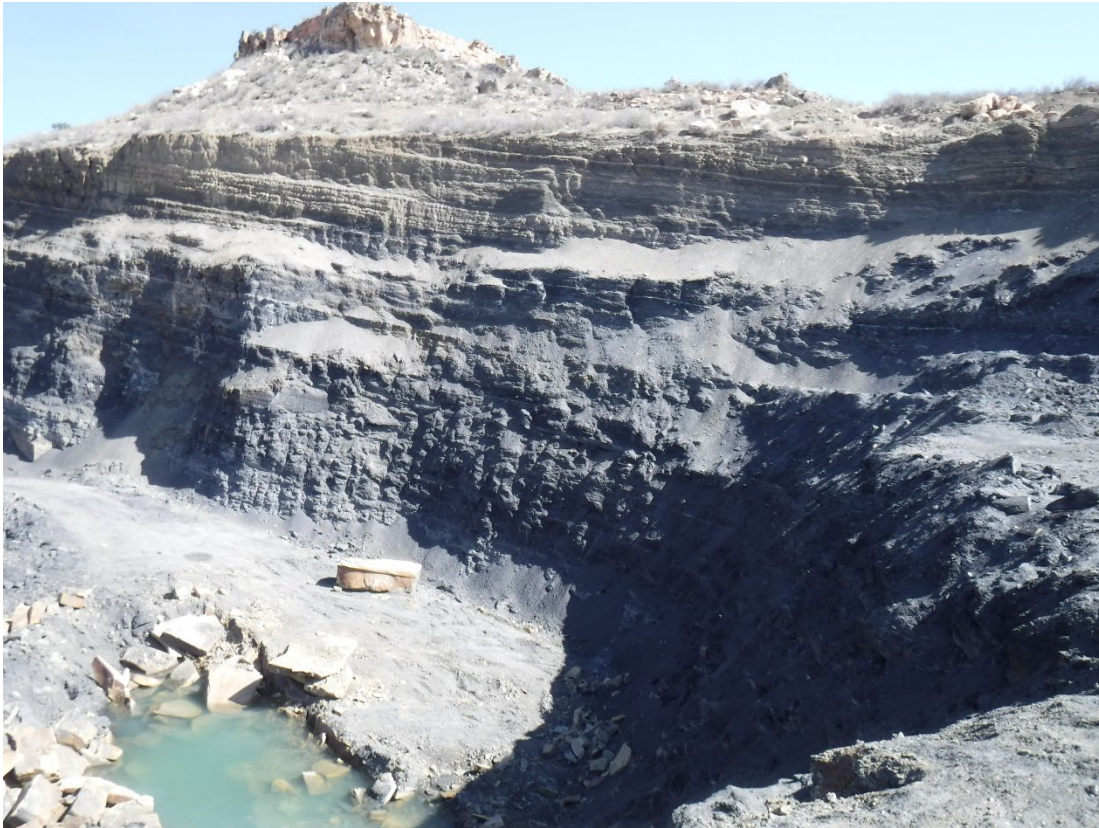
**Photo 5:** Primary pit area, water at bottom from strong rain storms overnight prior to inspection

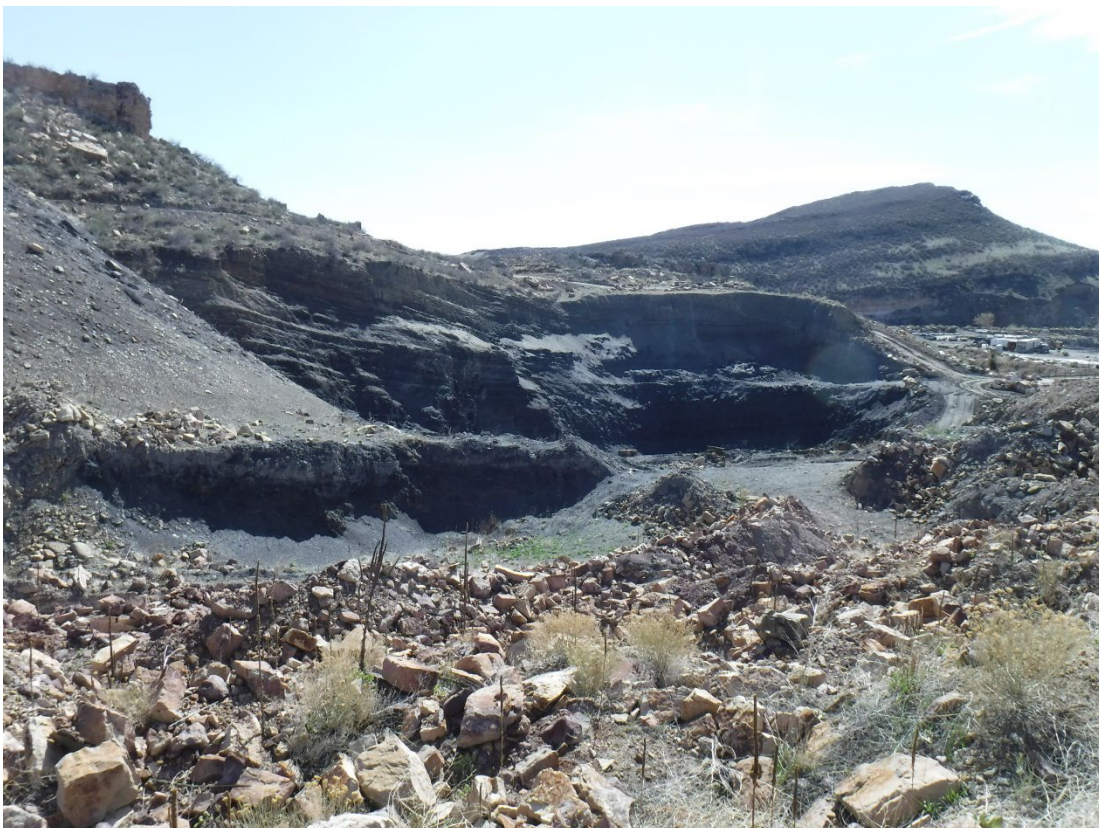
**Photo 6:** Looking southeast along the pit axis from the overburden stockpile area

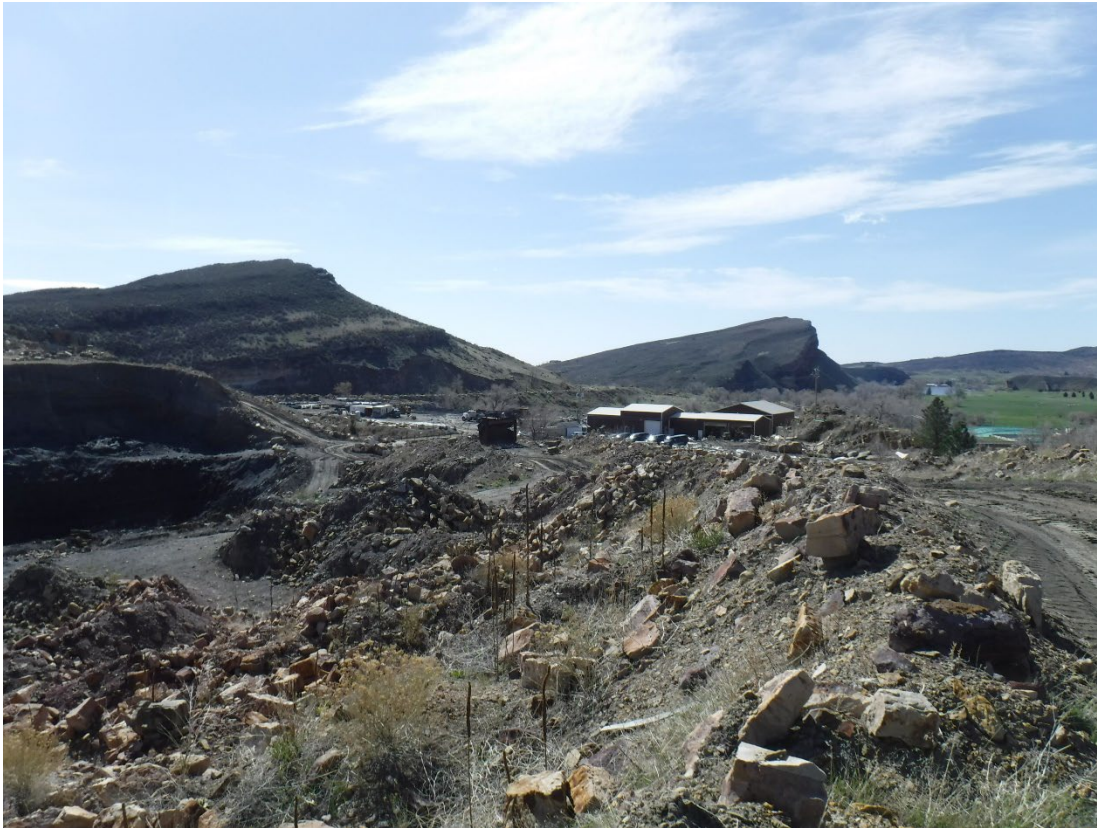
**Photo 7:** Looking south towards the material processing and laydown area

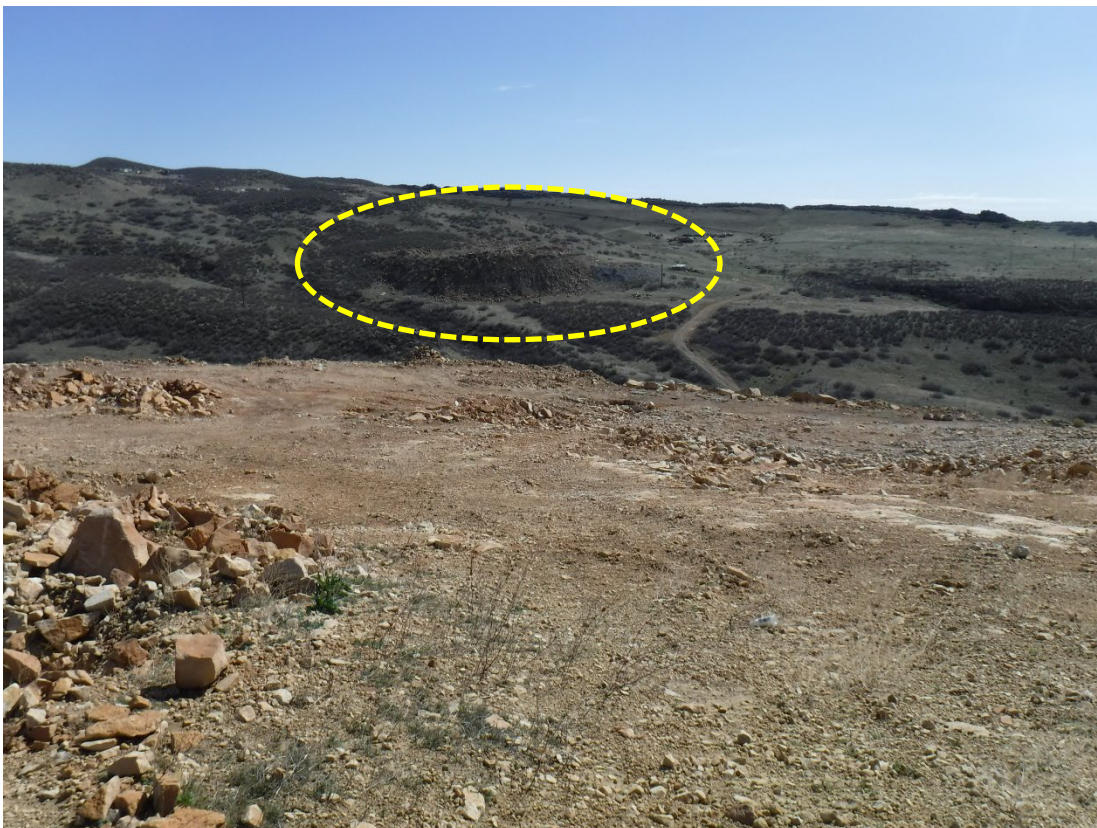
**Photo 8:** Graded former mining area located on top of hill adjacent to main pit area, looking northeast, former mining area and now storage area circled in yellow

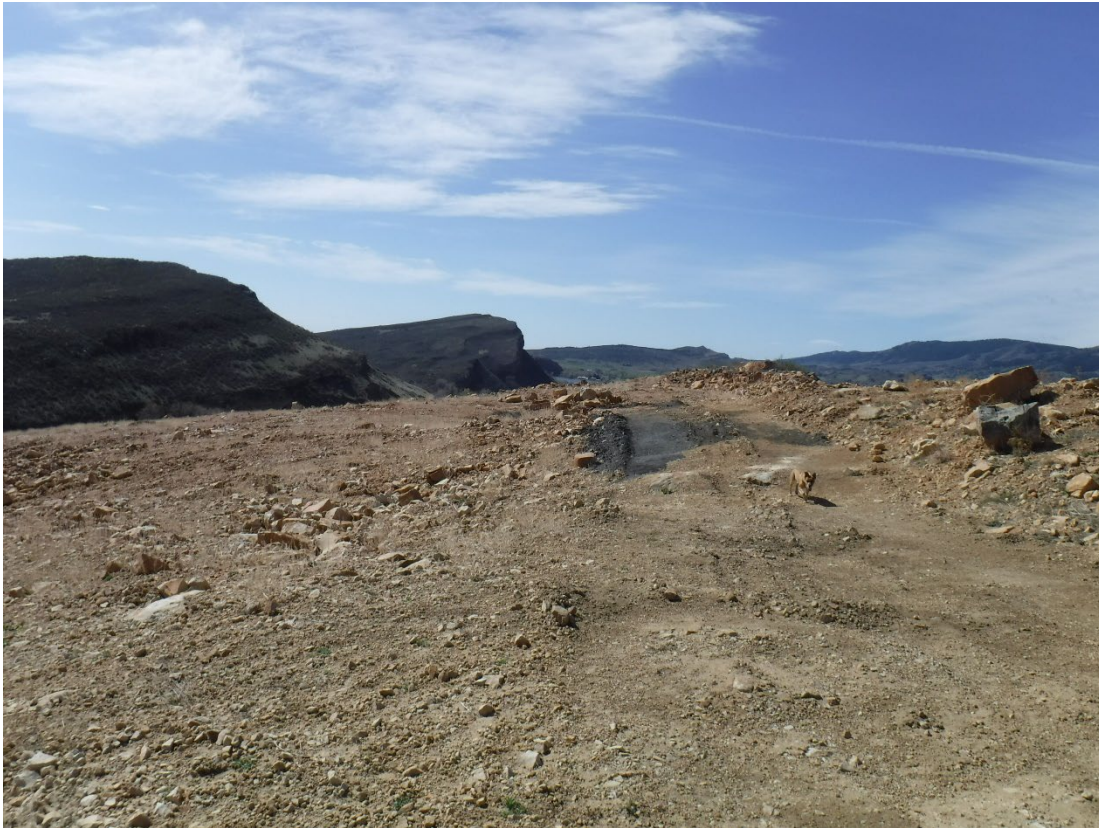
**Photo 9:** Graded former mining area located on top of hill looking south

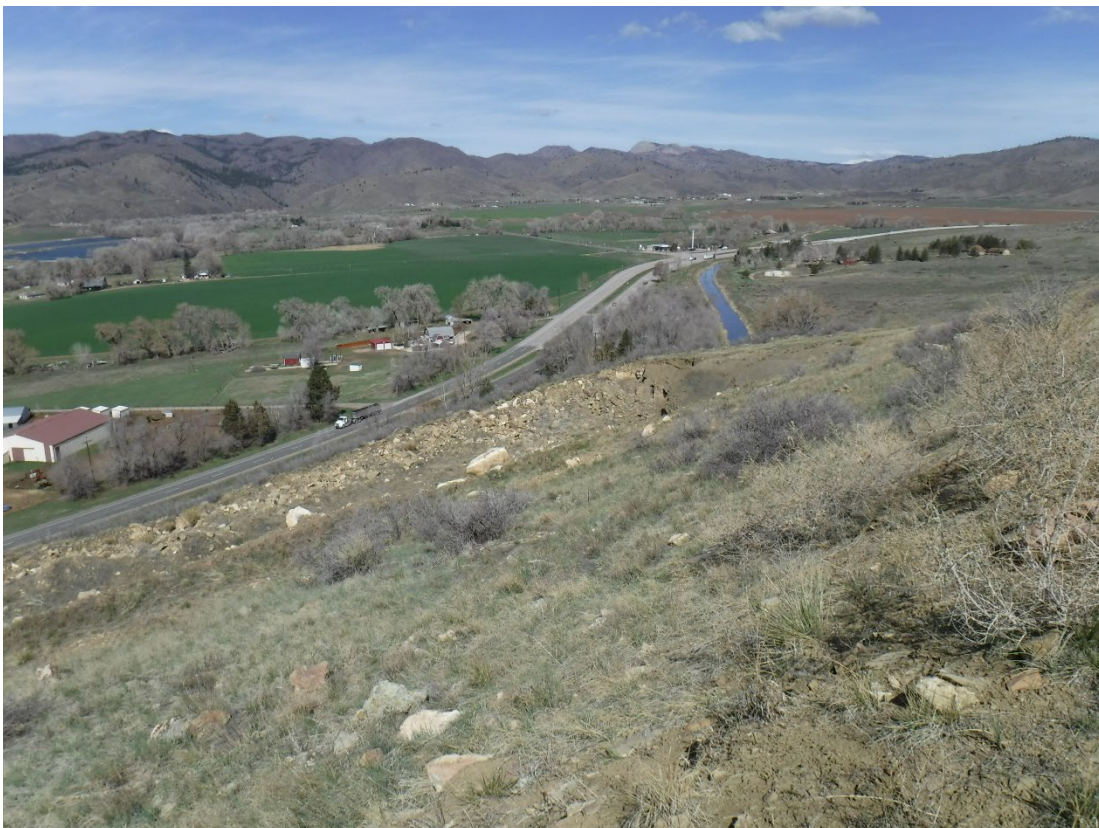
**Photo 10:** Mined out, peninsula, area

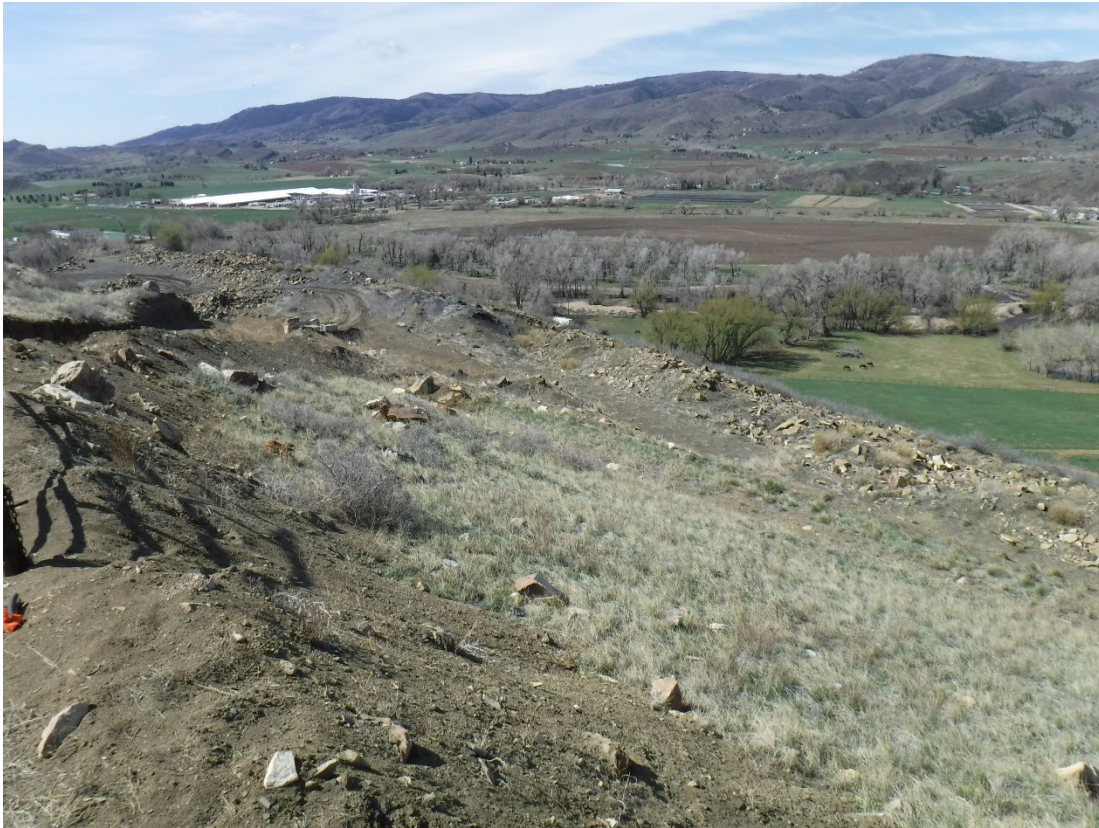
**Photo 11:** Mined out, peninsula, area looking south

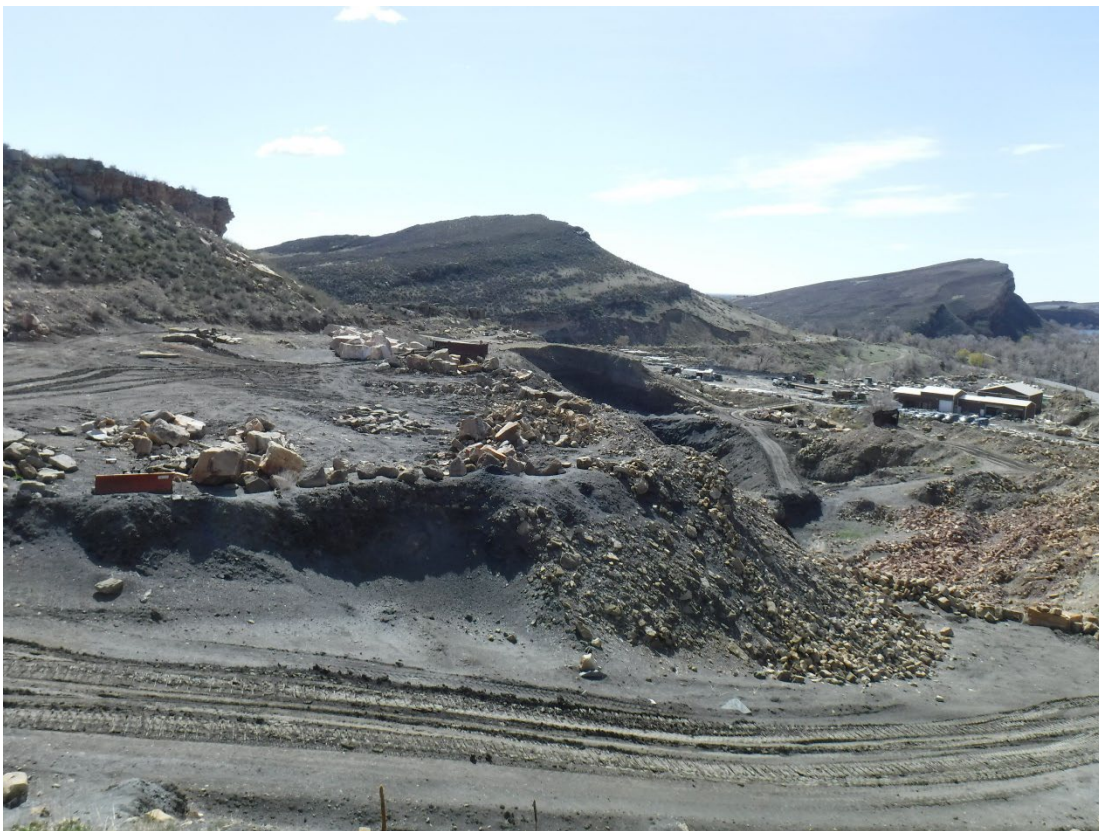
**Photo 12:** Site overview
