**MINERALS PROGRAM INSPECTION REPORT**  
**PHONE: (303) 866-3567**

<b>MINE NAME:</b> Weeden Pit No 30	<b>MINE/PROSPECTING ID#:</b> M-1993-087	<b>MINERAL:</b> Gravel	<b>COUNTY:</b> Prowers
<b>INSPECTION TYPE:</b> Monitoring	<b>WEATHER:</b> Clear	<b>INSP. DATE:</b> May 8, 2023	<b>INSP. TIME:</b> 10:30
<b>OPERATOR:</b> Baca County	<b>OPERATOR REPRESENTATIVE:</b> Danny Ausmus	<b>TYPE OF OPERATION:</b> 112c - Construction Regular Operation	
<b>REASON FOR INSPECTION:</b> Normal I&E Program	<b>BOND CALCULATION TYPE:</b> None	<b>BOND AMOUNT:</b> \$0.00	
<b>DATE OF COMPLAINT:</b> NA	<b>POST INSP. CONTACTS:</b> None	<b>JOINT INSP. AGENCY:</b> None	
<b>INSPECTOR(S):</b> Brock Bowles	<b>INSPECTOR'S SIGNATURE:</b>

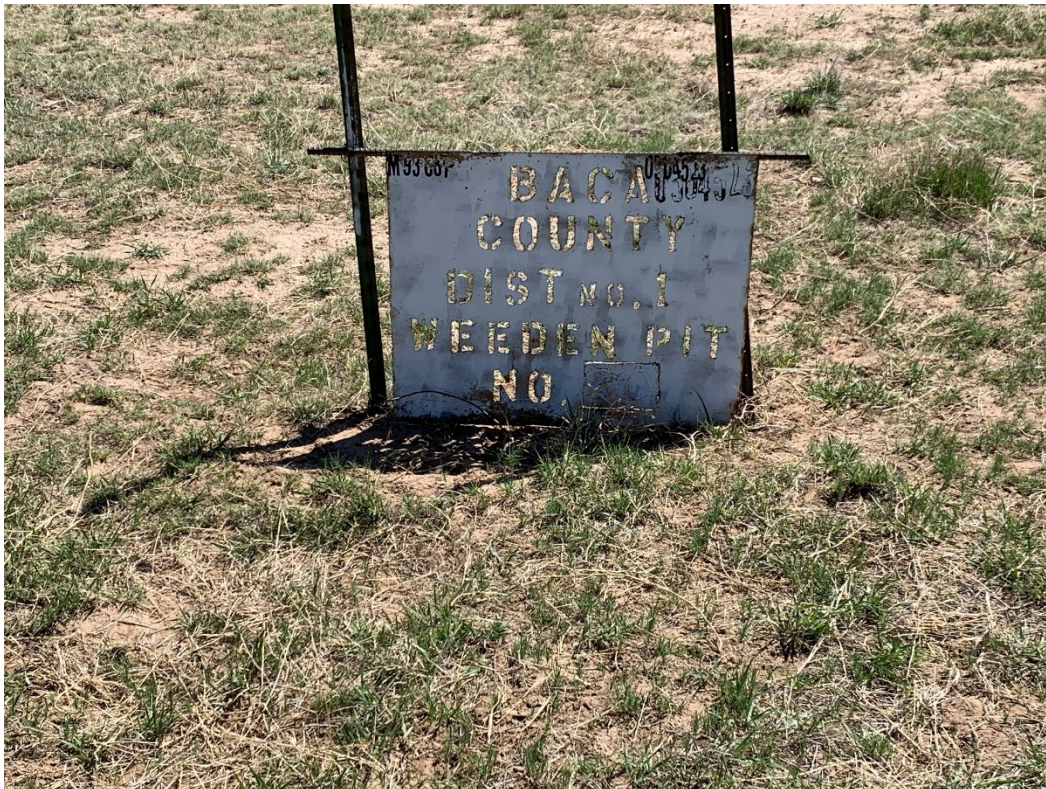
This site is permitted by Baca County but is actually located in Prowers County, 9 miles north of Two Buttes. The mine entrance sign was in place facing County Road 21 (photo 1). All the permit boundary markers were in place (photo 2). The entrance gate was locked upon arrival. Cattle with calves were grazing the pit area and chased the vehicles thinking food was being delivered.

Photo 1 – Mine entrance sign facing CR 21

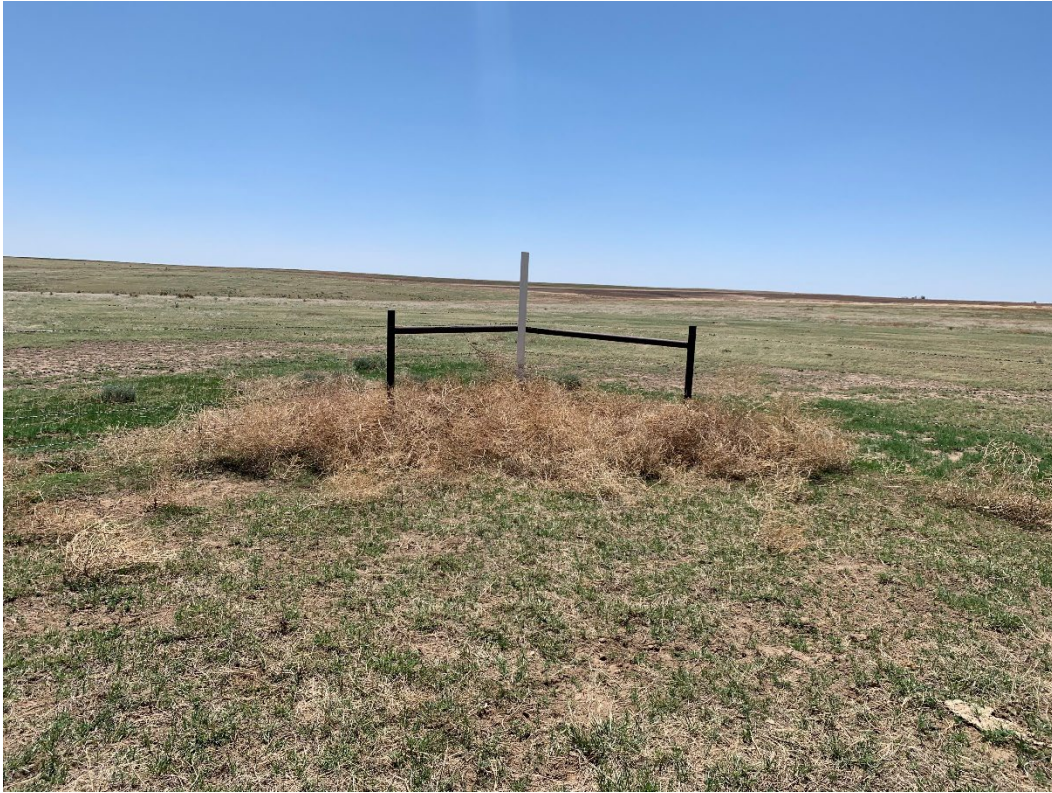
Photo 2 – Southeast permit boundary marker

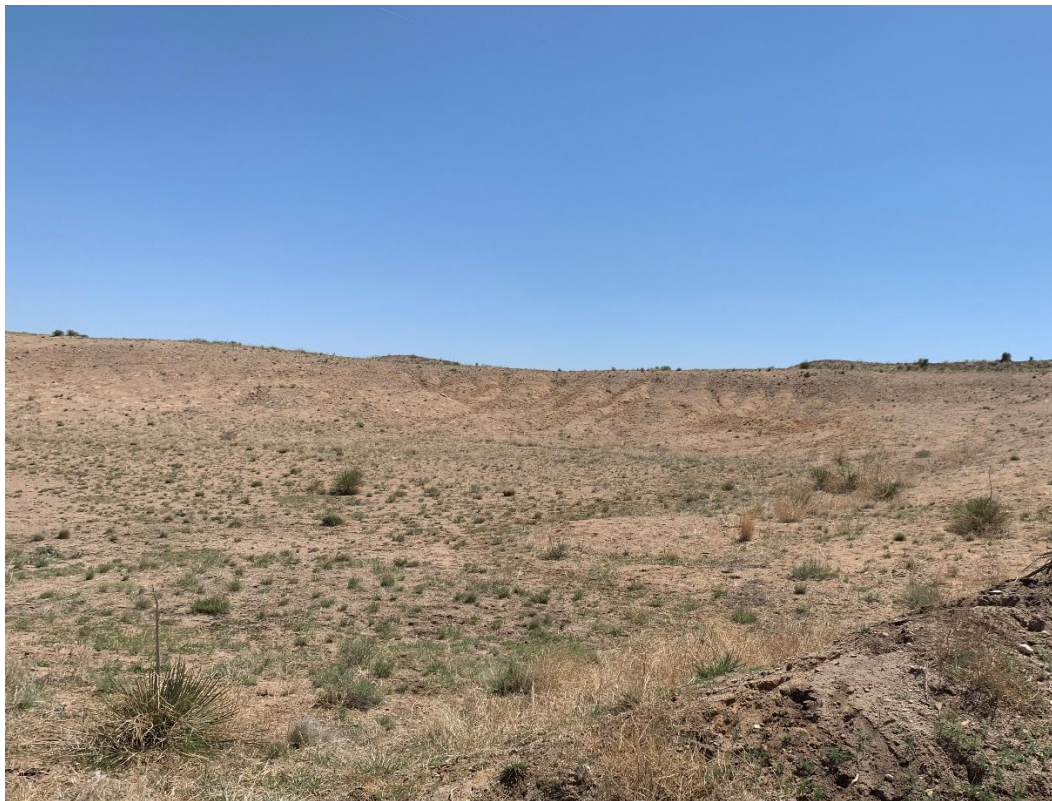
No mining was taking place during the inspection and no equipment was on site. A stockpile of material was located in the middle of the pit area. All the slopes around the pit area were graded to 3h:1v. The eastern slopes were not vegetated because the pit area advances to the east (photo 3). The disturbed areas to the west of the pit had been reclaimed.

Photo 3 – Eastern slopes of pit area

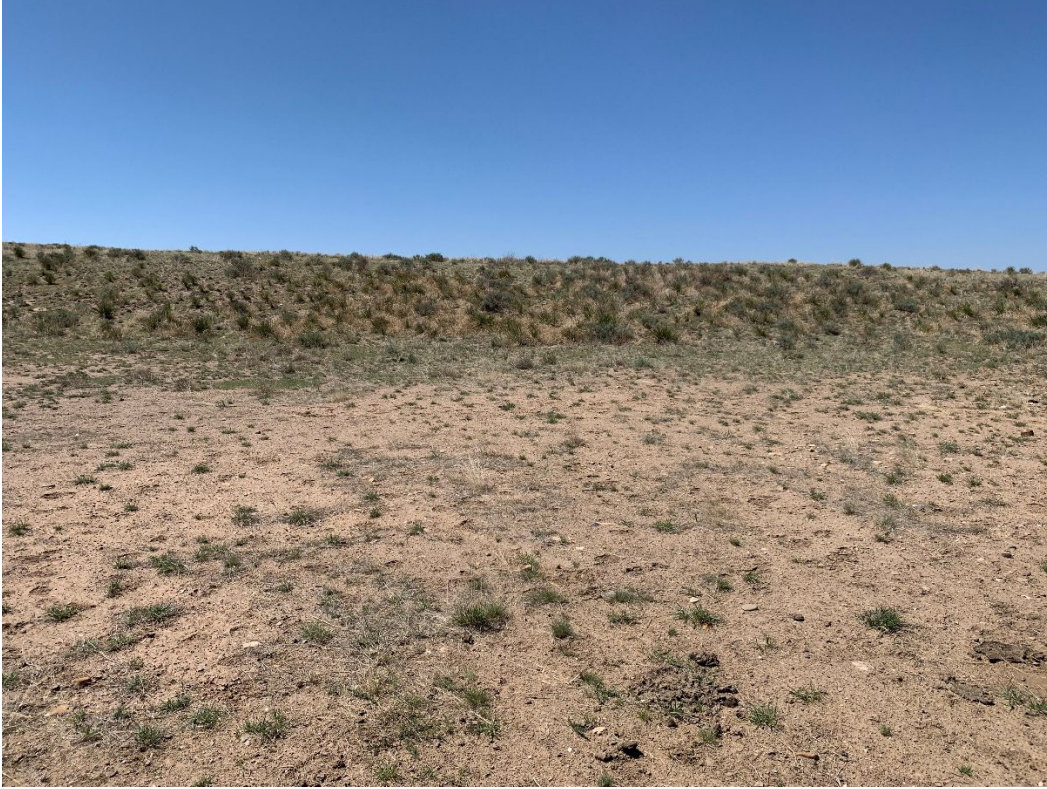
Topsoil in front of the pit area has been salvaged and is stored in well vegetated stockpiles (photo 4).

Photo 4 – Topsoil stockpile
