MINERALS PROGRAM INSPECTION REPORT
PHONE: (303) 866-3567

MINE NAME: Walsh Pit No. 2	MINE/PROSPECTING ID#: M-1977-479	MINERAL: Sand and gravel	COUNTY: Baca
INSPECTION TYPE: Monitoring	WEATHER: Clear	INSP. DATE: May 8, 2023	INSP. TIME: 14:00
OPERATOR: Baca County	OPERATOR REPRESENTATIVE: Danny Ausmus	TYPE OF OPERATION: 112c - Construction Regular Operation	
REASON FOR INSPECTION: Normal I&E Program	BOND CALCULATION TYPE: None	BOND AMOUNT: \$0.00	
DATE OF COMPLAINT: NA	POST INSP. CONTACTS: None	JOINT INSP. AGENCY: None	
INSPECTOR(S): Brock Bowles	INSPECTOR'S SIGNATURE:

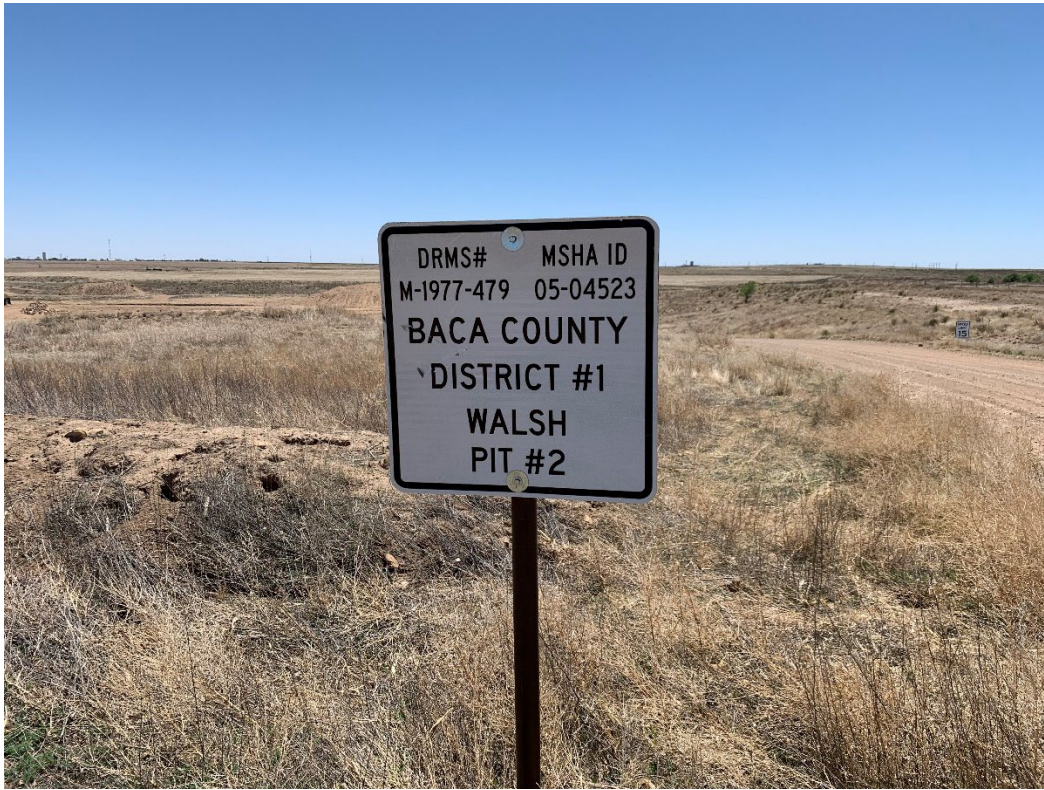
The mine entrance sign was in place facing CR FF (photo 1). The western permit boundary was marked with fenceline, the southwestern by a fenceline, the southeastern by an agriculture field, the eastern by the access road and the northern by CR FF. Corner posts were in place also.

Photo 1 – Entrance sign facing CR FF

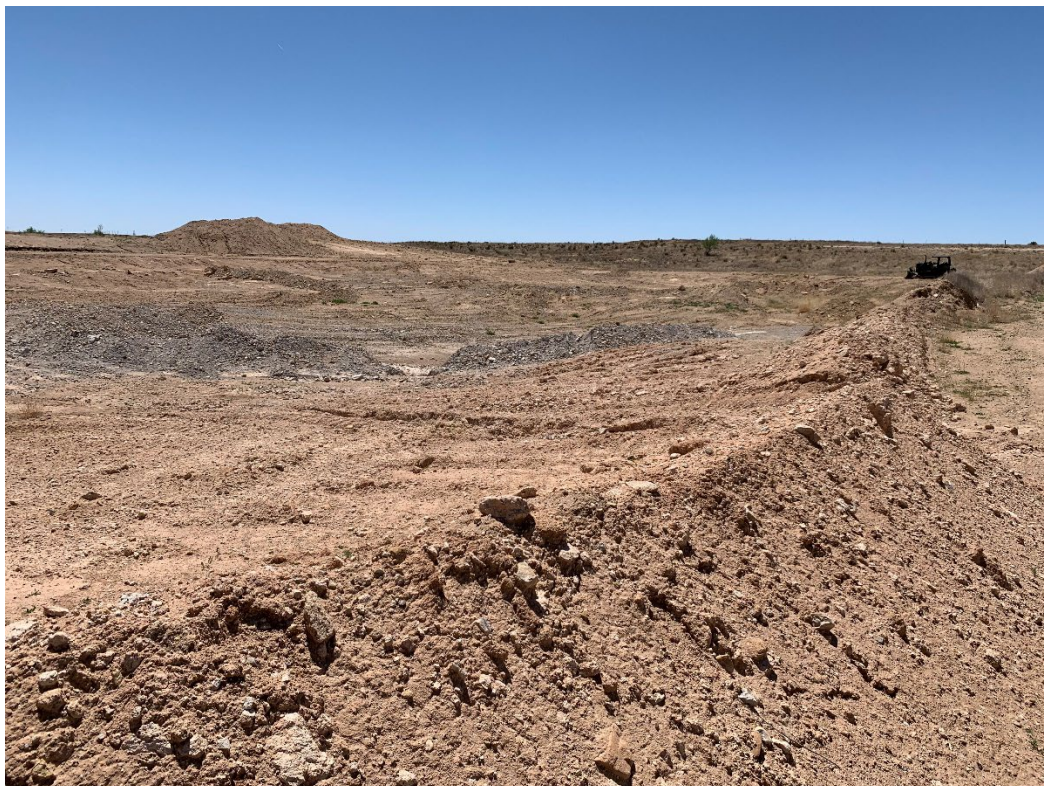
No mining activity was taking place during the inspection. There were several pieces of mining equipment onsite including screening equipment, 2 bulldozers and an excavator. Mining on the site started along the western side and is moving eastward. Mining is currently in about the middle of the permit area (photo 2). The disturbed areas along the western permit boundary have been reclaimed.

Photo 2 – North mining area facing west

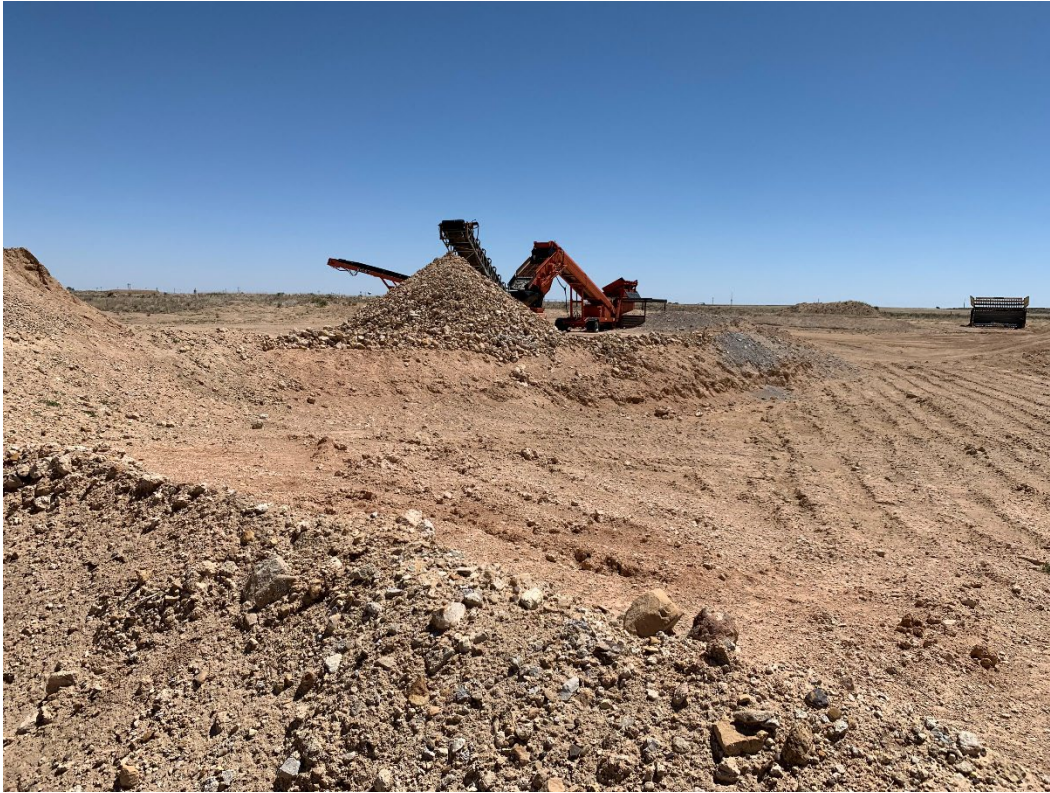
The mining area on the north side of Bear Creek contained several gravel stockpiles, some large rock stockpiles and all of the mining equipment (photo 3). The topsoil stock pile is located north of the access road and is well vegetated. The mining area on the south side had a couple of stock piles. The topsoil piles are located north and south of the mining area and were well vegetated (photo 4).

Photo 3 – Screening equipment

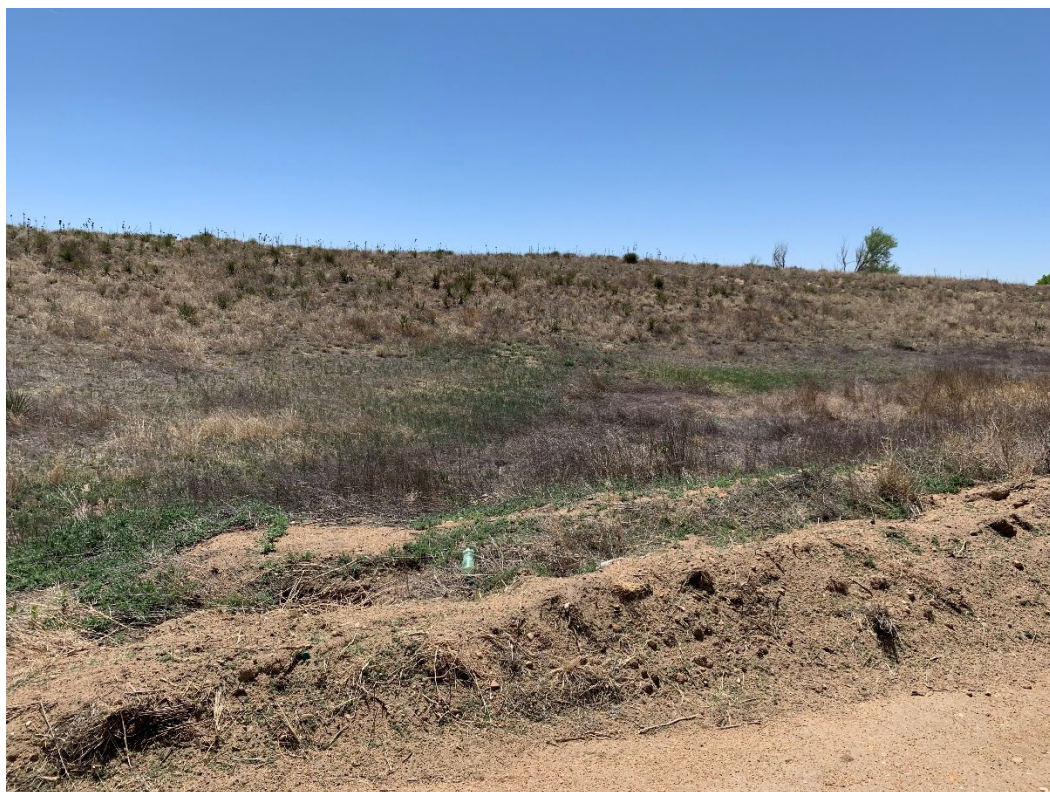
Photo 4 – Topsoil stockpile in south mining area along south boundary

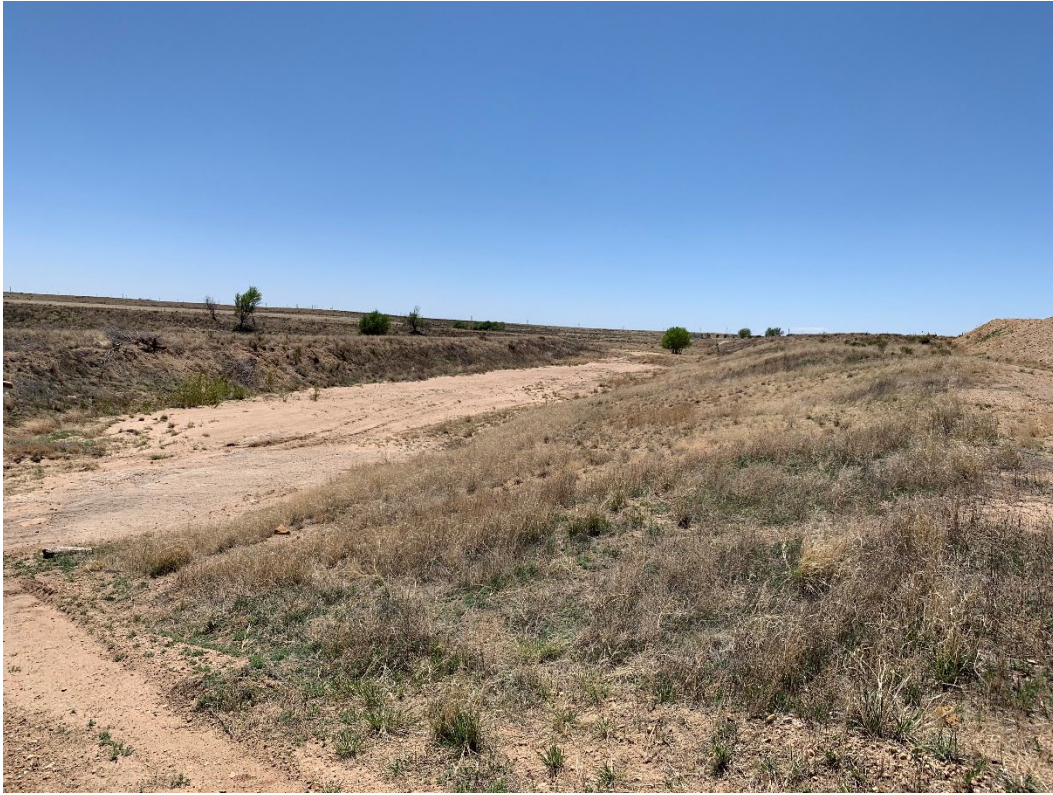
Two access roads crossed Bear Creek and Dry Creek. The access roads did not impede water flow through the creek (photo 5). The banks of the creek were in place and no water could flow into the mining area. No water was noted in the pits area.

Photo 5 – Bear Creek through mining area, facing west
