MINERALS PROGRAM INSPECTION REPORT
PHONE: (303) 866-3567

MINE NAME: Gunkel Pit No 31	MINE/PROSPECTING ID#: M-1993-088	MINERAL: Gravel	COUNTY: Baca
INSPECTION TYPE: Monitoring	WEATHER: Clear	INSP. DATE: May 8, 2023	INSP. TIME: 11:30
OPERATOR: Baca County	OPERATOR REPRESENTATIVE: Danny Ausmus	TYPE OF OPERATION: 112c - Construction Regular Operation	
REASON FOR INSPECTION: Normal I&E Program	BOND CALCULATION TYPE: None	BOND AMOUNT: \$0.00	
DATE OF COMPLAINT: NA	POST INSP. CONTACTS: None	JOINT INSP. AGENCY: None	
INSPECTOR(S): Brock Bowles	INSPECTOR'S SIGNATURE:

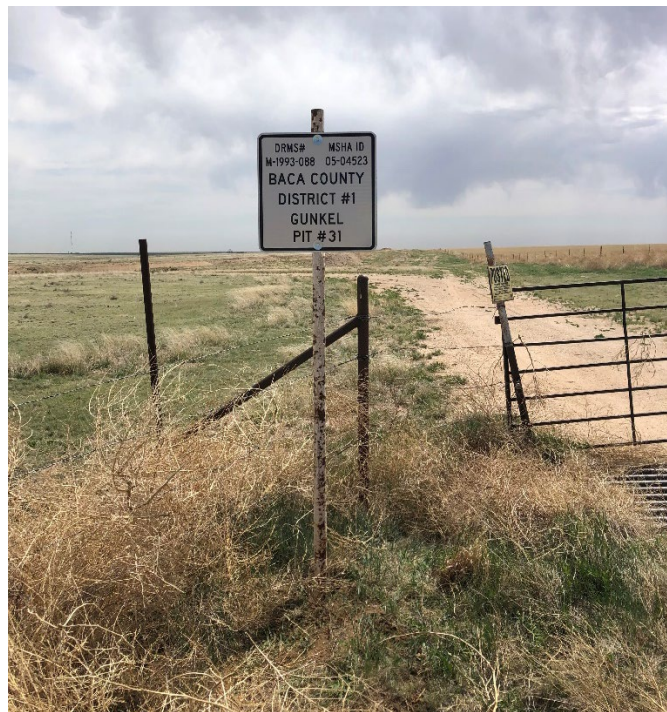
The mine entrance was in place facing CR 23 (photo 1). All permit boundary markers were in place. No mining was taking place and no equipment was on site. The product stockpiles were located in the middle of the pit area (photo 2).

Photo 1 – Entrance sign facing CR23

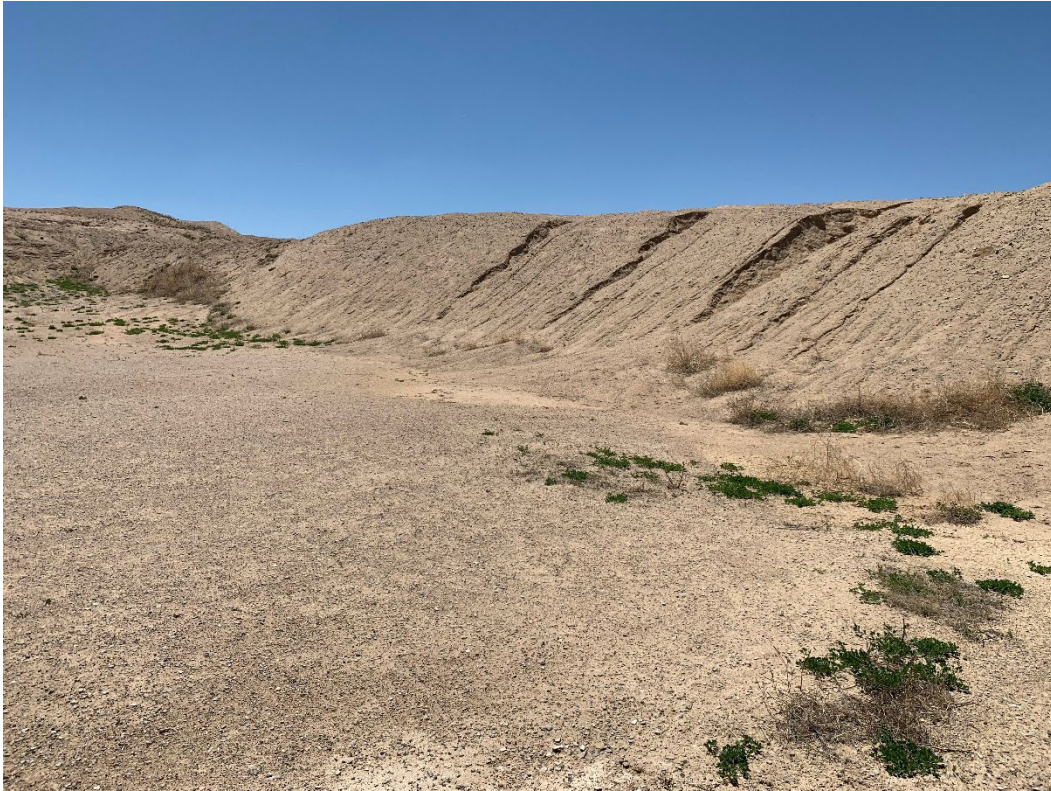
Photo 2 – Product stockpiles in pit area

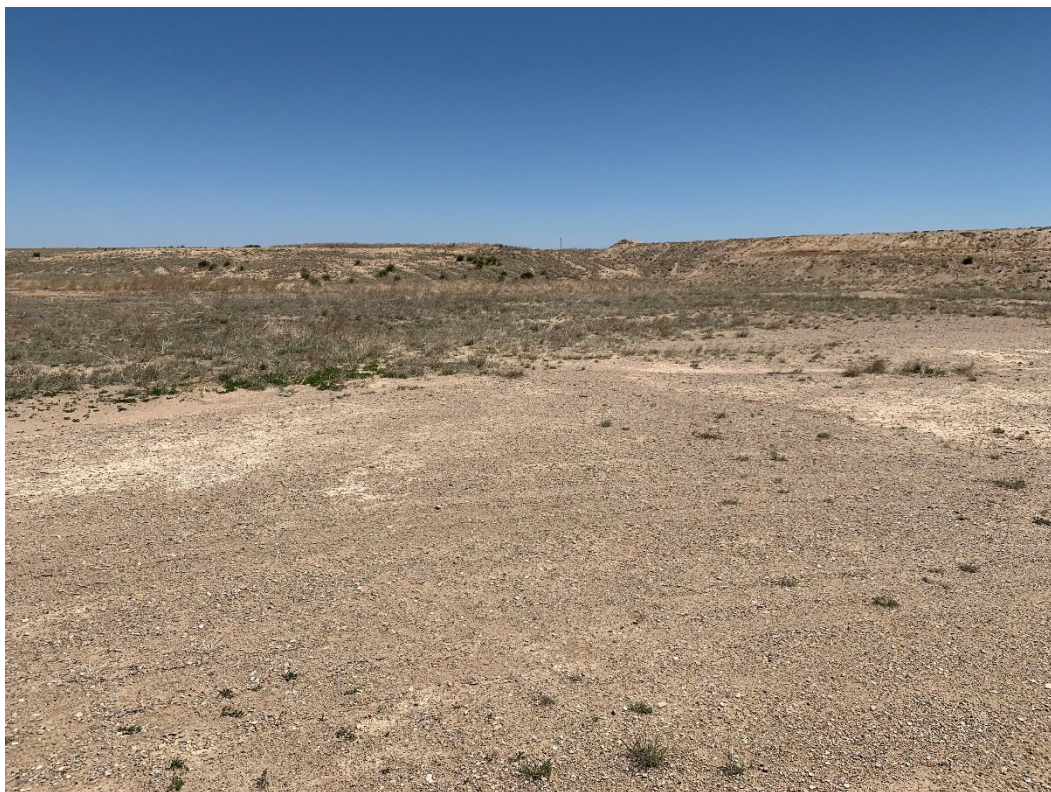
The slopes of the pit area were mined to 3h:1v. The slopes to the north had been reclaimed (photo 3). The mine is advancing to the east and the slopes are also mined to 3h:1v. Topsoil was stored to the west (photo 4) and south of the pit area and were well vegetated.

Photo 3- Reclaimed slopes on northern side of pit area

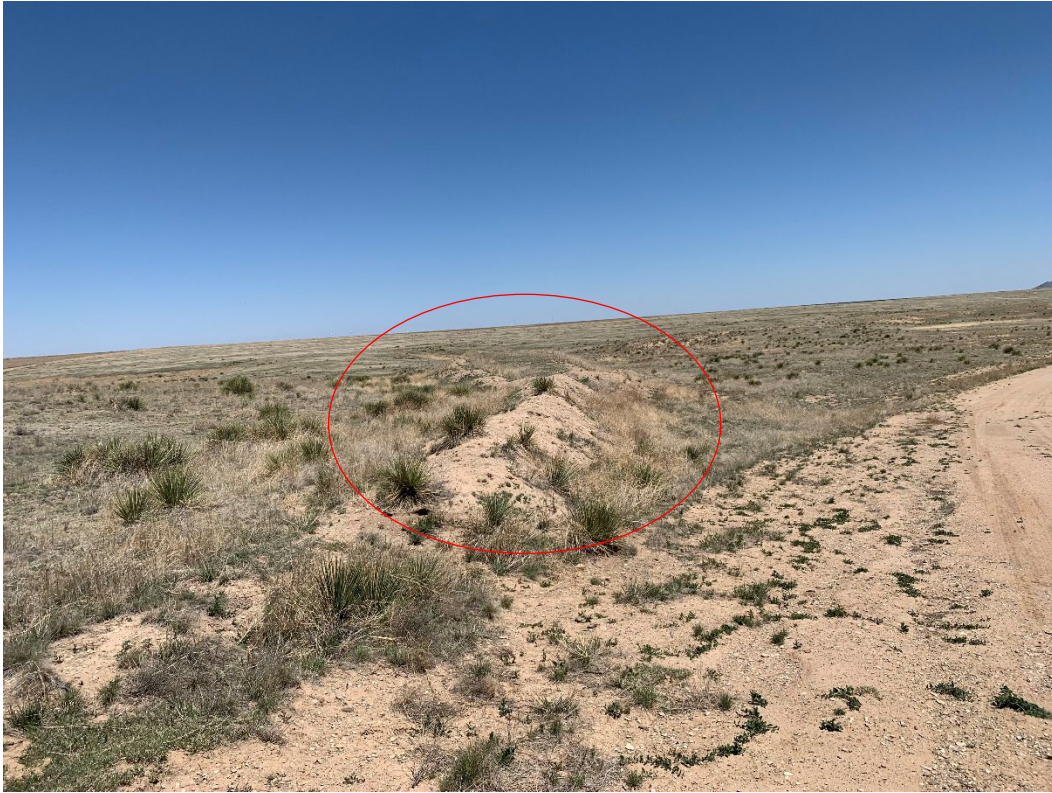
Photo 4 – Western topsoil stockpile
