**MINERALS PROGRAM INSPECTION REPORT**  
**PHONE: (303) 866-3567**

<b>MINE NAME:</b> Mundell Estate No. 32	<b>MINE/PROSPECTING ID#:</b> M-1995-019	<b>MINERAL:</b> Gravel	<b>COUNTY:</b> Baca
<b>INSPECTION TYPE:</b> Monitoring	<b>WEATHER:</b> Clear	<b>INSP. DATE:</b> May 8, 2023	<b>INSP. TIME:</b> 13:30
<b>OPERATOR:</b> Baca County	<b>OPERATOR REPRESENTATIVE:</b> Danny Ausmus	<b>TYPE OF OPERATION:</b> 112c - Construction Regular Operation	
<b>REASON FOR INSPECTION:</b> Normal I&E Program	<b>BOND CALCULATION TYPE:</b> None	<b>BOND AMOUNT:</b> \$0.00	
<b>DATE OF COMPLAINT:</b> NA	<b>POST INSP. CONTACTS:</b> None	<b>JOINT INSP. AGENCY:</b> None	
<b>INSPECTOR(S):</b> Brock Bowles	<b>INSPECTOR'S SIGNATURE:</b>

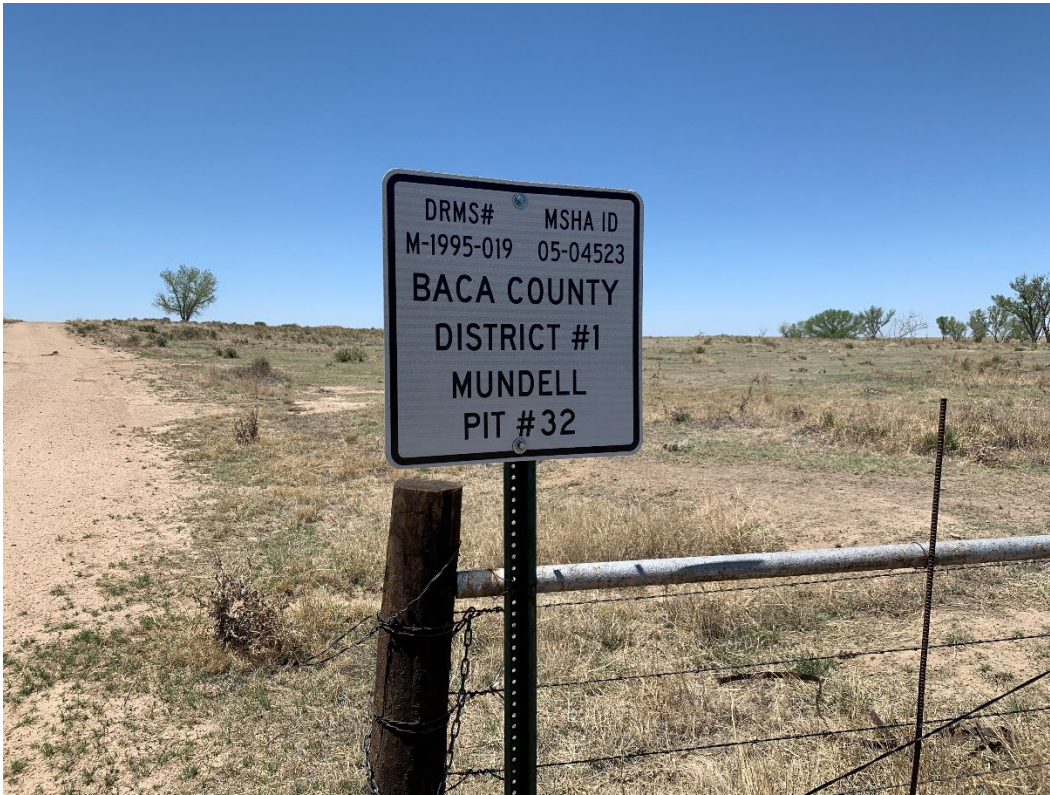
The mine entrance sign was in place (photo 1) facing CR 52. All the permit boundary markers were in place. No mining was taking place and no equipment was on site.

Photo 1 – Entrance sign facing CR 52

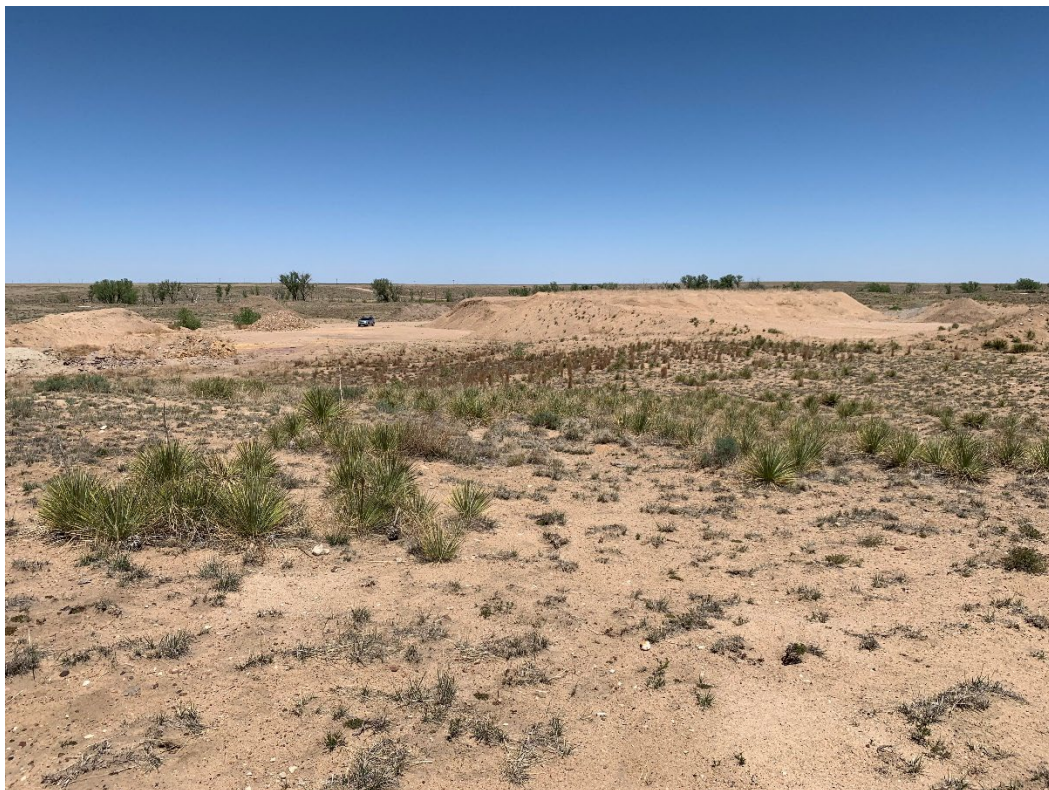
The gravel is pushed from the edges of the pit into the middle of the pit (photo 2). This is done so the product stockpiles are located in the middle of the pit area for centralized processing and loading. The slopes of the pit area were mined to 3h:1v.

Photo 2 – Gravel piles in middle of pit, facing northeast

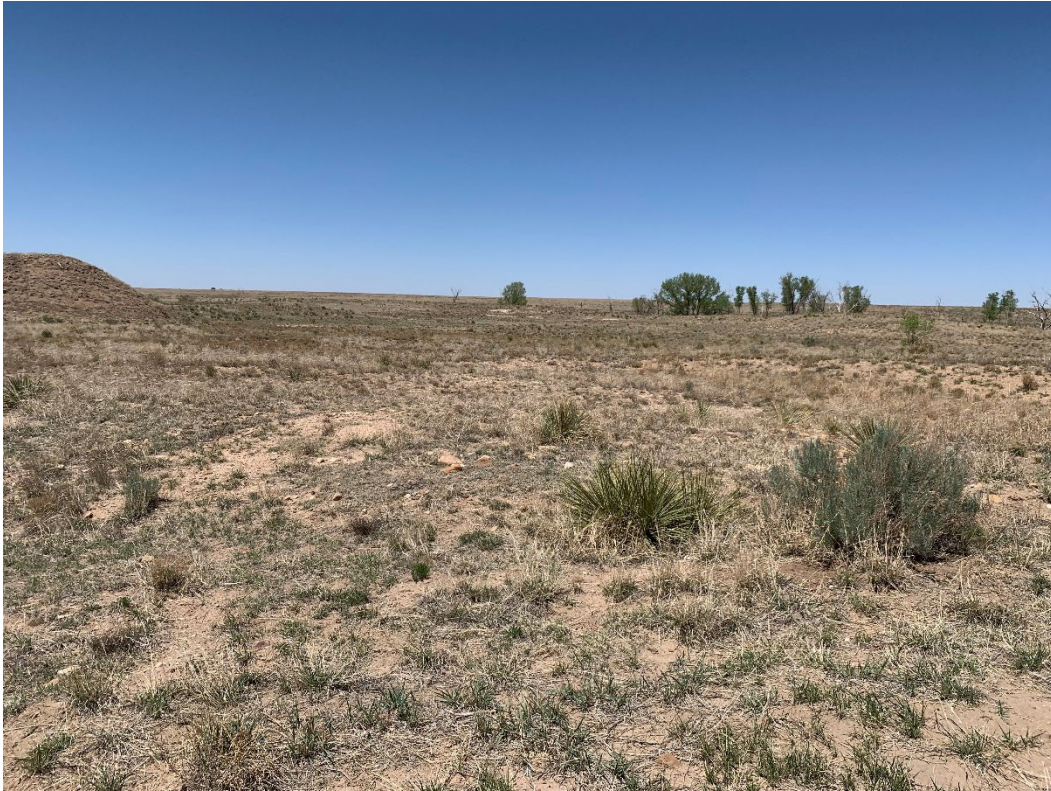
The northeast portion of the mining area had been reclaimed and the vegetation looked well established (photo 3). Topsoil was salvaged from in front of the mining area and was stored in rows along the southern (photo 4) and western boundaries.

Photo 3 – Northeast section of mine that has been reclaimed

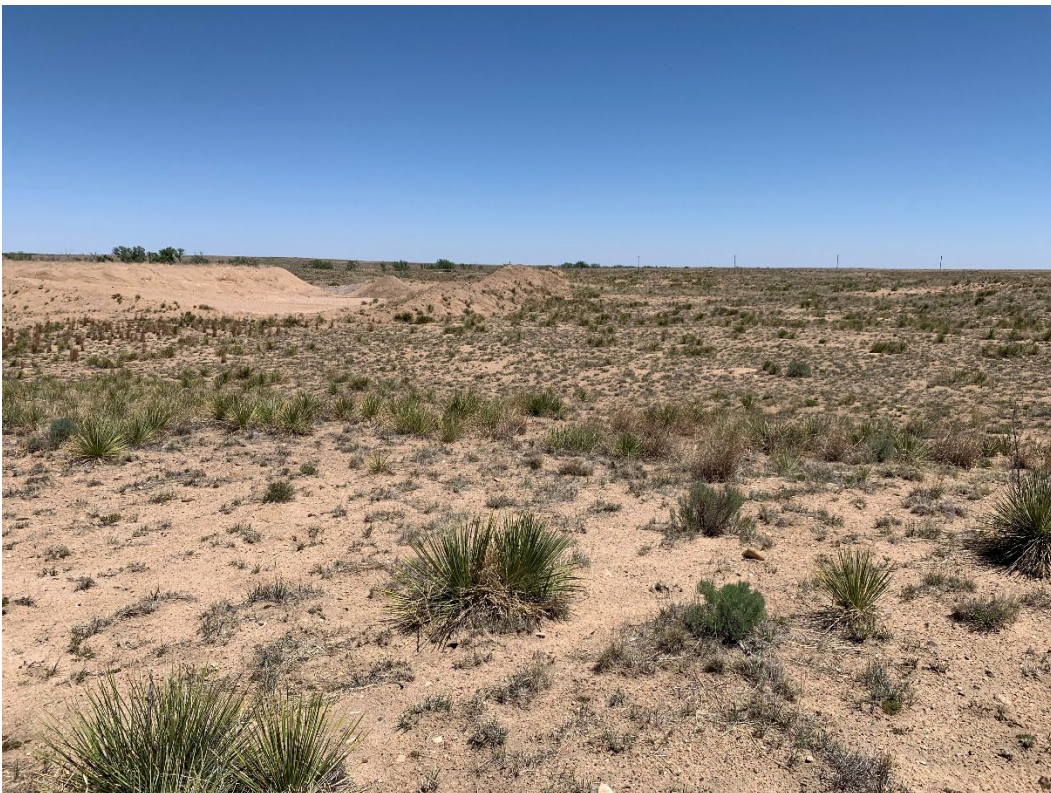
Photo 4 – Topsoil stockpile on southern boundary, facing east
