**MINERALS PROGRAM INSPECTION REPORT**  
**PHONE: (303) 866-3567**

| <b>MINE NAME:</b><br>Fetcher/Vale Pit | <b>MINE/PROSPECTING ID#:</b><br>M-2002-119 | <b>MINERAL:</b><br>Sand and gravel | <b>COUNTY:</b><br>Routt |
| <b>INSPECTION TYPE:</b><br>Monitoring | <b>WEATHER:</b> Clear | <b>INSP. DATE:</b><br>May 3, 2023 | <b>INSP. TIME:</b><br>09:30 |

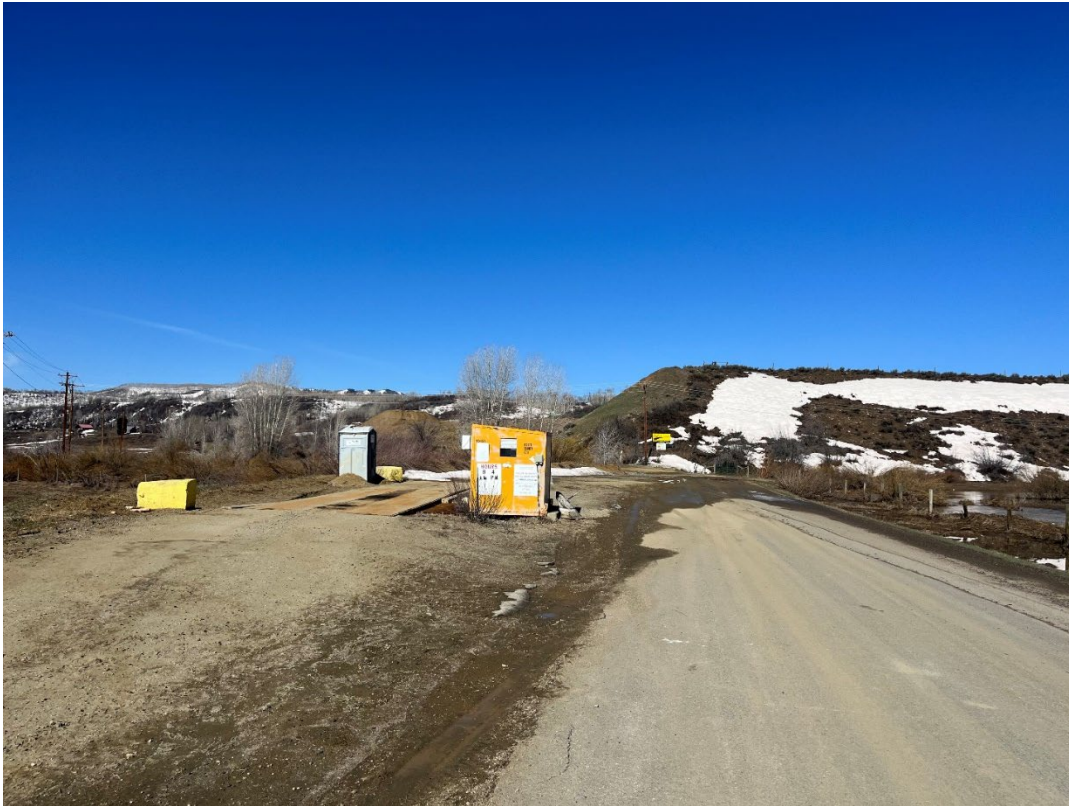
Photo 1: Scale and scale house located at the mine entrance.

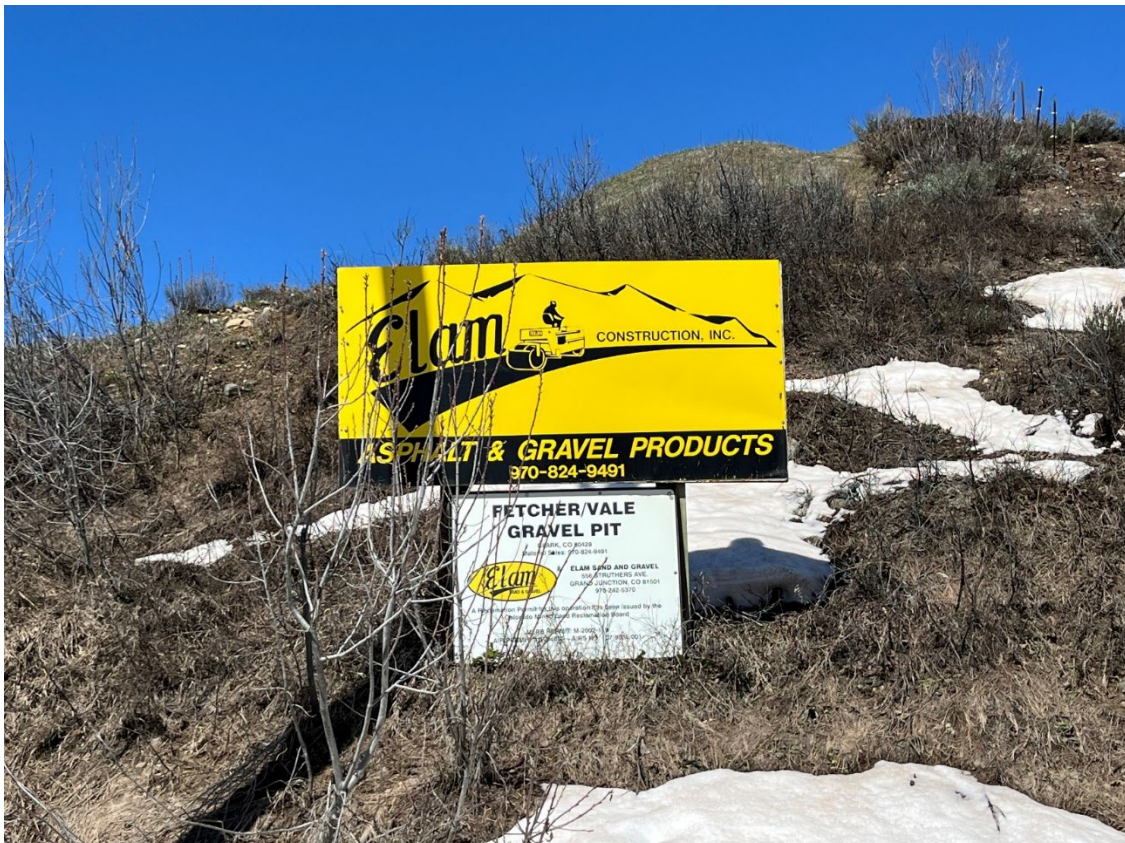
The mine identification sign (Photo 2) and affected area boundary markers are in place and in compliance with Rule 3.1.12. A fence delineates the permit boundaries. A scale and scale house are located on the entrance road (Photo 1). Aggregate materials are processed on site in the late summer, August through November, using a portable crusher/screener. The pit floor is approximately 40 feet deep. The site was not active at the time of inspection.

Photo 2: Mine sign posted at the entrance to the pit off CR62.

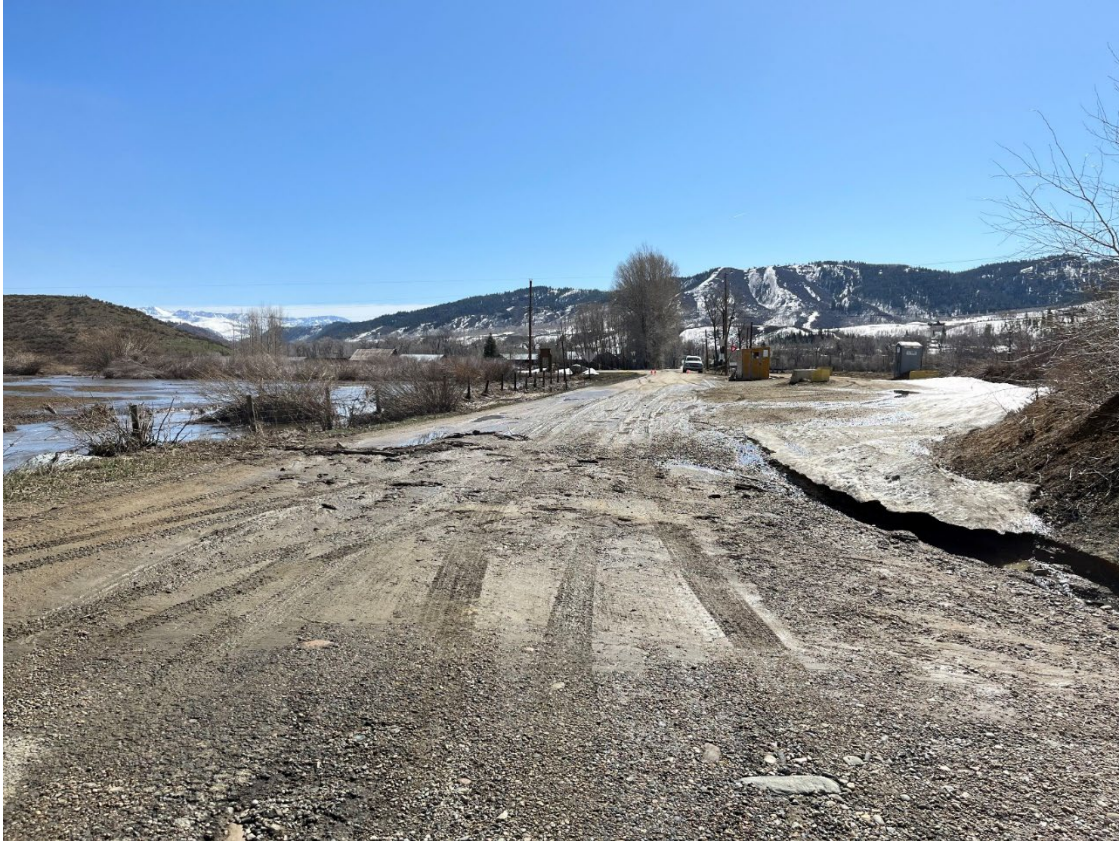
**Photo 3: View east of CR62, scale and scale house are visible to the south. Road shows erosional damage from recent flooding.**

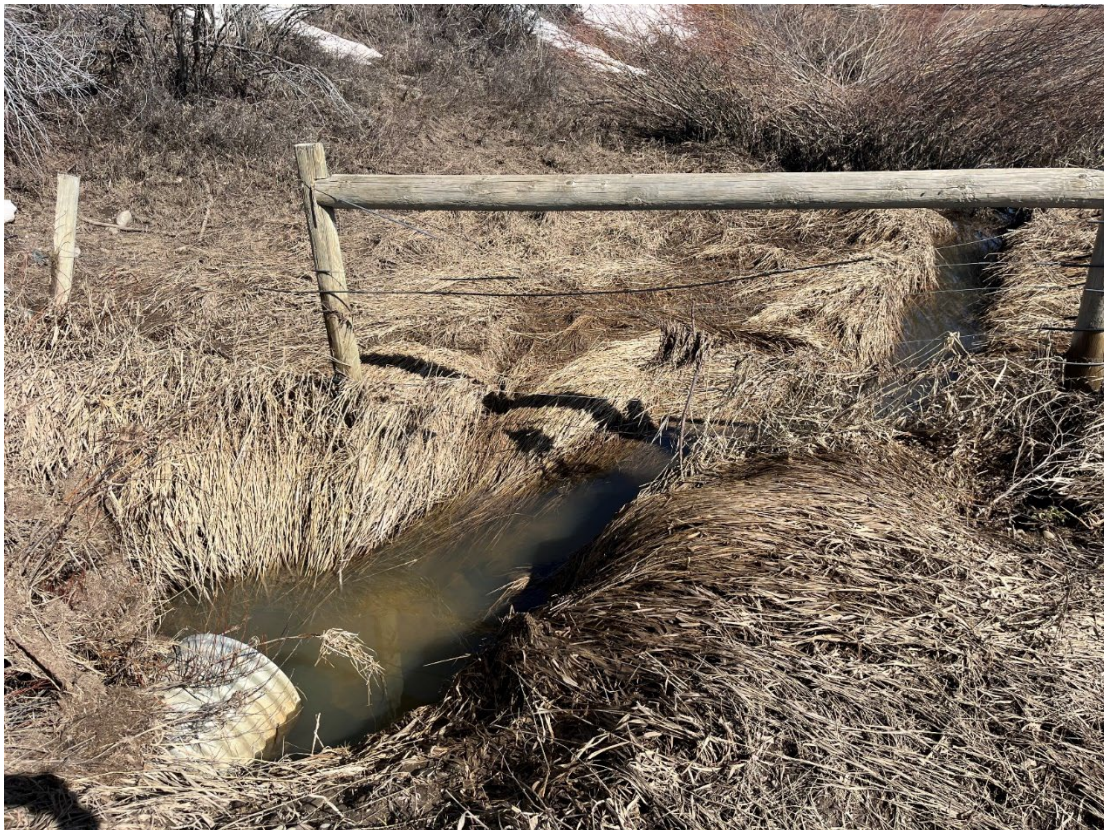
**Photo 4: Culvert located to the north, just before the mine sign, carries water under the road to Cottonwood Gulch. Culvert was clean and functioning properly.**

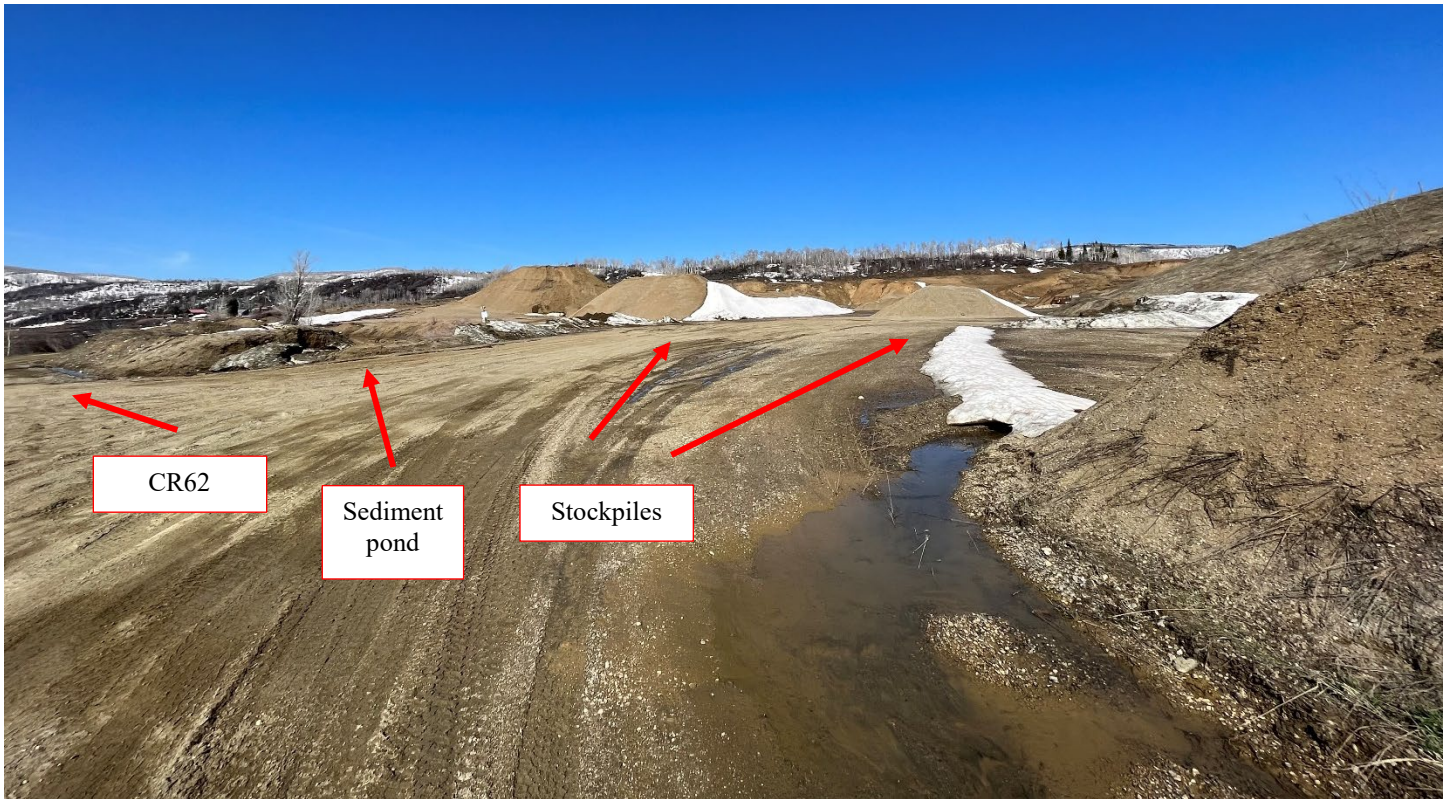
**Photo 5: View west at the entrance to the mine site.**

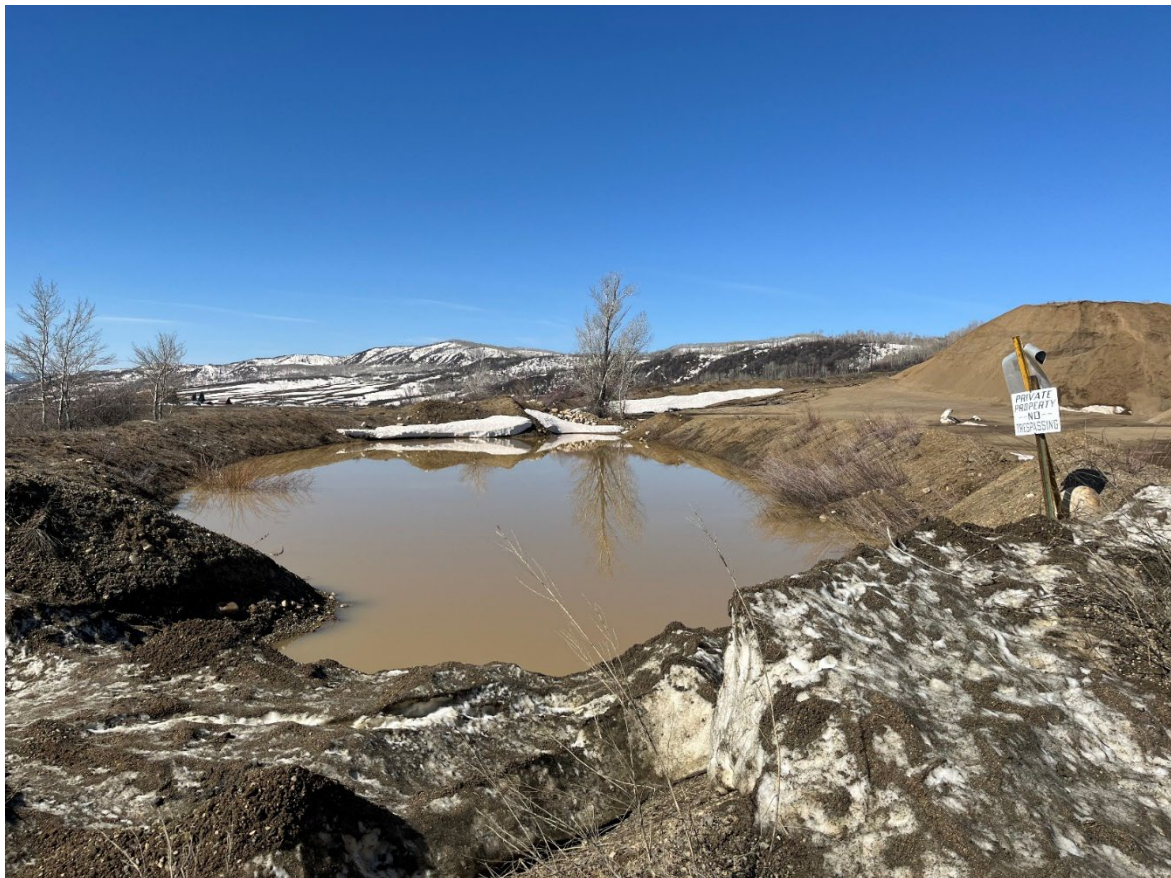
**PROBLEM/POSSIBLE VIOLATION:** Problem: The site's sediment pond dam has been damaged and is not functioning per the approved plan.

The sediment pond located in the southeast corner of the site has been damaged during the winter season. Likely due to snowplowing, the dam surrounding the pond has been breached and water from the sediment pond was noted to be flowing into the ditch on CR 62 (Photos 6, 7, 8). This pond is currently approved for sediment capture and any impounded water shall be allowed to seep back into the natural drainage. As of the inspection date, the pond is currently operating outside of the approved plan. Therefore, the Division is citing a problem for failure to minimize impacts to the prevailing hydrologic balance and for failure to prevent any unauthorized release of pollutants to the surface drainage system. Corrective action will require submitting evidence to the Division that the operator has repaired the broken dam by the corrective action due date. To avoid reoccurrence of this issue, the Division also requires the operator to submit a TR which redesigns the pond. A design change could be as simple as moving the pond further back from the county road or constructing a larger berm along CR 62. However, it will ultimately be up to the operator to propose a preferred design change.

**Photo 6: Sediment pond located to the southeast.**

**CORRECTIVE ACTIONS:** Corrective action will require submitting evidence to the Division that the pond dam has been repaired by the corrective action due date. The Division also requires the operator to submit a separate TR which redesigns the pond to avoid reoccurrence of the issue.

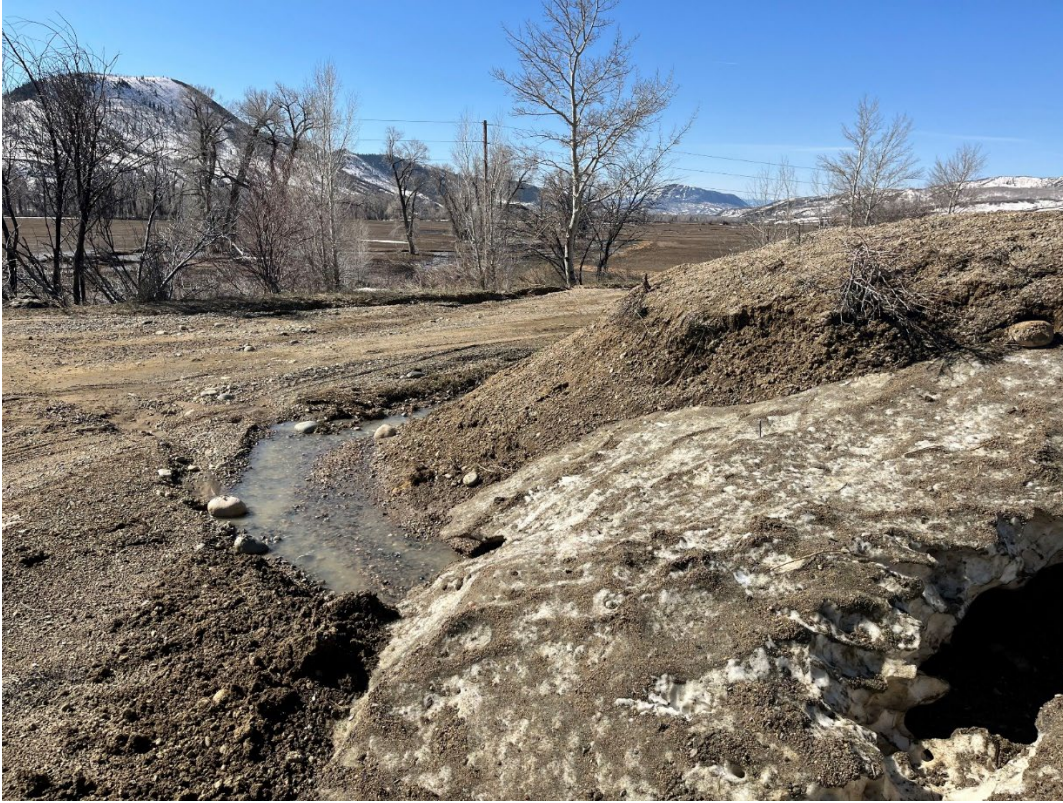
**Photo 7: Water is flowing through the dam surrounding the sediment pond and draining to a ditch along CR62.**

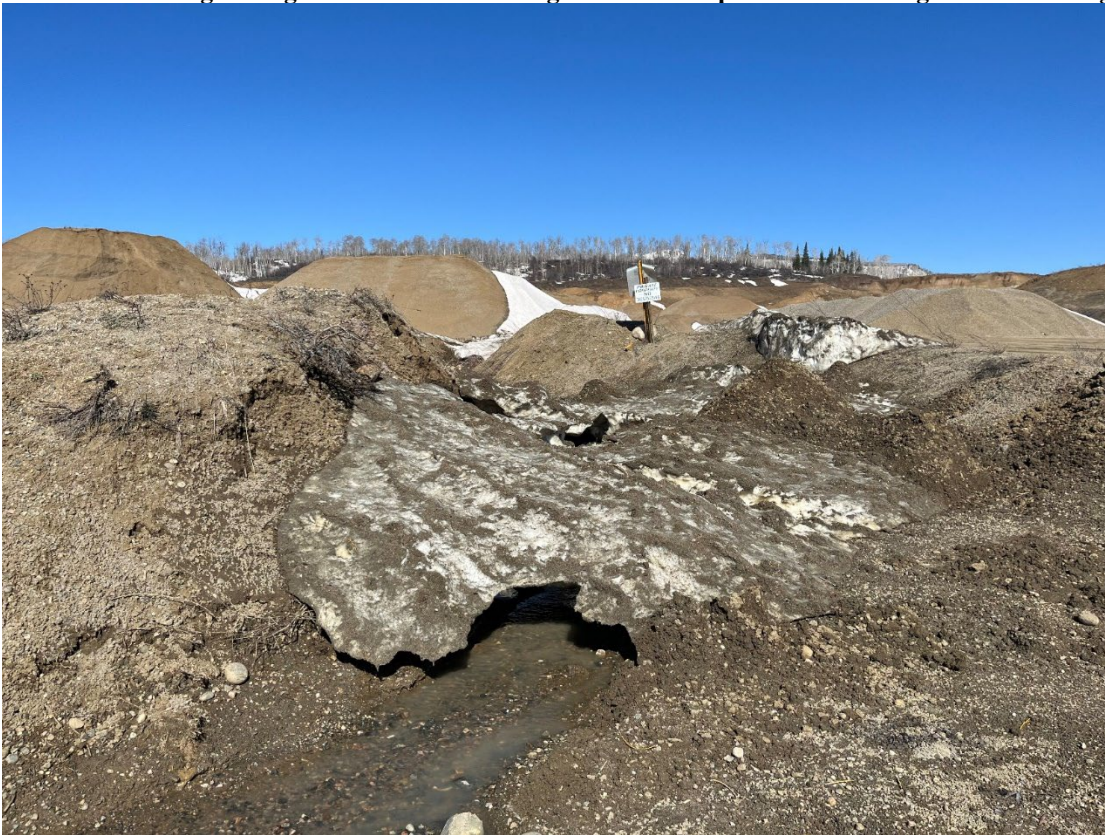
**Photo 8: View north of sediment pond and break in the dam which is allowing water to flow into the ditch along CR62. See above problem citation.**

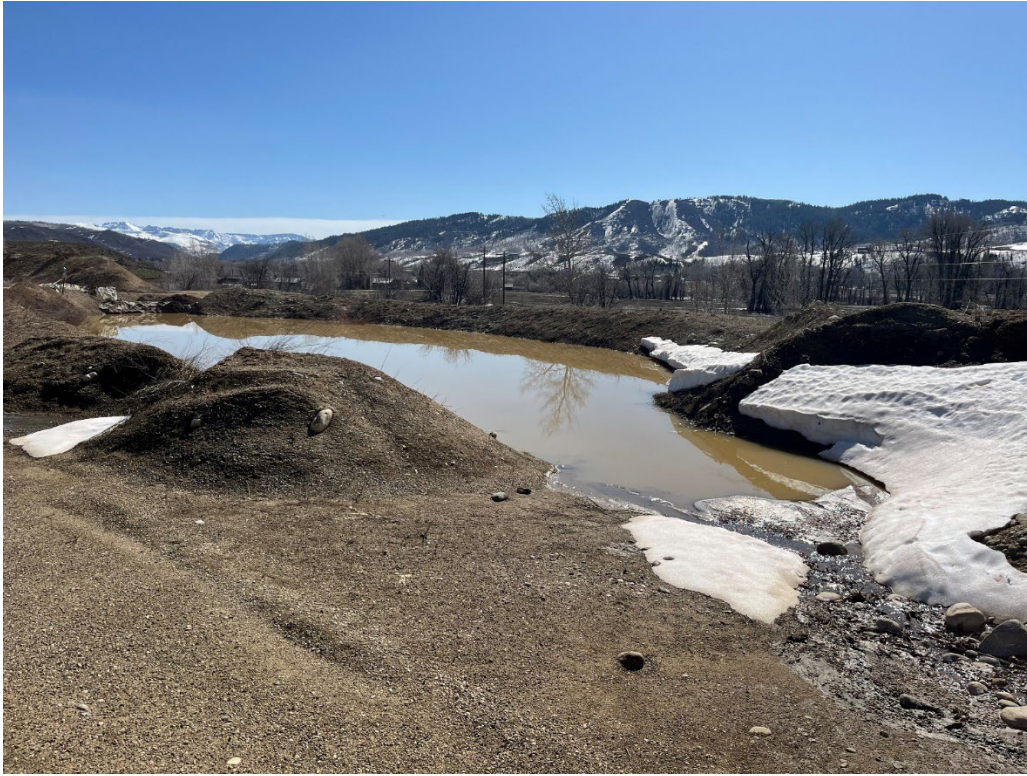
**Photo 9: View east of the sediment pond to which all site surface water drains.**

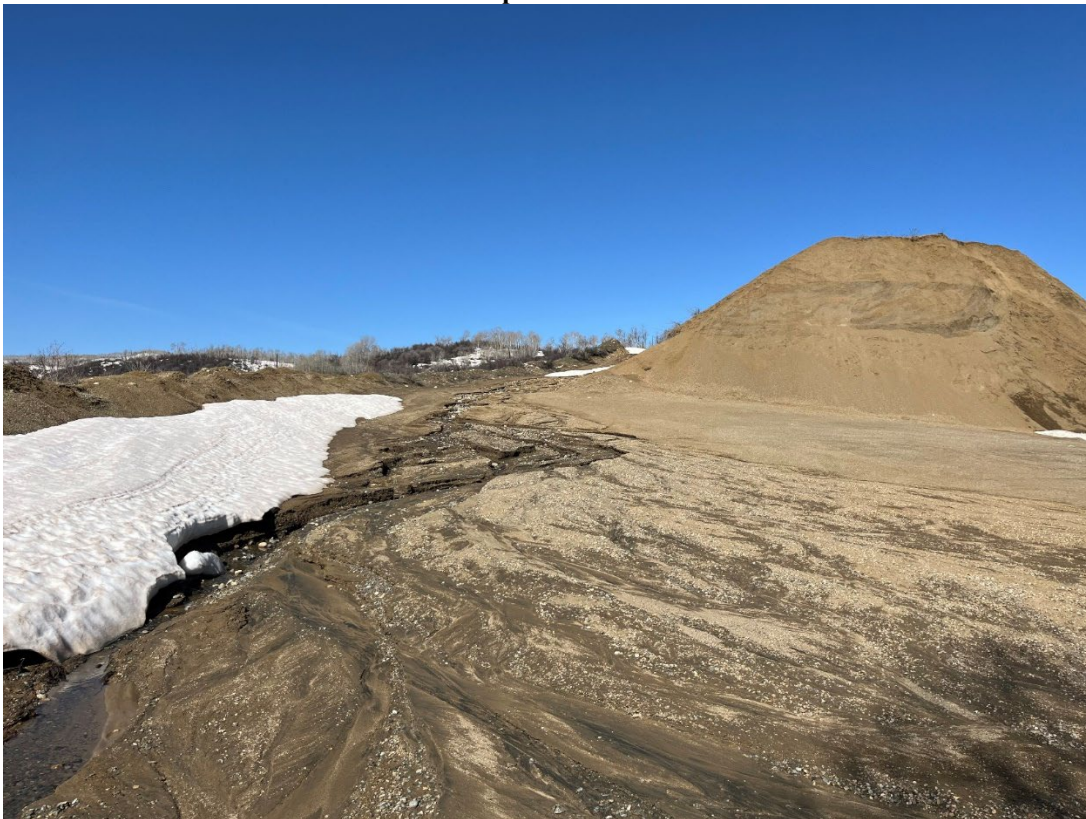
Unmined acreage within the permit boundary serves as buffer zones and topsoil/overburden stockpile areas. The largest of these topsoil and overburden piles are located to the west and to the south, atop the mined slopes (Photo 20). Several of these slopes show signs of deep erosional features (Photos 10, 15, and 16). The post mining land use approved in the original permit is Rangeland. Sufficient quantities of topsoil material will be available on site for reclamation, and enough topsoil will be salvaged in order to be distributed over the disturbed areas during reclamation at a depth of no less than 8 inches. Topsoil piles are currently vegetated. Several Sandhill cranes were observed in these unmined areas of the site.

**Photo 10: View north of the western pit boundary. Deeply incised erosional features are seen coming from uphill where water drains to the sediment pond. Water is flowing outside of the ditch in which it is designed to collect.**

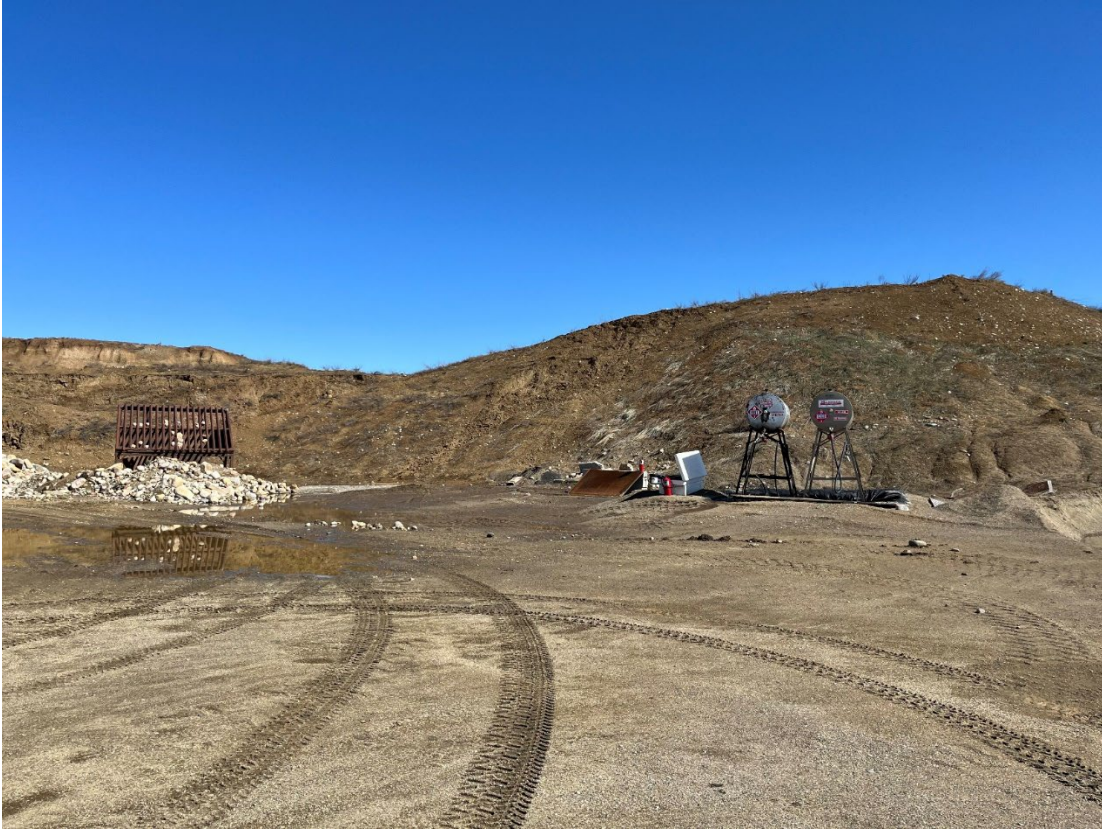
**Photo 11: Northeastern area of the pit which contains grizzly bars and fuel in secondary condiment.**

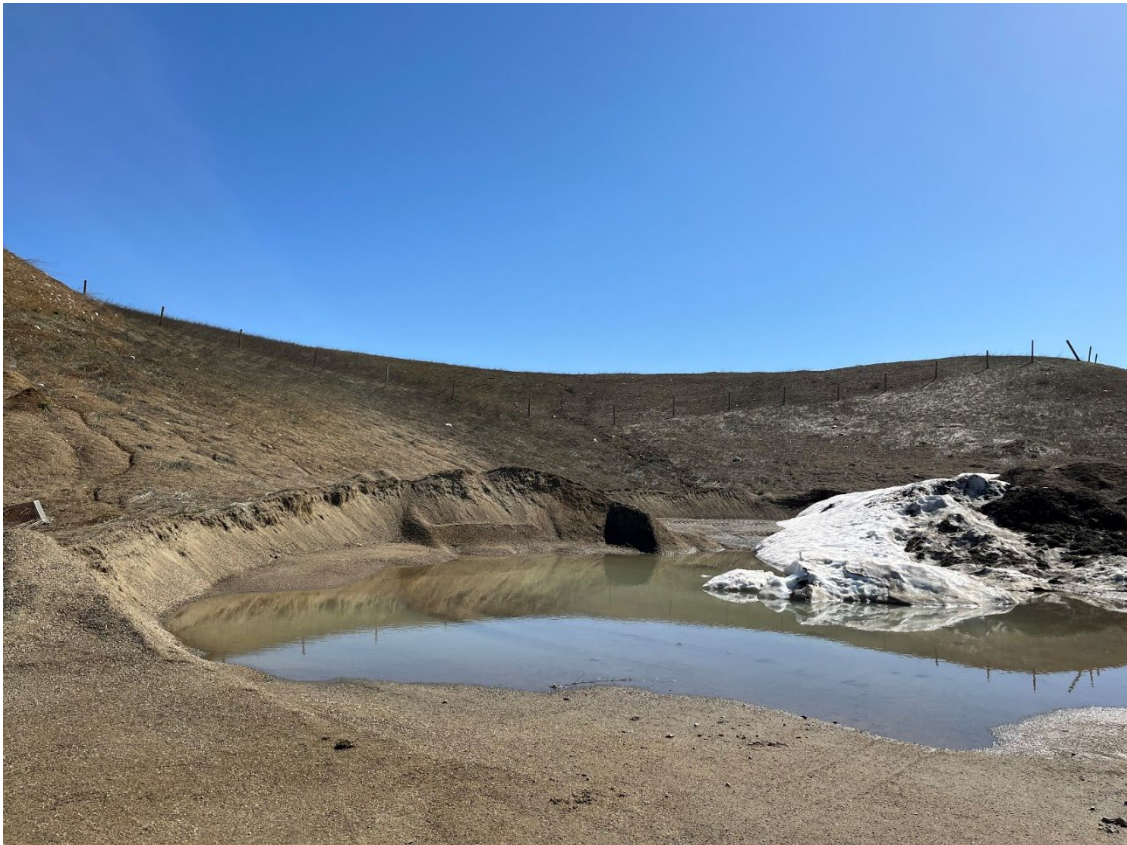
**Photo 12: Area directly east of the fuel storage area. Snowmelt in this area is draining slowly.**

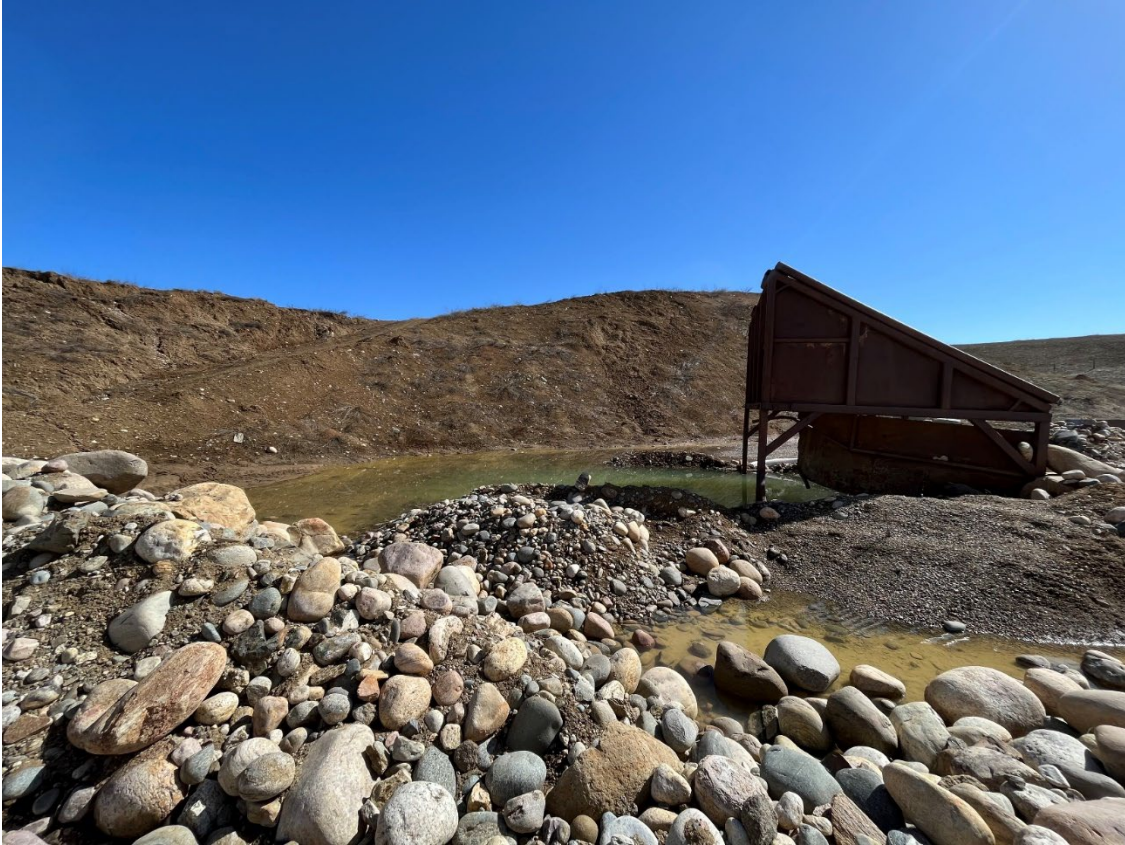
**PROBLEM/POSSIBLE VIOLATION:** Problem: The site is improperly impounding surface drainage/runoff.

Heavy winter precipitation and recent rapid snowmelt have made pit conditions wet and muddy. However, snowmelt is running downslope towards an approved sediment pond located in the southwest of the permit boundary. Recent flooding as a result of this snowmelt has also caused major flooding across Routt County, and has caused erosional damage to the mine access road (Photo 3). While most snowmelt puddles across the site are shallow, the areas behind the grizzly bars was noted to be impounding several inches of water (Photo 13). Various stockpiles around this area are blocking the natural drainage of this water. Pursuant to State Engineer (Division of Water Resources) statutes, all impounded storm water must be released o the natural drainage system within 72 hours of the event. Therefore, under Rule 3.1.6(1)(a), the Division is citing a problem for failing to comply with applicable Colorado water laws and regulations governing injury to existing water rights. Corrective action will require submitting evidence to the Division that the impoundment has been pumped by the corrective action due date.

**Photo 13: Area behind grizzly bars. Various stockpiles appear to be impounding several inches of water, blocking its flow to the approved drainage path of the site. See above problem citation.**

**CORRECTIVE ACTIONS:** Corrective action will require submitting evidence to the Division that the impounded stormwater has been released to the natural drainage system by the corrective action due date.

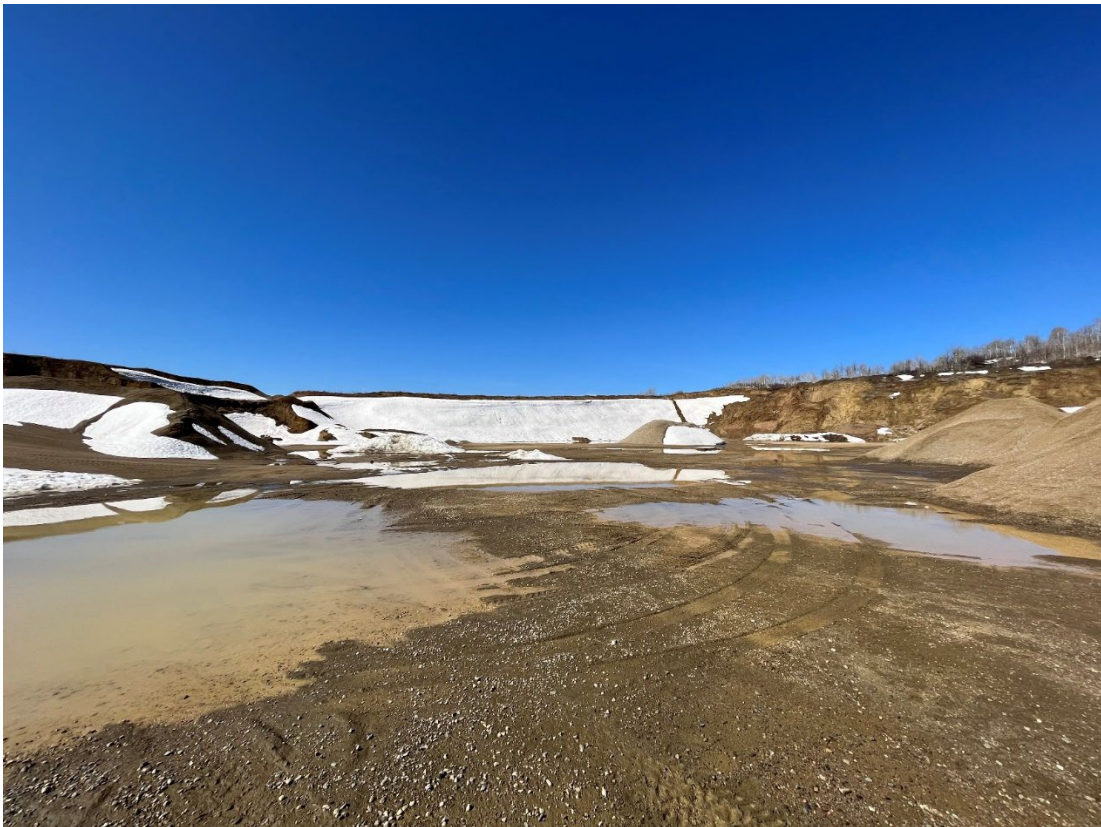
**Photo 14: View south of various stockpiles. Topsoil is stored above this slope to the west.**

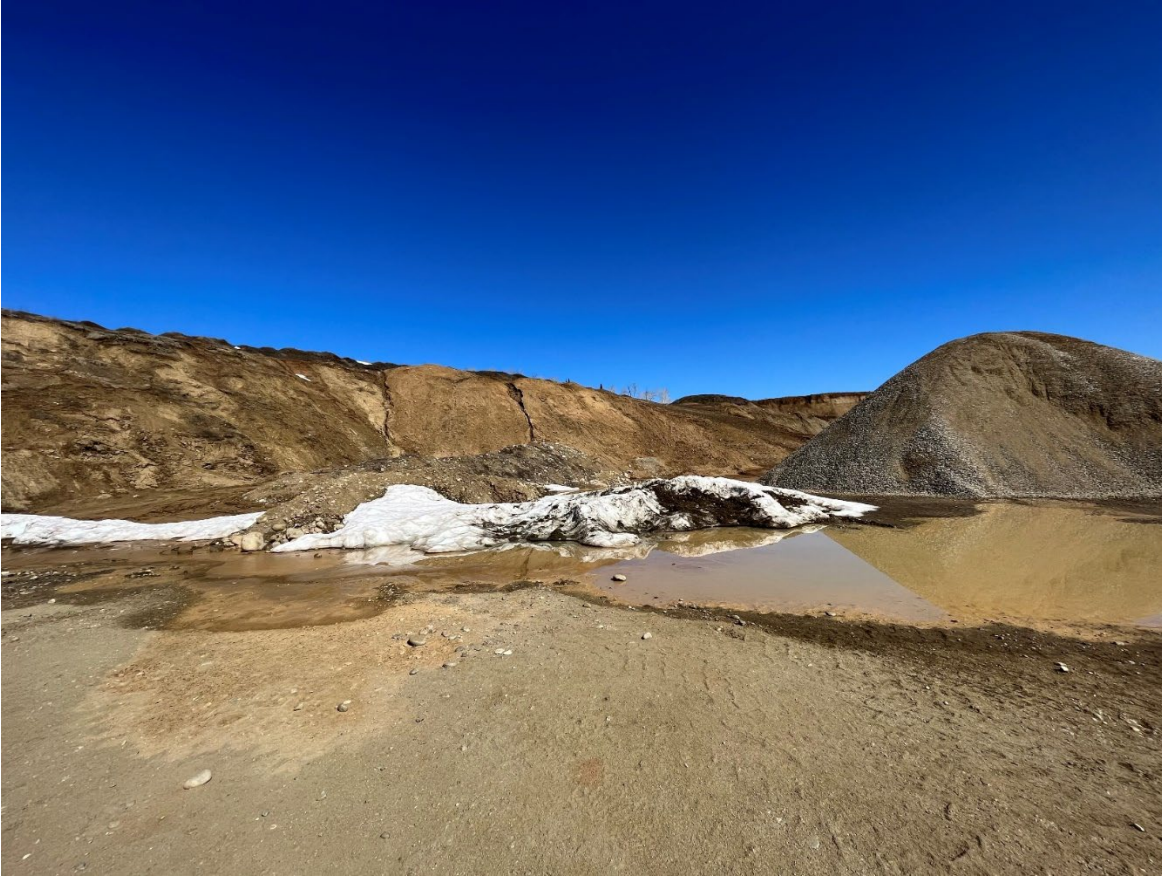
**Photo 15: View to the northwest of a stockpile. Topsoil is stored atop this slope. Erosional features are noted.**

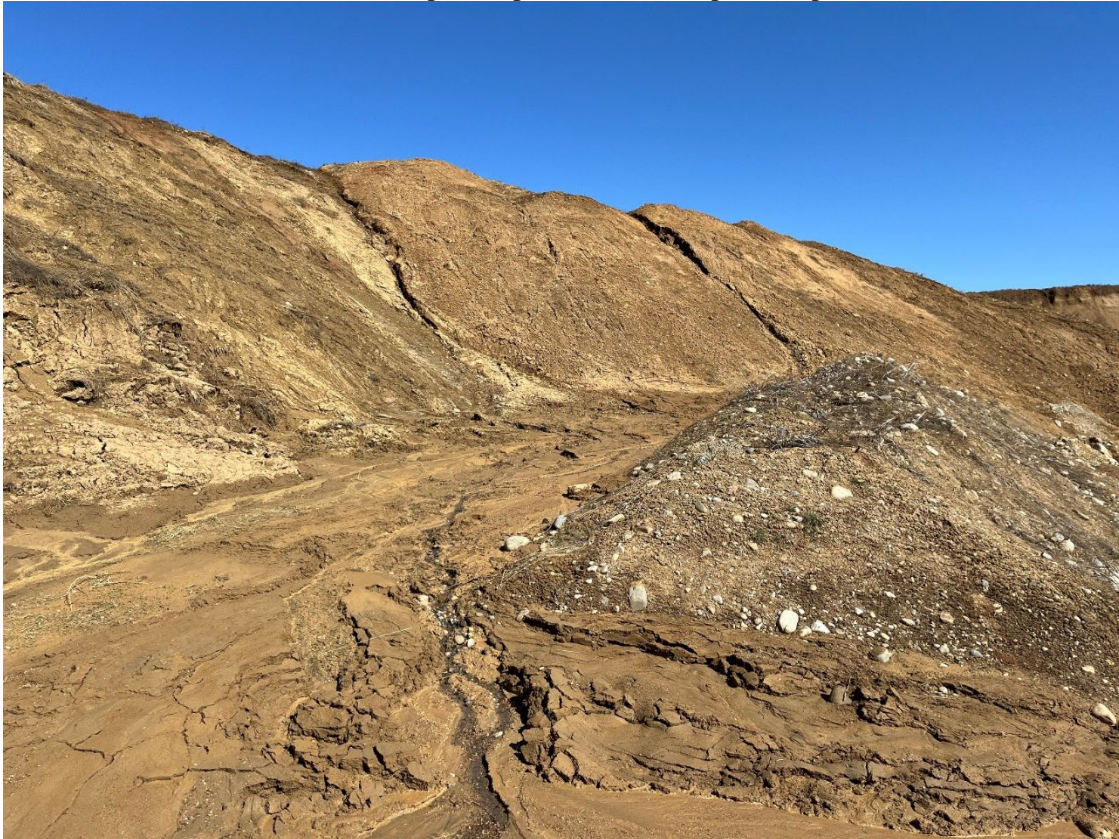
**Photo 16: View northwest of deeply incised erosional features seen on stockpile.**

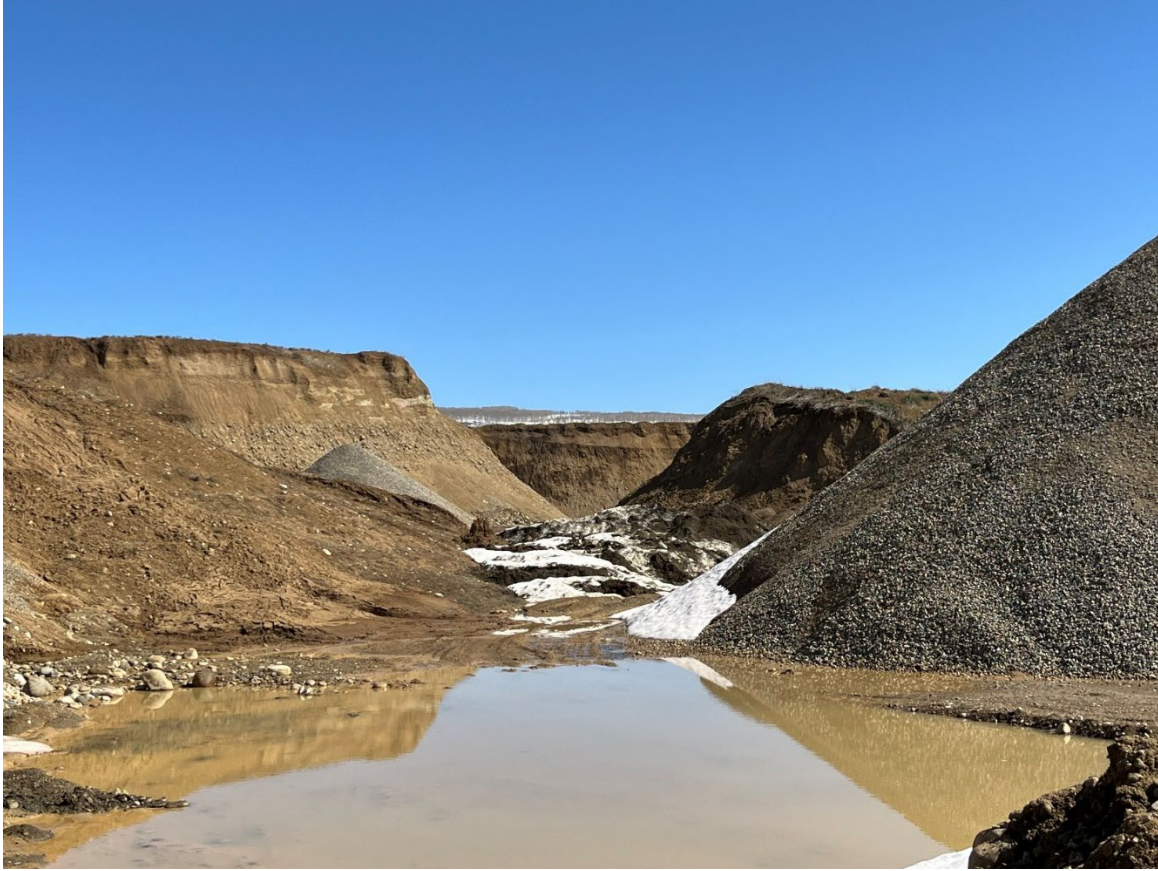
**Photo 17: View north of the expanded mining highwall area, area was added under AM1 and is comprised of 8 acres.**

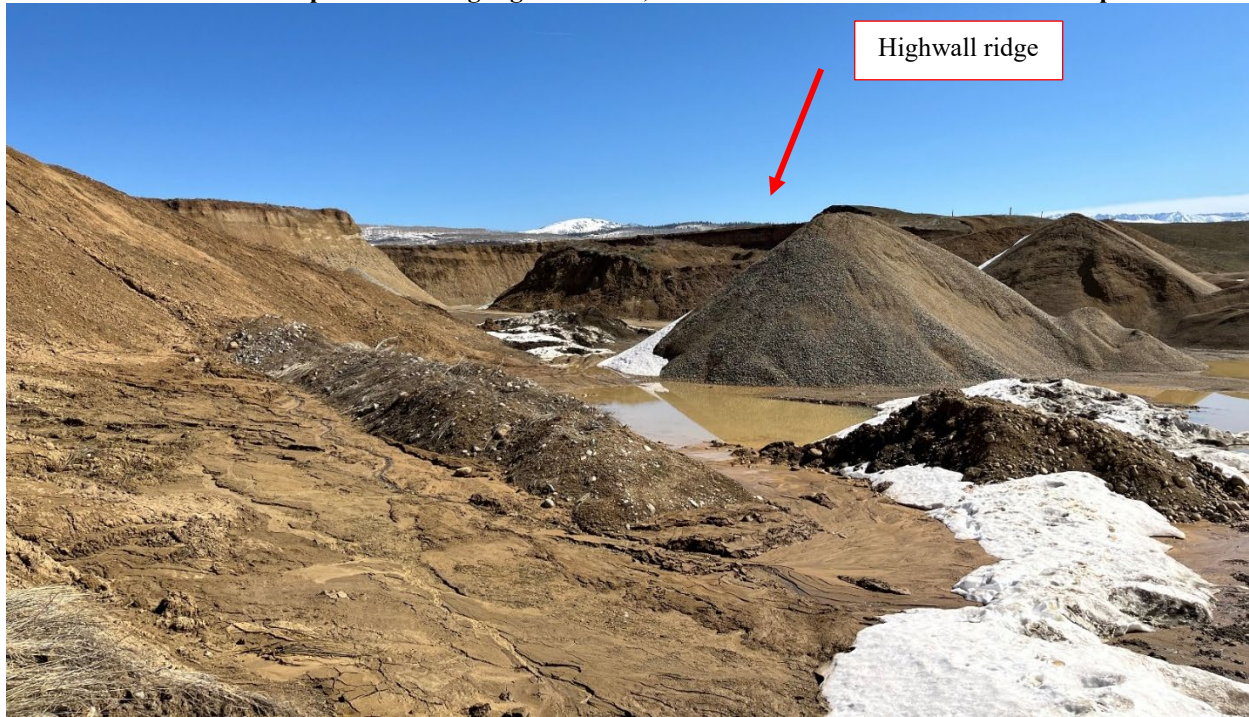
**Photo 18: View northeast of the AM1 expansion area. Upper ridge of highwall is visible.**

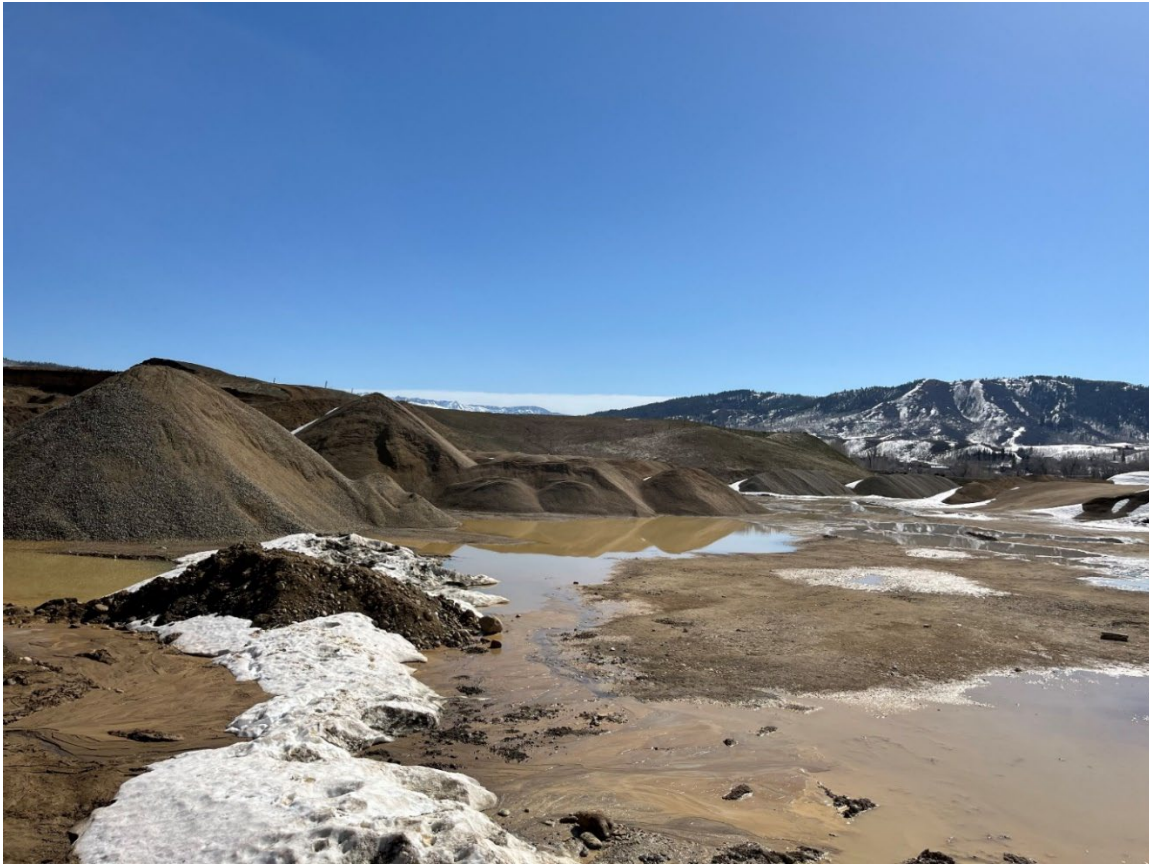
**Photo 19: View to the east of material stockpiles and slopes which are within the permit boundary, but not part of active mining.**

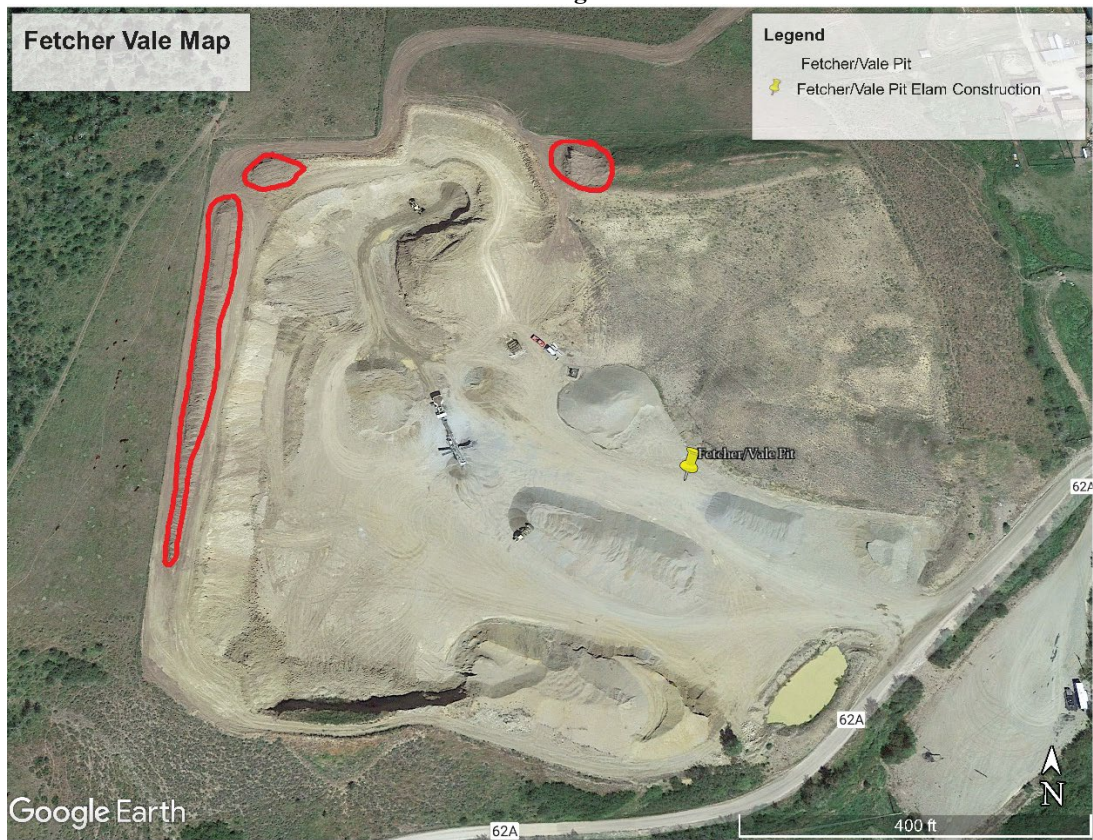
**Photo 20: Site map showing location of topsoil (west) and overburden (north) piles.**
