PERMIT INFORMATION

Permit Number: C-1981-019 Mine Name: Colowyo Coal Mine Operator: Colowyo Coal Company L.P. Operator Address: Mr Tony Tennyson 5731 State Highway 13 Meeker, CO 81641	County: Moffat, Rio Blanco Operation Type: Surface Permit Status: Active Ownership: Private
	Operator Representative Present: Tom Fry and Tony Tennyson
Operator Representative Signature: (Field Issuance Only)

Inspection Start Date: May 11, 2023 Inspection Start Time: 07:30 Inspection End Date: Inspection End Time:	Inspection Type: Coal Partial Inspection Inspection Reason: Normal I&E Program Weather: Raining	
Joint Inspection Agency: None	Joint Inspection Contacts:	
Post Inspection Agency: None	Post Inspection Contacts:	
Inspector(s): Zach Trujillo	Inspector's Signature:

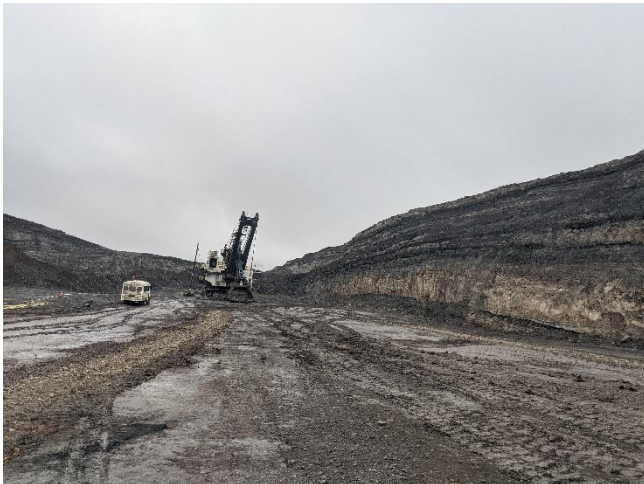
Shovel located within Collom Pit.

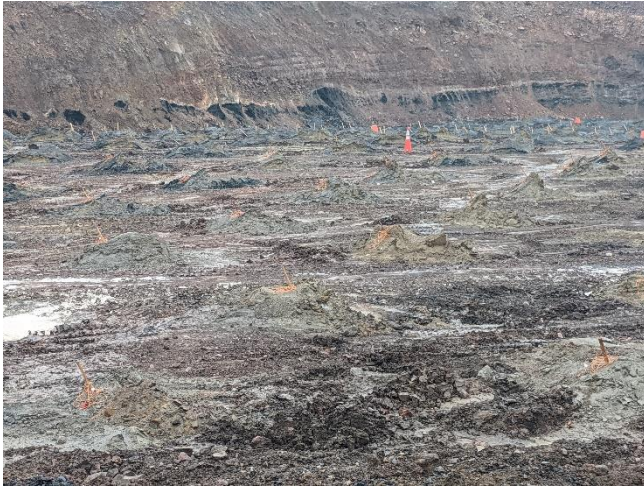
Drilling for a future blast had occurred prior to the inspection and were being prepared during the inspection. The blast was going to occur in the previous highwall miner bench located within the Little Collom Gulch. The fill will be used for future benching to allow the highwall miner to reach upper coal seams located along the other side of the drainage.

Blast hole preparation at Little Collom Gulch.

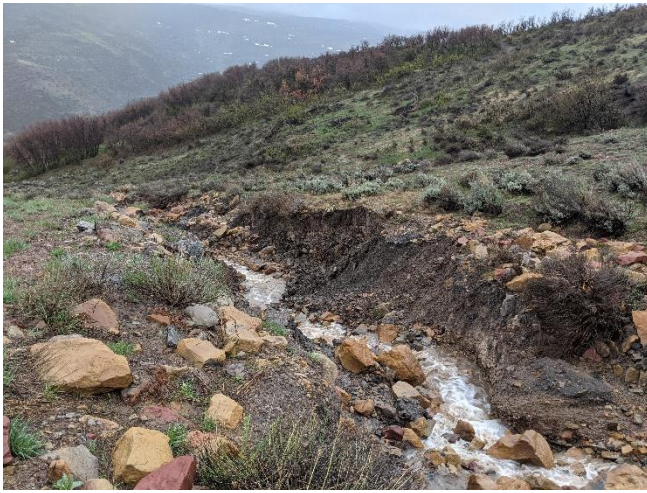
The entirety of the Final East Pit Ditch (FEPD) and North Trib. East Pit Ditch (NTEPD) was inspected. Due to recent snow melt as well as raining conditions during the inspection. The FEPD was flowing with surface runoff. The FEPD is broken into three reaches separated two by stock ponds. Reach 2 and 3 of the FEPD were stable with no issues and the associated stock pond EP2 was full and discharging into Reach 2 from the spillway. Stock pond 1 held limited water as a trickle tube has been installed at a lower elevation to the primary spillway. The lower steeper portion of Reach 1 of the FEPD was inspected. This reach was damaged during a 2022 storm event. Maintenance on Reach 1 has not yet occurred due to winter and adverse ground conditions. Even with flowing conditions in the FEPD, not additional cutting can occur as the channel has reached bedrock. Flow from FEPD then reports to the South Collection Ditch which has been fully repaired and finally to the Prospect Pond. Repair work of the FEPD is planned for this coming spring/summer once ground conditions allow access for equipment. No issues were observed.

Reach 1 of FEPD.

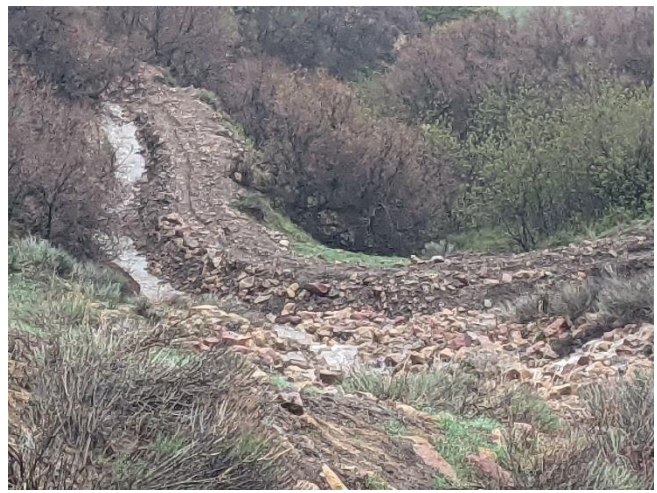
Intersection of FEPD and South Collection Ditch

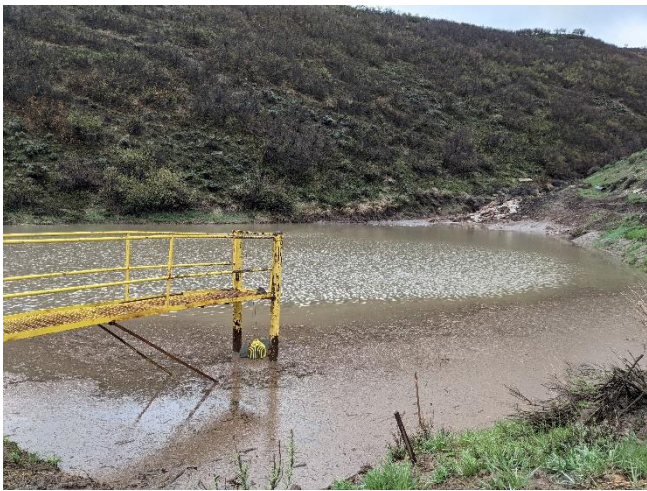
The Streeter and Prospect Pond were inspected. These ponds receive surface runoff associated with the East Pit. Both ponds held water and were discharging at the time of the inspection. Noted in the previous inspection, dead vegetation and debris was frozen along the primary spillway and was in need of maintenance. The debris had been removed and the primary spillway and was working properly. No issues were observed with either pond.

Prospect Pond primary spillway.

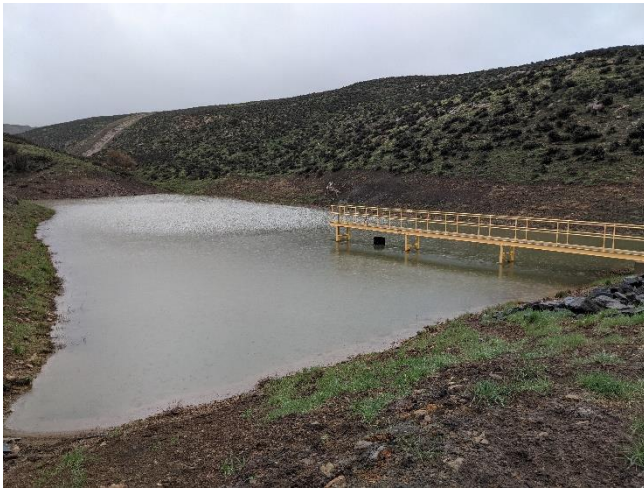
Section 36, Section 25 and Middle Ponds were inspected. These ponds are associated with Collom Pit and run in series with each other. Each of these ponds held water with discharge. Each pond was stable, well vegetated with no issues observed.

Section 25 Pond.

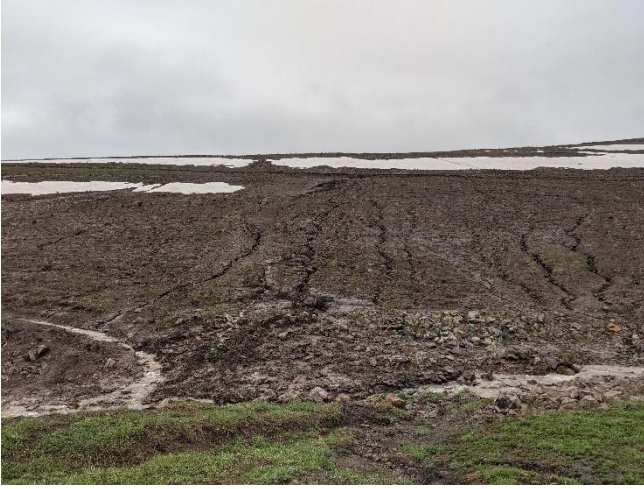
Minor rilling was observed along the north facing slope along the Final East Pit Ditch drainage. This is generally standard for this area due to the seeps, precipitation along the area as well as the generally steep slopes. At this time, there is no major issue but should be monitored and repaired as necessary as part of normal husbandry practices.

Minor rilling at the Final East Pit Ditch drainage.
