MINERALS PROGRAM INSPECTION REPORT

MINE NAME: Project P.J.	MINE/PROSPECTING ID#: M-2018-007	MINERAL: Gemstones	COUNTY: Teller
INSPECTION TYPE: Surety Release Inspection	INSPECTOR(S): Elliott Russell	INSP. DATE: June 30, 2022	INSP. TIME: 11:15
OPERATOR: Taylor Conway	OPERATOR REPRESENTATIVE: Trent Smith	TYPE OF OPERATION: 110(1) - Hard Rock Limited Impact	
REASON FOR INSPECTION: Surety Release Requested	BOND CALCULATION TYPE: None	BOND AMOUNT: \$21,000.00	
DATE OF COMPLAINT: NA	POST INSP. CONTACTS: None	JOINT INSP. AGENCY: None	
WEATHER: Clear	INSPECTOR'S SIGNATURE:

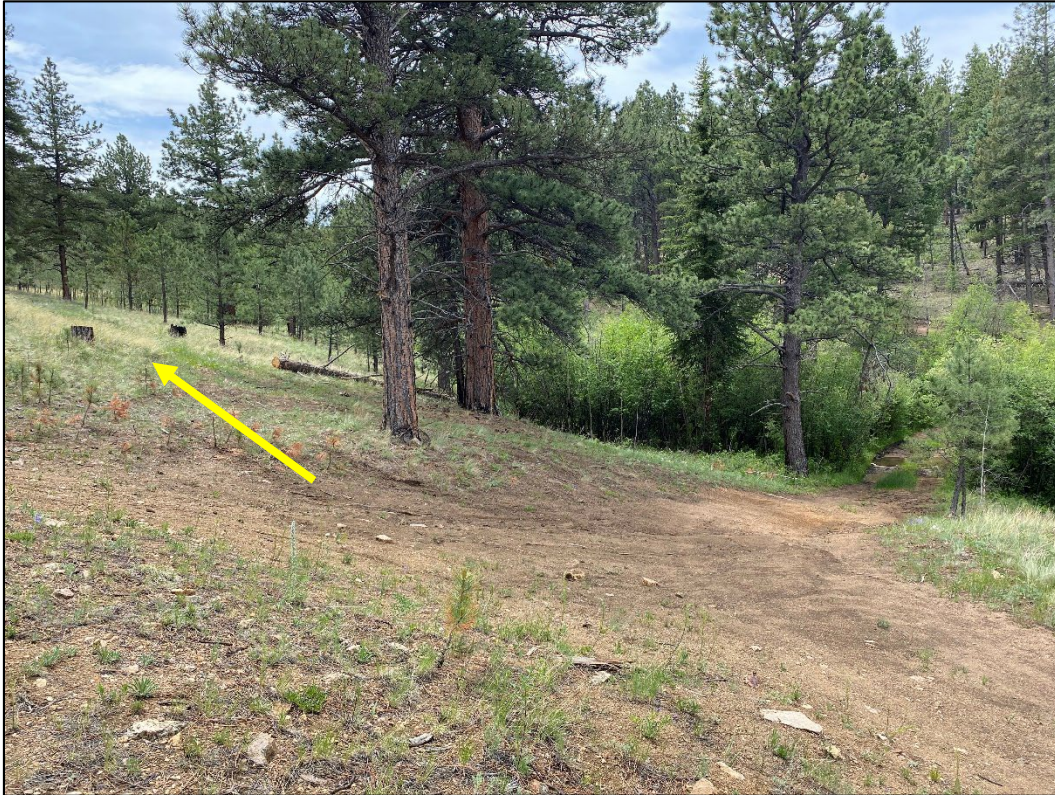
The Division met Trent Smith at the new mine site entrance along the access road to the Amazonite #8 mining area of Permit No. M-2014-042. The Division walked the entire route of the new proposed access road. This consisted of a very faint, old two-track route that the Operator will now use for accessing the Project P.J. mining areas. Mr. Smith indicated the Forest Service is requiring the Operator to establish multiple water bars to minimize on the erosion and sedimentation from the new access road.

Photo 1. New access route (arrow) entrance along M-2014-042 access road #8; looking south.

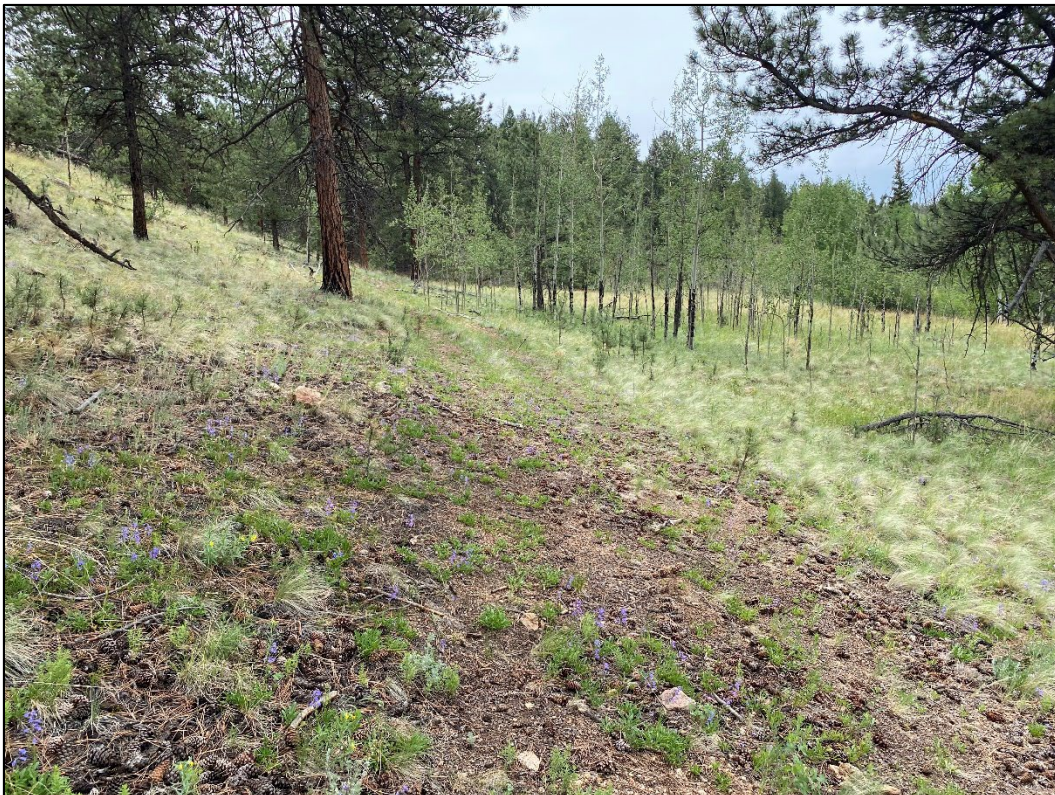
Photo 2. Example photo along new access route; looking south.

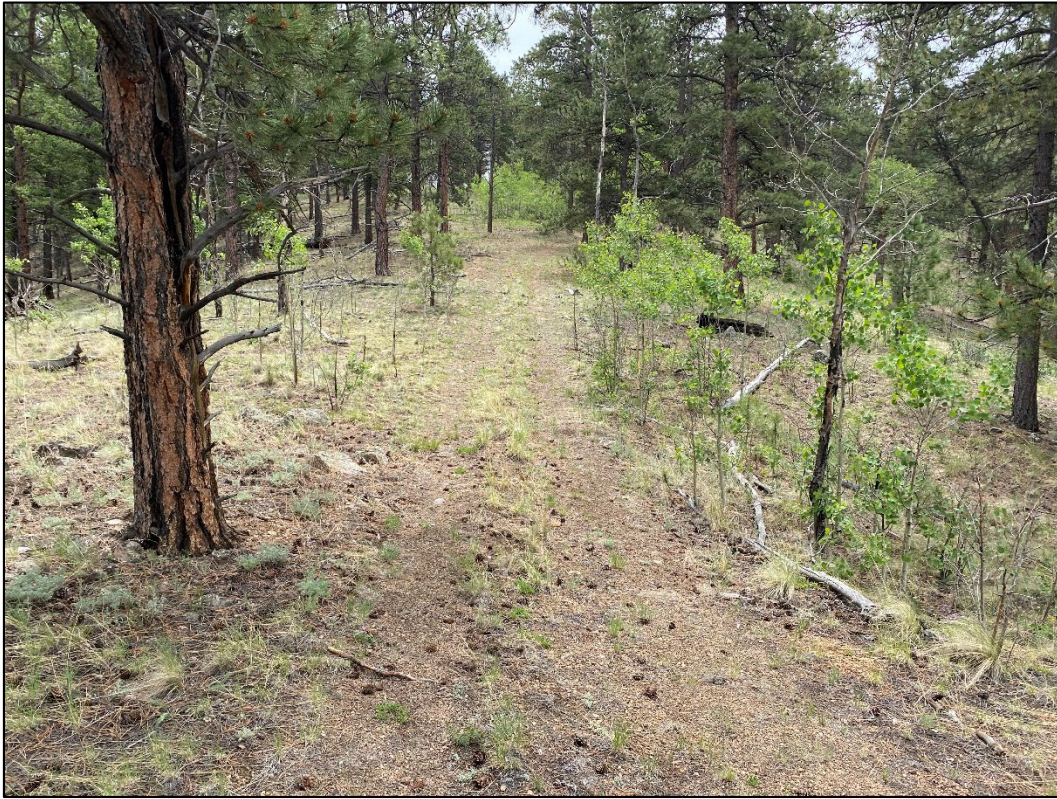
Photo 3. Example photo along new access route; looking east.

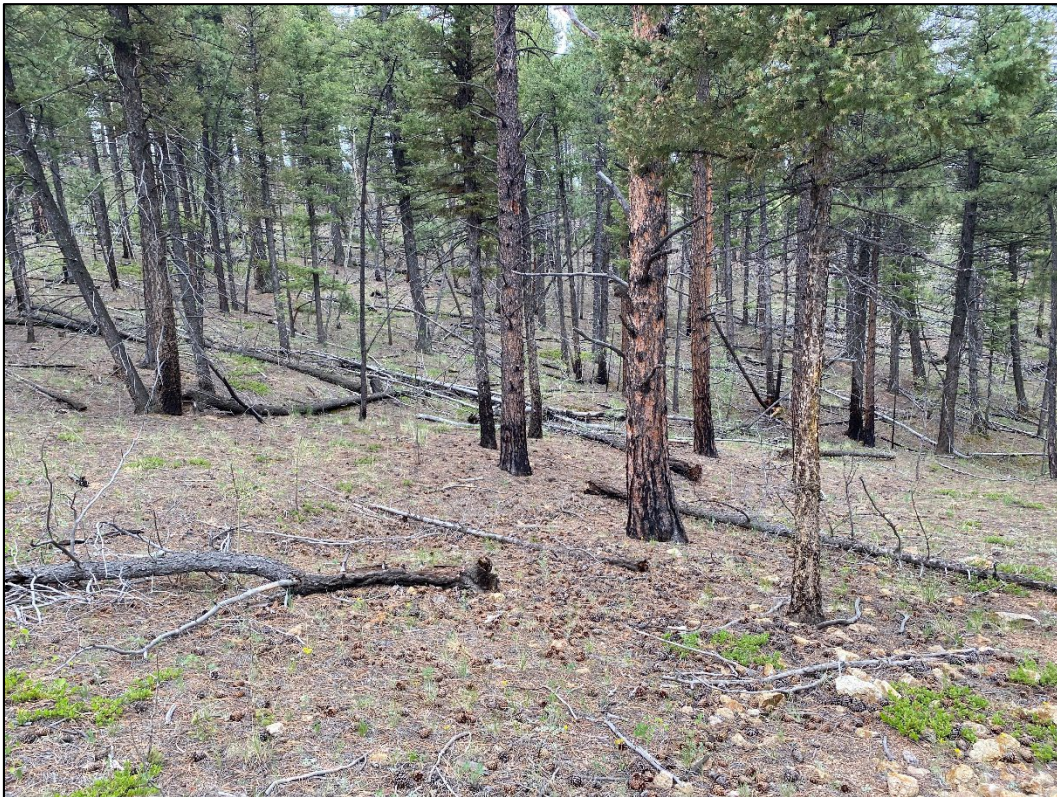
Photo 4. Example photo of Mining Area #3; looking southwest.

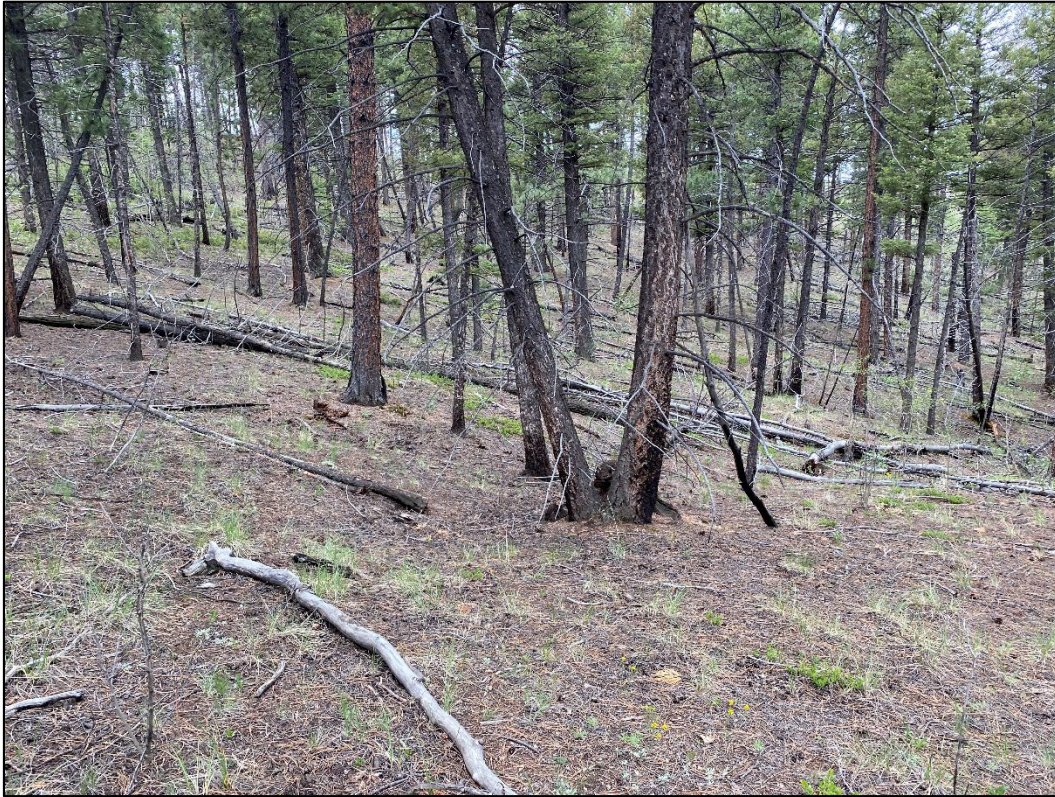
Photo 5. Example photo of Mining Area #3; looking southwest.

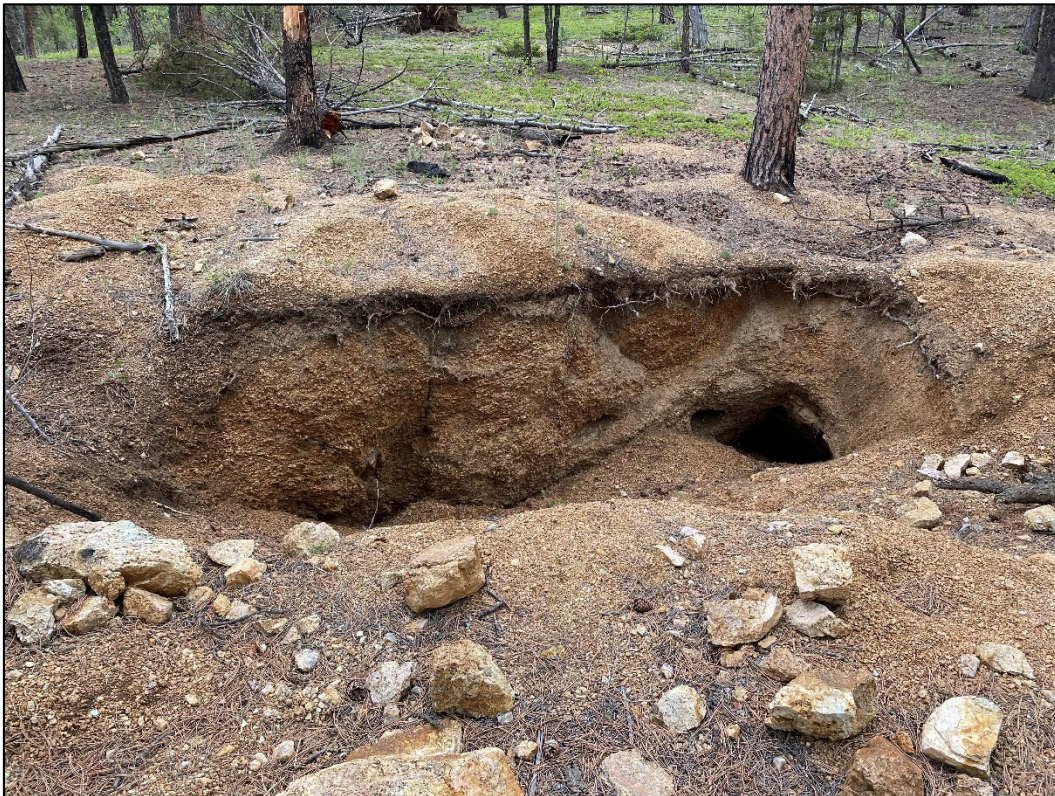
The Division inspected Mining Area #3. As the Operator has discussed, no mining has occurred under this permit, the intent of the inspection was to confirm there are no recent disturbances to the land. Please note, Mining Area #3 included pre-existing disturbances, some of which are associated with File No. M-2013-044, an illegal operation. Mining Area #3 also contains some small hand-digging disturbances from recent mineral trespassers. The Operator indicated that they hope to backfill these disturbances and complete reclamation on them, if authorized by the Forest Service to do so, once they can use the new access route. Based on observations made during the inspection, the Division will approve the Request for Acreage Reduction AR1, and therefore AM1, which has been in an approvable form, will also be approved.

Photo 6. M-2013-044 disturbances in Mining Area #3; looking east.

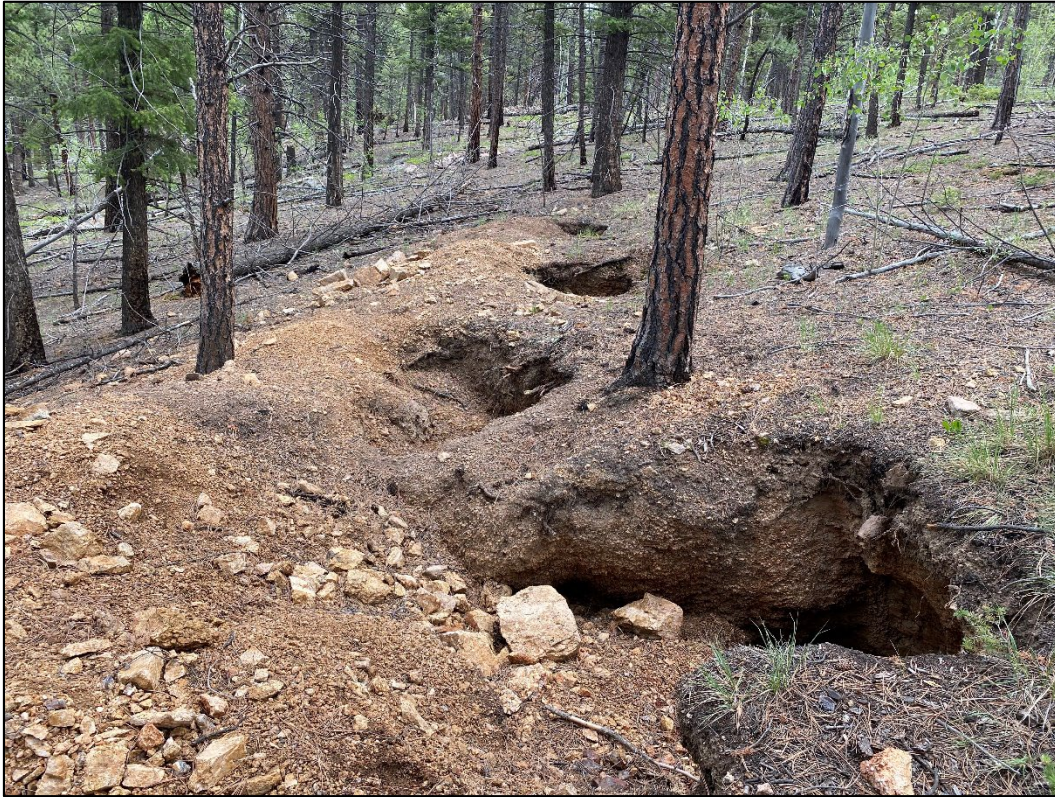
Photo 7. Mineral trespass hand-digging disturbances in Mining Area #3; looking east.
