**MINERALS PROGRAM INSPECTION REPORT**  
**PHONE: (303) 866-3567**

<b>MINE NAME:</b> The Bank	<b>MINE/PROSPECTING ID#:</b> P-2014-013	<b>MINERAL:</b> Gemstones	<b>COUNTY:</b> Park
<b>INSPECTION TYPE:</b> Monitoring	<b>WEATHER:</b> Cloudy	<b>INSP. DATE:</b> June 30, 2022	<b>INSP. TIME:</b> 10:30
<b>OPERATOR:</b> Smash Brothers Explorations	<b>OPERATOR REPRESENTATIVE:</b> Trent Smith	<b>TYPE OF OPERATION:</b> MP - Mineral Prospecting	
<b>REASON FOR INSPECTION:</b> Normal I&E Program	<b>BOND CALCULATION TYPE:</b> Complete	<b>BOND AMOUNT:</b> \$7,100.00	
<b>DATE OF COMPLAINT:</b> NA	<b>POST INSP. CONTACTS:</b> None	<b>JOINT INSP. AGENCY:</b> None	
<b>INSPECTOR(S):</b> Elliott Russell	<b>INSPECTOR'S SIGNATURE:</b>

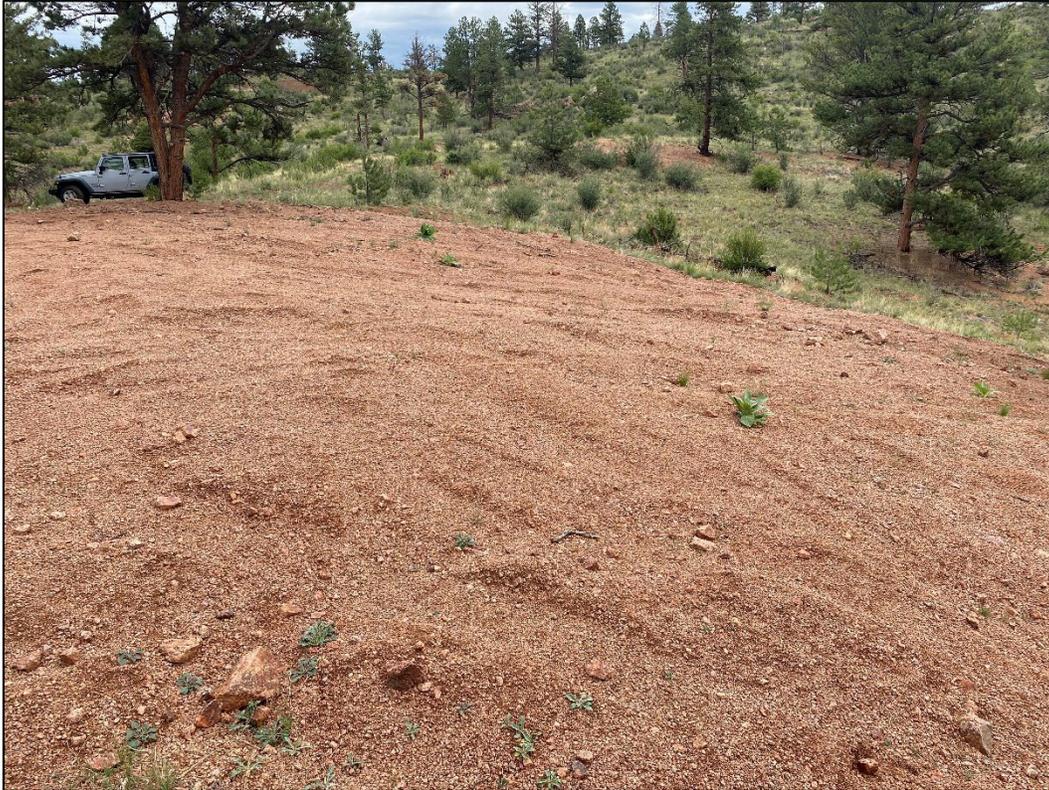
Backfilling and Grading: The site has been appropriately backfilled and graded to blend with the surrounding area.

**Photo 1.** Backfilled and graded site; looking north.

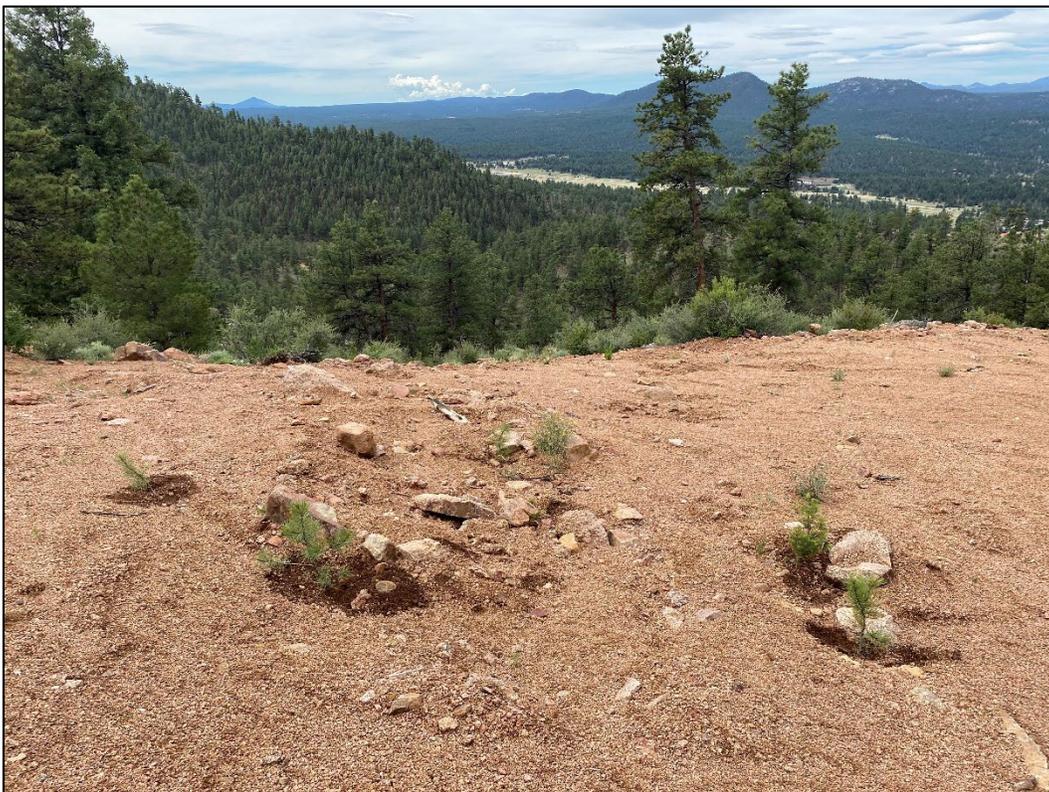
**Photo 2.** Backfilled and graded site; looking south.

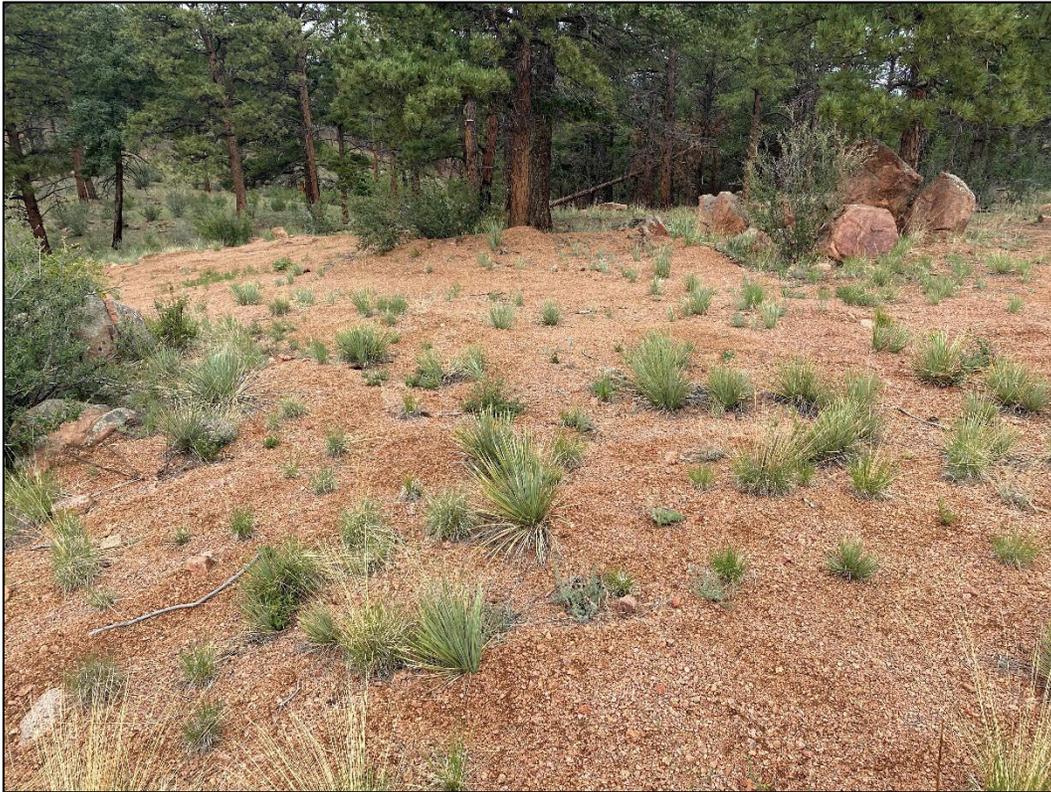
Revegetation: Appropriate vegetative cover has yet to reestablish on the disturbance area; the Division recommends the Prospector evaluate the site this fall and possibly reseed/inter-seed to help achieve revegetation timelier. No noxious weed infestations were observed on the revegetated disturbances.

**Photo 3.** Backfilled and graded site, volunteer vegetation establishing; looking west.
