**COLORADO**Division of Reclamation,
Mining and Safety

PERMIT INFORMATION

| Permit Number: C-1981-012 Mine Name: New Elk Mine Operator: New Elk Coal Company, LLC Operator Address: Mr. Mark Gray 12250 Highway 12 Weston, CO 81091 | County: Las Animas Operation Type: Underground Permit Status: Active Ownership: Private |

INSPECTION INFORMATION

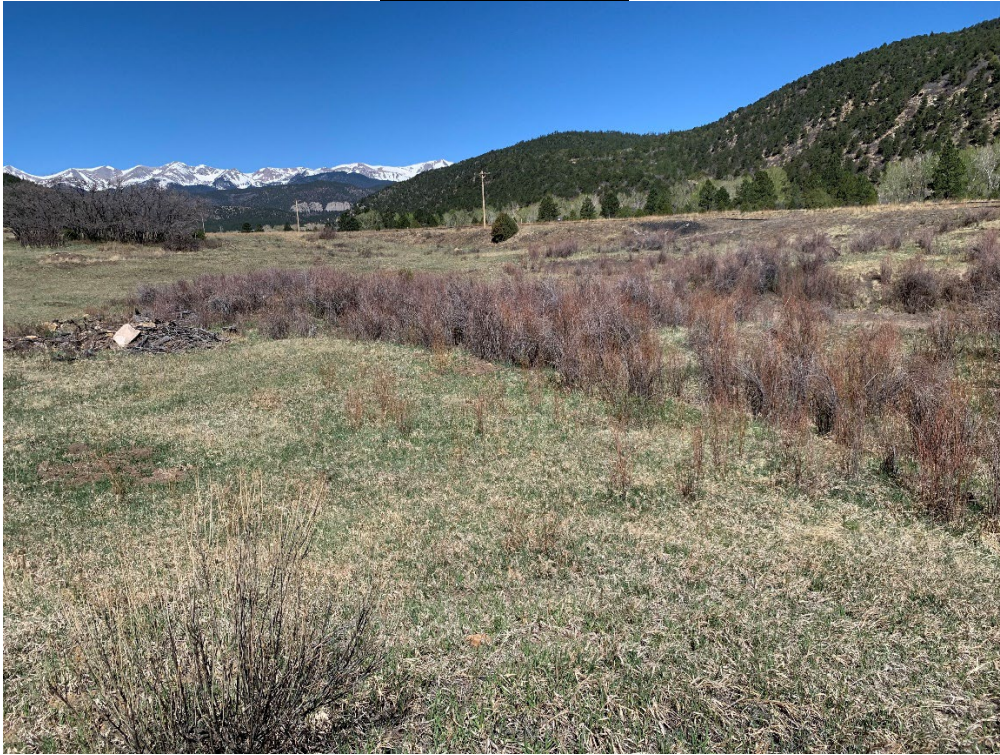
Containment area 1 was well vegetated with grasses and willows (photo 1). The embankment appeared to be stable. The area east of the containment pond will need to be reclaimed in order to qualify for bond release. Containment Area 2 was well vegetated with grasses and did not contain water. The embankment appeared to be stable. The area between containment 2 and the fan will have to be re-contoured to address permanent drainage issues before this area can qualify for final bond release.

Photo 1 – Containment Area 1 facing west

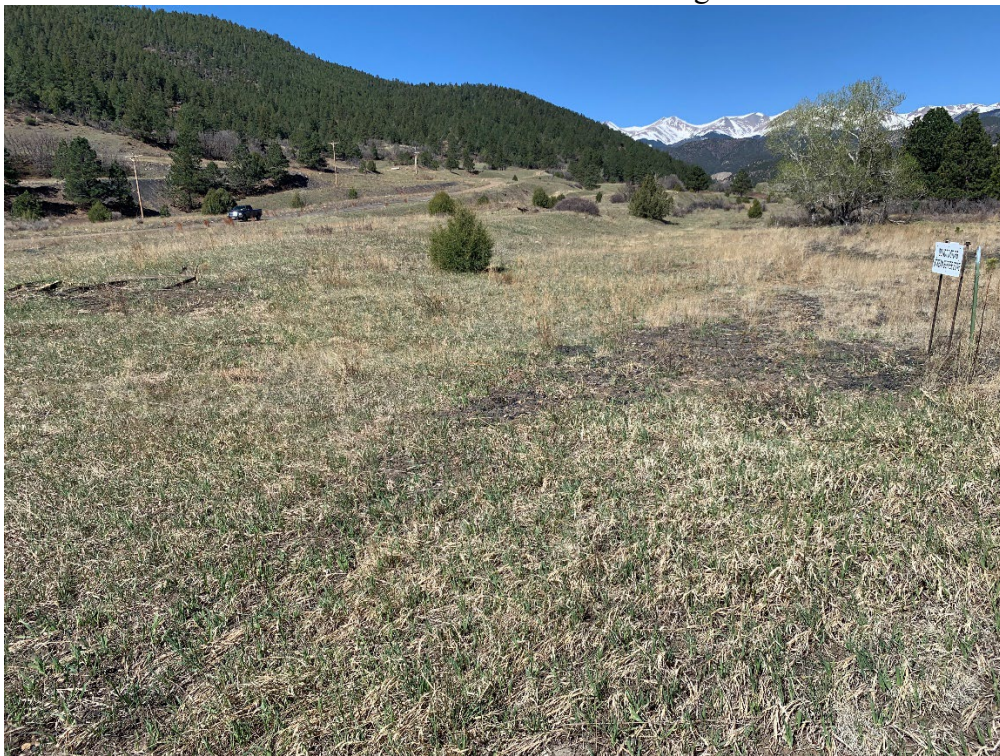
The vegetation in most of the western areas looked really good (photo 2). It is well established and effectively controlling erosion. There are some area that still need to be topsoiled and seeded and these areas will be noted on the update ARR maps.

Photo 2 – Western part of mining facilities area

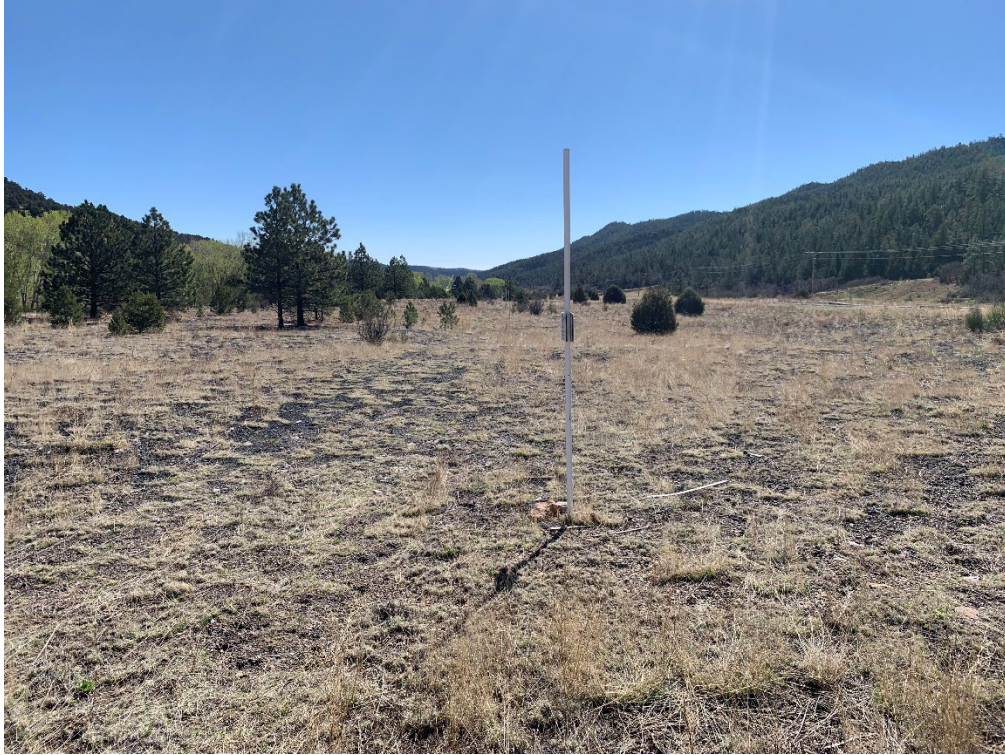
The mine entrance sign was in place at the entrance. The stream buffer zone signs were in place along the western portion of the permit area. The permit boundary markers on the western portion of the permit area are in place and well-marked (photo 3).

Photo 3 – Permit boundary marker

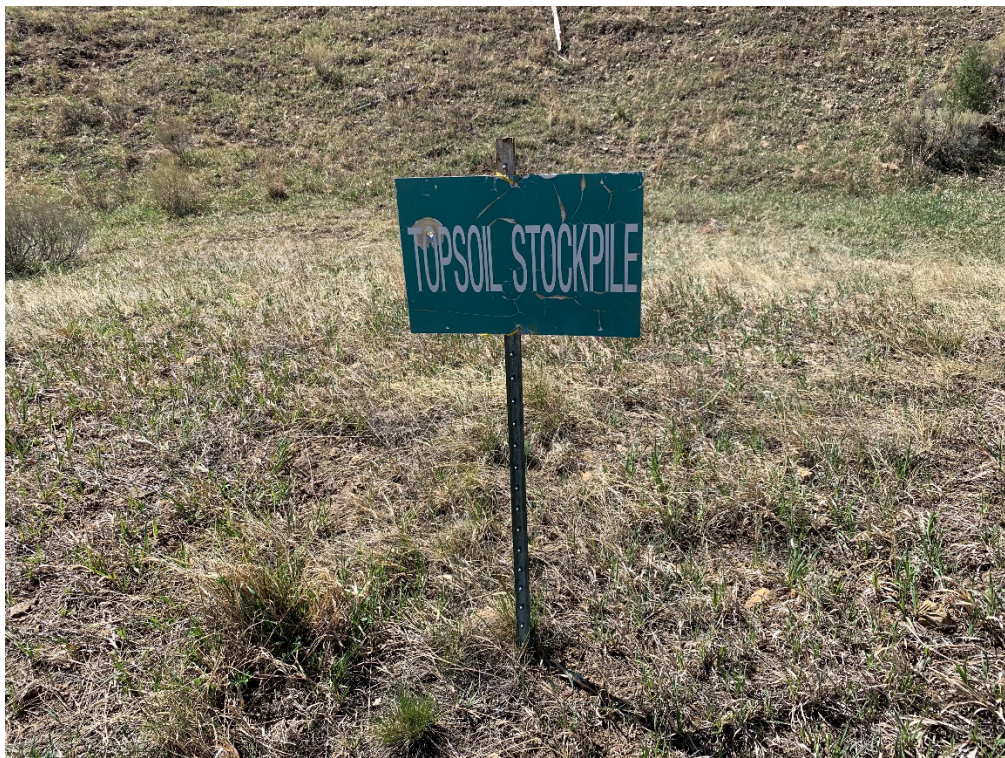
The topsoil stockpile south of containment area 1 is well vegetated and clearly marked with a sign (photo 4).

Photo 4 – Topsoil stockpile by Containment Area 1
