Bowie #2 inspection report

Permit Number: C-1996-083 Mine Name: Bowie No. 2 Mine Operator: Bowie Resources, LLC Operator Address: Mr. Basil Bear P.O. Box 1488 Paonia, CO 81428	County: Delta Operation Type: Underground Permit Status: Active Ownership: Private
	Operator Representative Present: Basil Bear
Operator Representative Signature: (Field Issuance Only)

Inspection Start Date: May 9, 2023 Inspection Start Time: 10:15 Inspection End Date: May 9, 2023 Inspection End Time: 11:50		Inspection Type: Coal Partial Inspection Inspection Reason: Normal I&E Program Weather: Clear	
Joint Inspection Agency: None		Joint Inspection Contacts:	
Post Inspection Agency: None		Post Inspection Contacts:	
Inspector(s): Clayton Wein Robert Zuber, P.E.	Inspector's Signature:

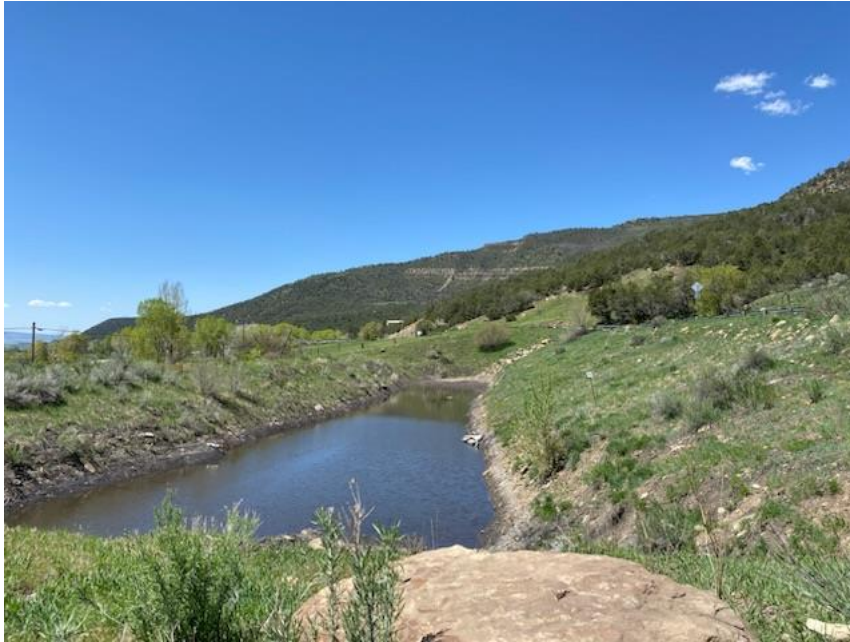
Photo 1: Pond B

Due to the closure of Highway 133, a couple of the ponds at the mine were not able to be inspected. Pond B was holding water below the level of the primary discharge outlet. The embankments of the pond were stable with vegetative cover. There were no indications of erosional features. The inlet and outlets of the pond were clear of debris. Pond C was holding a small amount of water in it at the time of the inspection. There was no discharge from the pond observed. The embankment of the pond was vegetated and stable. There were no erosional features noted. The inlet and outlet of the pond was clear. Pond D was also holding a puddle of water in it. The level of water in the pond was below the discharge outlet. The embankment was stable with no erosional features. The embankment was sufficiently vegetated. The inlet and discharge outlet for Pond D were clear of debris. Pond F, located at the southeast base of Gob pile no. 2, was impounding water. No discharge was observed. The embankment for the pond was stable with vegetative cover. There were no erosional features identified.

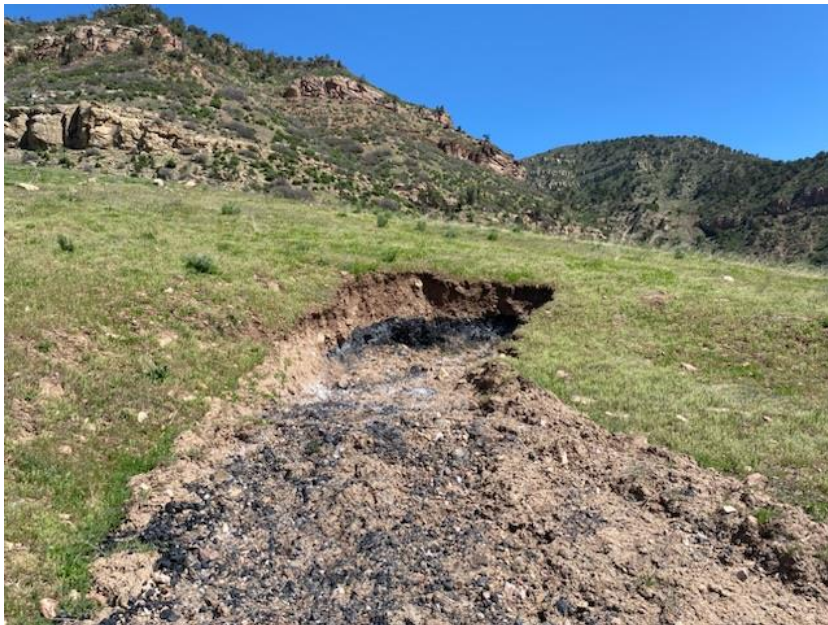
Gob Pile no.4 was covered with vegetative growth from the spring. The majority of the pile was stable with no erosional concerns. There was one slough identified during the Division's April 2023 inspection. The slough did not appear to have enlarged since the previous inspection. Minimal water seepage was observed. The size of the slough is approximately 6 feet deep by 8-10 feet wide and 20 feet long. Repairs on this section of Gob pile 4 should be feasible in the near future when the soil has had more time to dry. There were no other observed indications of instability on Gob Pile 4. No off-site impacts were observed.

Photo 4: Sloughed material on Gob Pile #4.

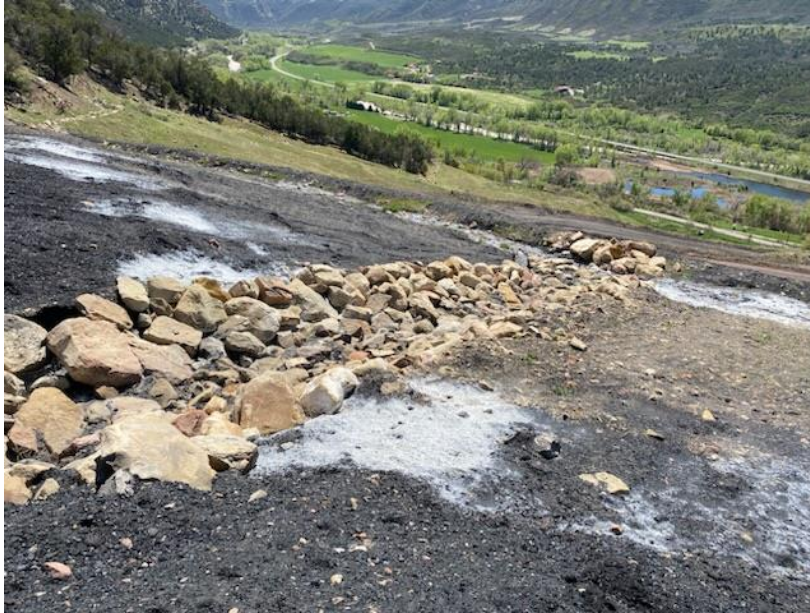
Gob Pile No. 2 has been partially reclaimed. The lower portions of the pile were observed to be stable with vegetative cover. No erosional concerns were identified. The upper portion of the pile is currently exposed. The top of the pile was stable and the surface drainage features were in good condition. Surface drainage from the top of the pile is directed to a riprap lined channel at the south east corner. The channel was stable with no indications of erosional features.

Photo 5: The riprap channel near the top of Gob Pile #2.

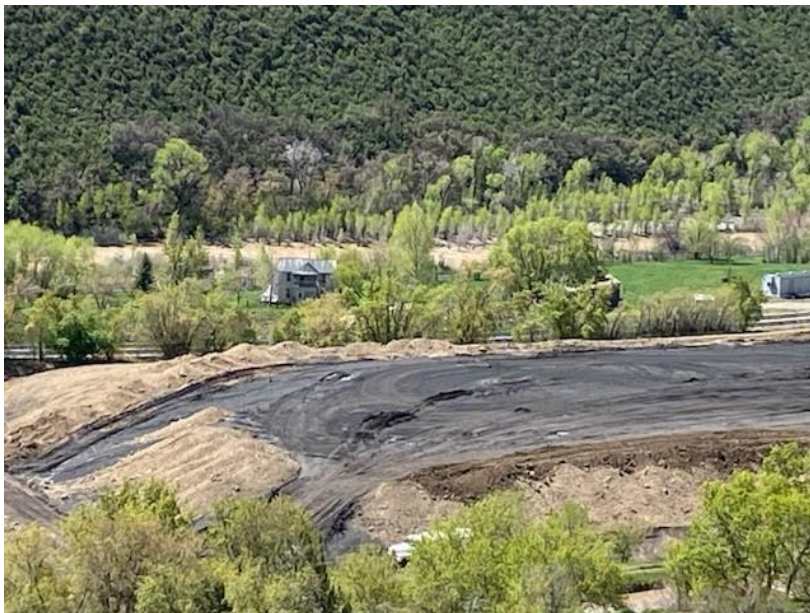
Photo 6: Gob Pile #3.

Work on Gob Pile 3 has progressed. Subsoil has been placed on a portion of the pile. The slopes of the pile were stable with no observed erosional features. Surface drainage features at the base of the pile were unobstructed. The Ditch located to the south of Gob Pile No. 3 had recently been cleaned out. The ditch was stable with no obstructions observed.

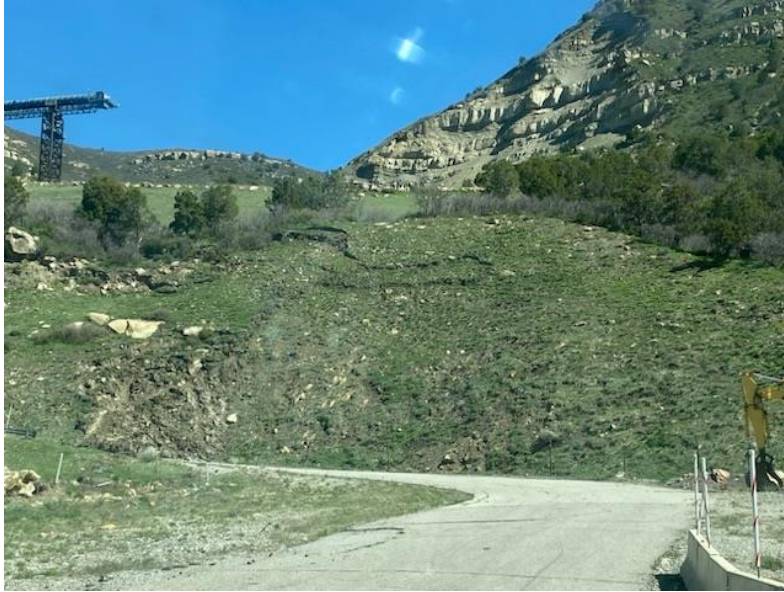
Photo 7: Curve 10 slide

The Division inspected a recent slide on the hill above curve 10 on the haul road. The slide had compressed and covered the concrete ditch along the haul road. The operator had cut a small channel through the base of the slide to allow water in the ditch to continue flowing. Water was observed flowing through this temporary channel and continuing to Pond C. The slide still appeared to have moisture in the hill and will likely continue to move. The operator is currently formulating a plan with the Division to repair the ditch or change the ditch design to avoid the area affected by the slide.

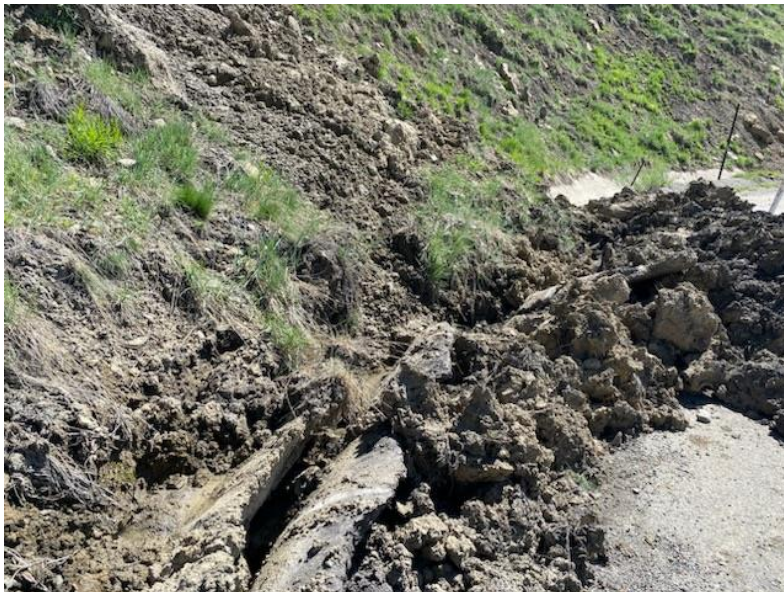
Photo 8: Temporary drainage cut through Curve 10 slide

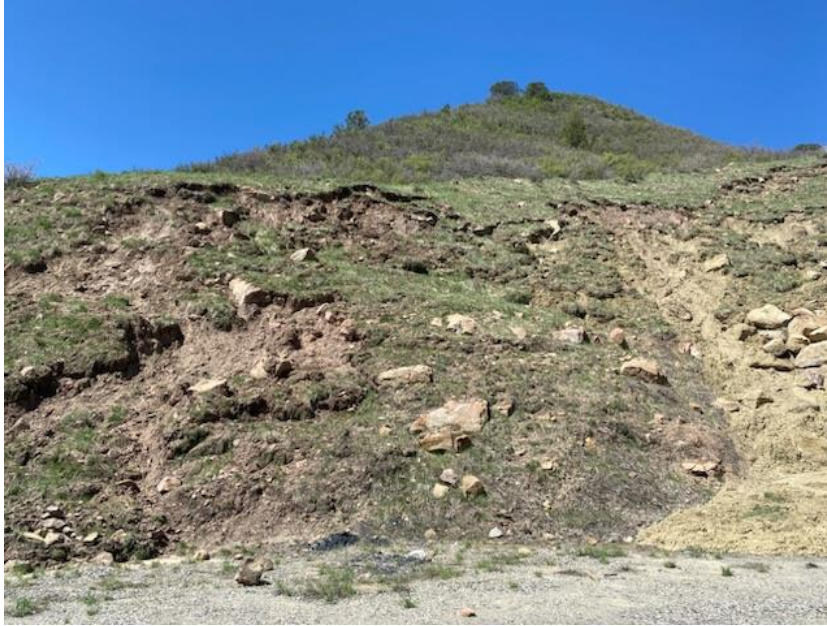
Due to the exceptional amount of snowpack at the mine site over the winter several minor slides have occurred throughout the mine's facilities this spring. A slide was observed on the southwest slope of the B Portals bench. The slide has not impacted the infrastructure on the portals bench. Another small slide was observed on the slope directly above the B portals. An additional slide was spotted on the curve below the mine office above the haul road. This slide has been identified in previous inspections and appears to have stabilized for the time. No impacts to the haul road were observed.

Photo 9: Slide on the southwest side of the B Portal bench

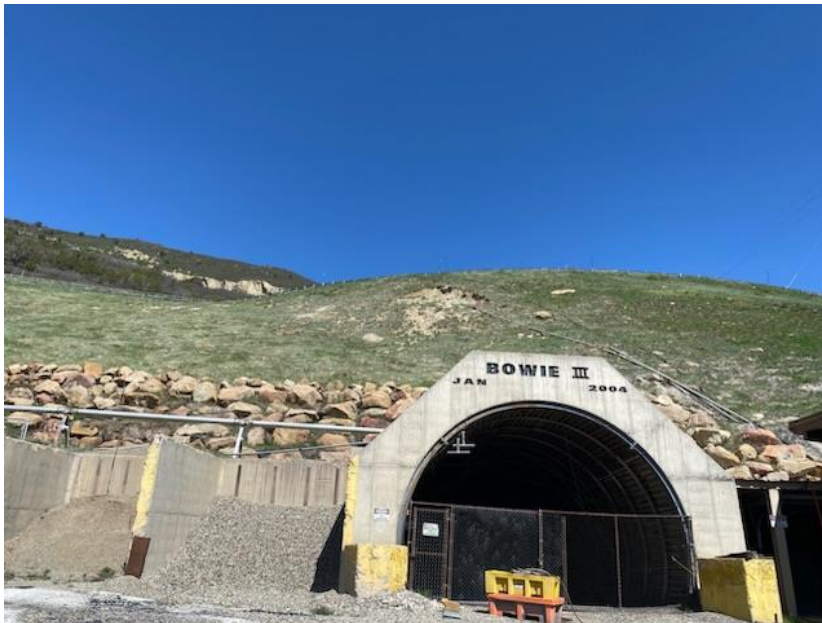
Photo 10: Minor slide above B portal

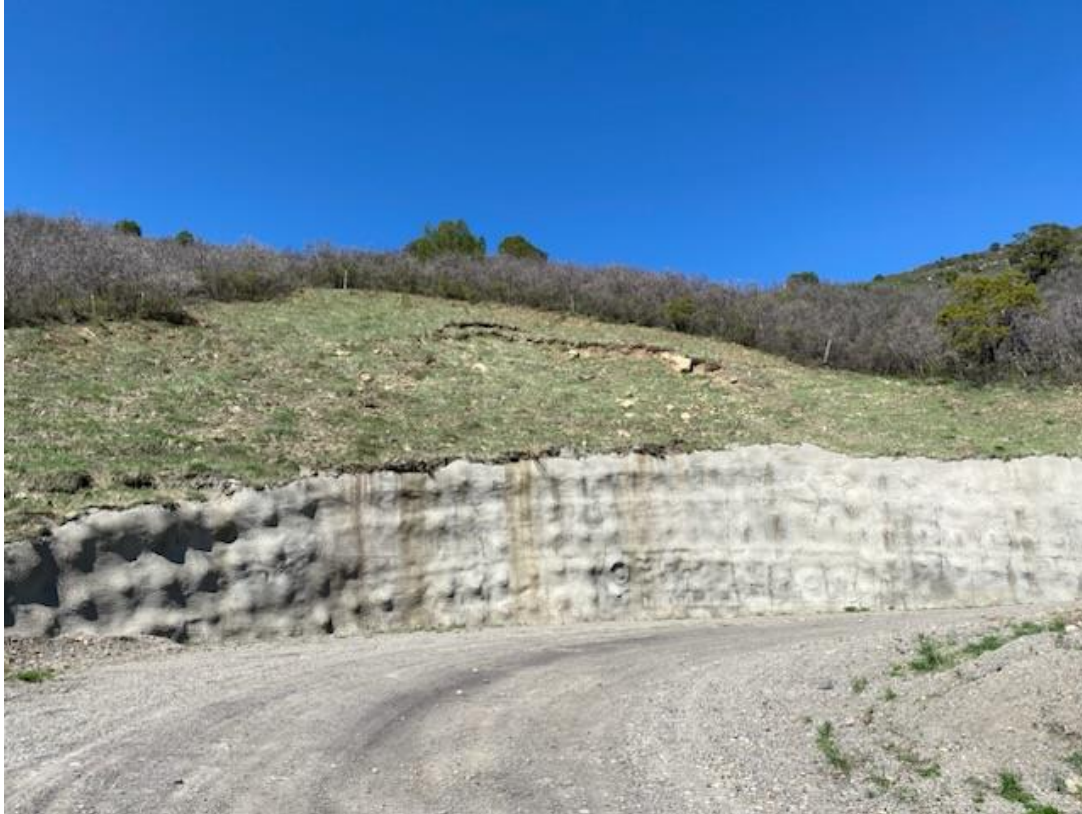
Photo 11: Slide on Haul Road below the mine office (Curve 11)
