PERMIT INFORMATION

Permit Number: C-1981-038 Mine Name: Bowie No. 1 Mine Operator: Bowie Resources, LLC Operator Address: Mr. Basil R Bear P.O. Box 1488 Paonia, CO 81428	County: Delta Operation Type: Underground Permit Status: Active Ownership: Private
	Operator Representative Present: Basil Bear
Operator Representative Signature: (Field Issuance Only)

Inspection Start Date: May 9, 2023 Inspection Start Time: 12:25 Inspection End Date: May 9, 2023 Inspection End Time: 13:40		Inspection Type: Coal Partial Inspection Inspection Reason: Normal I&E Program Weather: Clear	
Joint Inspection Agency: None		Joint Inspection Contacts: None	
Post Inspection Agency: None		Post Inspection Contacts: None	
Inspector(s): Clayton Wein	Inspector's Signature: <i>Clayton Wein</i>		Signature Date: 5/22/2023

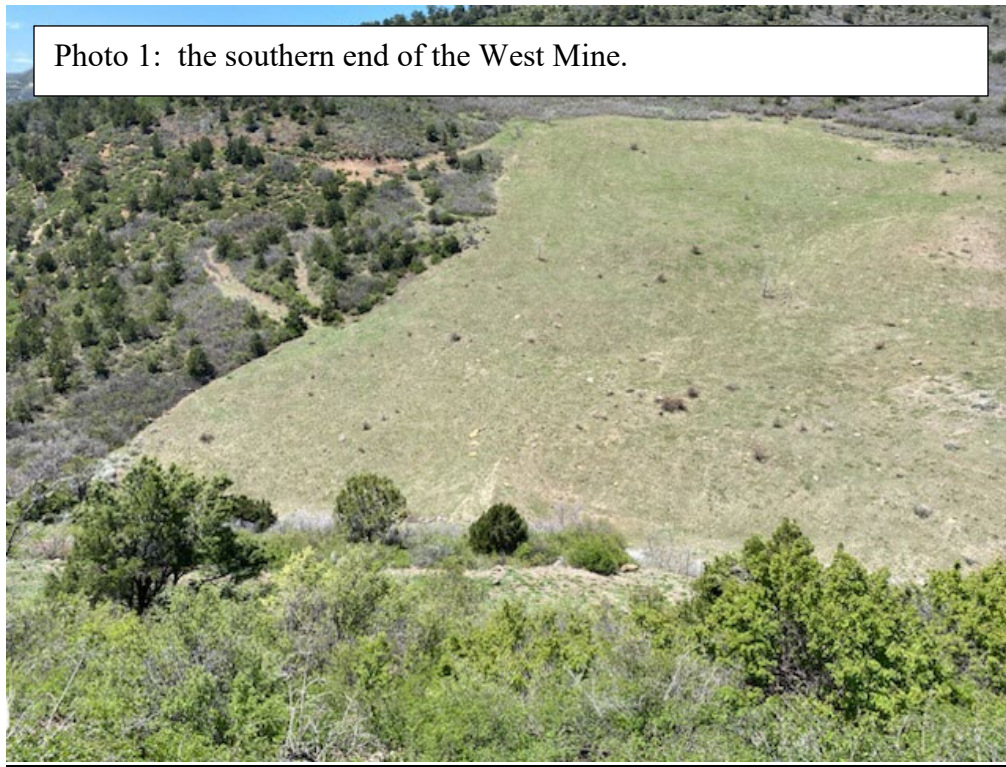
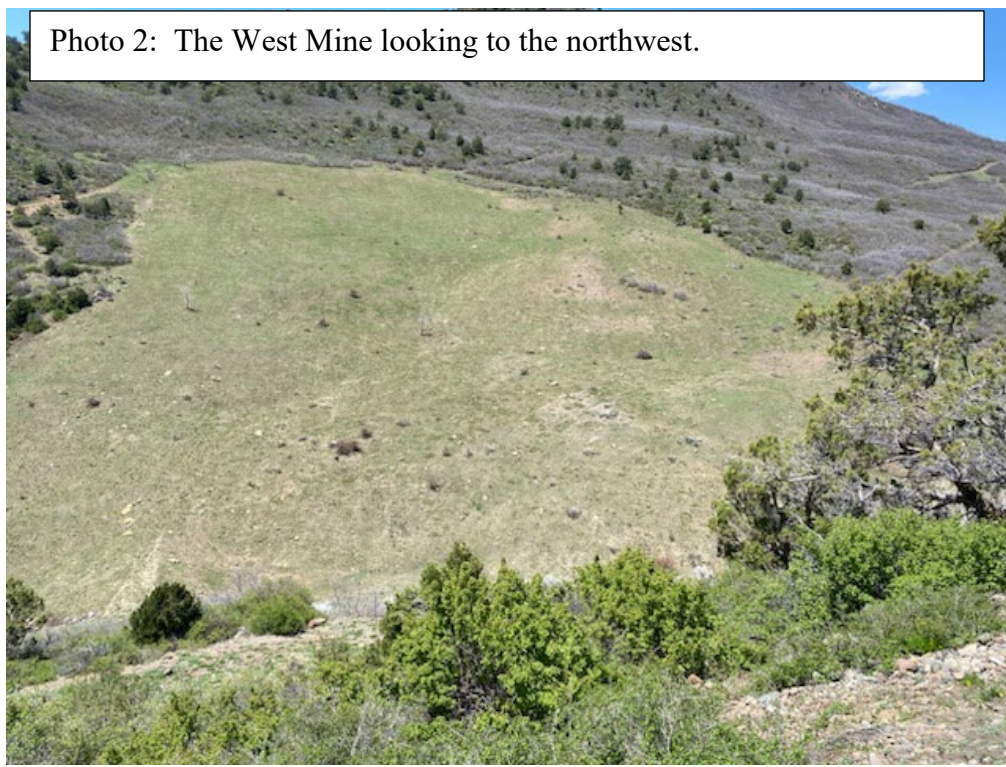
The Bowie No. 1 Mine is currently in the reclamation phase, no active mining is taking place. The mine site consists of the West Mine, the ROM area, the East Mine and the Bowie No. 1 Loadout. The remaining reclaimed portions of the West Mine were stable with vegetative cover (Photos 1 and 2). There were no indications of erosional features observed.

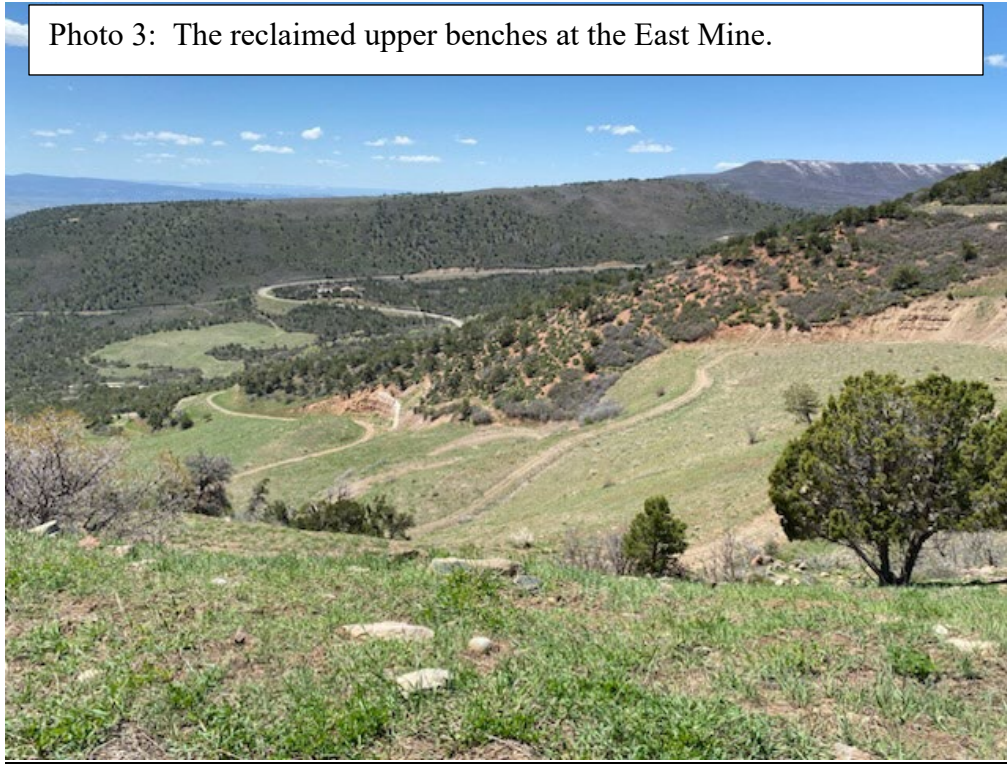
The East Mine's reclaimed benches were stable with vegetative cover (Photos 3 and 4). With the exception of one small feature, there were no erosional concerns identified. On the reclaimed portals bench a small slide has occurred (Photo 5). This slide is similar to the one observed by the Division in 2017 and in nearly the same location. The slide has appeared to have stabilized. No off site impacts or damage to lower benches was observed.

Photo 3: The reclaimed upper benches at the East Mine.

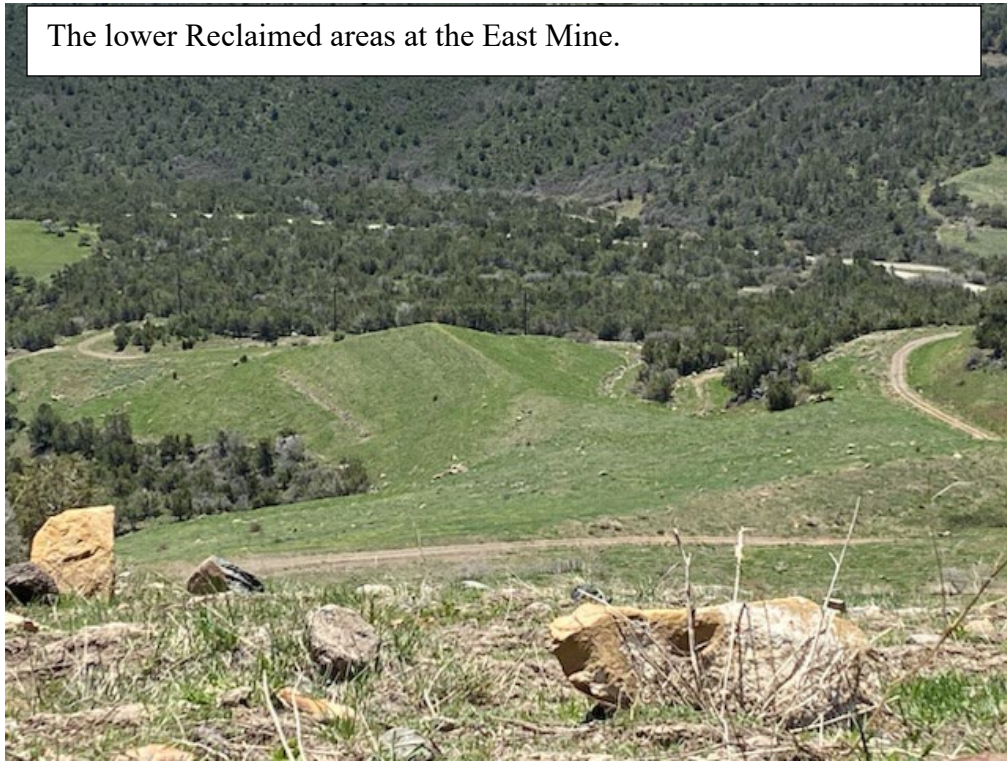
The lower Reclaimed areas at the East Mine.

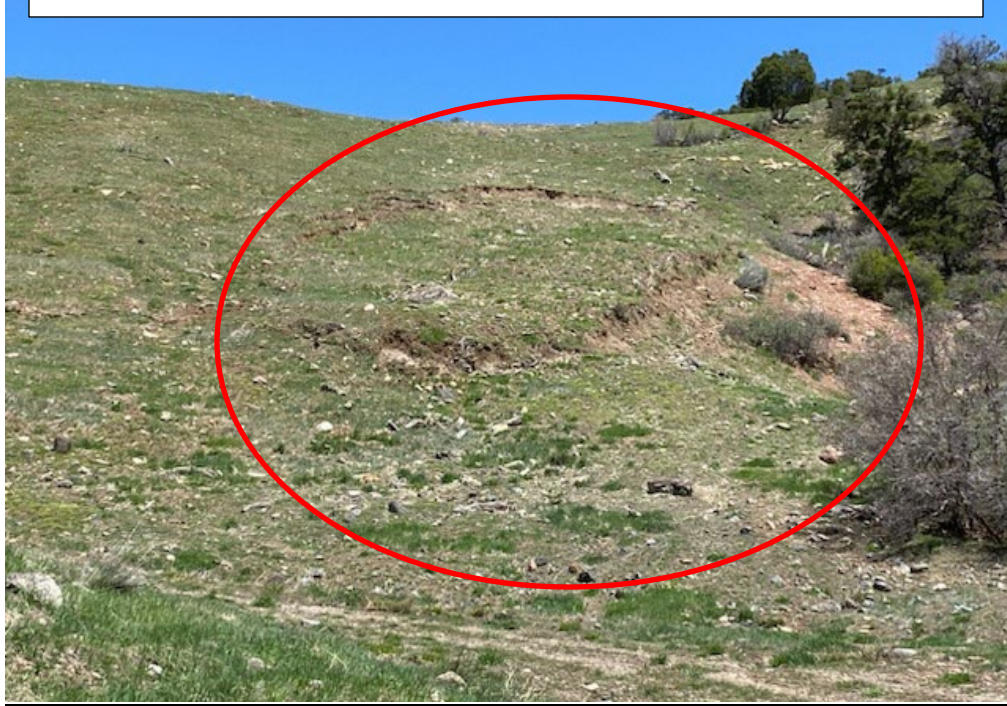
Photo 5: The minor slide observed on the reclaimed portals bench.

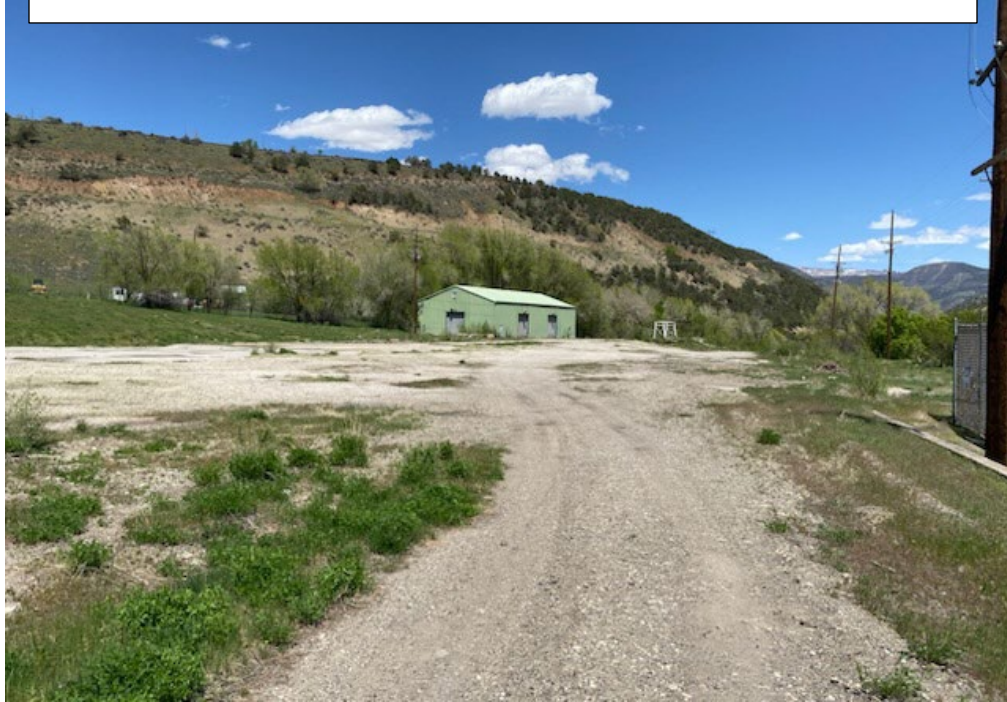
The Bowie No. 1 Loadout is located south of the mine site, off of Colorado Highway 133. The berms at the loadout were in good condition and functioning as designed. No off site impacts were observed. The topsoil pile was stable and vegetated. There were no erosional features identified. The shop pad was in good condition and stable (Photo 6). The area to the west of the shop pad is used as a laydown area for equipment from the Bowie No. 2 Mine. The equipment was well organized (Photo 7). No fluids or fuels were stored on-site. The coal

Photo 6: the shop pad at the Loadout.

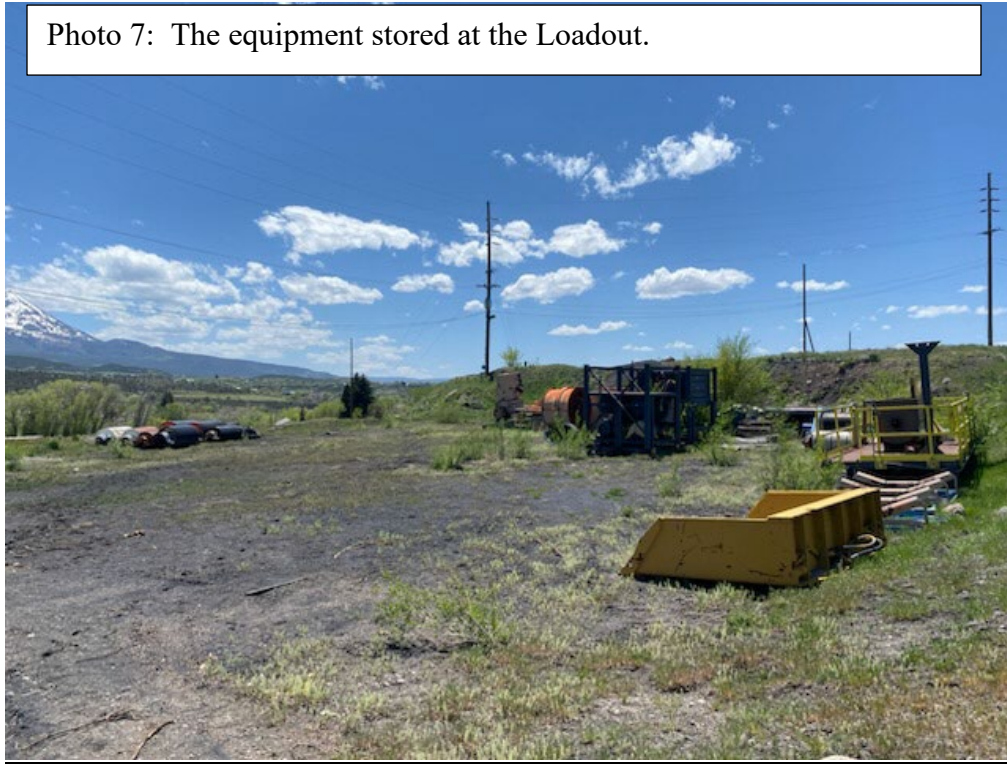
Photo 7: The equipment stored at the Loadout.

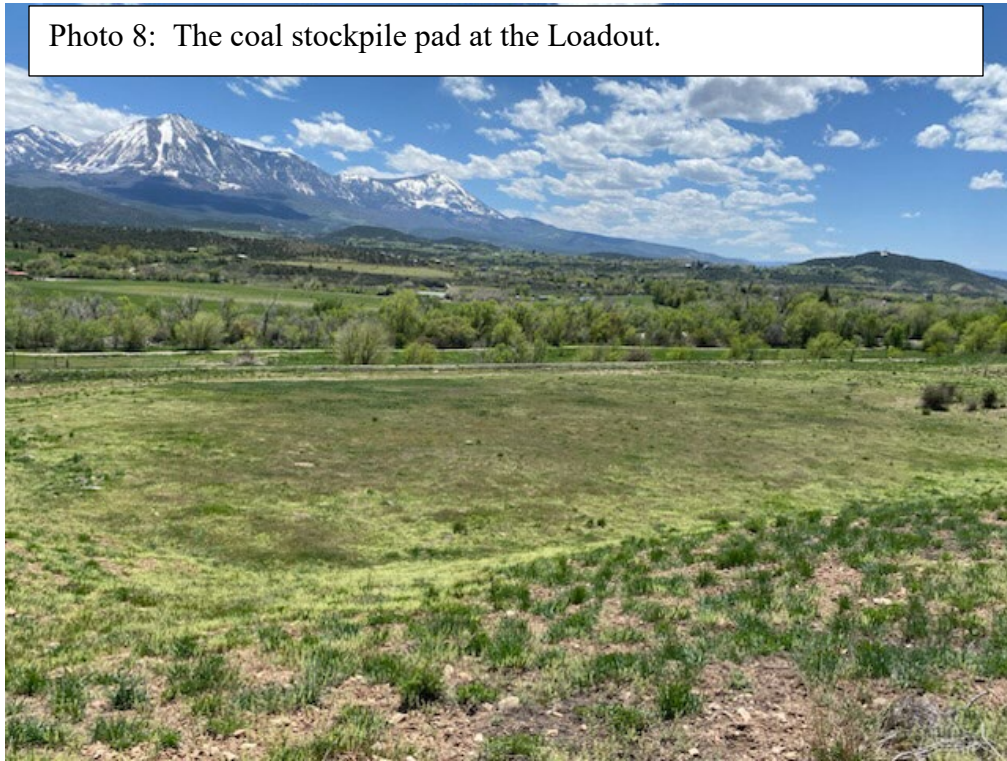
stockpile pad is located on the west end of the permitted area on the west side of Black Bridge Road. The pad was stable with vegetative cover (Photo 8). No erosional features were observed. The perimeter ditches were clear of debris and no off site impacts were noted. The culvert underneath Black Bridge Road was stable. The Farmers Ditch is located on the eastern end of the permit area and is in a culvert underneath the loadout facility permit area. Both the inlet and outlet of the culvert were observed to be clear of blockages.

Photo 8: The coal stockpile pad at the Loadout.
