**MINERALS PROGRAM INSPECTION REPORT**  
**PHONE: (303) 866-3567**

<b>MINE NAME:</b> Precious Mine	<b>MINE/PROSPECTING ID#:</b> P-2013-008	<b>MINERAL:</b> Platinum, palladium an	<b>COUNTY:</b> Crowley
<b>INSPECTION TYPE:</b> Monitoring	<b>WEATHER:</b> Clear	<b>INSP. DATE:</b> May 16, 2022	<b>INSP. TIME:</b> 08:30
<b>OPERATOR:</b> Catalix International, LLC	<b>OPERATOR REPRESENTATIVE:</b> Loren Howells	<b>TYPE OF OPERATION:</b> MP - Mineral Prospecting

<b>REASON FOR INSPECTION:</b> Surety Release Requested	<b>BOND CALCULATION TYPE:</b> None	<b>BOND AMOUNT:</b> \$5,800.00
<b>DATE OF COMPLAINT:</b> NA	<b>POST INSP. CONTACTS:</b> None	<b>JOINT INSP. AGENCY:</b> None
<b>INSPECTOR(S):</b> Amber Michels	<b>INSPECTOR'S SIGNATURE:</b>

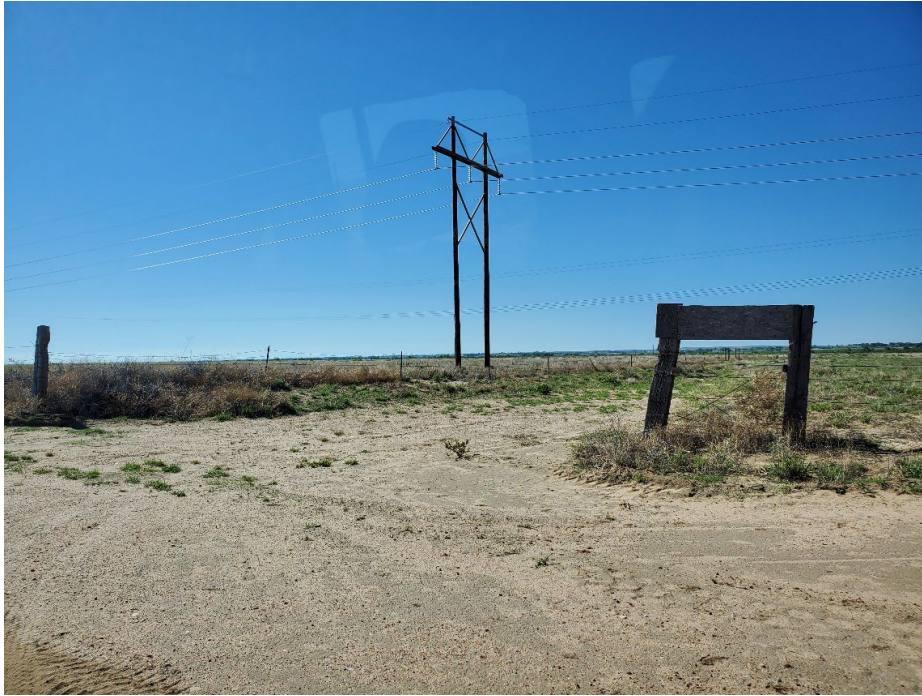
Pursuant to Rule 5.5.2(h), existing roads which are to remain as permanent roads after prospecting activities are completed, shall be left in a condition equal to or better than the pre-prospecting condition. Photos 1-3 show various points along the entrance road to the NOI location. The Division believes the roads, which are to remain post-prospecting activities, to be in sufficient condition.

**Photo 1:** Looking south-east at the open entrance gate to the site.

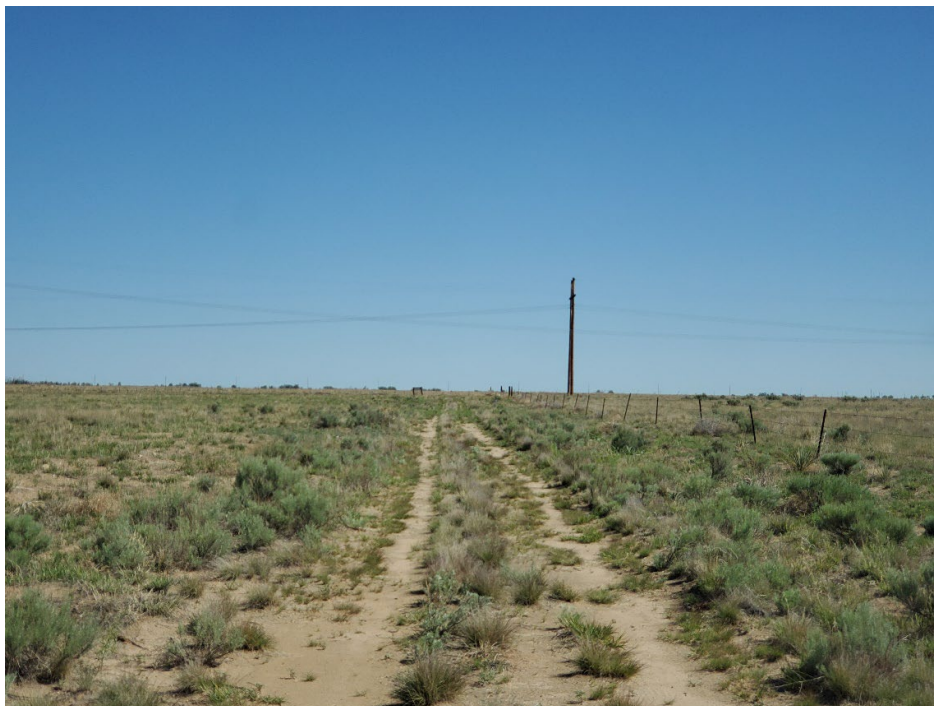
**Photo 2:** Looking north along the entrance road to the entrance location.

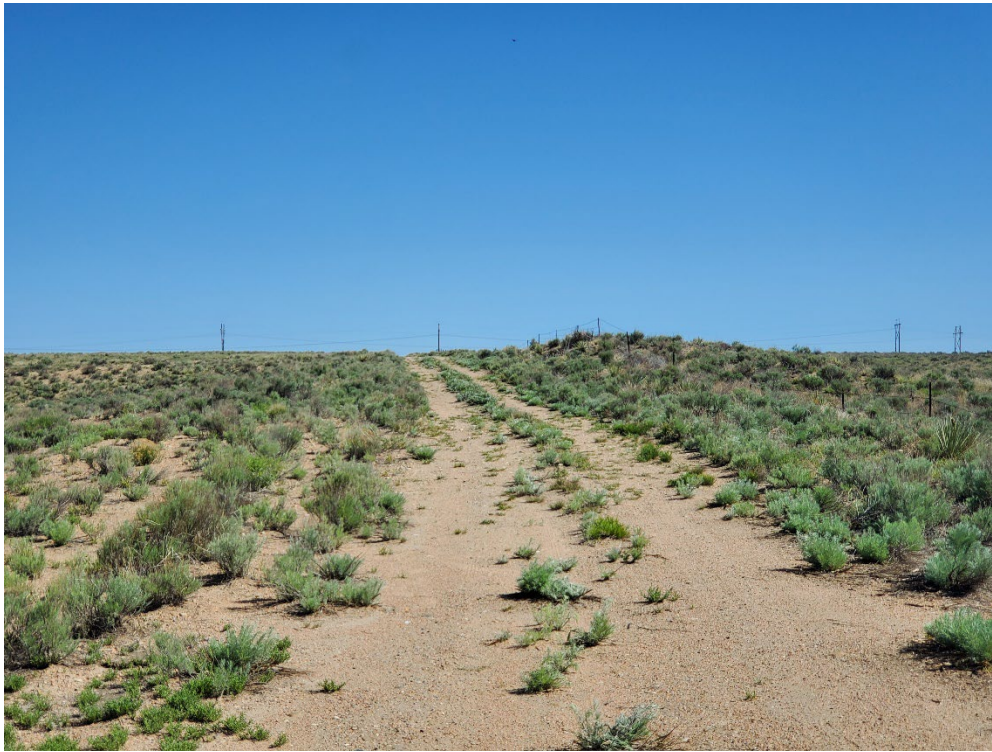
**Photo 3:** Looking north along the entrance road.

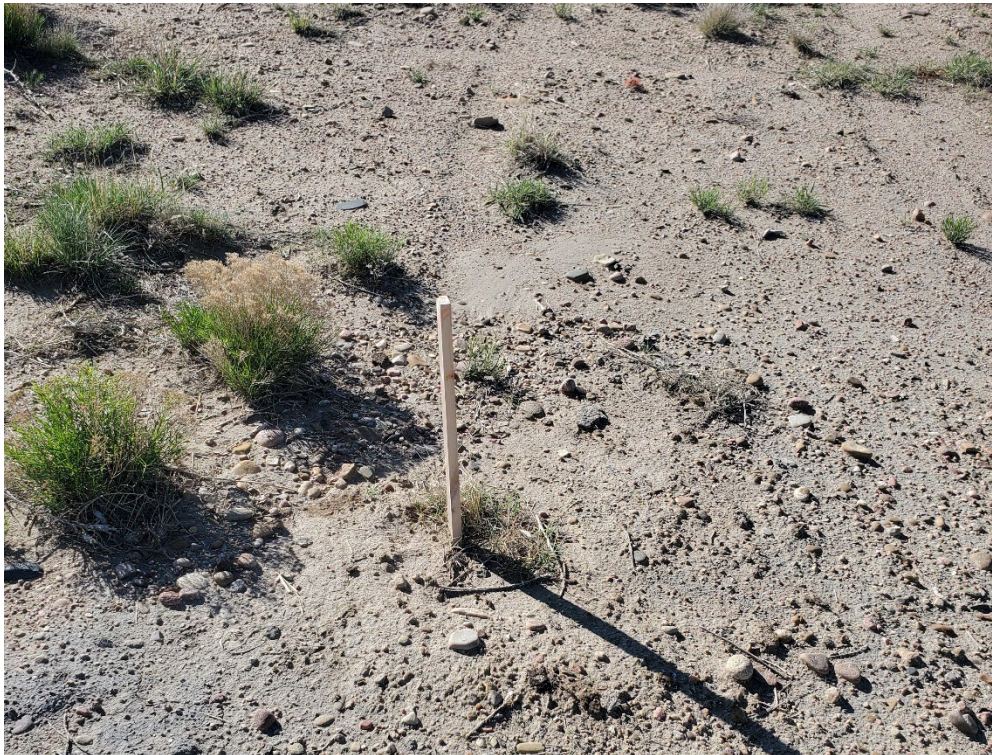
The exploration area, the small topsoil pile locations, and the drill holes were broadcast seeded with the seed mix described in the Operator's approved reclamation plan (Photos 4, 12, 19, 24, 31 & 32). Once seeded, the topsoil was back-dragged to help cover and stabilize the seedbed. Additionally, grass plugs were planted in the abandoned drill holes in addition to the broadcast seeding conducted in these locations. At the time of the inspection, some vegetation has begun to grow. However, there are a few areas that have little to no vegetation that may need to be seeded again next growing season. When comparing to the adjacent undisturbed land (Photos 18, 21, 22, 23, & 25-30) the seeded areas may require one to three more growing seasons to reach the cover and quality of its surroundings.

**Photo 4:** Abandoned and reclaimed drill hole #1.

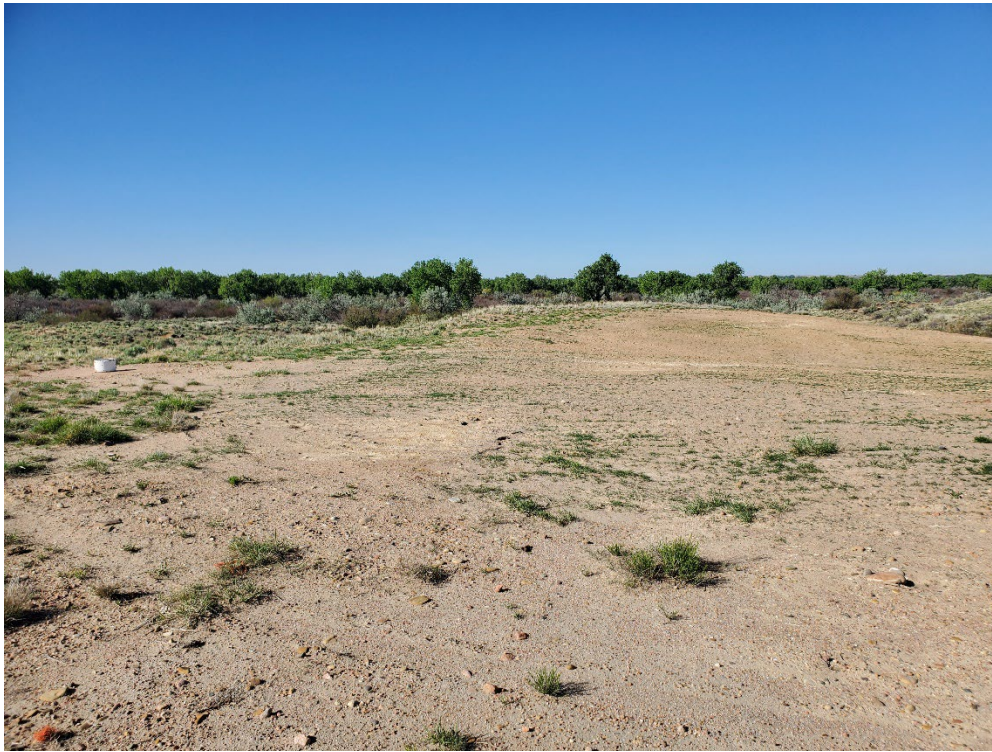
**Photo 5:** Looking south-west at the southern extent of the reclaimed excavation area.

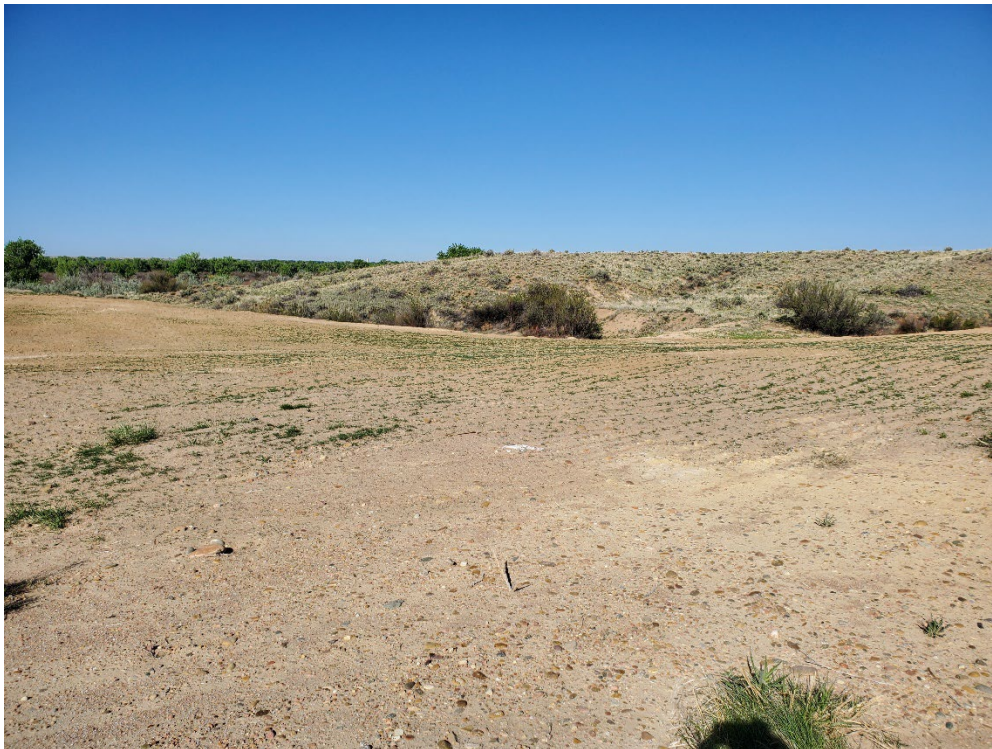
**Photo 6:** Looking west across the reclaimed excavation area.

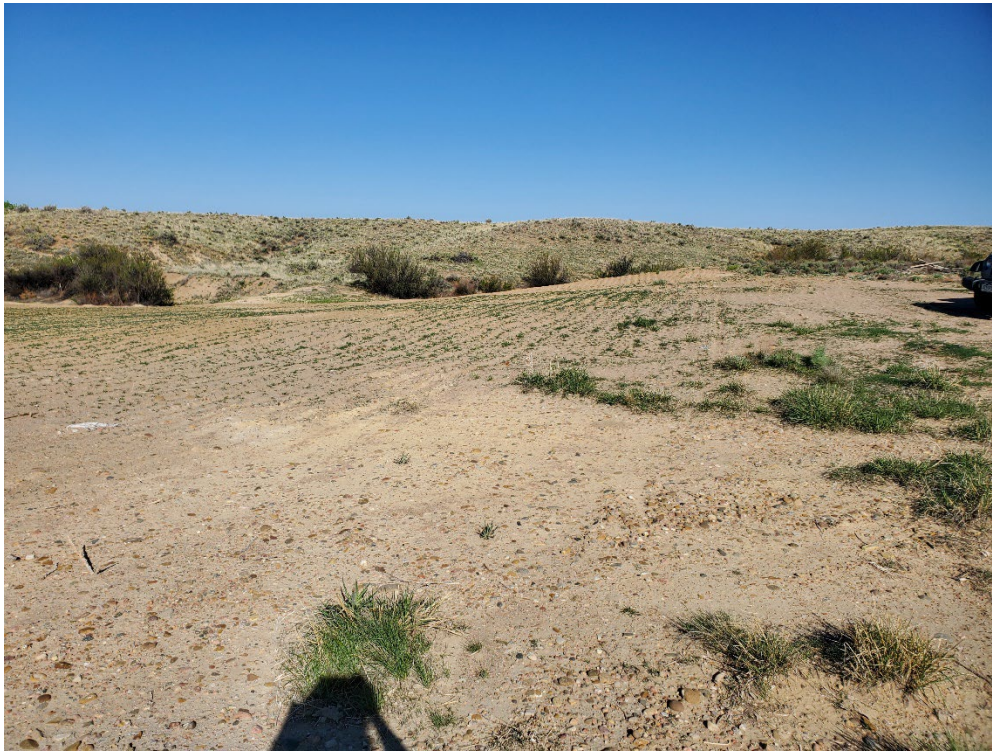
**Photo 7:** Looking north-west at the northern extent of the reclaimed excavation area.

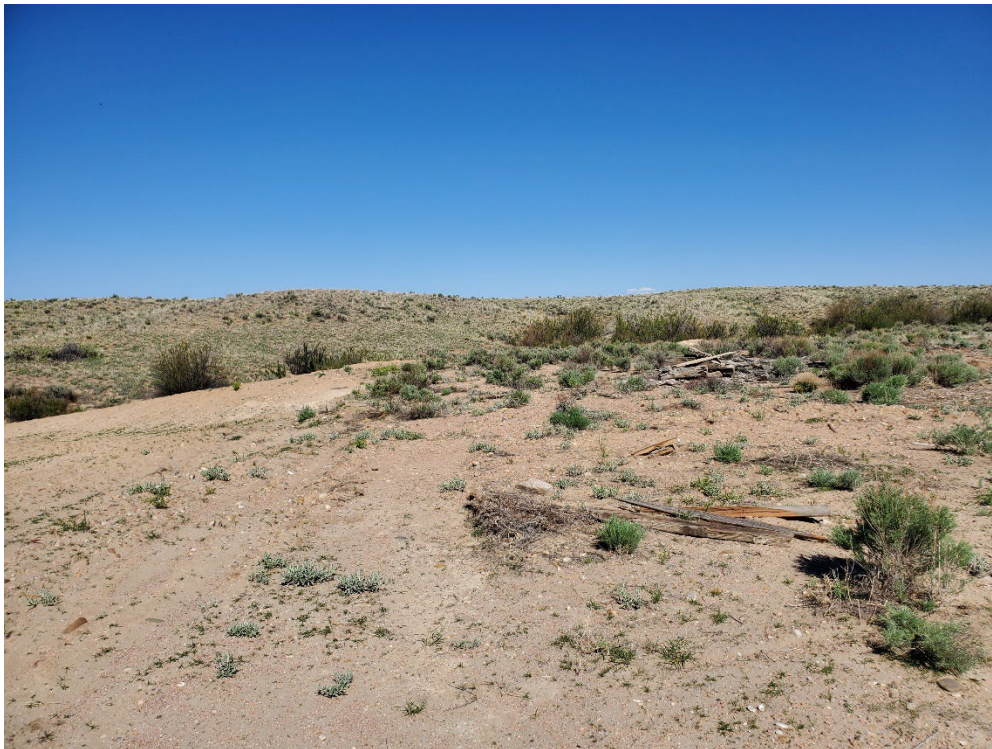
Pursuant to Rule 5.5.2(b), all vegetation cleared from the site must be properly disposed of or dispersed. The only cleared vegetation noted onsite was a small pile of logs and branches located north-west of the reclaimed exploration area (Photos 8 & 9; Maps 1 and 2). This material is in an insignificant quantity, and may be left in situ upon reclamation.

**Photo 8:** Looking west along the northern extent of the reclaimed excavation area and the western area where drill holes 4-6 were installed.

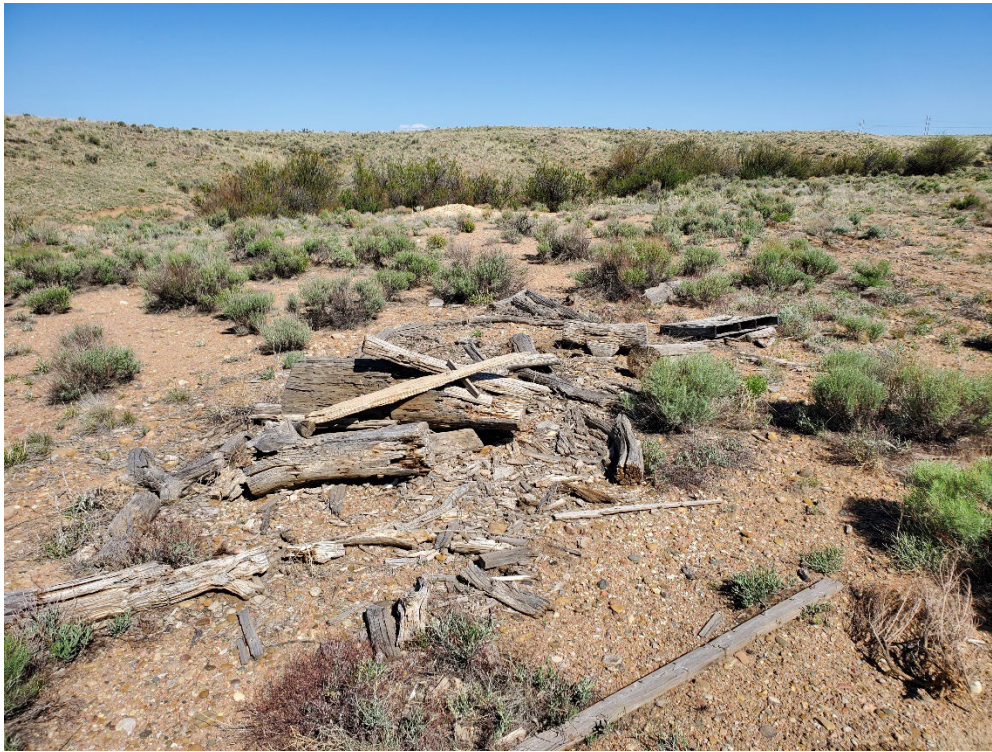
**Photo 9:** Looking at the small pile of logs in branches at the north end of the reclaimed excavation area.

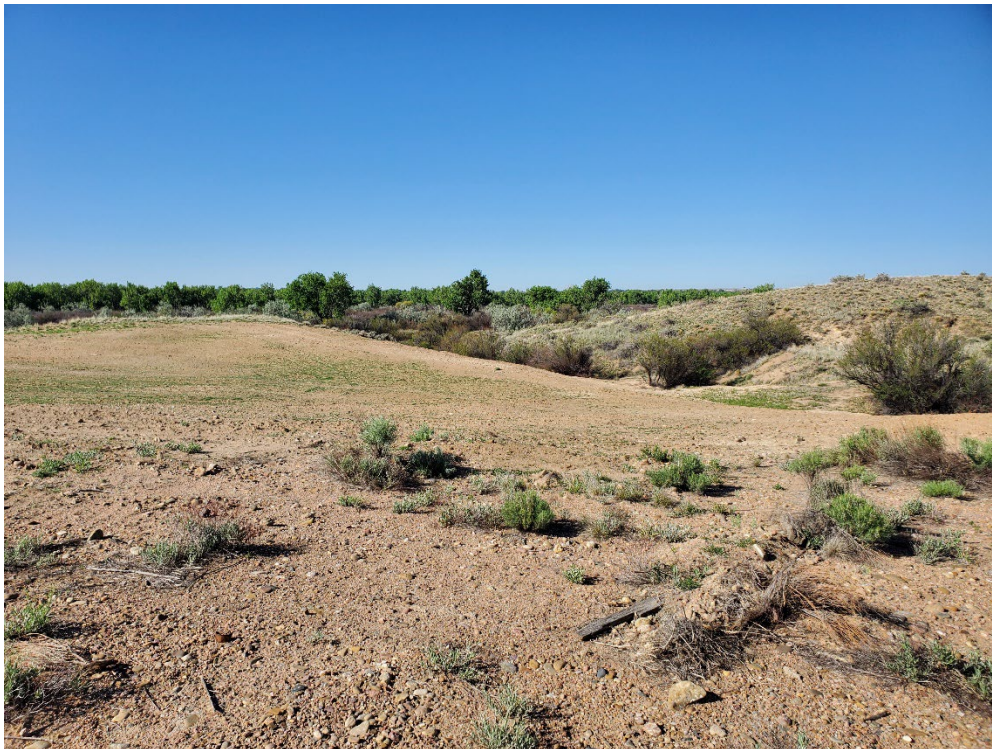
**Photo 10:** Looking south from the northern extent of the reclaimed excavation area.

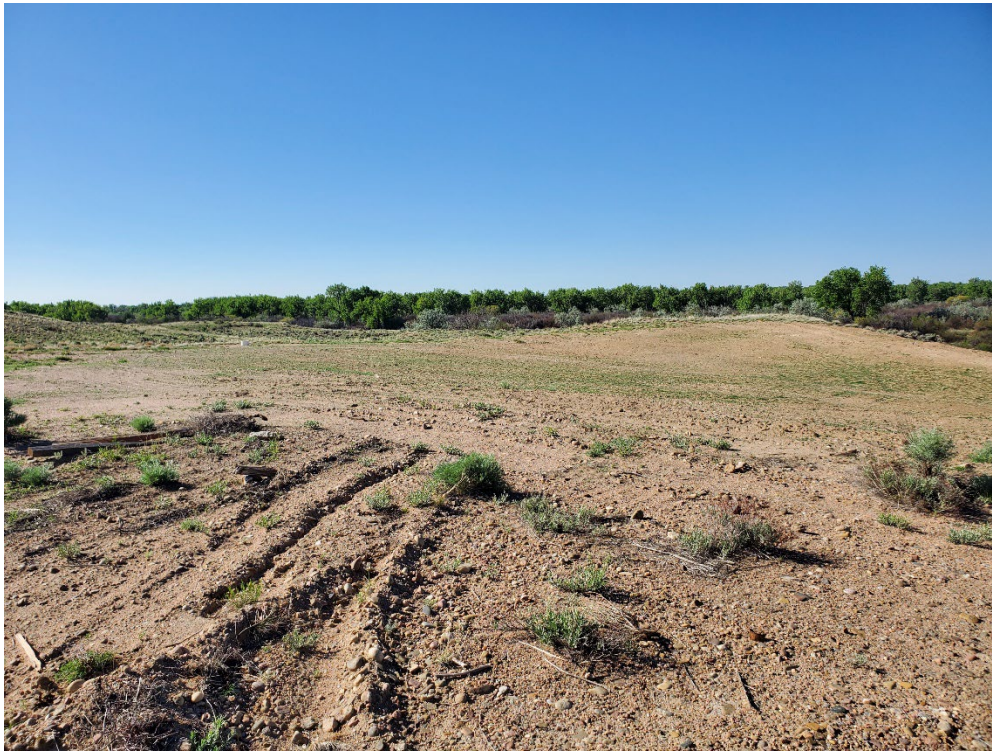
**Photo 11:** Looking south across the reclaimed excavation area.

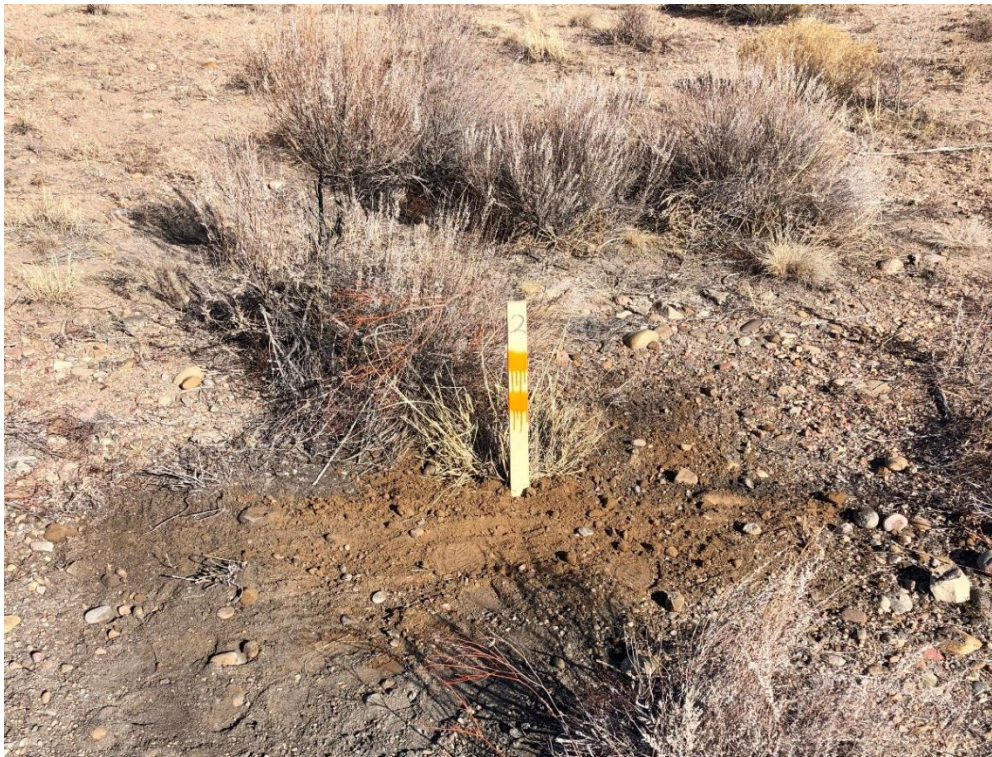
The reclaimed drill holes were marked with wooden posts labeled from 1-6. Each drill hole was located during the inspection and georeferenced using the Esri Field Maps application (see Map 3). Photos of each drill hole were also taken during the inspection, excluding drill hole 2 (DH2) by mistake. Photo 12 of DH2 was extracted from the reclaimed drill hole photos that were included within the Operator's Reclamation Report.

**Photo 12:** Abandoned and reclaimed drill hole #2.

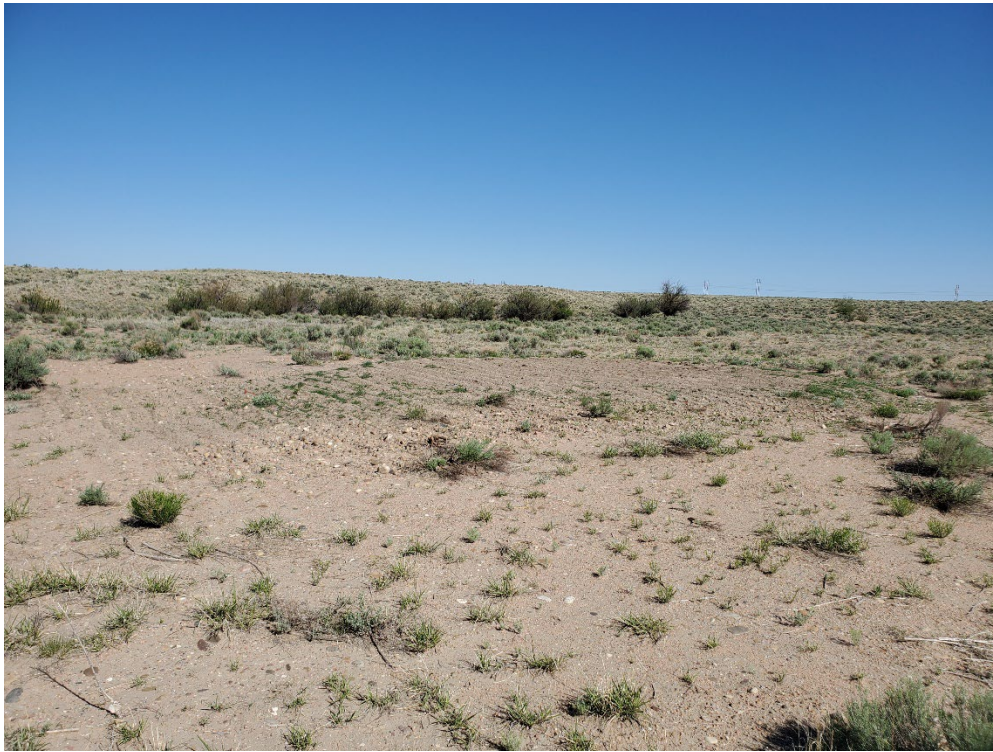
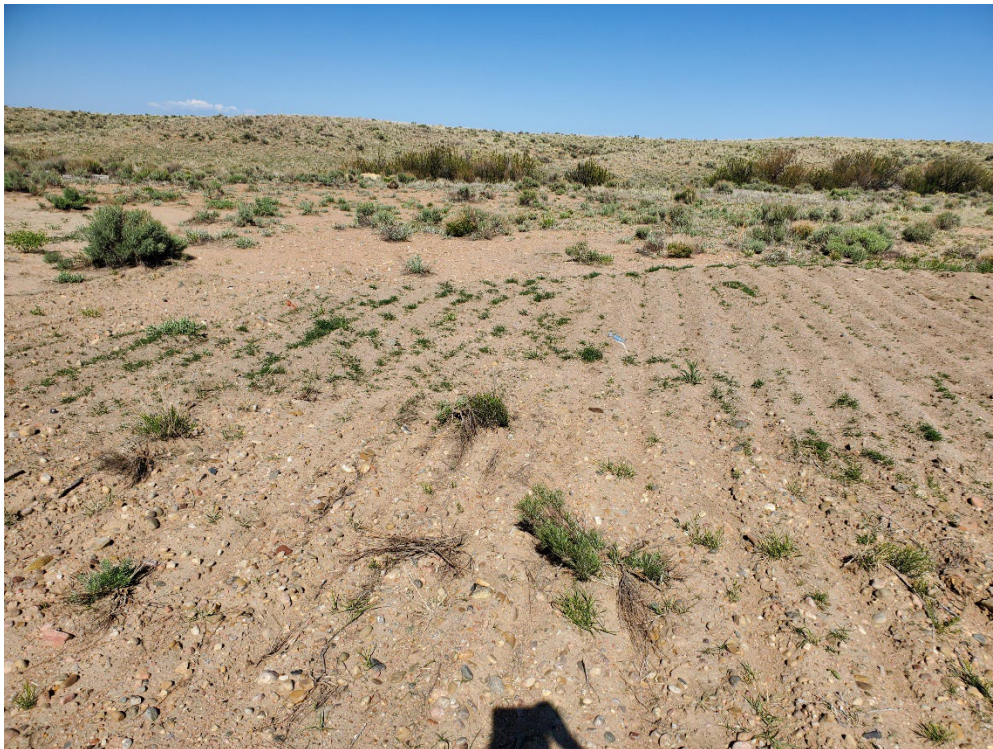
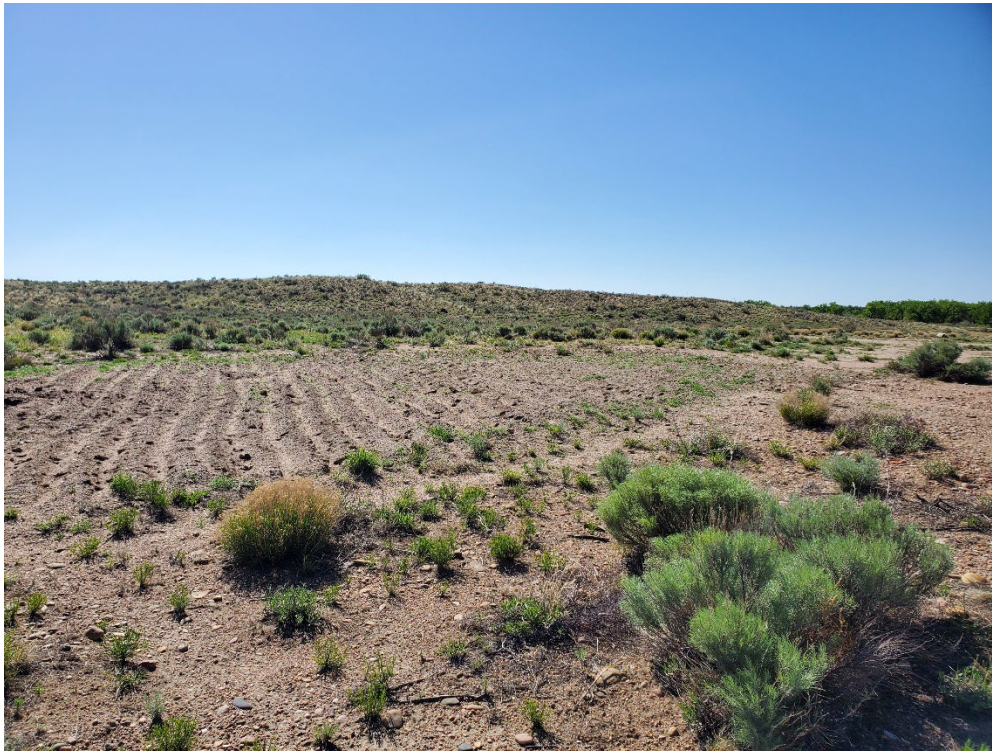
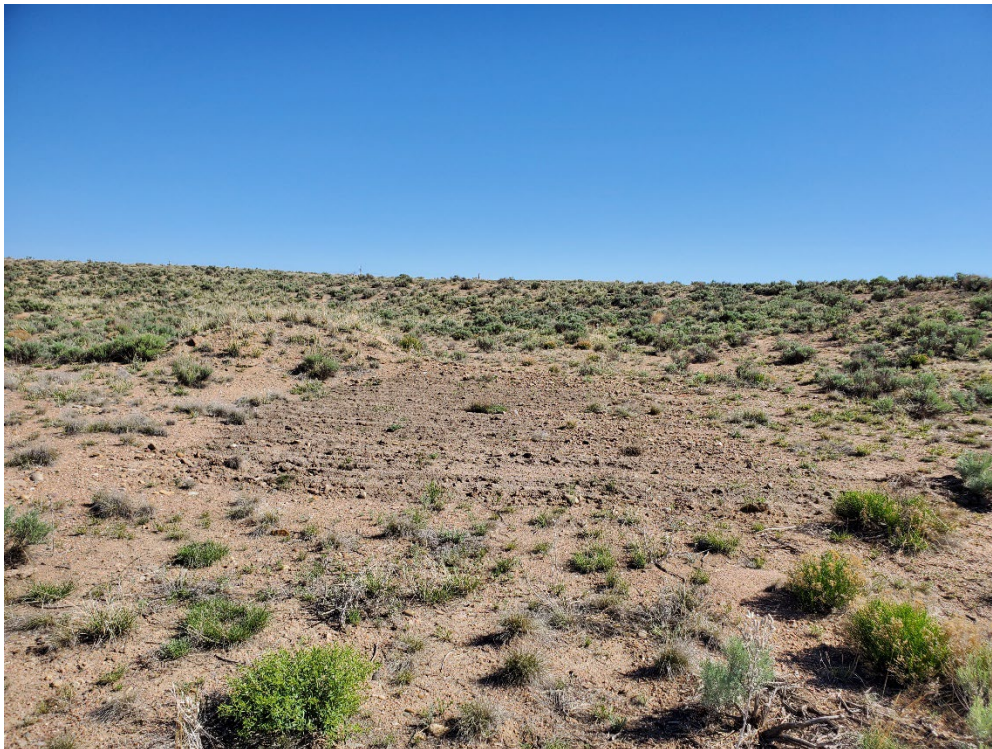
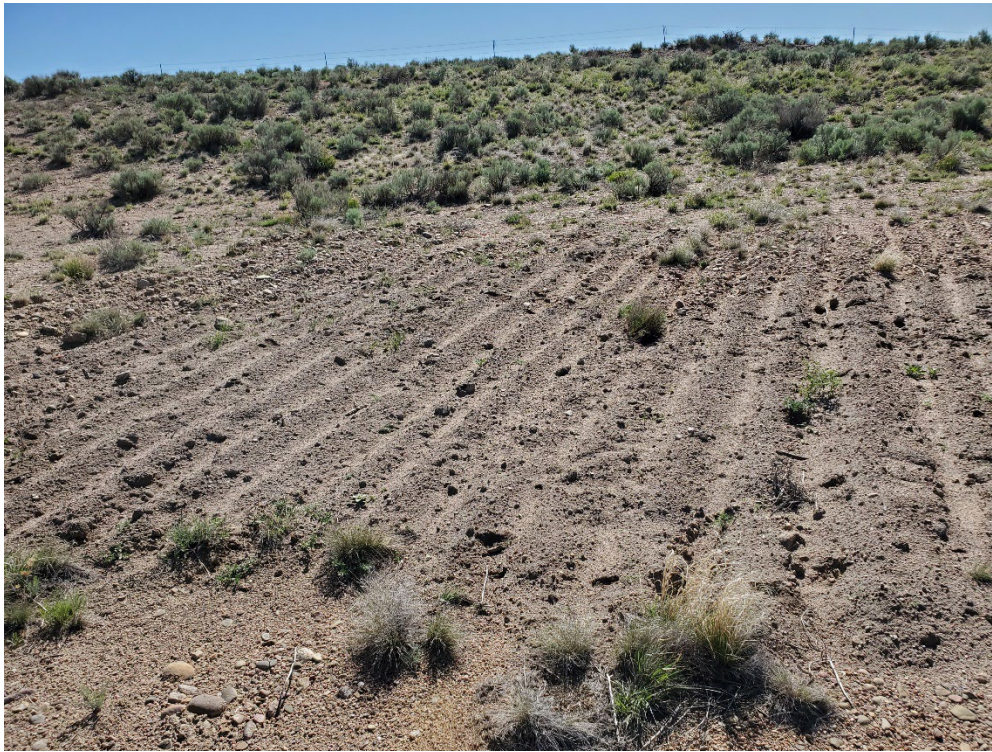
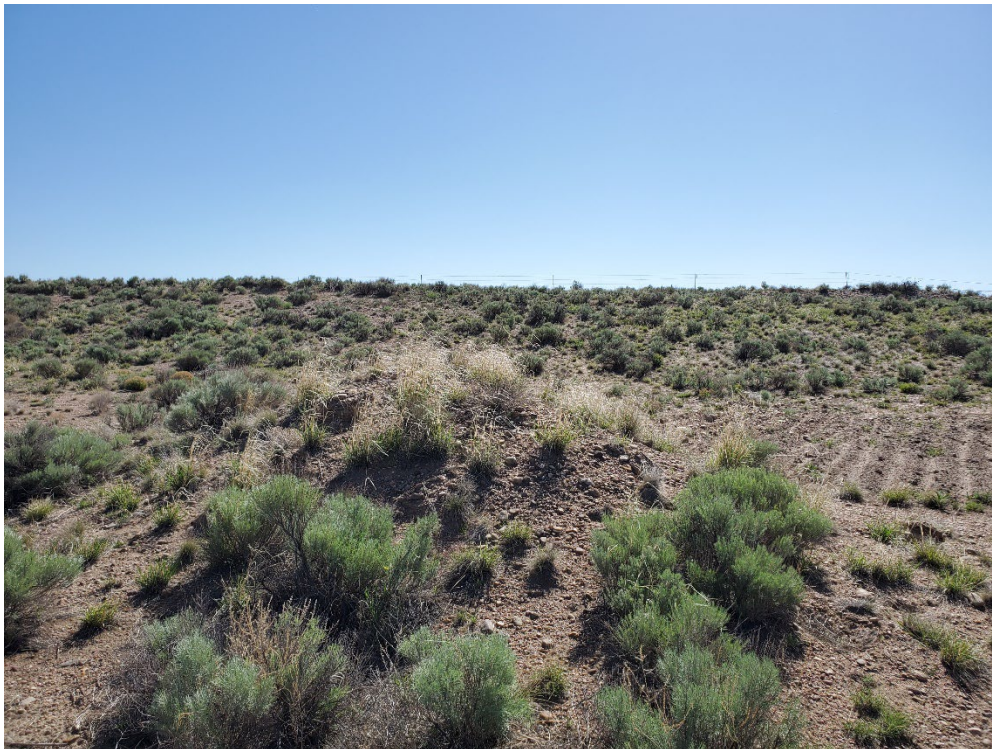
Within the old M-2013-008 permit boundary, some topsoil piles had been left to be used in the reclamation area. These piles have since been removed, excluding 3-4 inches that was spread over the area that the piles occupied (Photos 13-18; Maps 1 and 2). In combination with the small topsoil mounds on site, JH Sand and Gravel imported 375 additional tons of topsoil to spread over the exploration area and for use with reclaiming the drill holes. The additional topsoil was purchased from a nearby supplier and was placed at a depth of 3-4 inches throughout the reclaimed area.

**Photo 13:** Looking west across one of the previous topsoil pile locations at the topsoiled and seeded ground.

**Photo 14:** Looking west across one of the previous topsoil pile locations at the topsoiled and seeded ground.

**Photo 15:** Looking east across one of the previous topsoil pile locations at the topsoiled and seeded ground.

**Photo 16:** Looking north across one of the previous topsoil pile locations at the topsoiled and seeded ground.

**Photo 17:** Looking east across one of the previous topsoil pile locations at the topsoiled and seeded ground.

**Photo 18:** Looking north-east across one of the previous topsoil pile locations at the topsoiled and seeded ground.

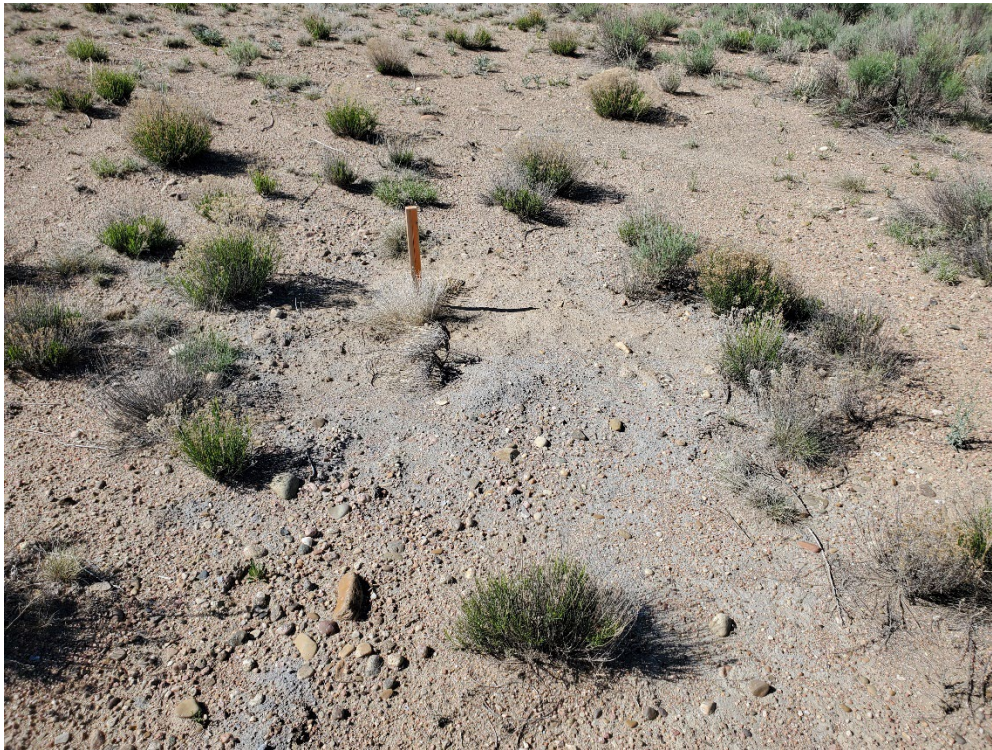
**Photo 19:** Abandoned and reclaimed drill hole #3.

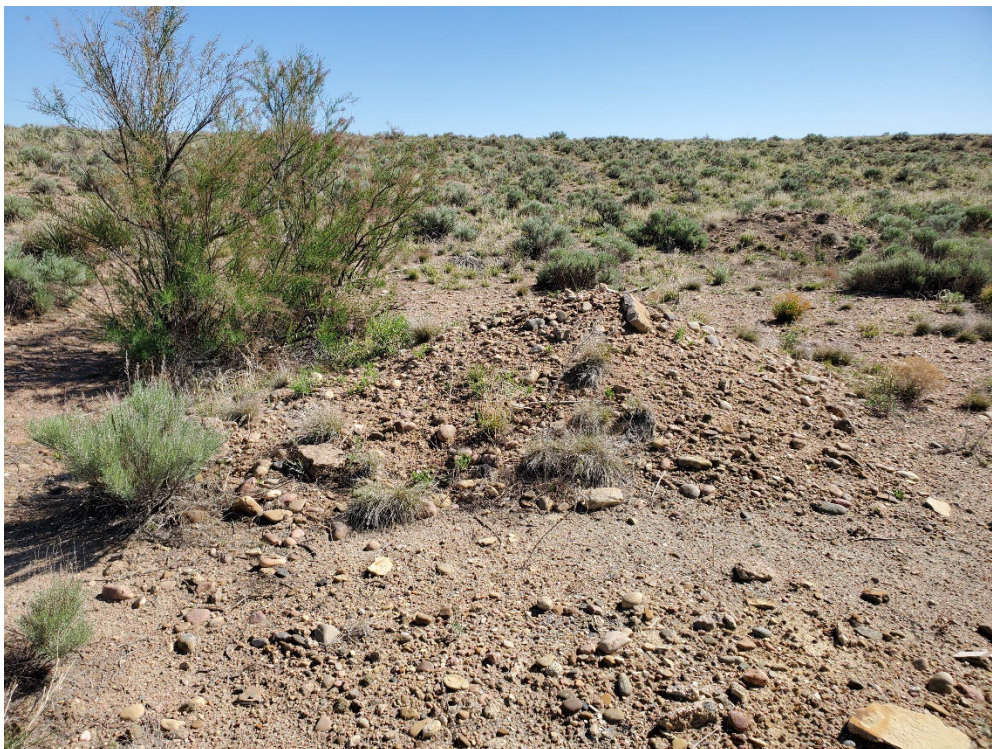
**Photo 20:** Looking north at one of the small material mounds remaining onsite.

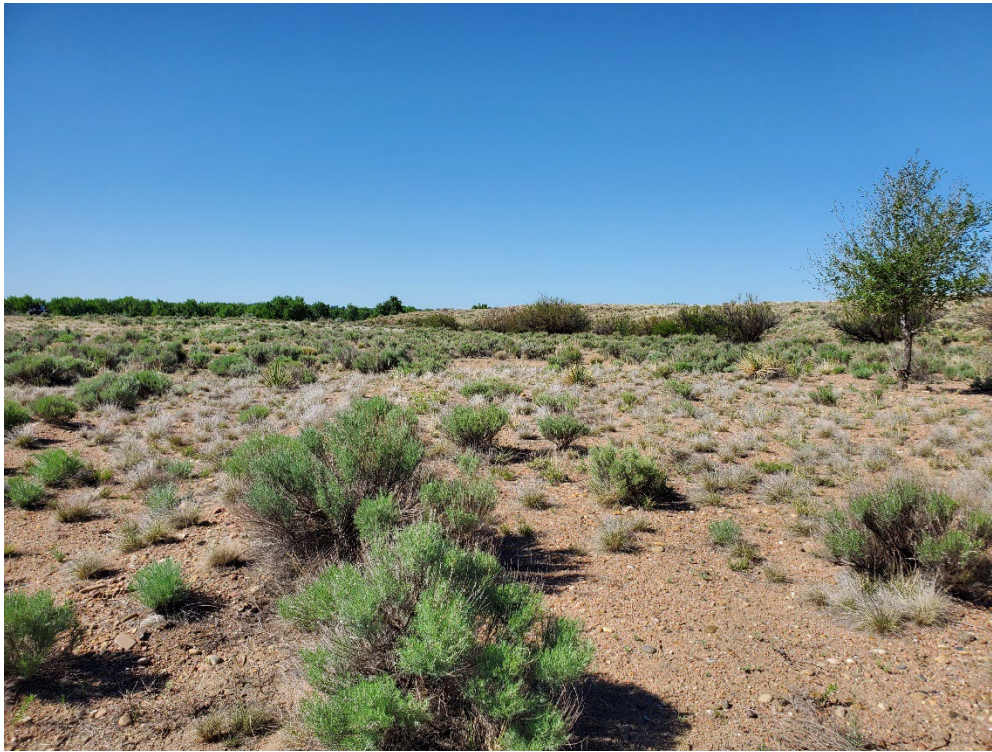
**Photo 21:** Looking south at the vegetation established within the old M-2013-008 permit boundary adjacent to the recently reclaimed areas.

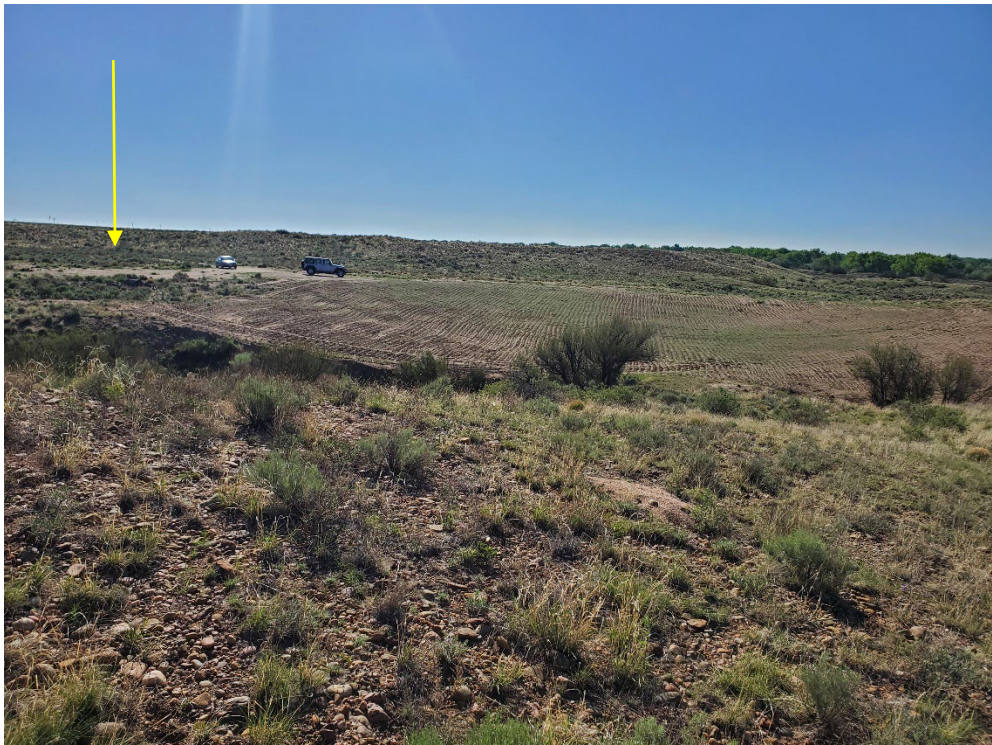
**Photo 22:** Looking east from the western area beyond the old M-2013-008 permit boundary. The yellow arrow indicates the location from which Photo 3 was taken.

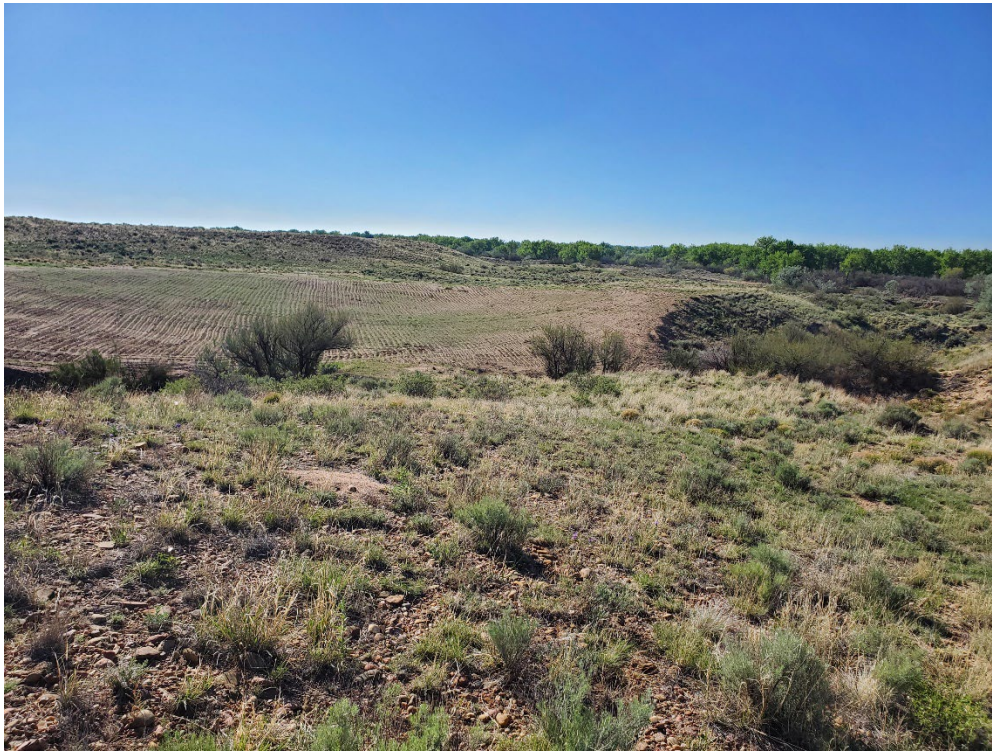
**Photo 23:** Looking south-east from the western area beyond the old M-2013-008 permit boundary.

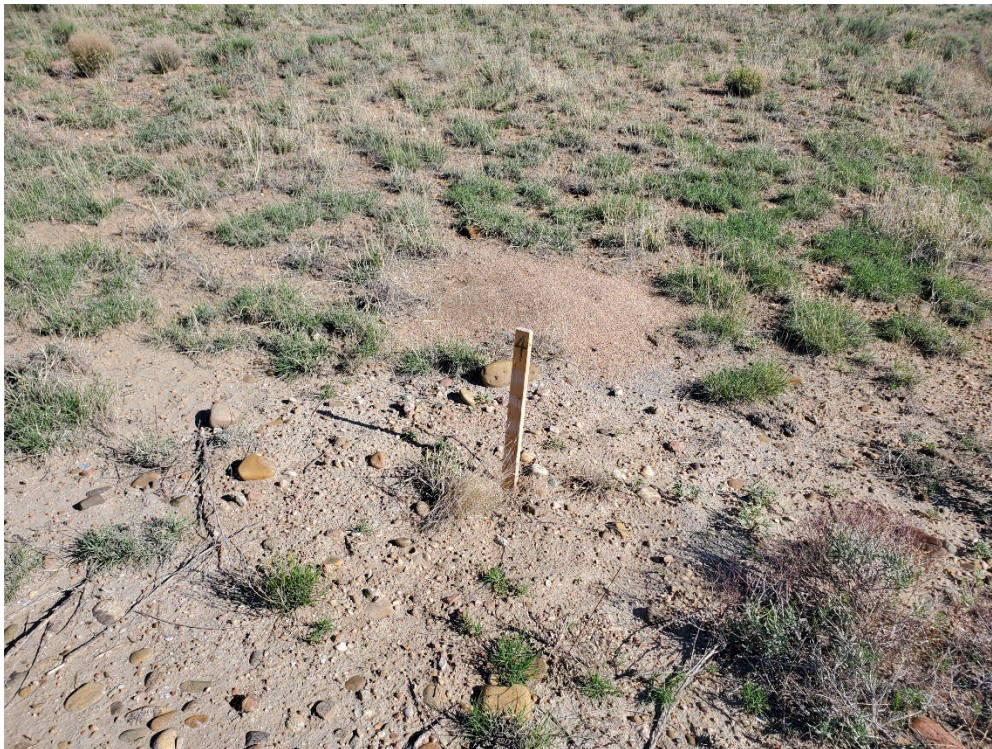
**Photo 24:** Abandoned and reclaimed drill hole #4.
