**MINERALS PROGRAM INSPECTION REPORT**  
**PHONE: (303) 866-3567**

<b>MINE NAME:</b> Precious Mine	<b>MINE/PROSPECTING ID#:</b> P-2013-008	<b>MINERAL:</b> Platinum, palladium an	<b>COUNTY:</b> Crowley
<b>INSPECTION TYPE:</b> Monitoring	<b>WEATHER:</b> Clear	<b>INSP. DATE:</b> May 16, 2022	<b>INSP. TIME:</b> 08:30
<b>OPERATOR:</b> Catalix International, LLC	<b>OPERATOR REPRESENTATIVE:</b> Loren Howells	<b>TYPE OF OPERATION:</b> MP - Mineral Prospecting

<b>REASON FOR INSPECTION:</b> Surety Release Requested	<b>BOND CALCULATION TYPE:</b> None	<b>BOND AMOUNT:</b> \$5,800.00
<b>DATE OF COMPLAINT:</b> NA	<b>POST INSP. CONTACTS:</b> None	<b>JOINT INSP. AGENCY:</b> None
<b>INSPECTOR(S):</b> Amber Michels	<b>INSPECTOR'S SIGNATURE:</b>

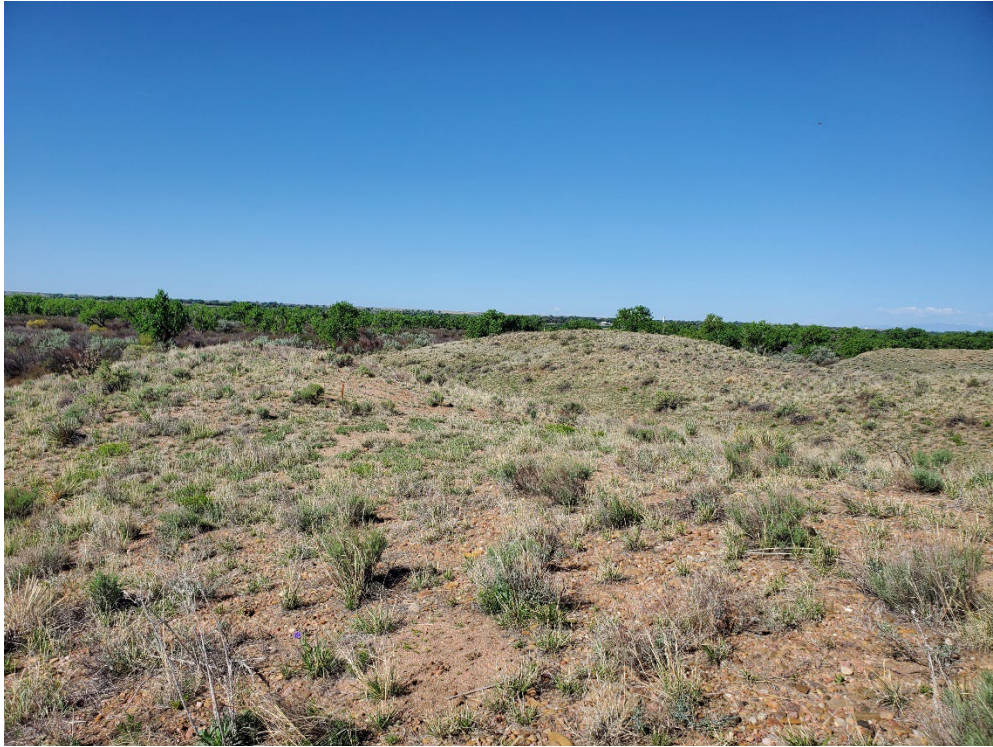
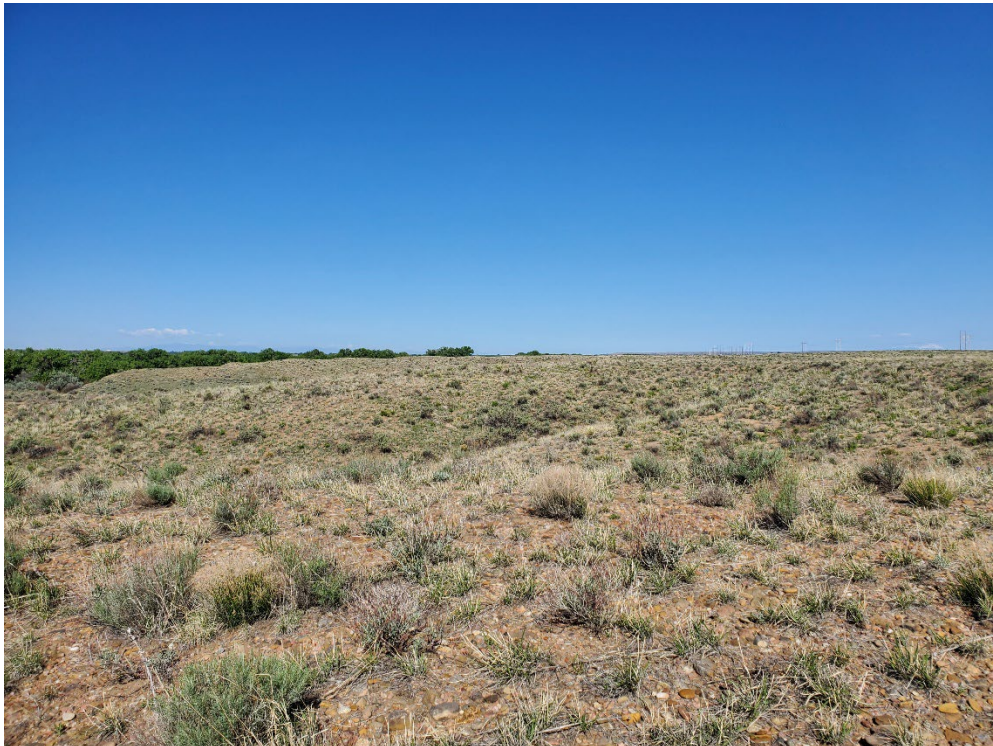
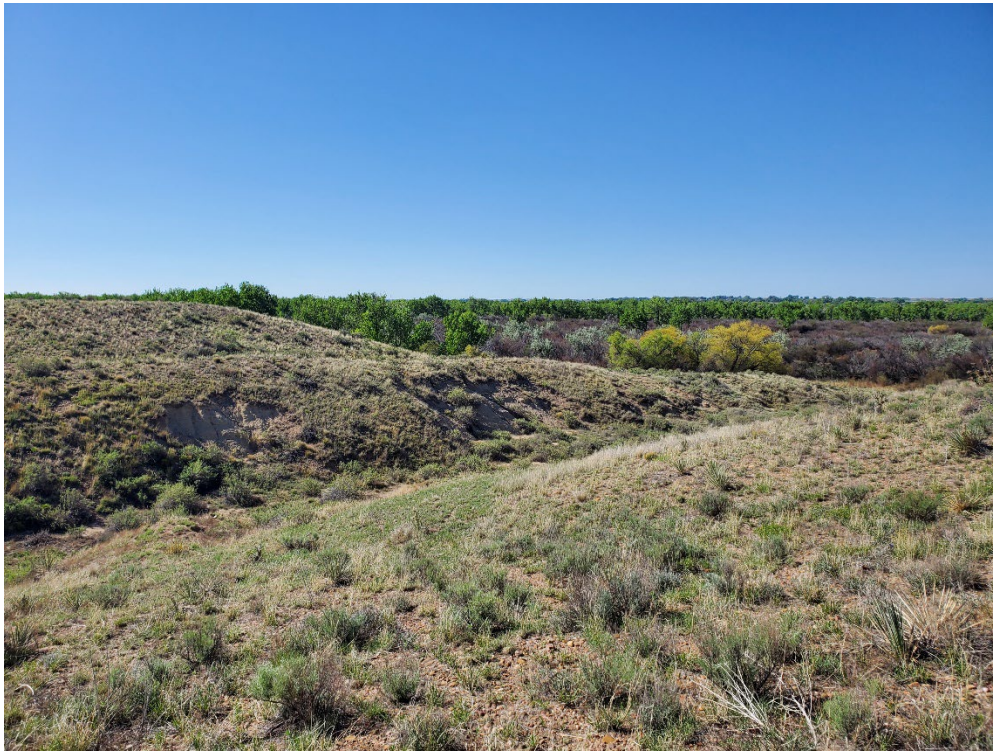
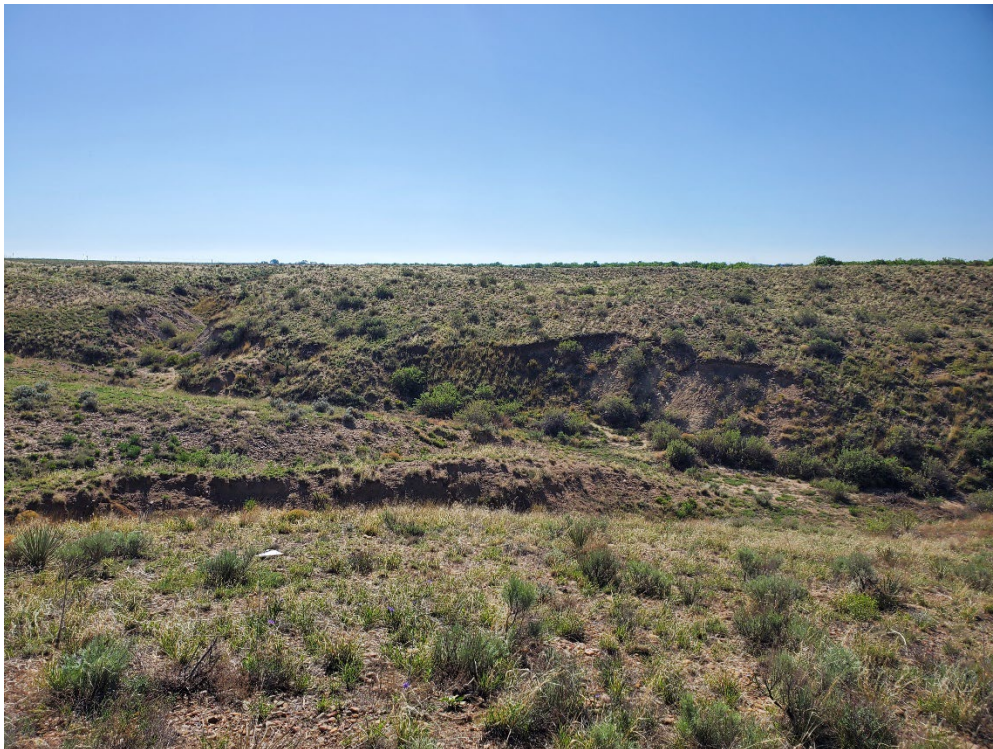
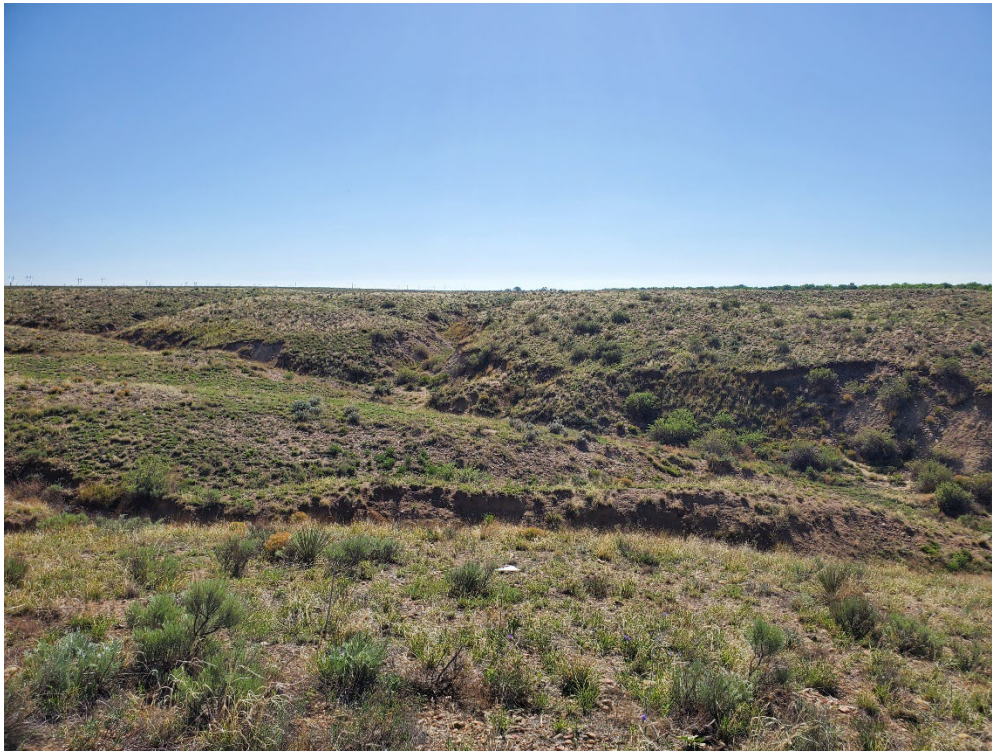
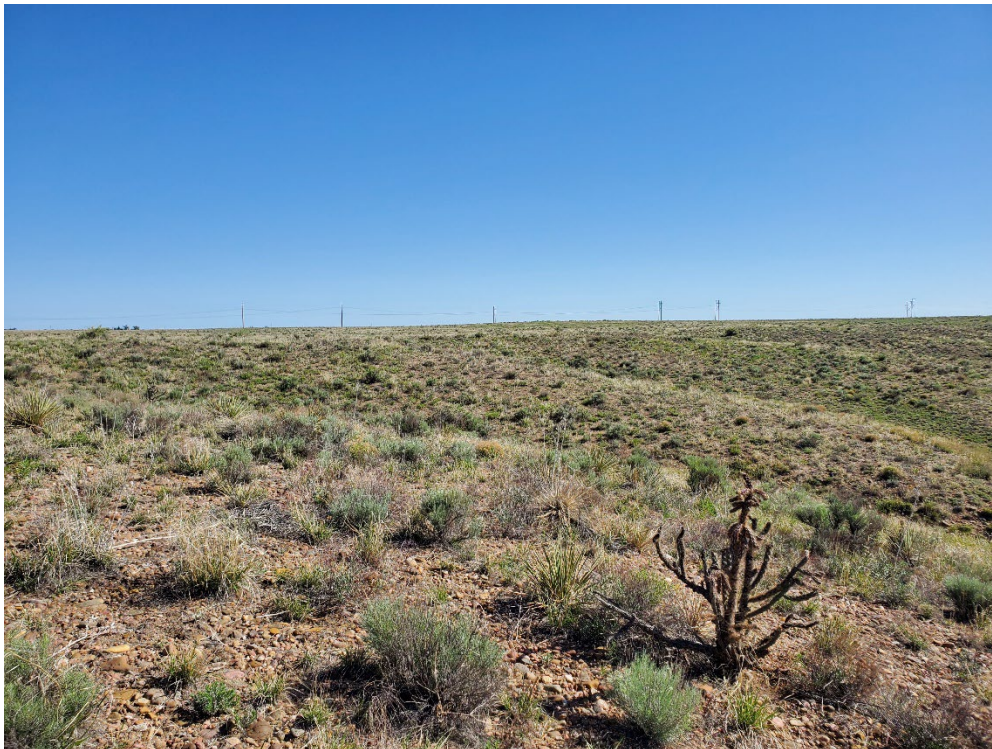
**Photo 25:** Looking south in the western area beyond the old M-2013-008 permit boundary at the DH5 location.

**Photo 26:** Looking west from the DH5 location.

**Photo 27:** Looking south-east from the DH5 location.

**Photo 28:** Looking east from the DH5 location.

**Photo 29:** Looking north-east from the DH5 location.

**Photo 30:** Looking north from the DH5 location.

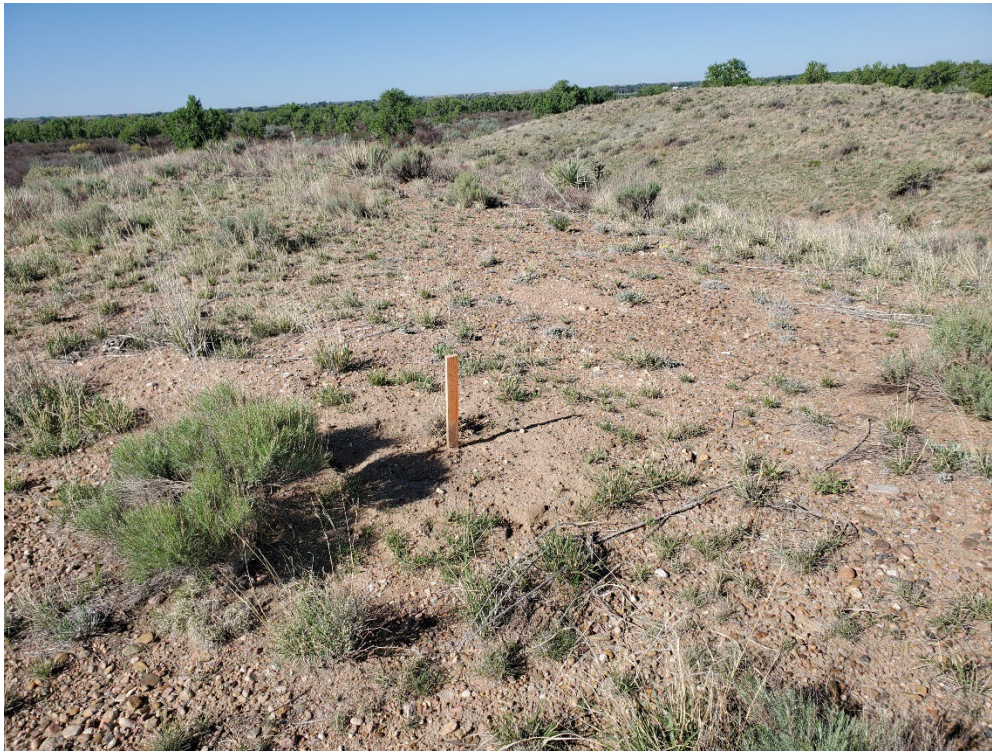
The exploration area, the small topsoil pile locations, and the drill holes were broadcast seeded with the seed mix described in the Operator's approved reclamation plan (Photos 4, 12, 19, 24, 31 & 32). Once seeded, the topsoil was back-dragged to help cover and stabilize the seedbed. Additionally, grass plugs were planted in the abandoned drill holes in addition to the broadcast seeding conducted in these locations. At the time of the inspection, some vegetation has begun to grow. However, there are a few areas that have little to no vegetation that may need to be seeded again next growing season. When comparing to the adjacent undisturbed land (Photos 18, 21, 22, 23, & 25-30) the seeded areas may require one to three more growing seasons to reach the cover and quality of its surroundings.

**Photo 31:** Abandoned and reclaimed drill hole #5.

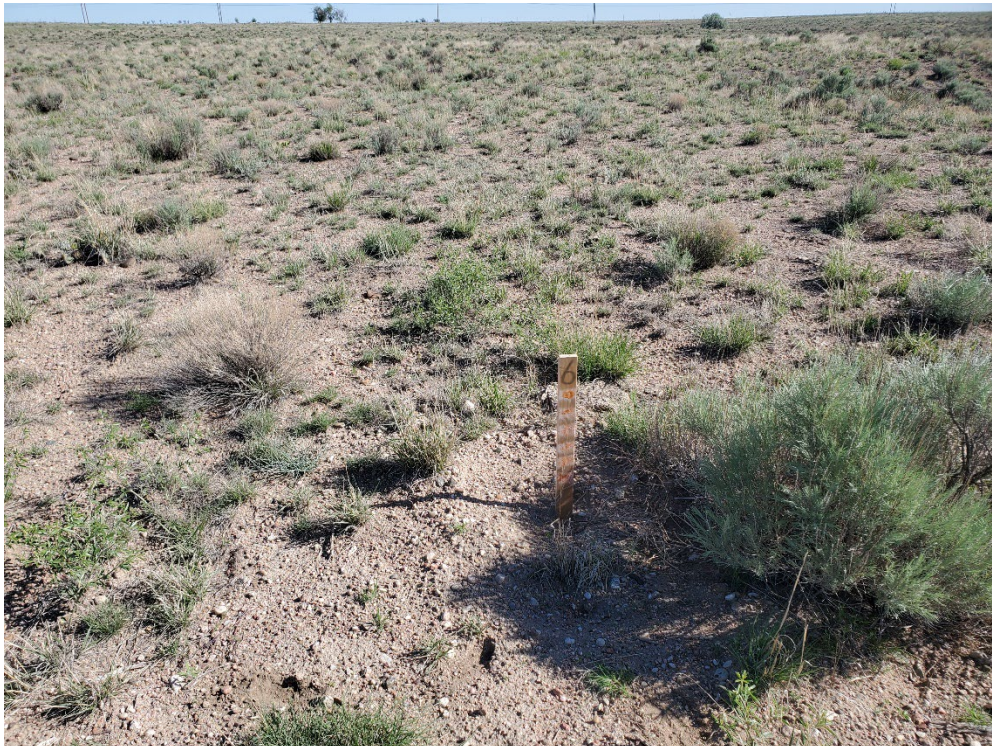
**Photo 32:** Abandoned and reclaimed drill hole #6.

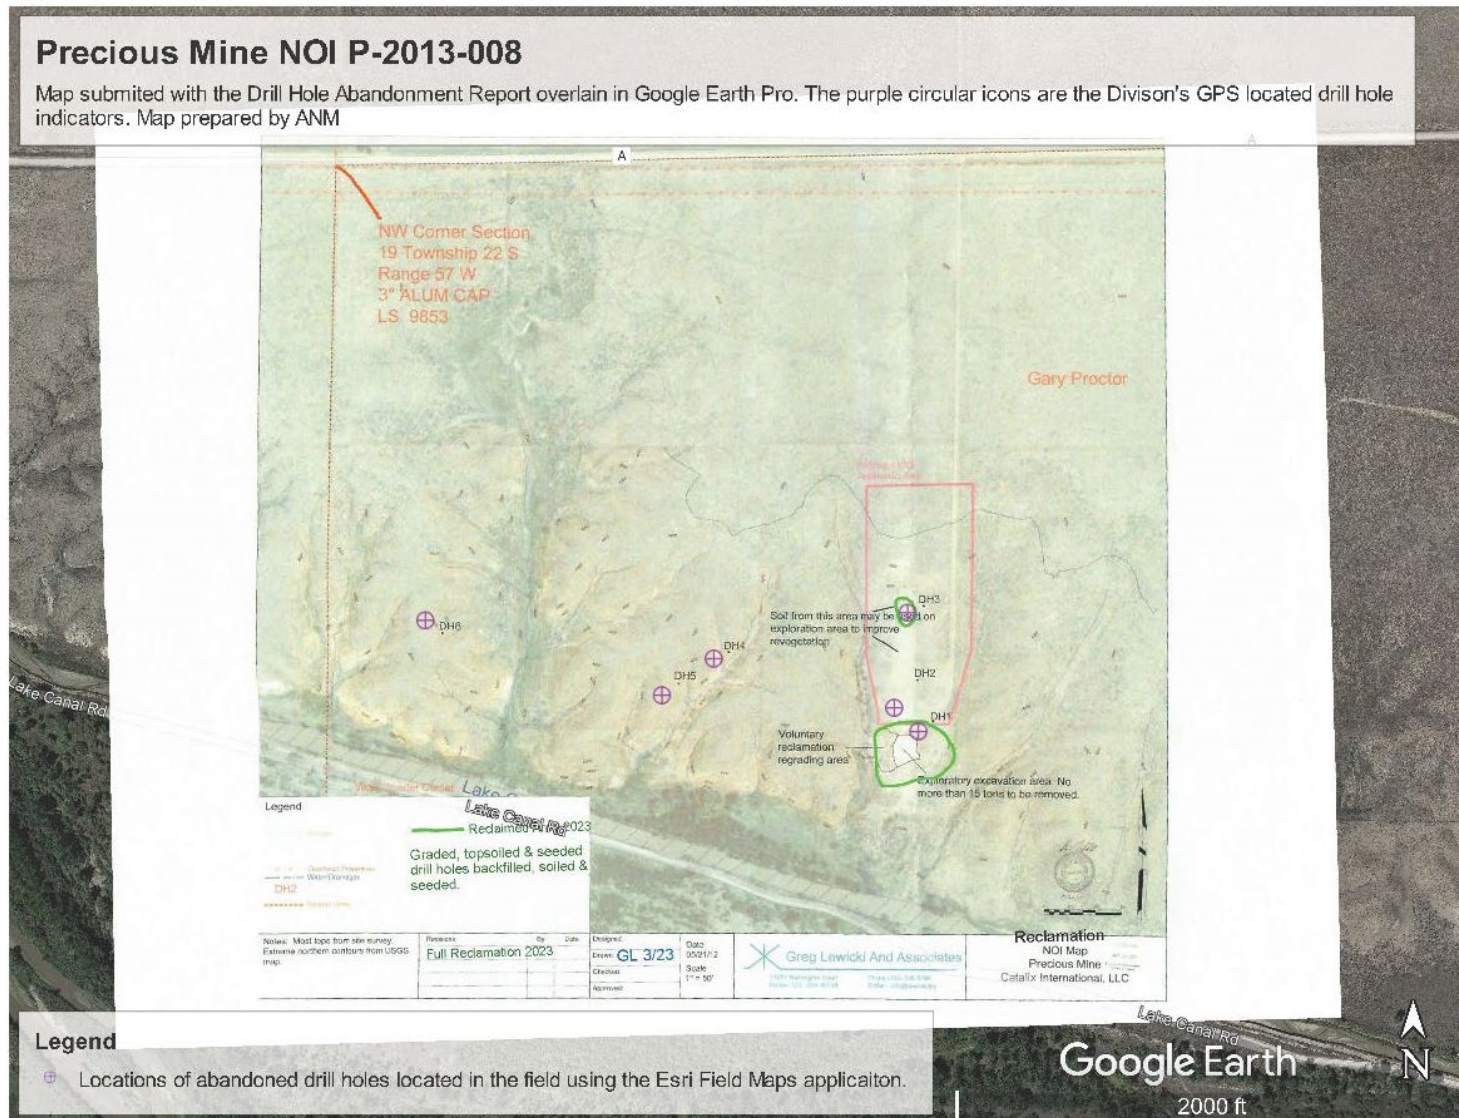
**Map 3:** Map generated in Google Earth Pro containing the drill holes located with the Esri Field Maps application (purple circles) with an overlain image of the reclamation map submitted by the Operator

The reclaimed drill holes were marked with wooden posts labeled from 1-6. Each drill hole was located during the inspection and georeferenced using the Esri Field Maps application (see Map 3). Photos of each drill hole were also taken during the inspection, excluding drill hole 2 (DH2) by mistake. Photo 12 of DH2 was extracted from the reclaimed drill hole photos that were included within the Operator's Reclamation Report.
