## C1983059, Terror Creek Loadout, May Inspection Report

**PERMIT INFORMATION**

<b>Inspection Start Date:</b> May 16, 2023 <b>Inspection Start Time:</b> 14:00 <b>Inspection End Date:</b> <b>Inspection End Time:</b>	<b>Inspection Type:</b> Coal Partial Inspection <b>Inspection Reason:</b> Normal I&E Program <b>Weather:</b> Clear
<b>Joint Inspection Agency:</b>  None	<b>Joint Inspection Contacts:</b>  
<b>Post Inspection Agency:</b>  None	<b>Post Inspection Contacts:</b>  
<b>Inspector(s):</b>  Leigh Simmons	<b>Inspector's Signature:</b>

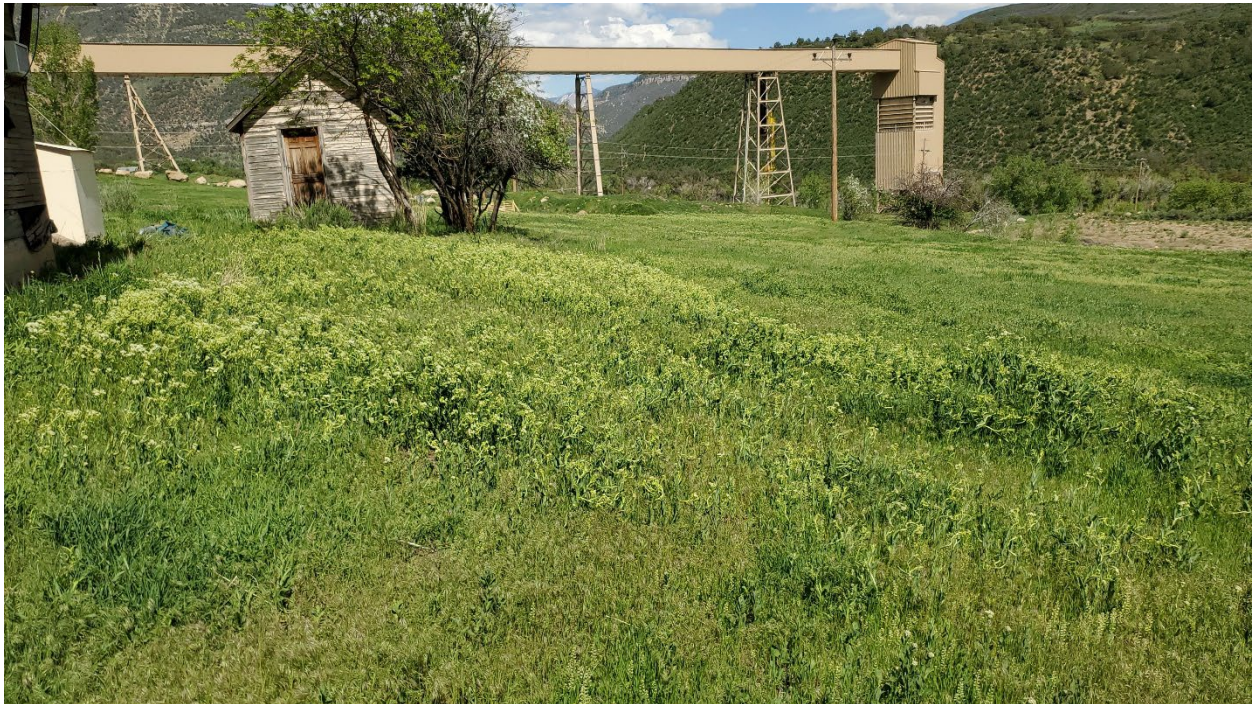
Oxbow staff had been spraying weeds at the site earlier in the day and for the days preceding. Whitetop (Hoary cress, *Lepidium draba*) was very prevalent at the site at the time of the inspection, presumably the wet winter and spring had created particularly favorable conditions this year, since it seemed more widespread around the area than in recent years.

*Figure 1: Whitetop, recently sprayed*

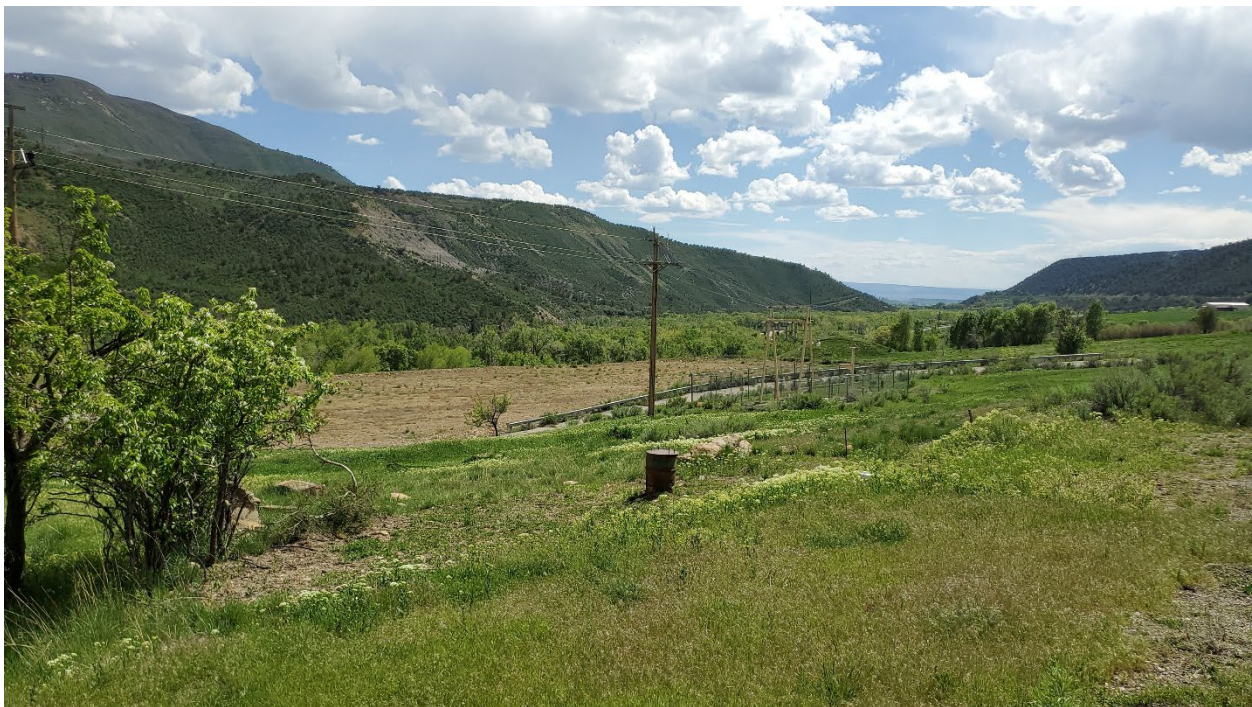
*Figure 2: Overview of site, looking to the south west*

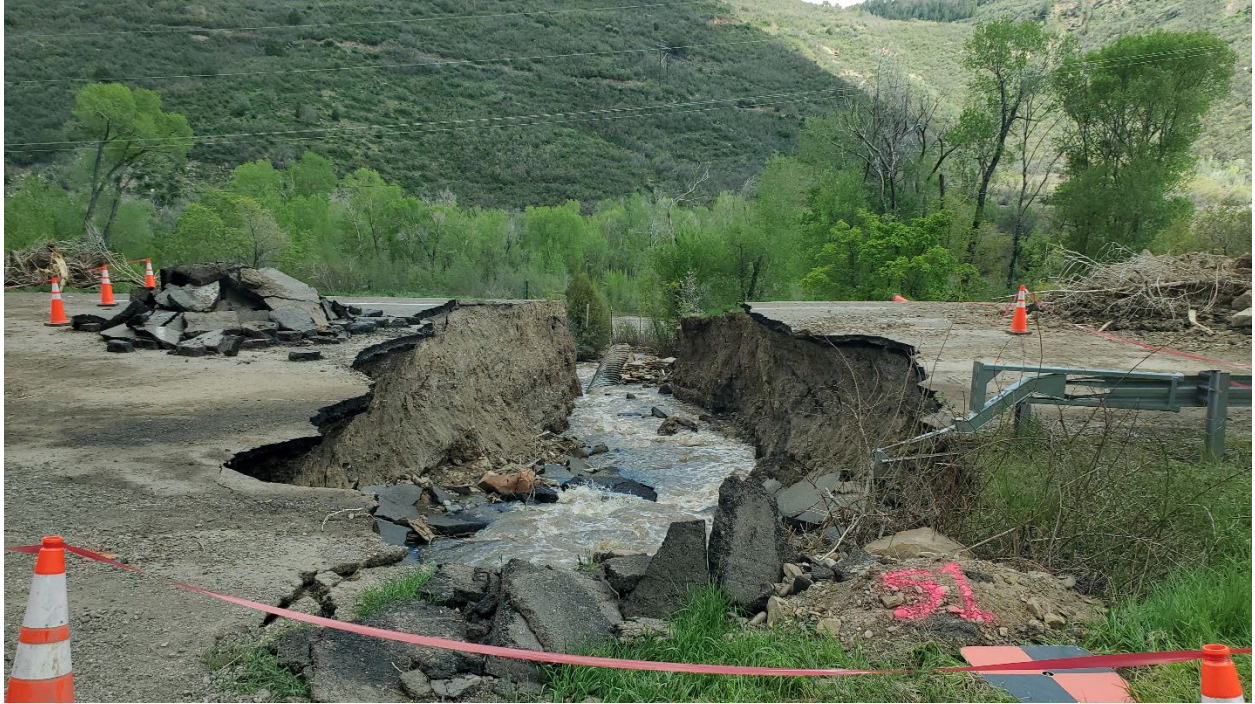
Access between the Terror Creek Loadout and the Oxbow office at the Elk Creek Mine was complicated by the closure of Highway 133 at Bear Creek where the road had washed out. No estimated time was known for either temporary or permanent repairs.

*Figure 3: Road damage to Hwy 133 at Bear Creek*
