MINERALS PROGRAM INSPECTION REPORT
PHONE: (303) 866-3567

MINE NAME: Whitewater Pit 500	MINE/PROSPECTING ID#: M-1977-129	MINERAL: Sand and gravel	COUNTY: Mesa
INSPECTION TYPE: Monitoring	WEATHER: Clear	INSP. DATE: May 9, 2023	INSP. TIME: 10:00
OPERATOR: Whitewater Building Materials Corporation	OPERATOR REPRESENTATIVE: Mark Gardner	TYPE OF OPERATION: 112c - Construction Regular Operation	
REASON FOR INSPECTION: Normal I&E Program	BOND CALCULATION TYPE: Complete Bond	BOND AMOUNT: \$287,500.00	
DATE OF COMPLAINT: NA	POST INSP. CONTACTS: None	JOINT INSP. AGENCY: None	
INSPECTOR(S): Amy Yeldell	INSPECTOR'S SIGNATURE:

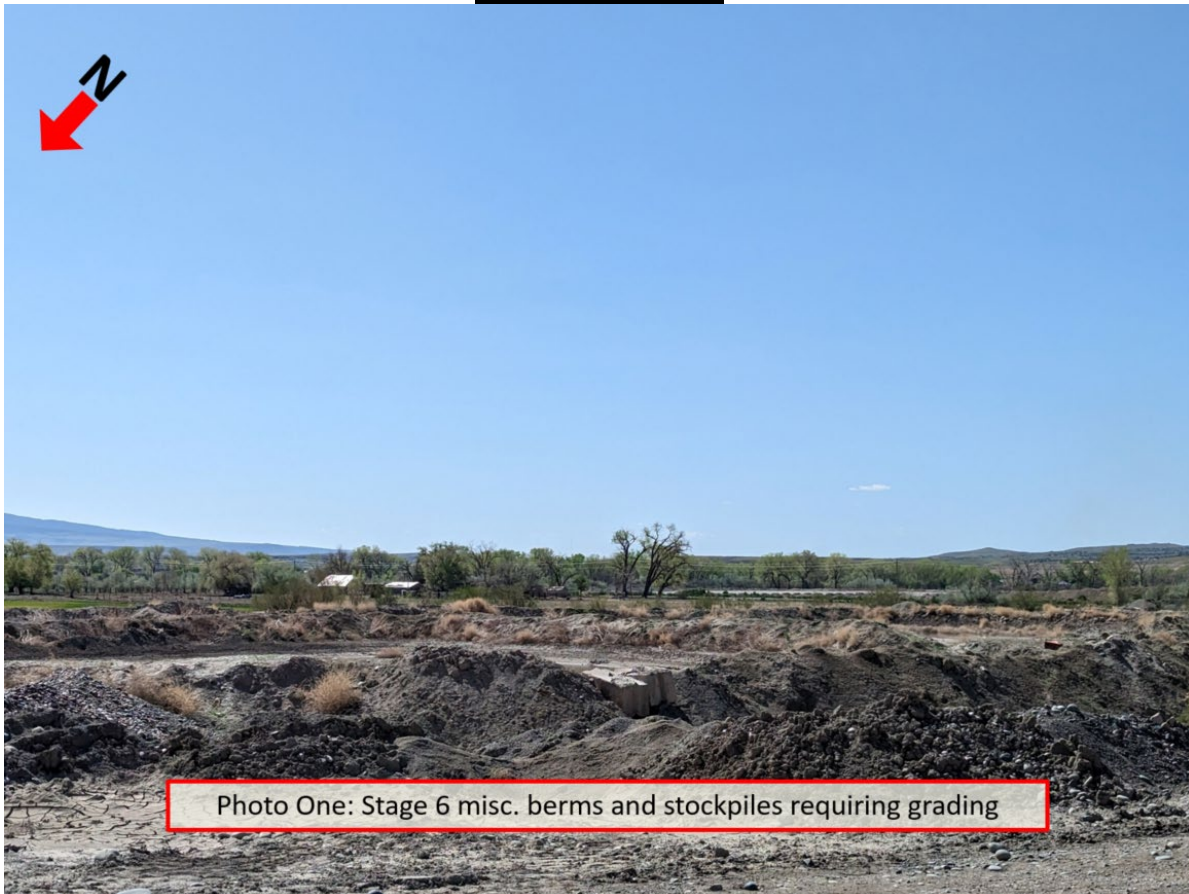
Stage 6, little to no mining excavations have taken place. Only grading/flattening of stockpiles is required in this phase (Photo One). Given its use for stockpile storage the area will also require ripping prior to topsoil application and revegetation.

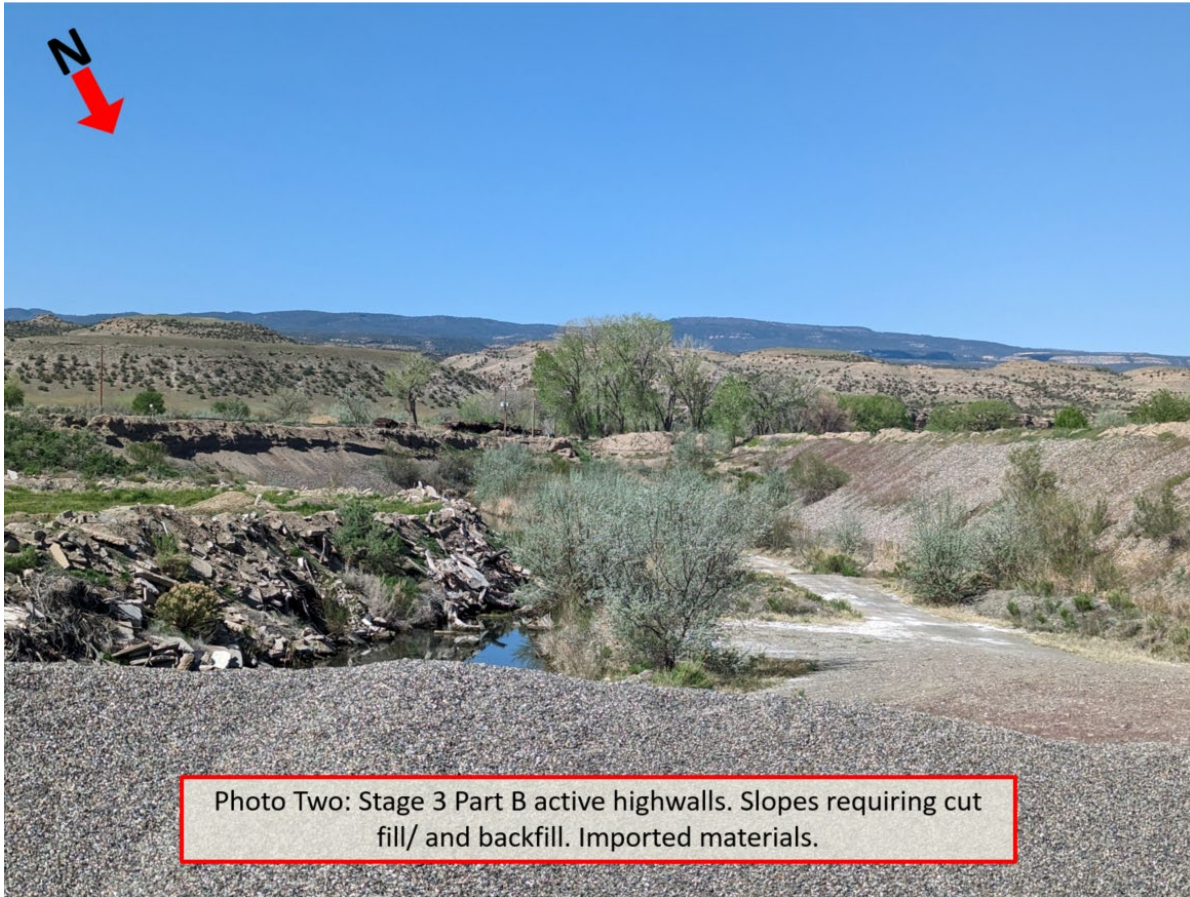
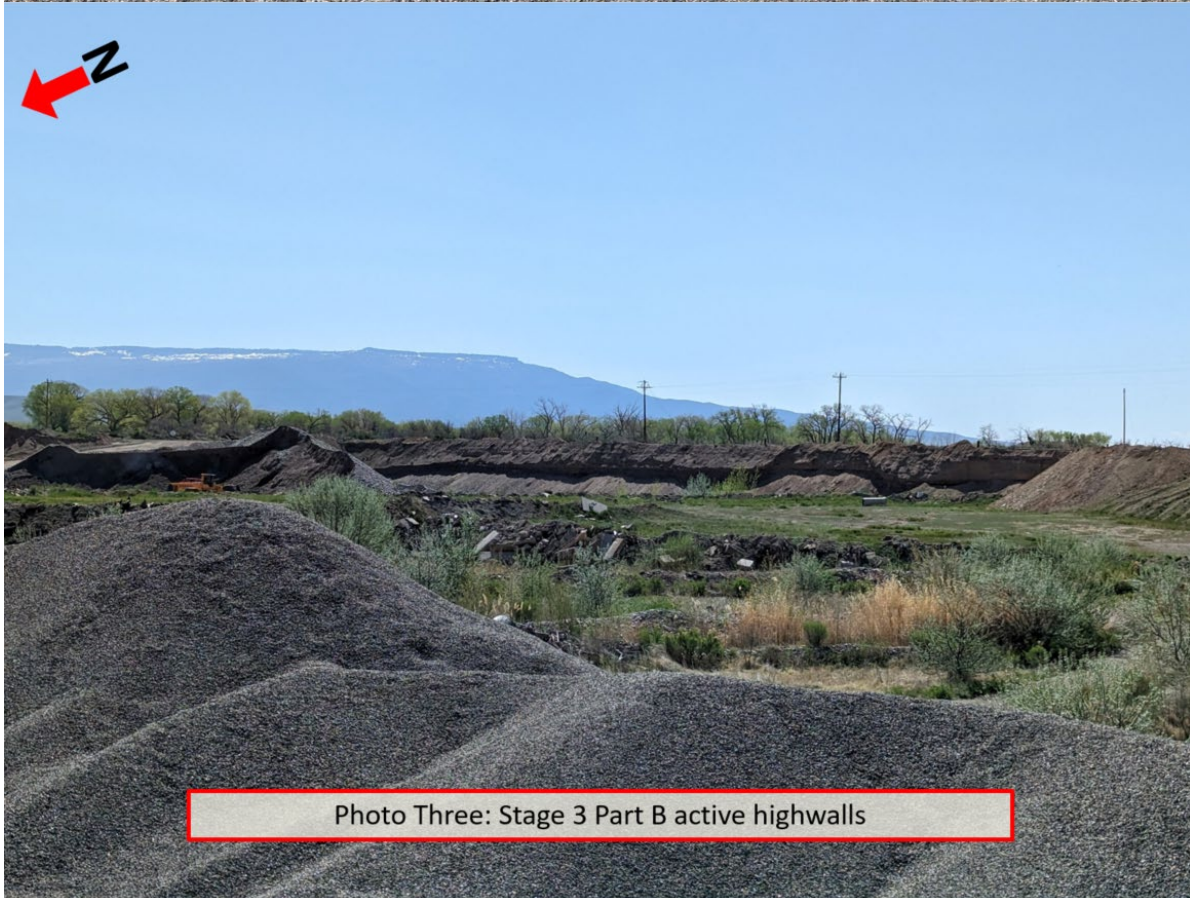
Stage 3 Part B (3N) is mined to a depth of 20 feet (Photos Two and Three). The pit floor has been partially backfilled in areas. A portion of the southern highwall along the railroad tracks has been sufficiently graded to a 3H: 1V or less, approximately 500 LF. The southwestern highwall adjacent to the railroad track is approximately 1H: 1V slope (approx. 400LF) and will require backfill. The western highwall is 2H: 1V and will be mined through as the operation progresses to the west. This highwall can be cut/fill, approx. 1,500 LF, averaging 20 ft. high.

The current Mine Plan (revised under TR-5) commits to no more than 1,500 LF of backfilled/unfinished slopes at any given time. More than 1,500 LF of slopes were observed on site. This is cited as a problem for failure to comply with the general requirements of approved Mining Plan. In the form of a Technical Revision, please revise the Mining Plan to reflect the current operation.

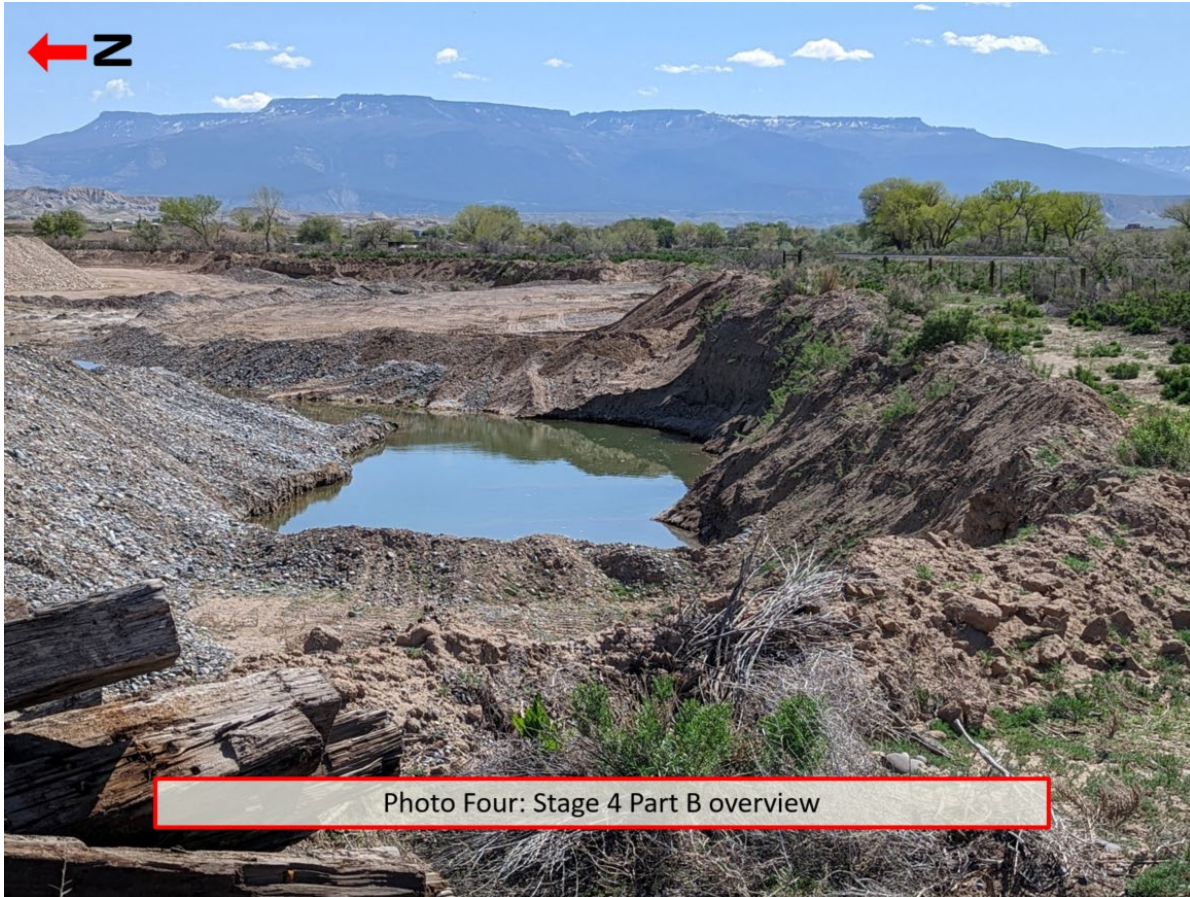
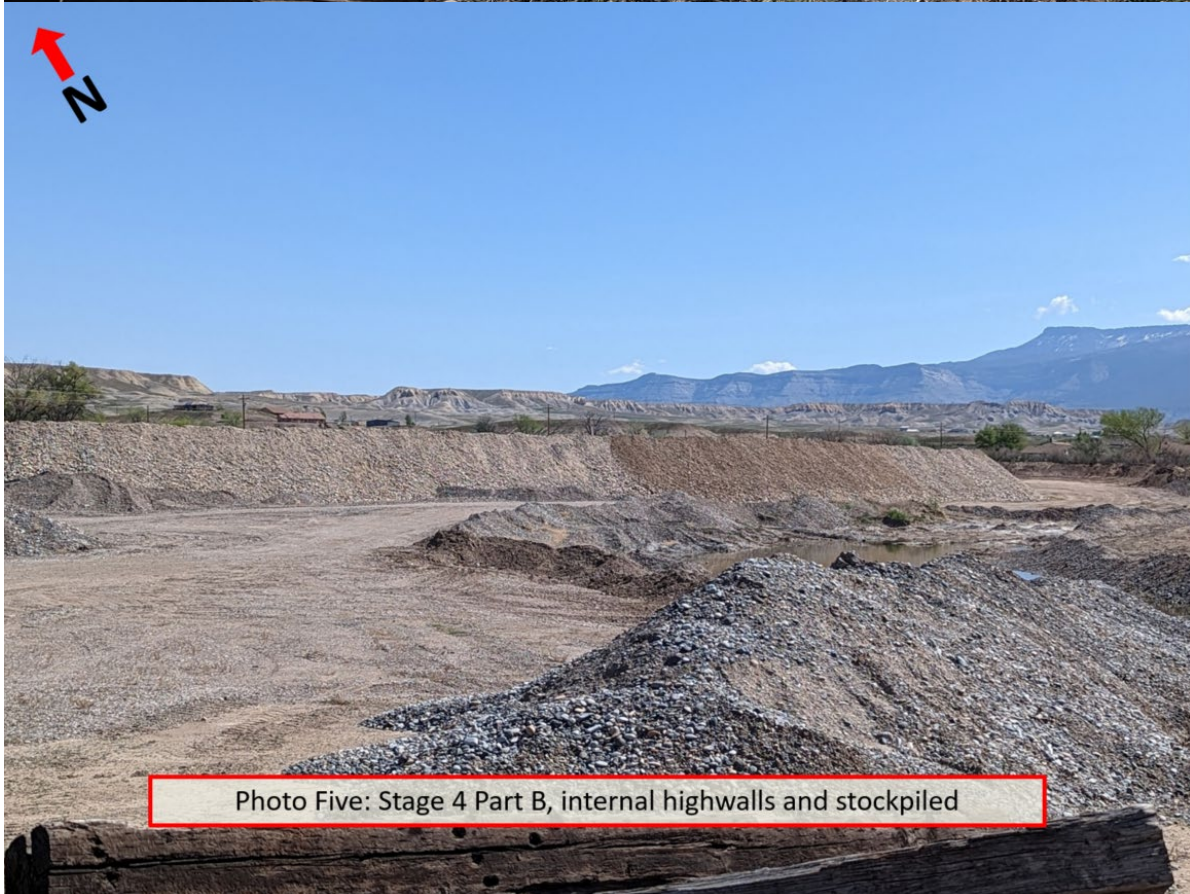
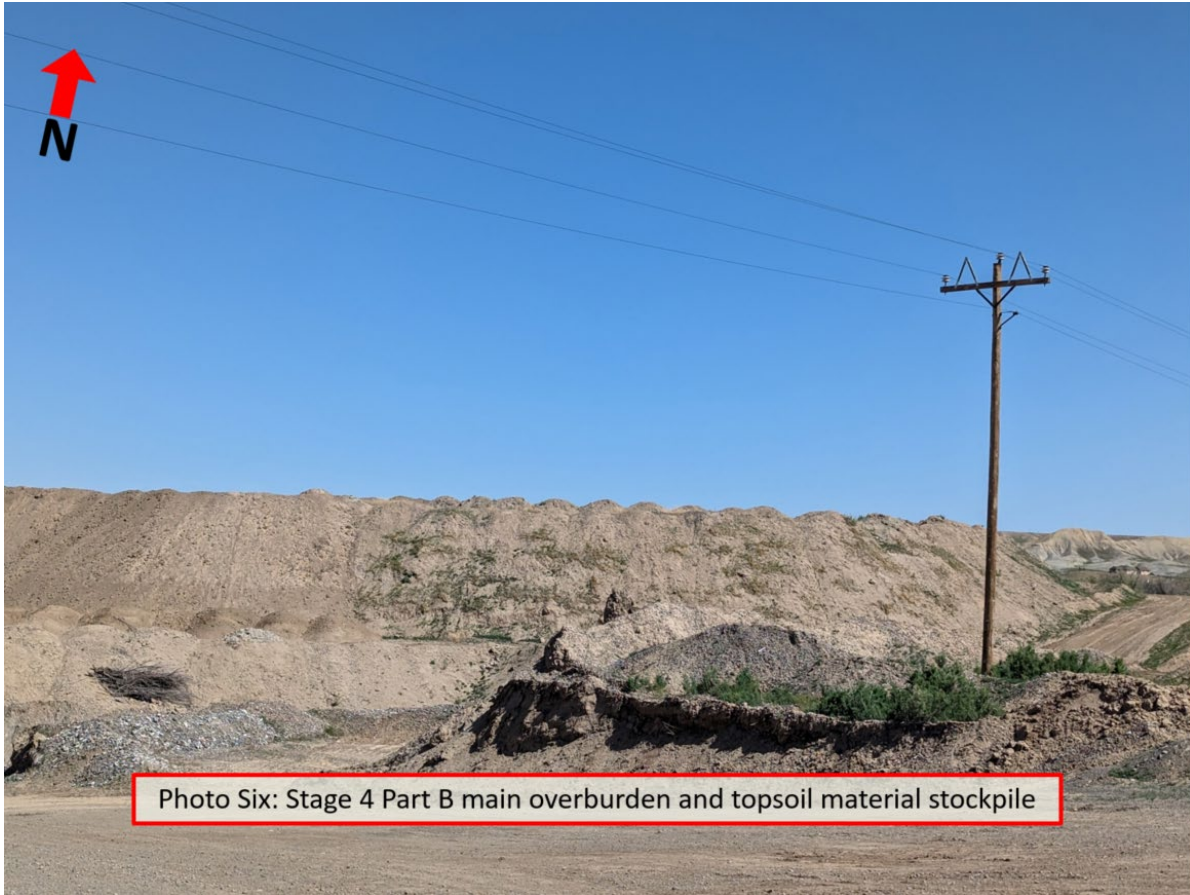
Stage 4 Part B (4N) nearly the entire phase is stripped. Mining is occurring to a depth of 20 feet within this phase (Photos Four, Five and Six). The southwestern half is completely mined. A portion of the highwall along the railroad tracks has been regraded to a 3H: 1V slope and still require topsoil and revegetation (approx. 400 LF). The more central and easterly highwalls along the railroad tracks are at 1H: 1V and will require backfill (approx. 1,200 LF). Active mining slopes within the pit along the east and north are at 2H: 1V and can be sloped using cut/fill.

Stage 4 Part B (4N) is also partially mined out (Photos Four, Five and Six). A large stockpile (4 ac) of

overburden is located along the northern edge adjacent to Coffman Road. Additional stockpiles of imported material are being stored on the east side of the phase. A powerline runs through this phase. "Islands" are being maintained around the poles. Eventually the Operator plans to backfill underneath the right of way to provide/maintain access to the powerline.

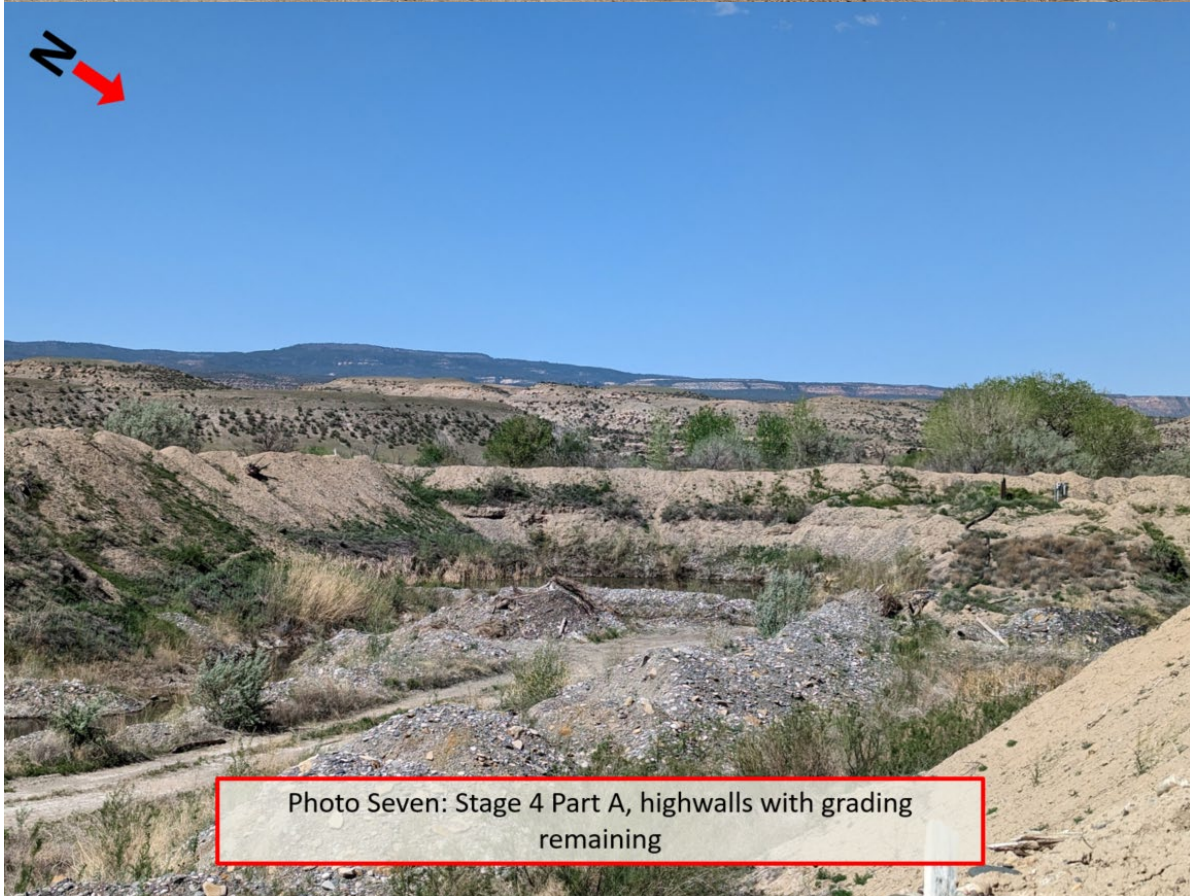
Stage 4 Part A (4S) the majority of the pit is properly sloped to a 3H: 1V or less. Minor repairs are necessary

where water infiltrating from the river has caused sluffing or settling (Photo Seven). A small portion (approx. 1,100 LF) in the northwest corner requires additional grading. This area is currently at a 1H: 1V slope (Photo Eight).

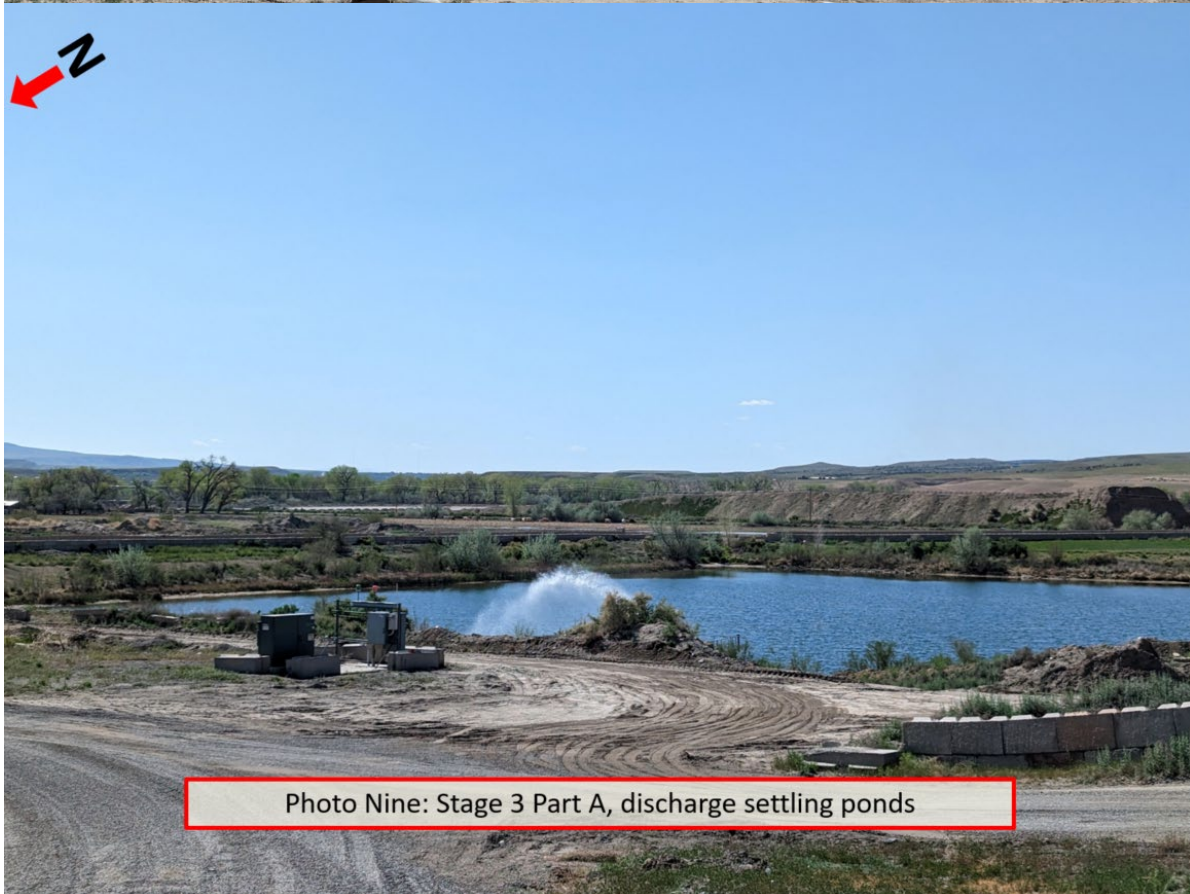
The discharge and settling ponds for the processing plant (located outside of the permit boundary) are located in the northern portion of Stage 3 Part A (3N). Ponds appeared to be stable and well vegetated (Photo Nine).

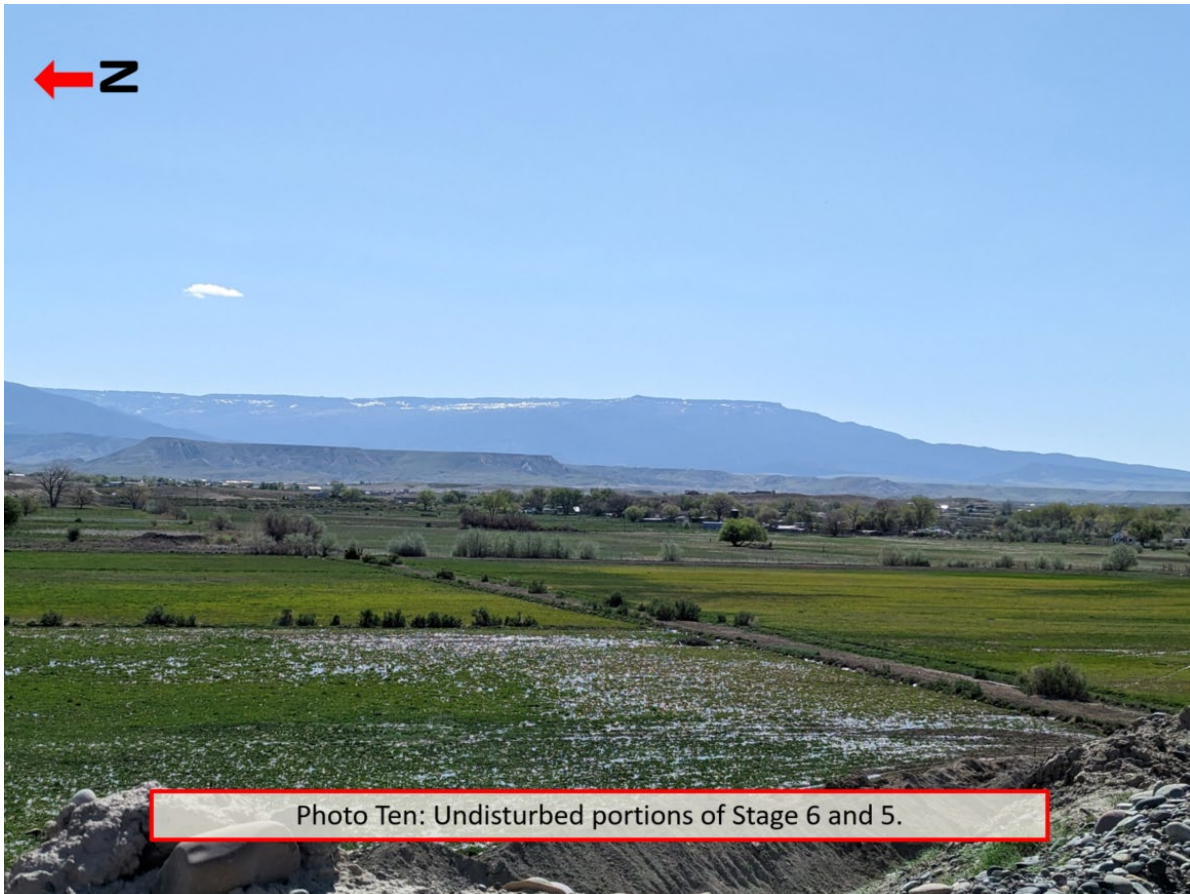
A large processing stockpile is located partially within Phase 6 on the west side. Just to the south of the stockpile adjacent to the haul road is an area used to land farm material removed from the settling ponds. The area slightly dips towards the south east and is bermed off from the rest of Phase 6. Pits appeared mostly dry at the time of the inspection. The total disturbance of Phase 6 is approximately 9.3 ac (Photo One). The remaining area (approx. 61.3 ac) of Stage 6 is undisturbed and remains in use as an irrigated agricultural fields (Photo Ten).

All of Stage 5 is undisturbed (Photo Ten).

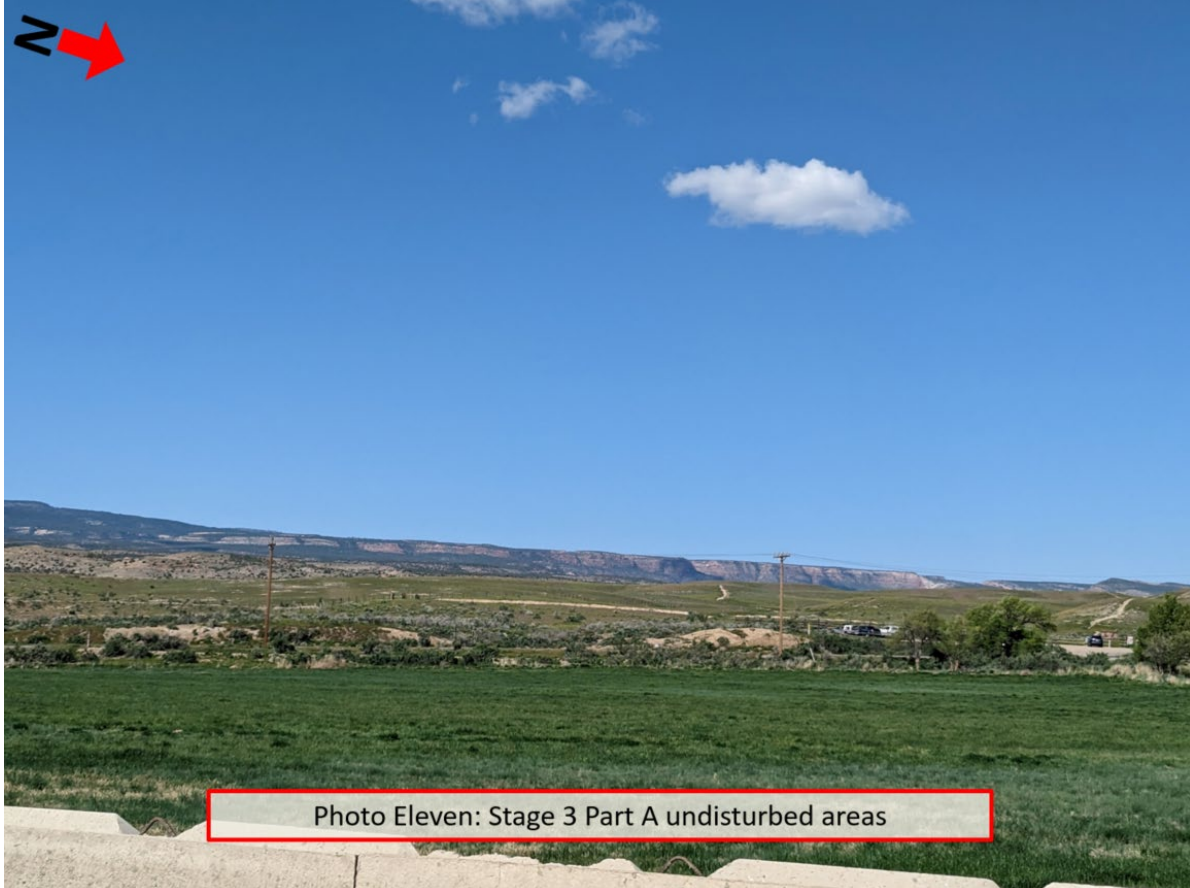
The southern portion of Stage 3 Part A (3N) remains undisturbed and reserved for future mining (Photo Eleven). This area is approximately 7.5 acres. The northern portions which were previously mined are used as a settling pond. No stockpiles are located within this phase.

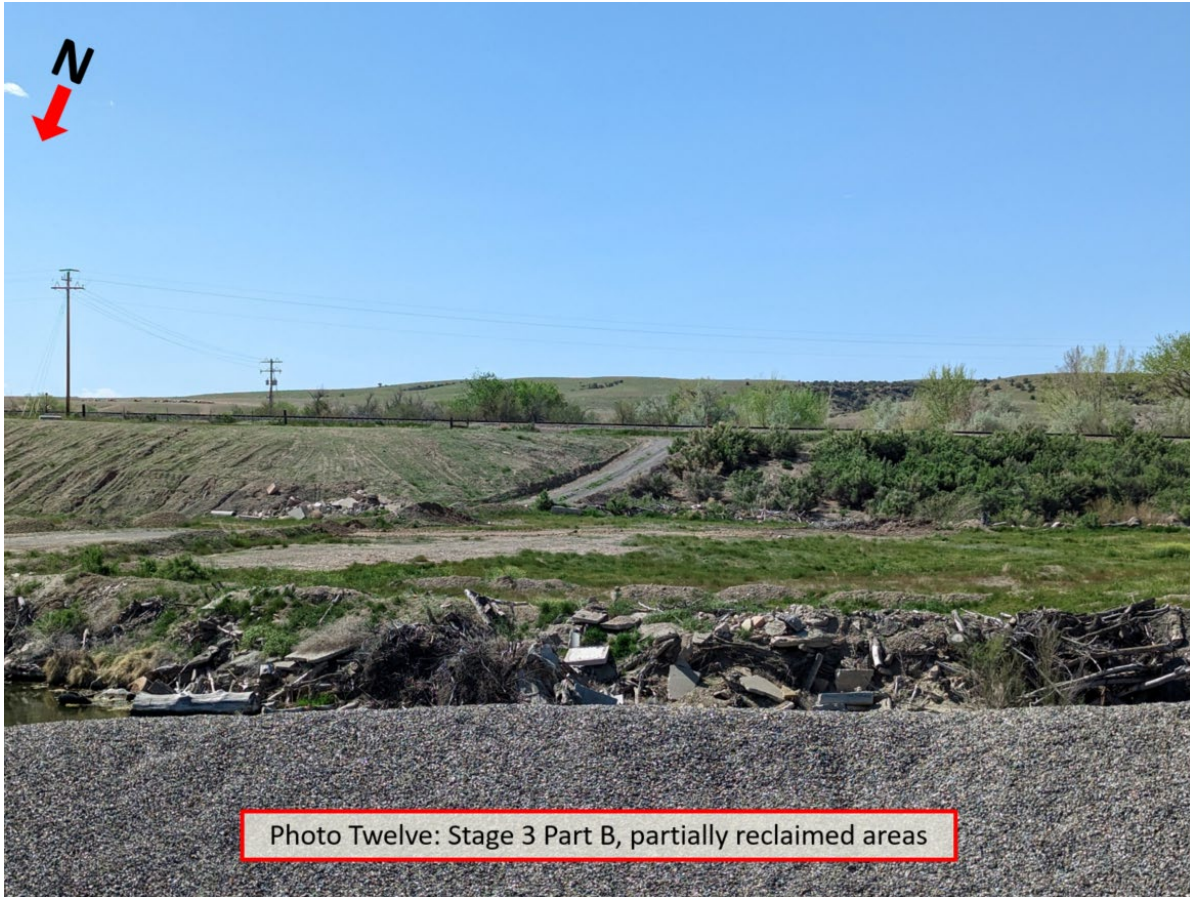
Stage 3 Part B (3S) is partially mined out (Photos Two, Three and Twelve). Approximately 18 ac out of the total 67 ac phase has been affected to date. The western side of Stage 3 Part B remains unaffected. Imported material is being used as backfill in this stage.

Photo Twelve: Stage 3 Part B, partially reclaimed areas

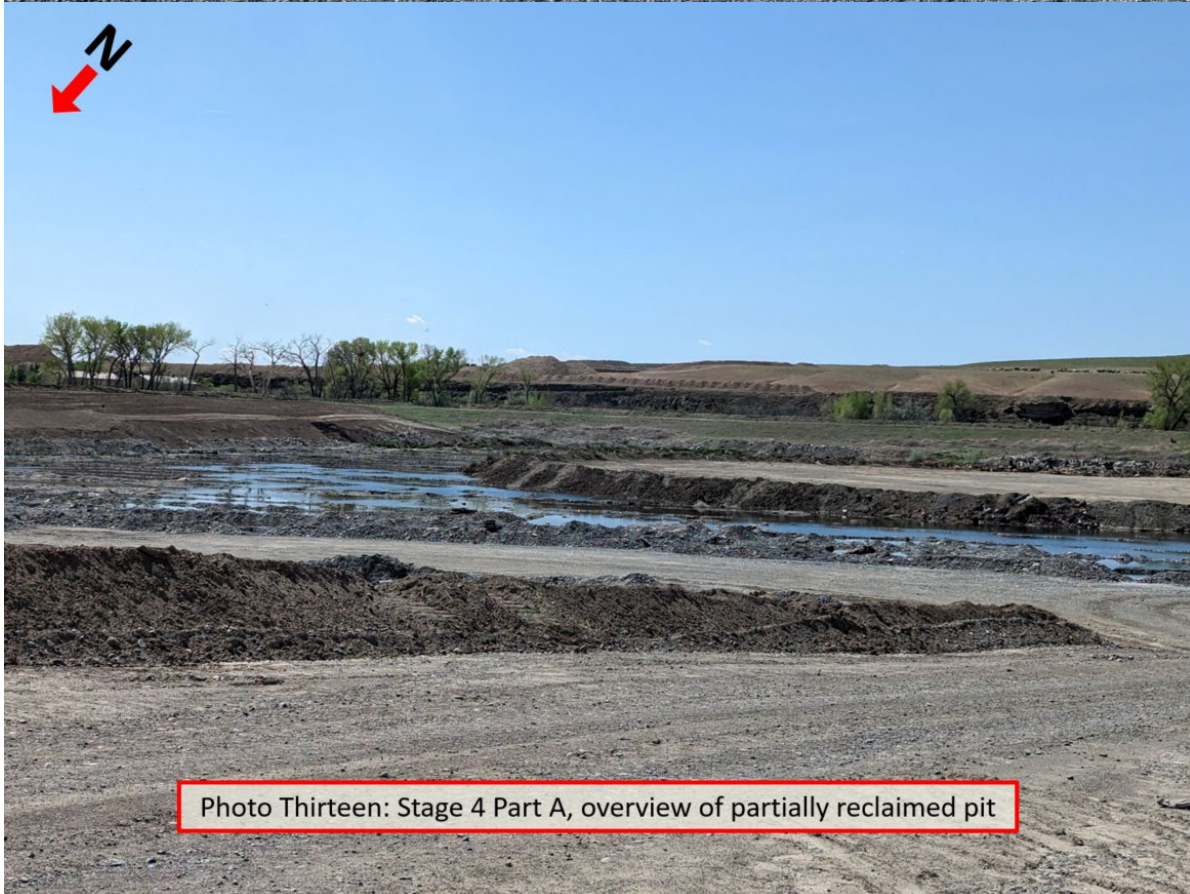
Stage 4 Part A is separated by the railroad tracks and is accessed through Stage 4 Part B (4N). This pit is completely dewatered and mined out to a depth of 25 feet. Final reclamation work has commenced (Photos Thirteen and Fourteen). Grading and topsoiling is mostly complete. A small section requires grading and topsoiling. Seeding of this phase has yet to occur. The pit will likely be re-inundated in 2024. There is a 100 foot setback from the Gunnison River.

Photo Thirteen: Stage 4 Part A, overview of partially reclaimed pit

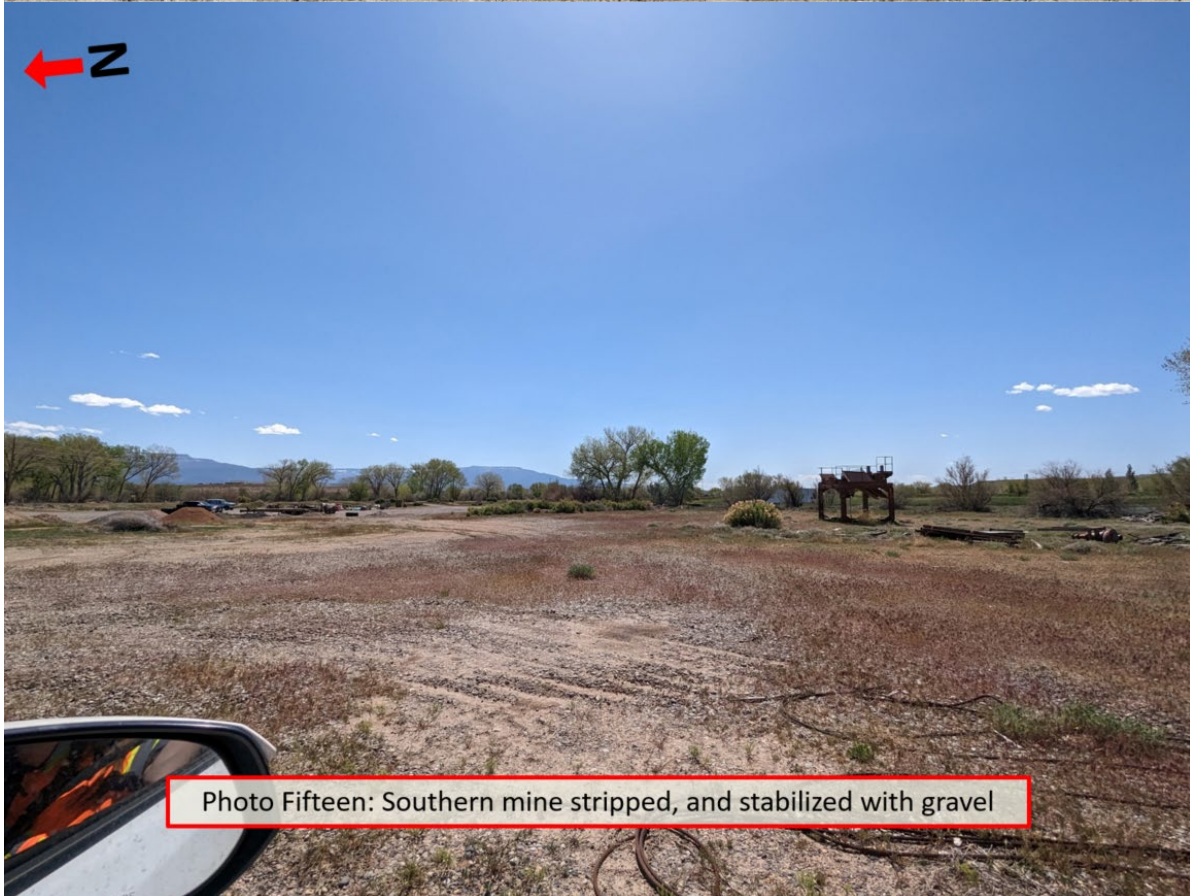
The southern portions of the pit which includes Phase Z, 2W, 2E, and W remain inactive. There is still material available to mine however the operator has chosen to mine reserves closer to its processing plant. Previously mined lakes all appear to have proper sloping and have been revegetated. Disturbed lands with remaining reclamation are approximately 33.9 ac. (Photo Fifteen)

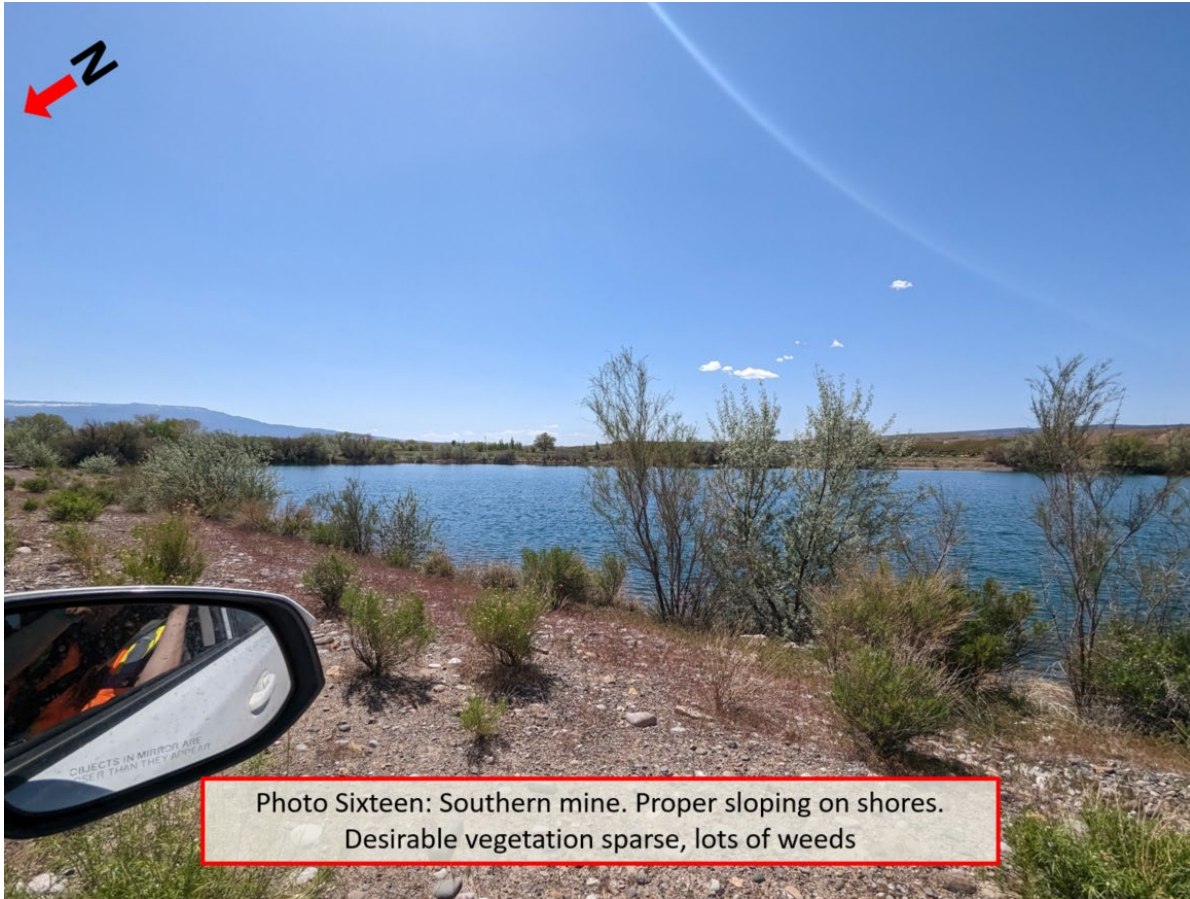
Within Phase Z, 2W, 2E, and W, portions of the lakes are revegetated, however desirable vegetation is inadequate. Noxious weeds have degraded reclaimed areas. Void or sparse areas could benefit from additional touch up seeding (Photo Sixteen). If areas void of vegetation or sparse in desirable species do not germinate in the next few weeks additional seeding efforts are recommended.

Photo Sixteen: Southern mine. Proper sloping on shores.
Desirable vegetation sparse, lots of weeds

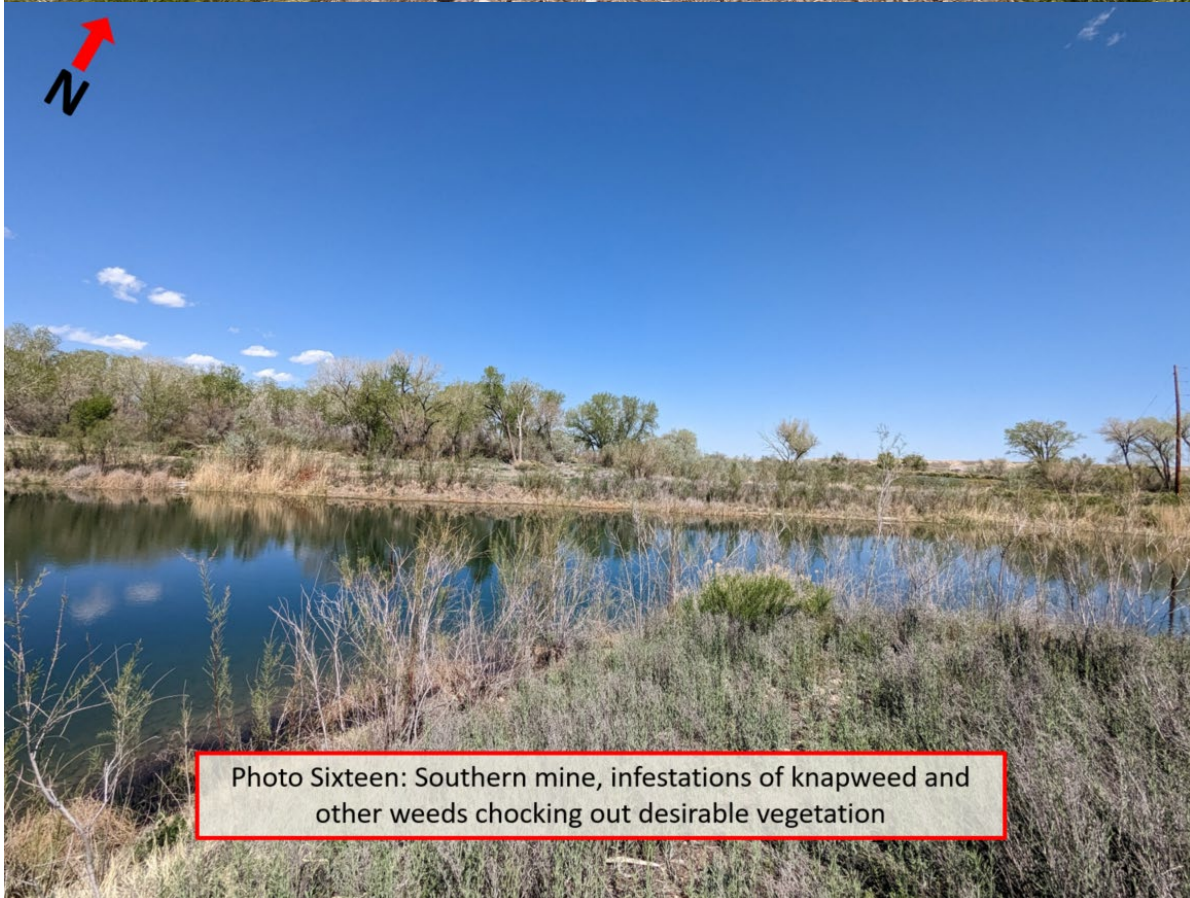
An infestation of knapweed was observed on the southeast finger of the pond in Phase 2W (Photo Seventeen). Noxious weeds in the southern areas need to be more aggressively managed. Site wide the Operator needs to be

diligent in treating of weeds to avoid building up a seed bank on site. Treatment of noxious weeds includes the management and removal of Tamarisk and Russian Olive for those areas reclaimed after 2005. While a Noxious Weed Management Plan was incorporated under TR-3 the plan and its implementation are inadequate. Noxious weeds are threatening the continued development of desirable vegetation, this is a problem pursuant to Rule 3.1.10(6). The Operator needs to provide photo documentation that a spring treatment of noxious weed has occurred. Additionally the Noxious Weed Management Plan needs to be revised to reflect current site conditions.

Photo Sixteen: Southern mine, infestations of knapweed and
other weeds choking out desirable vegetation

CORRECTIVE ACTIONS: The current weed control plan is inadequate. The operator shall update their weed control and management plan in accordance with Section 3.1.10 (6) of the Rule. This plan should be developed in consultation with the county extension agency, or weed control district office and should include specific control measures to be applied, a schedule for when control measures will be applied and a post-treatment monitoring plan. This weed control plan shall be submitted to the Division as a Technical Revision to the approved plan with the appropriate Technical Revision fee of \$216.00 by the corrective action date. Additionally the Operator needs to provide photo documentation that a spring treatment of noxious weed has occurred.
