# COLORADO

Division of Reclamation,  
Mining and Safety

## MINERALS PROGRAM INSPECTION REPORT

<b>MINE NAME:</b> Pikeview Quarry	<b>MINE/PROSPECTING ID#:</b> M-1977-211	<b>MINERAL:</b> Limestone (general), granite, granite gneiss and dolomite	<b>COUNTY:</b> El Paso
<b>INSPECTION TYPE:</b> Monitoring	<b>WEATHER:</b> Partly Cloudy	<b>INSP. DATE:</b> May 10, 2023	<b>INSP. TIME:</b> 09:30
<b>OPERATOR:</b> Riverbend Industries Inc.	<b>OPERATOR REPRESENTATIVE:</b> Jerry Schnabel	<b>TYPE OF OPERATION:</b> 112c - Construction Regular Operation	
<b>REASON FOR INSPECTION:</b> Normal I&E Program	<b>BOND CALCULATION TYPE:</b> None	<b>BOND AMOUNT:</b> \$13,389,784.00	
<b>DATE OF COMPLAINT:</b> NA	<b>POST INSP. CONTACTS:</b> None	<b>JOINT INSP. AGENCY:</b> None	
<b>INSPECTOR(S):</b> Timothy Cazier, P.E.	<b>INSPECTOR'S SIGNATURE:</b>

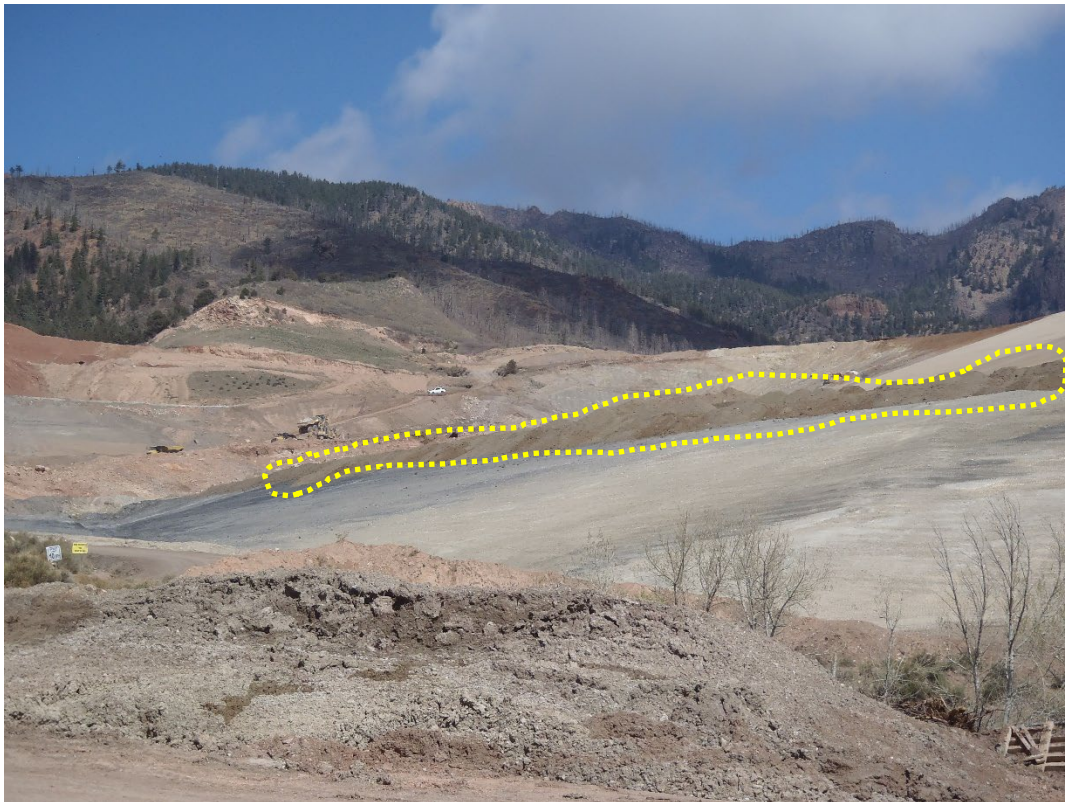
**Backfilling and Grading:** Final grading was near completion in former shop area (see **Photo 1**) with topsoil stockpiles on the upgradient side for spreading in the near future. Final grading was also near completion west of the quarry road and below the bench on which the GEOMOS system building sits (see **Photo 2**). Site representatives stated the buttress backfill had been placed to approximately elevation 7,340 feet (see **Photo 3**) and that roughly 63 percent of the necessary fill was in place at the time of the inspection. Material was being excavated for buttress placement in the private area of the north borrow area (see **Photo 4**) during the inspection. Some minor sloughing had occurred on the upgradient side of the south borrow area (see **Photo 5**). The area was expected to be stabilized as additional material is excavated and the borrow area is sloped back to final grades.

Photo 1. Nearly final grade in former shop area – topsoil (circled) placed at crest (looking NW).

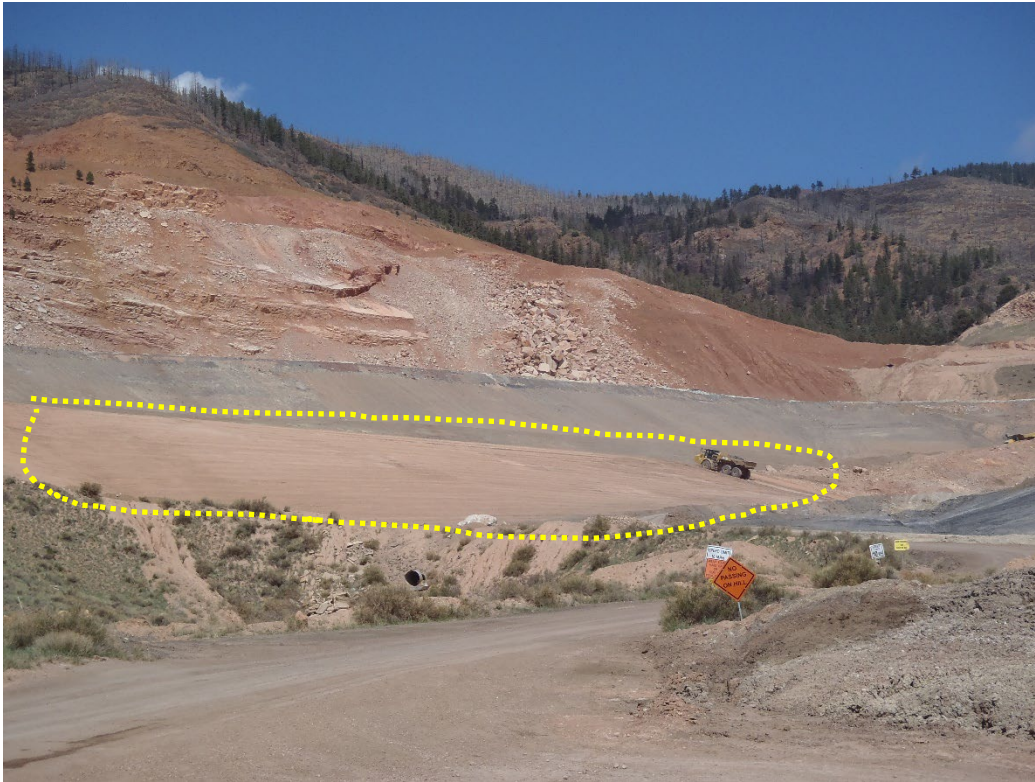
Photo 2. Recently graded lower slope between haul road and lowest bench (looking west).

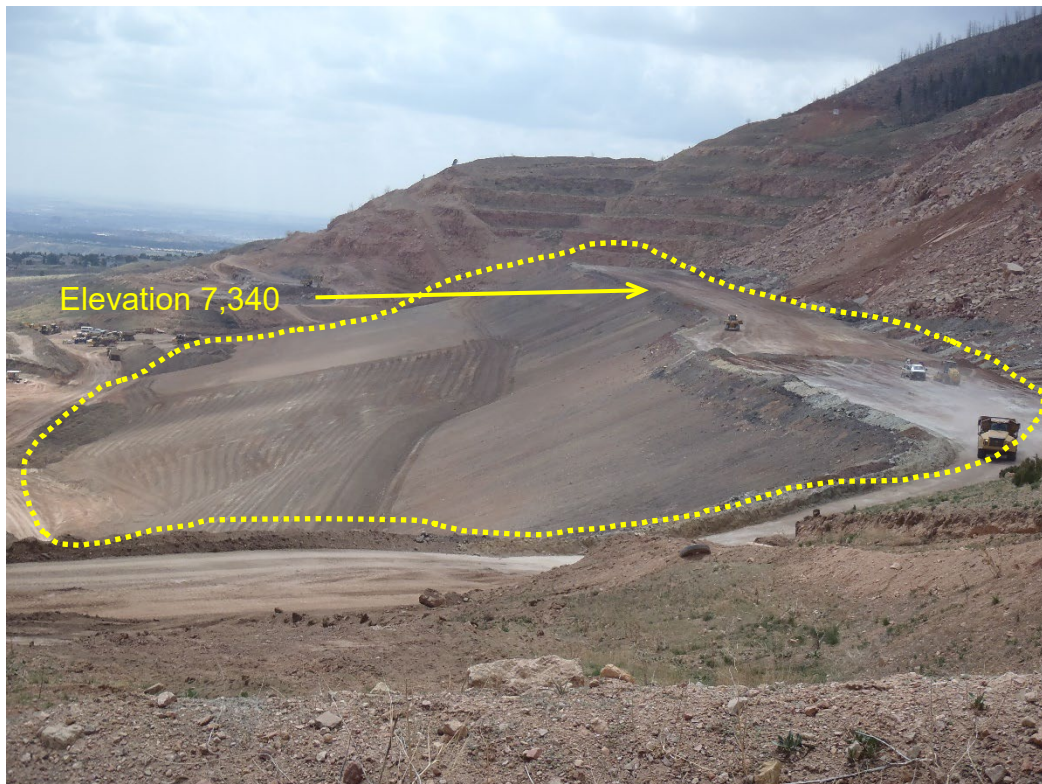
Photo 3. Placed and compacted buttress material (circled, looking south).

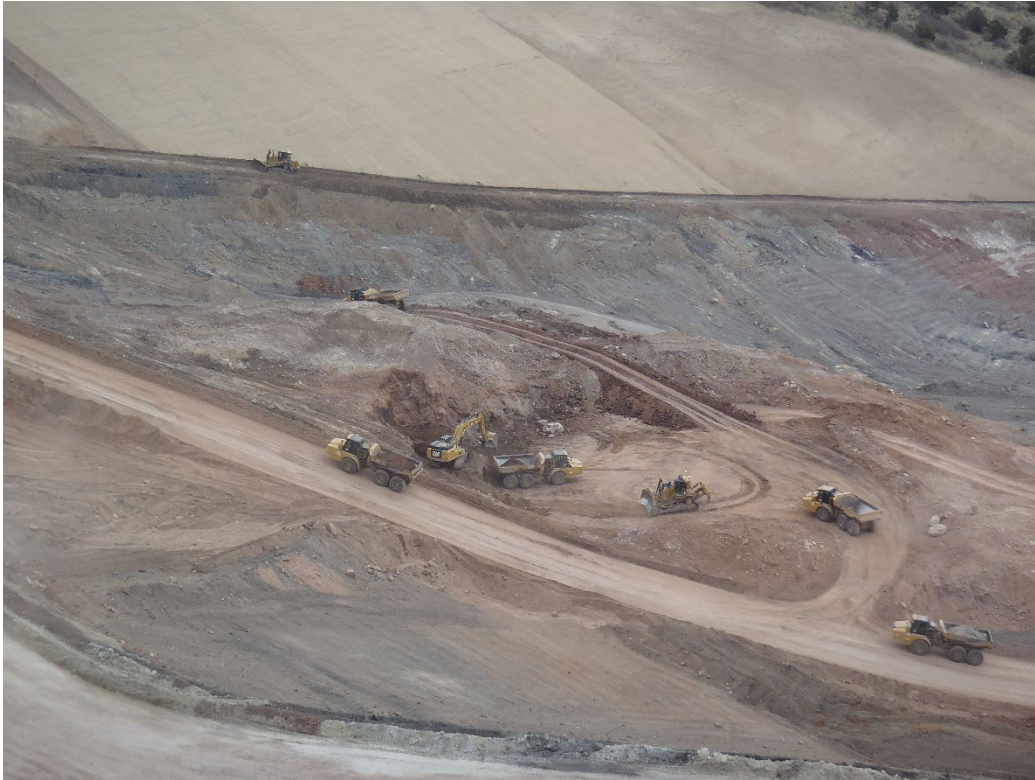
Photo 4. Material excavation from north (private area) borrow area (looking NE from above the slide area).

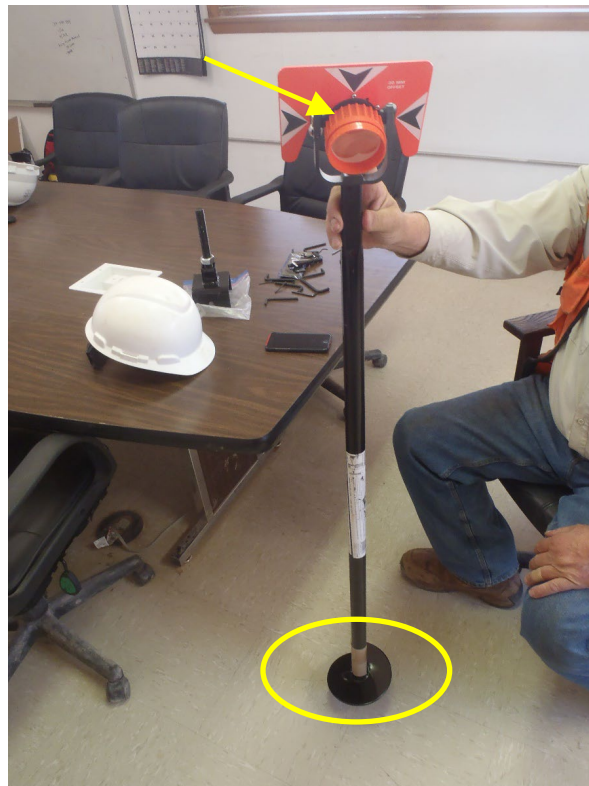
In anticipation of placing new monitoring prisms on the completed backfill, Riverbend has decided to use auger-based prisms (see **Photo 6**). These will be easier to place and remove (once no longer required) than prisms set in concrete. There is a short auger at the base of the support pipe that will allow the pipe to be screwed into the compacted buttress backfill at least two feet.

Photo 5. New auger-based prism (auger at base, prism on top).
