**MINERALS PROGRAM INSPECTION REPORT**  
**PHONE: (303) 866-3567**

<b>MINE NAME:</b> Climax Mine	<b>MINE/PROSPECTING ID#:</b> M-1977-493	<b>MINERAL:</b> Molybdenum	<b>COUNTY:</b> Lake, Summit
<b>INSPECTION TYPE:</b> Monitoring	<b>WEATHER:</b> Snowing	<b>INSP. DATE:</b> May 18, 2023	<b>INSP. TIME:</b> 08:23
<b>OPERATOR:</b> Climax Molybdenum Company	<b>OPERATOR REPRESENTATIVE:</b> Eric Detmer	<b>TYPE OF OPERATION:</b> 112d-3 - Designated Mining Operation	
<b>REASON FOR INSPECTION:</b> Normal I&E Program	<b>BOND CALCULATION TYPE:</b>	<b>BOND AMOUNT:</b> \$91,011,850.00	
<b>DATE OF COMPLAINT:</b> NA	<b>POST INSP. CONTACTS:</b> None	<b>JOINT INSP. AGENCY:</b> None	
<b>INSPECTOR(S):</b> Lucas West	<b>INSPECTOR'S SIGNATURE:</b>

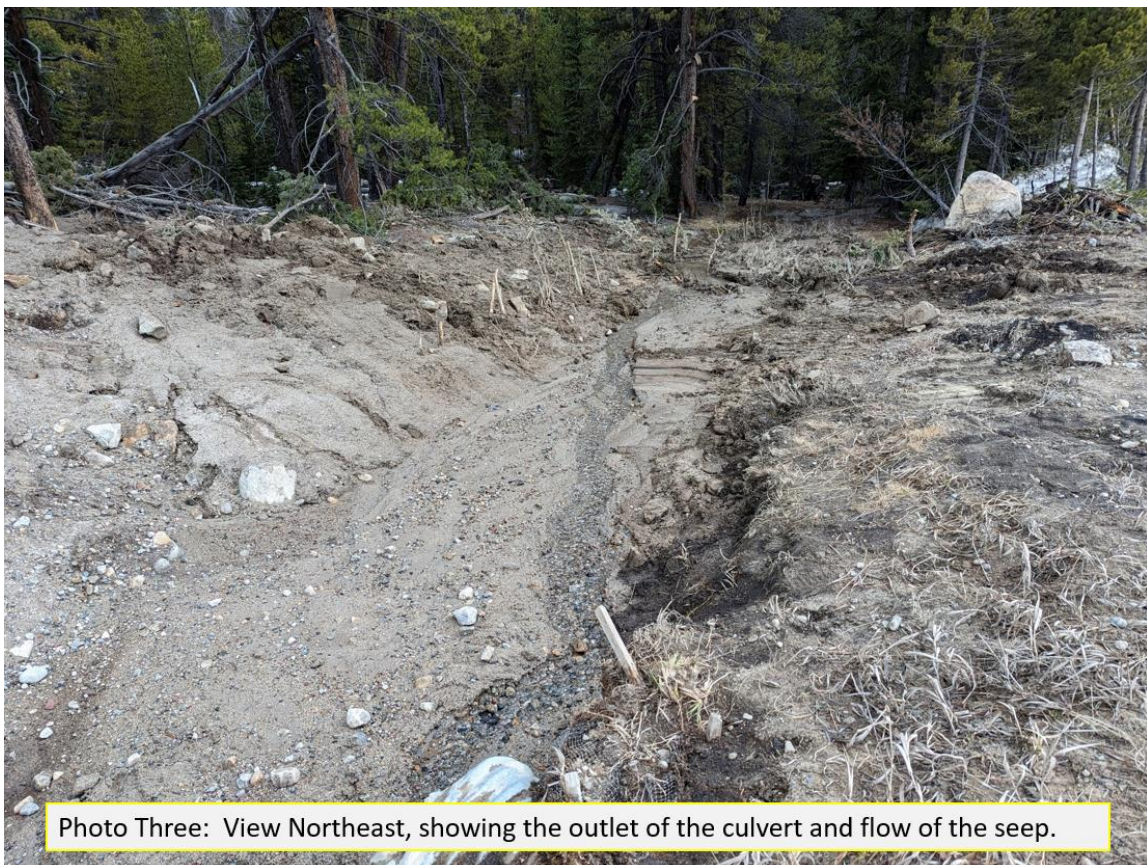
Spill notification area: On May 6, 2023 the Division received a spill notification for the mayflower return line, near the Mayflower Pump Station at a rate of approximately 1 gallon per minute. The written notification was received on May 10, 2023. The spill consisted of a consisted of a seep making a surface expression near the access road in that area. At the time of the inspection, the seep was flowing at a consistent rate, visually consistent with one gallon per minute. Since the time of the original incident the Operator has been investigating the source of the spill. The Mayflower return line, is the line that brings water from the PDWTP back into the system for re-use. The Operator had shut down and drained the line for inspection, however found the rate of flow at the seep did not change. Several other investigation efforts were conducted which resulted in no change in flow rate. The results of these investigations suggest that the seep is not coming from the Mayflower Return Line. The area and flow of the seep can be seen in Photos One and Two. The flow showed no visible signs of water quality impairment, and no mineral staining in the area was noted. On site discussions with the Operator suggest the possible source of the seep is the Clinton Canal, which diverts un-impacted water from the disturbed area eventually joining with 10 Mile Creek. Due to higher than recent snow pack and ongoing precipitation that conclusion is plausible and highly likely. The Operator will be performing more tests in the coming days to further rule out the possibility that this seep is coming from any impacted water source and will be submitting those findings as soon as they are complete. The management of the water is being done by diverting the seep into a culvert, seen in Photo Two, which runs under the access road and into a drainage shown in Photo Three. The flow then reports to 10 mile creek.

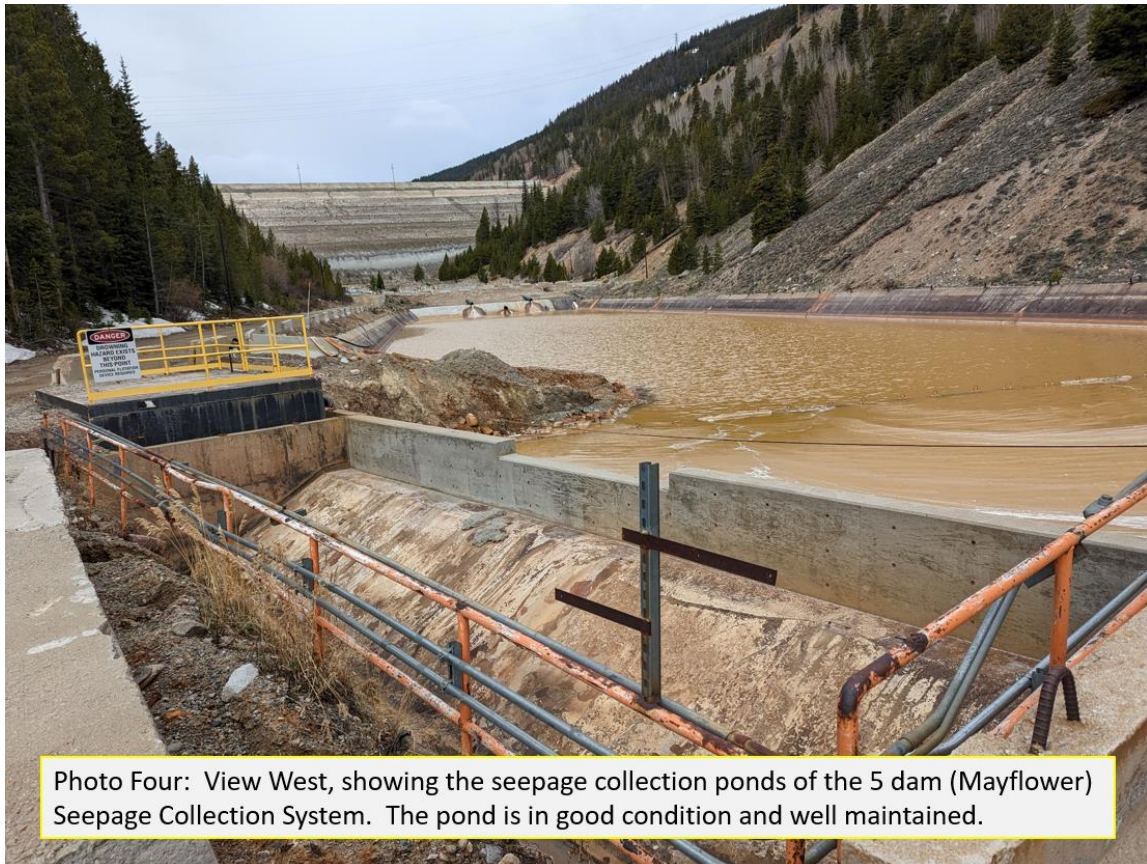
5 dam (Mayflower) seepage collection and pump back system: The collection ponds of the 5 dam seepage collection system were observed to be in good condition with a steady flow reporting. Flows collected in the pond are pumped back to the Mayflower TSF for evaporation. The main pond can be seen in Photo Four. The ponds have sufficient freeboard and no problems were noted. Inside the pump station building, all equipment and lines appear to be in good working order, the inside of the building is well kept and in good condition. Photo Five shows the inside of the pump station building. Secondary containment of the pump system is accomplished by way of the network of floor sumps, all of which were clear and appeared able to function as designed.

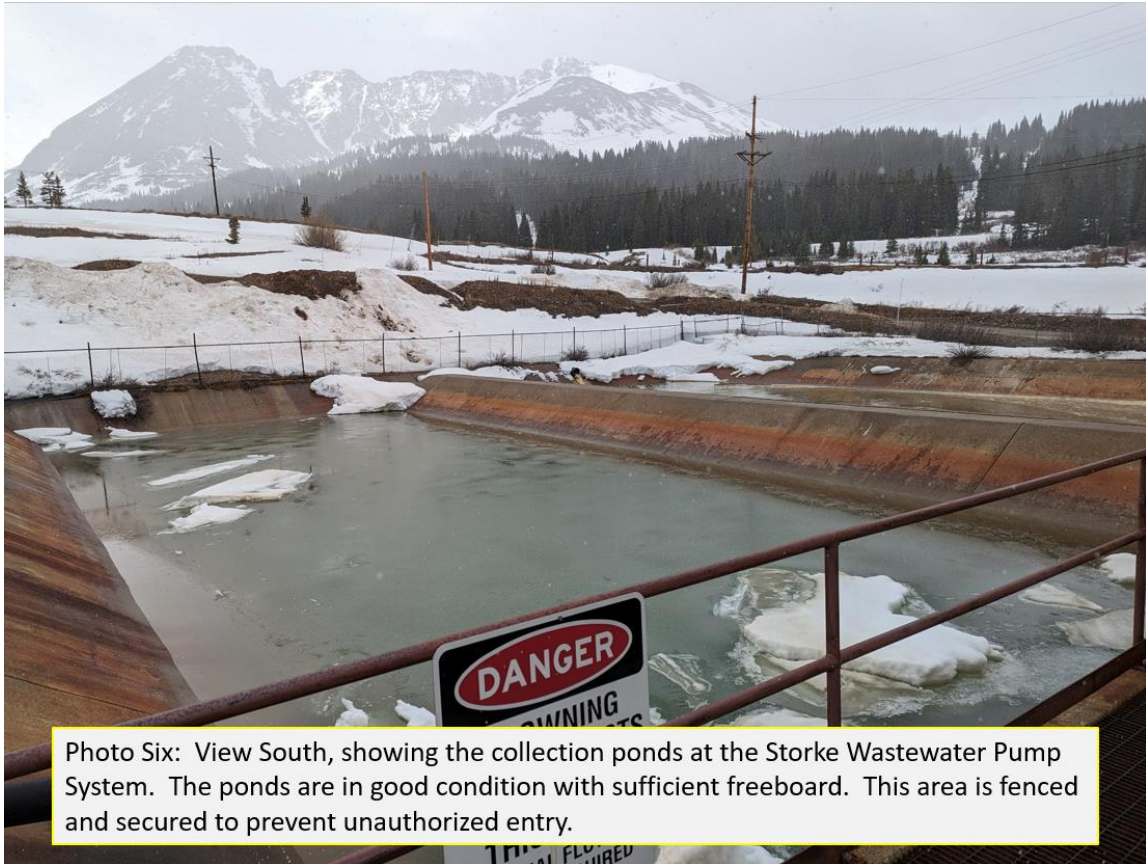
Storke Wastewater Pump System: The Storke Wastewater collection and pump system is located on the other side of Freemont Pass, near the No. 5 Shaft. The system collects wastewater in the adjacent ponds which can be seen in Photo Six. The ponds were in good condition, with sufficient freeboard. The ponds are fenced to prevent unauthorized entry. Water collected in the ponds is pumped back into the system by way of a subsurface pump network. The pumps can be seen in Photo Seven. Most of the pumps were in good working order, and operating at the time of the inspection. The furthest two had minor leaking, however the leak was being caught in the secondary containment system of floor sumps. The Operator alerted maintenance, as the leaking pumps are not uncommon but should be addressed. Overall the pump station building was in excellent condition and well kept.

Photo Six: View South, showing the collection ponds at the Storke Wastewater Pump System. The ponds are in good condition with sufficient freeboard. This area is fenced and secured to prevent unauthorized entry.

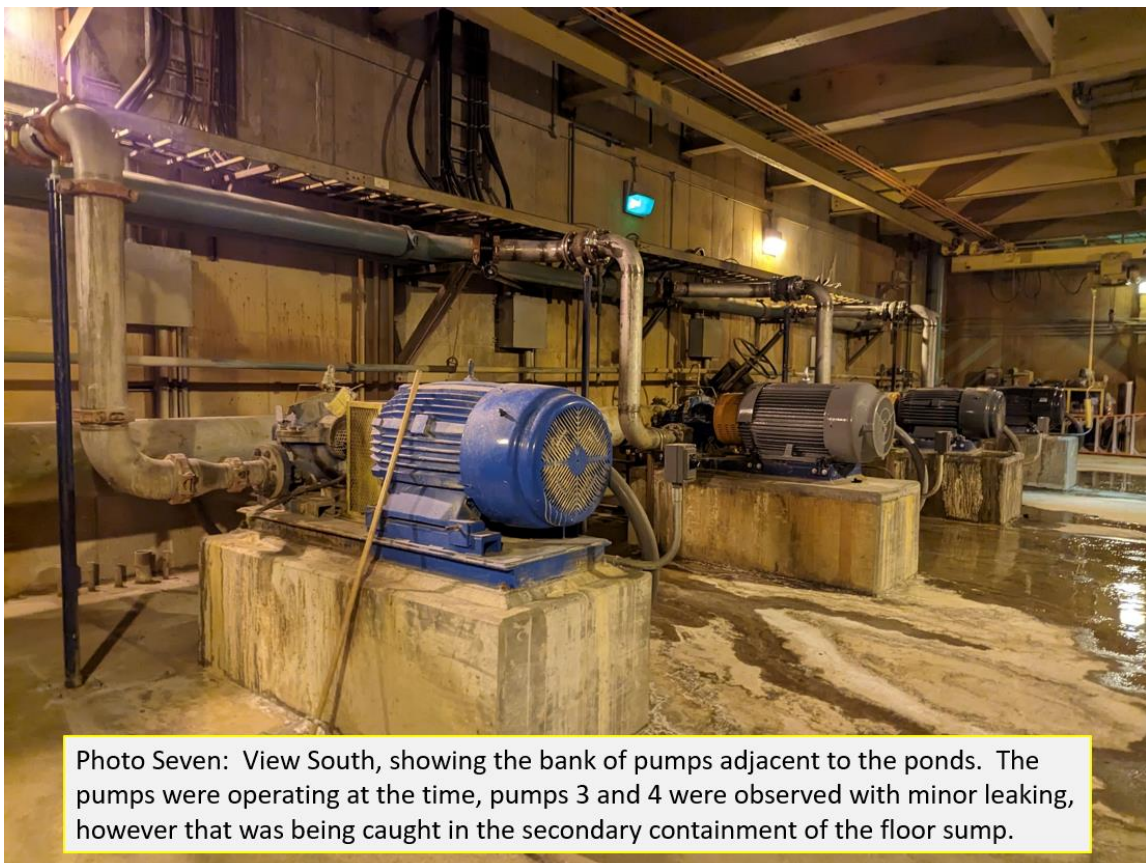
Photo Seven: View South, showing the bank of pumps adjacent to the ponds. The pumps were operating at the time, pumps 3 and 4 were observed with minor leaking, however that was being caught in the secondary containment of the floor sump.
