## C1981022, Elk Creek Mine, May Inspection Report

<b>Permit Number:</b> C-1981-022 <b>Mine Name:</b> Elk Creek Mine <b>Operator:</b> Oxbow Mining, LLC <b>Operator Address:</b> Mr Doug Smith 3737 Hwy 133 P. O. Box 535 Somerset, CO 81434	<b>County:</b> Delta, Gunnison <b>Operation Type:</b> Underground <b>Permit Status:</b> Active <b>Ownership:</b> Private
	<b>Operator Representative Present:</b>  Doug Smith
<b>Operator Representative Signature: (Field Issuance Only)</b>

<b>Inspection Start Date:</b> May 16, 2023 <b>Inspection Start Time:</b> 10:00 <b>Inspection End Date:</b> <b>Inspection End Time:</b>	<b>Inspection Type:</b> Coal Partial Inspection <b>Inspection Reason:</b> Normal I&E Program <b>Weather:</b> Clear
<b>Joint Inspection Agency:</b>  None	<b>Joint Inspection Contacts:</b>  
<b>Post Inspection Agency:</b>  None	<b>Post Inspection Contacts:</b>  
<b>Inspector(s):</b>  Leigh Simmons	<b>Inspector's Signature:</b>

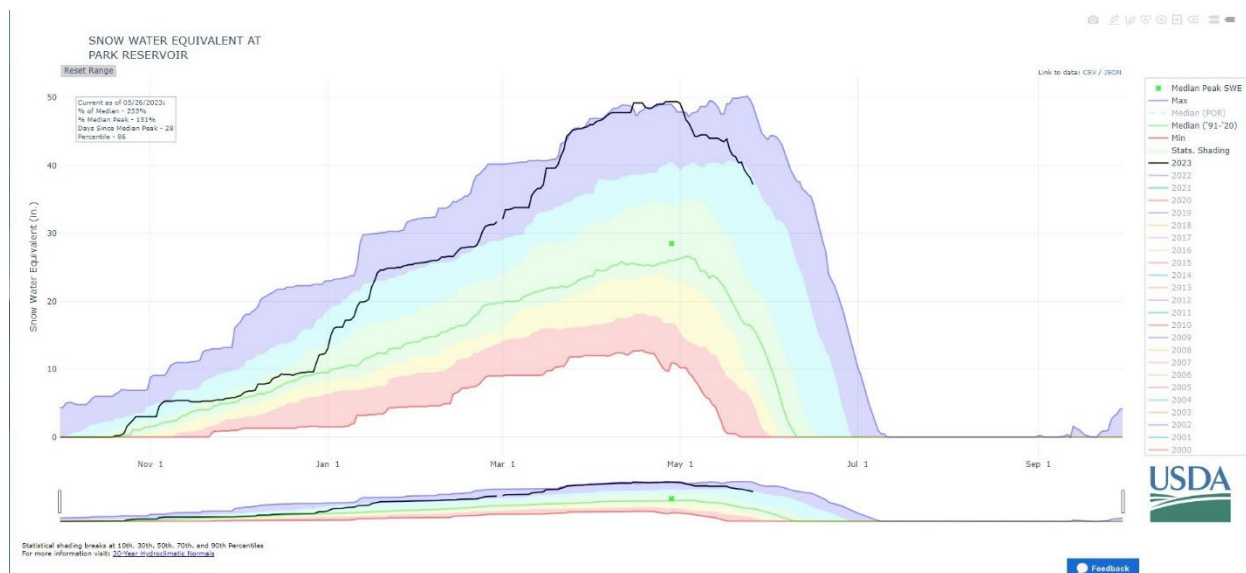
The area around the Elk Creek Mine had been significantly impacted by the spring run-off of an unusually deep winter snowpack, exacerbated by a wetter than average spring. The Natural Resources Conservation Service (NRCS) of the United States Department of Agriculture maintains an automated system of 730 snowpack sensors across the Western United States called SNOTEL (SNOW TELelemetry). Three SNOTEL stations are situated on the high ground north of the mine (from west to east, Park Reservoir, Overland Reservoir and McClure Pass), shown in Figure 1. The data from each of these stations show that the snow-water equivalent (which is a proxy for snowpack depth) in 2023 peaked close to, or above, the maximum recorded since 1990, and that there was a period of rapid melting around the beginning of May (see Figures 2-4).

Figure 2: Snow water equivalent at Park Reservoir SNOTEL station

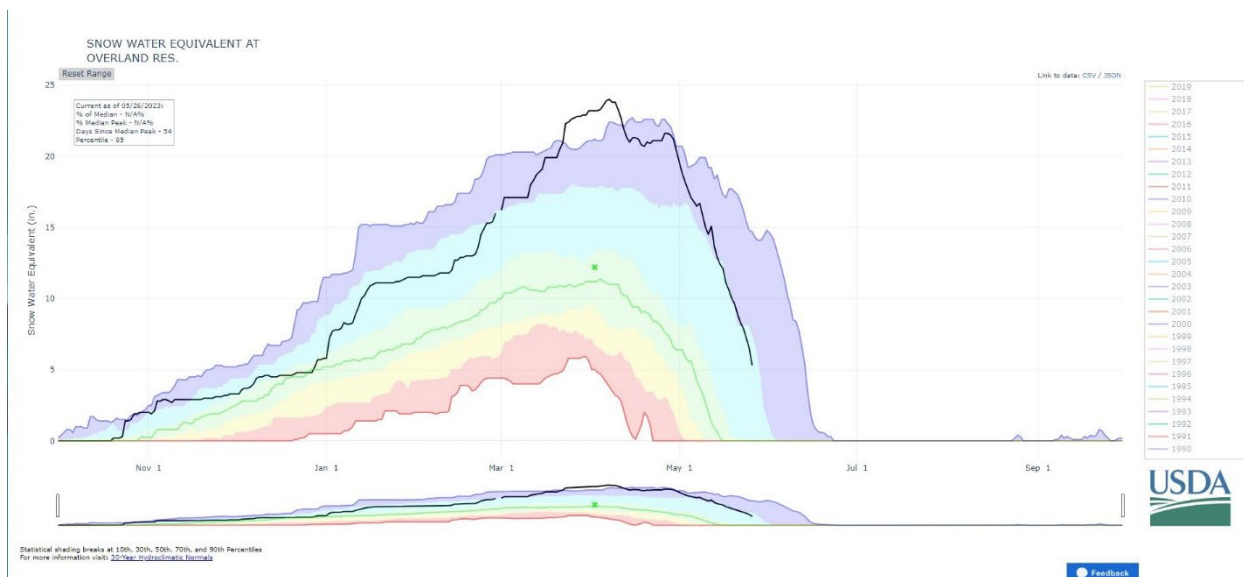
Figure 3: Snow water equivalent at Overland Reservoir SNOTEL station

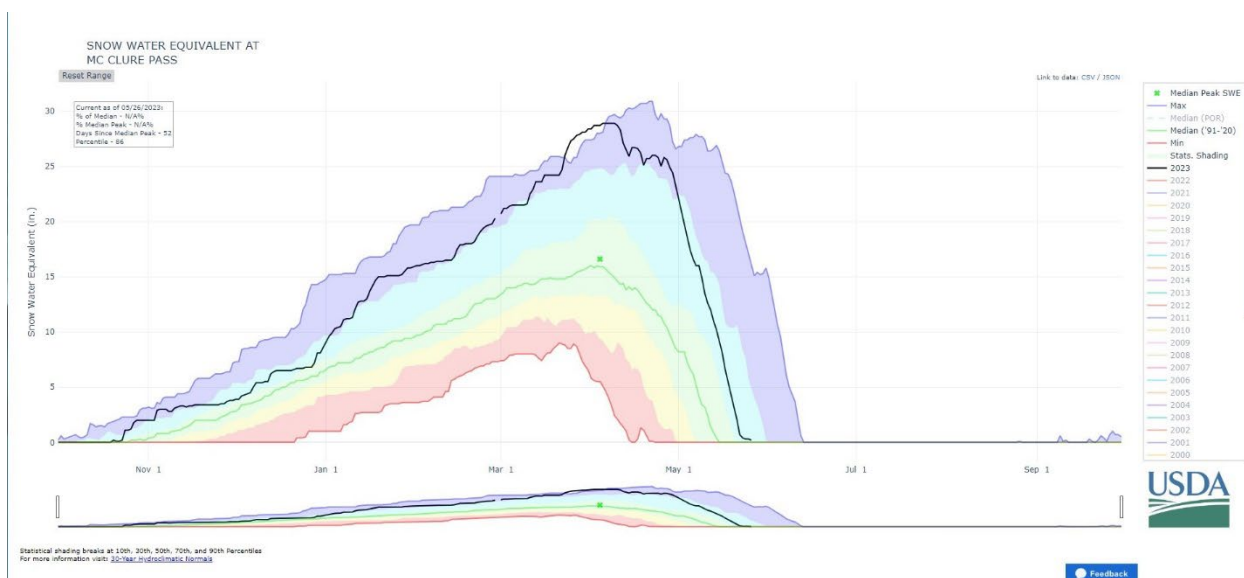
Figure 4: Snow water equivalent at McClure Pass SNOTEL station

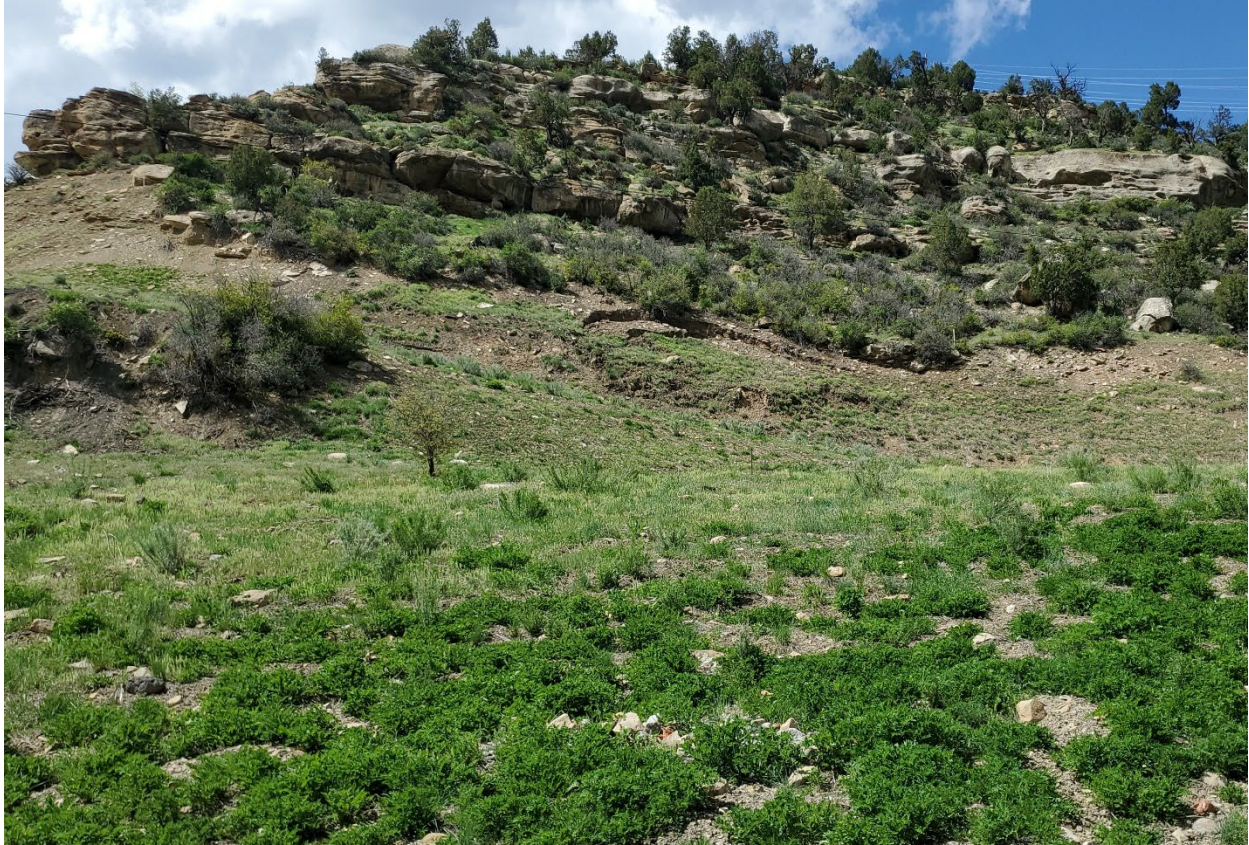
A small slump had occurred at the western end of the Phase II released East Yard Waste Pile. Extensive repair is likely not necessary here, although some supplemental seeding and “shovel work” will be needed to stabilize the area so that it does not continue to deteriorate in the future.

*Figure 5: Small slump at the western end of the East Yard Waste Pile*

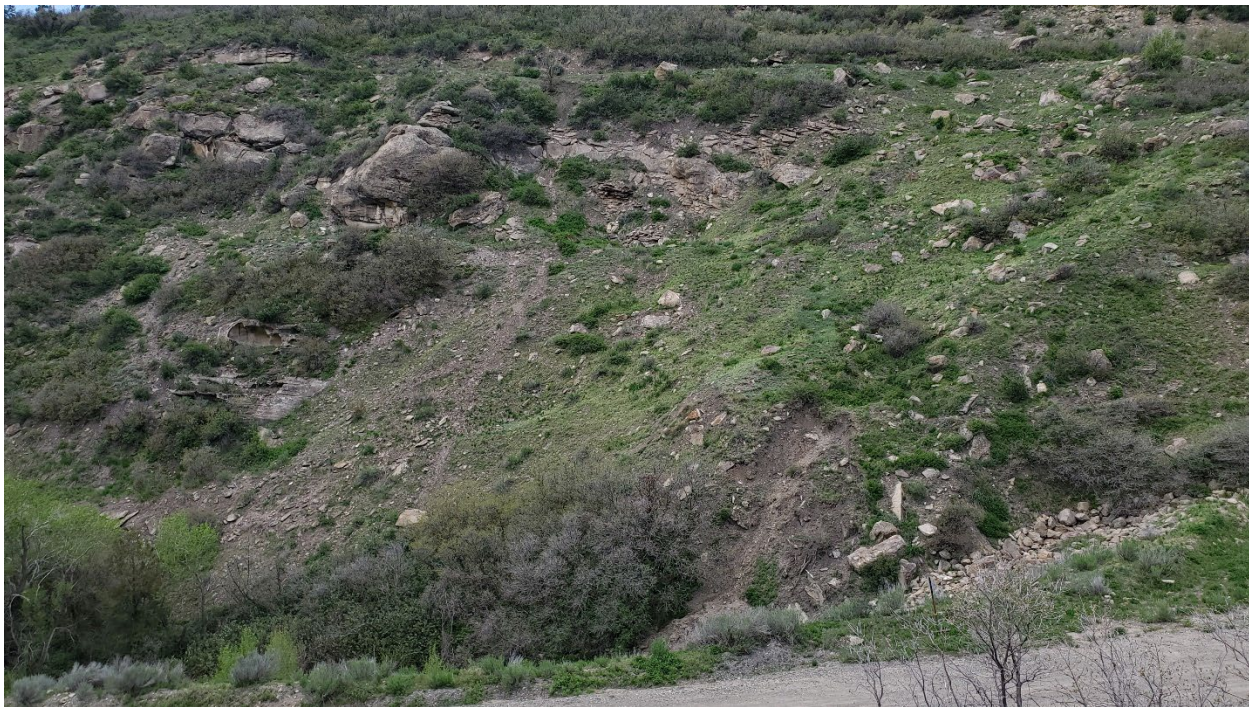
A small slide had occurred just inside the disturbance boundary, west of the outlet of the first section of the Elk Creek culvert. Again, extensive repair would be likely to cause more harm than good, but spreading some seed on the disturbed soil would be beneficial.

*Figure 6: Small slide west of the outlet of the first section of the Elk Creek culvert*

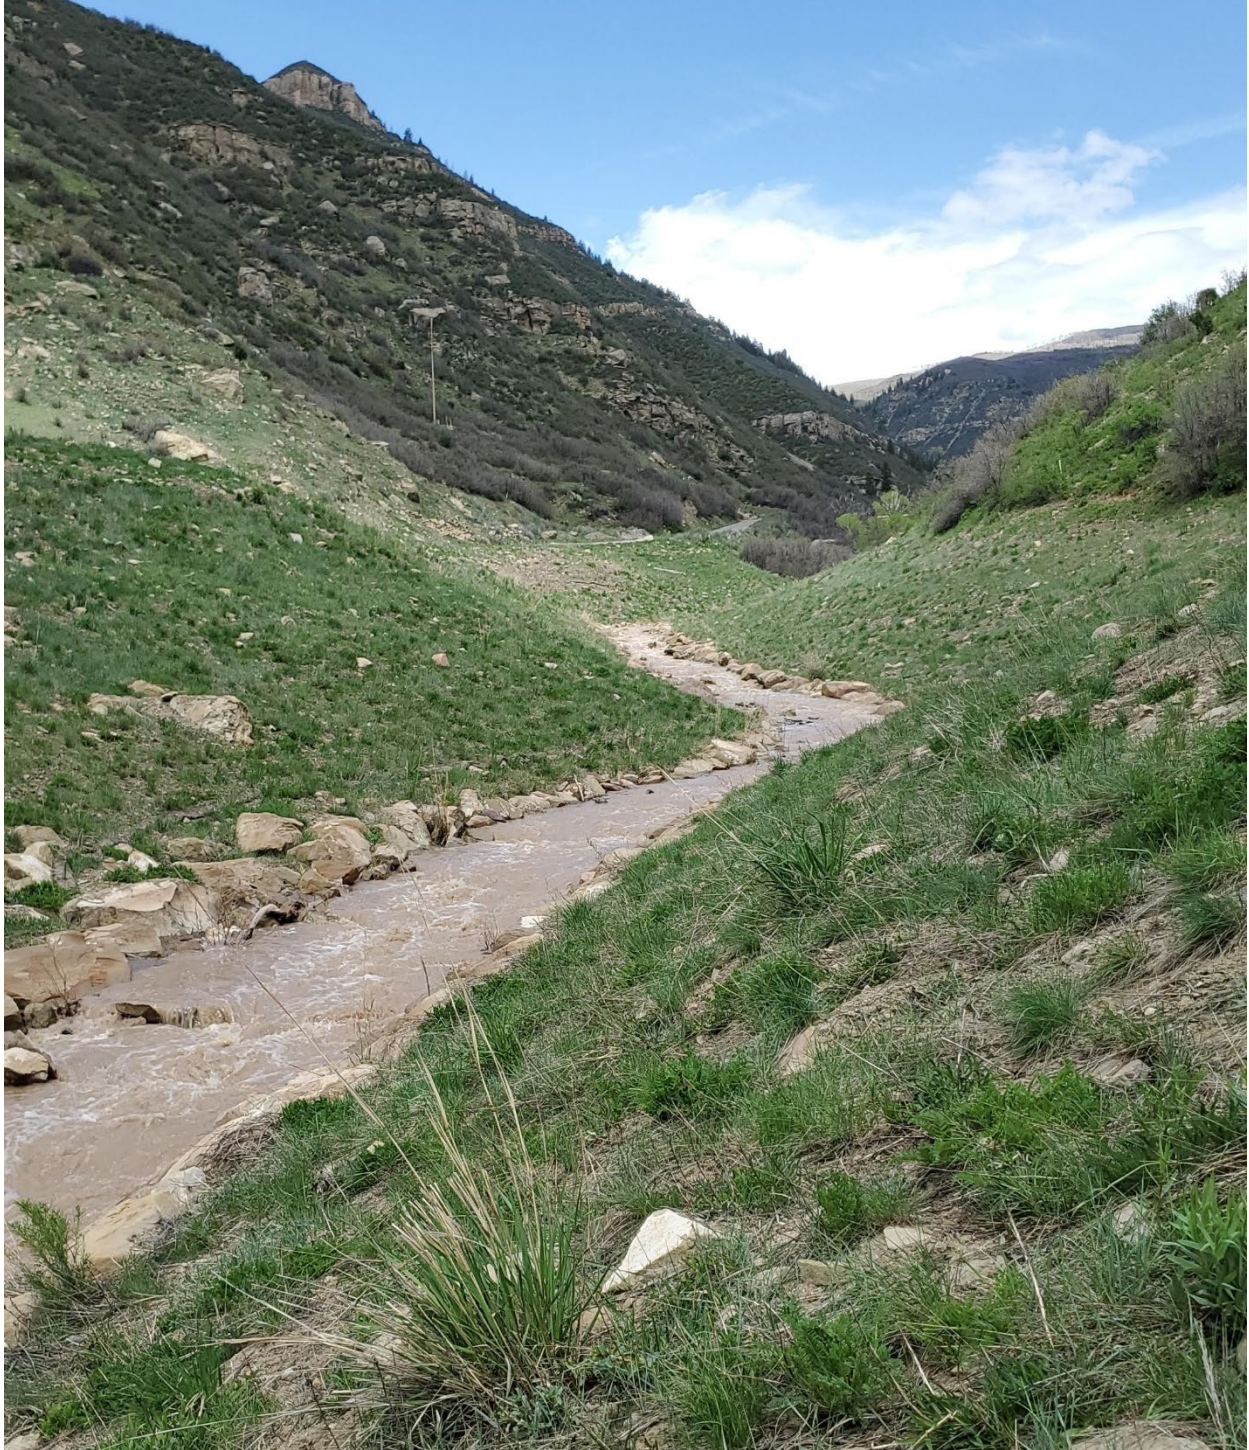
*Figure 7: Upper section of reclaimed Elk Creek channel*

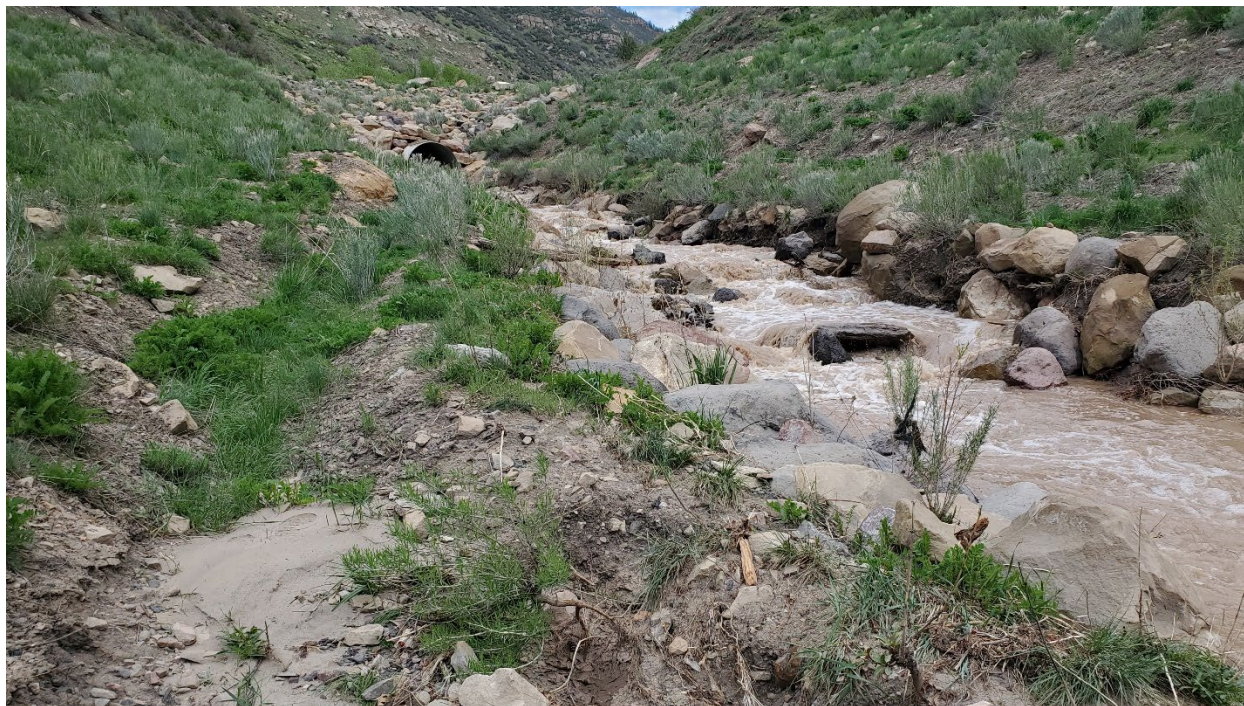
The upper section of the reclaimed Elk Creek channel appeared to be in good shape, but the lower section of the channel had been damaged by high flows. It appeared that under flood conditions the stream had breached the sediment ditches, T1 and T2. Water had flowed in the sediment ditches which were not designed to convey such a flow. The ditches had been eroded which had cut the banks behind the large boulders and contributed to the erosion of the stream channel. Repairs will be needed to stabilize the stream channel, but it is likely to be some time before the water level drops sufficiently to allow repair work to be carried out. Since the area has already received Phase II bond release there will be no need to reconstruct the sediment control ditches, which had been expected to fill in over time.

*Figure 9: Point where Elk Creek first breached Ditch T-1, below outlet of first section of Elk Creek culvert*

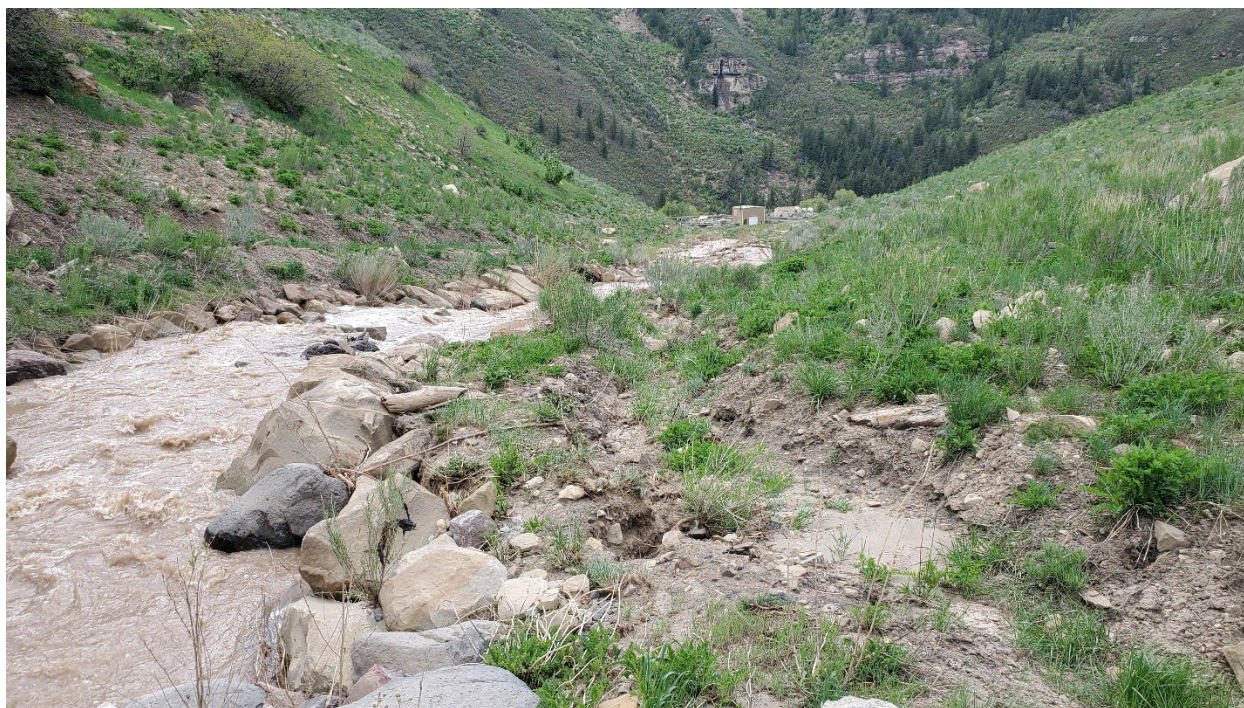
*Figure 10: View downstream from point where Elk Creek first breached Ditch T-1*

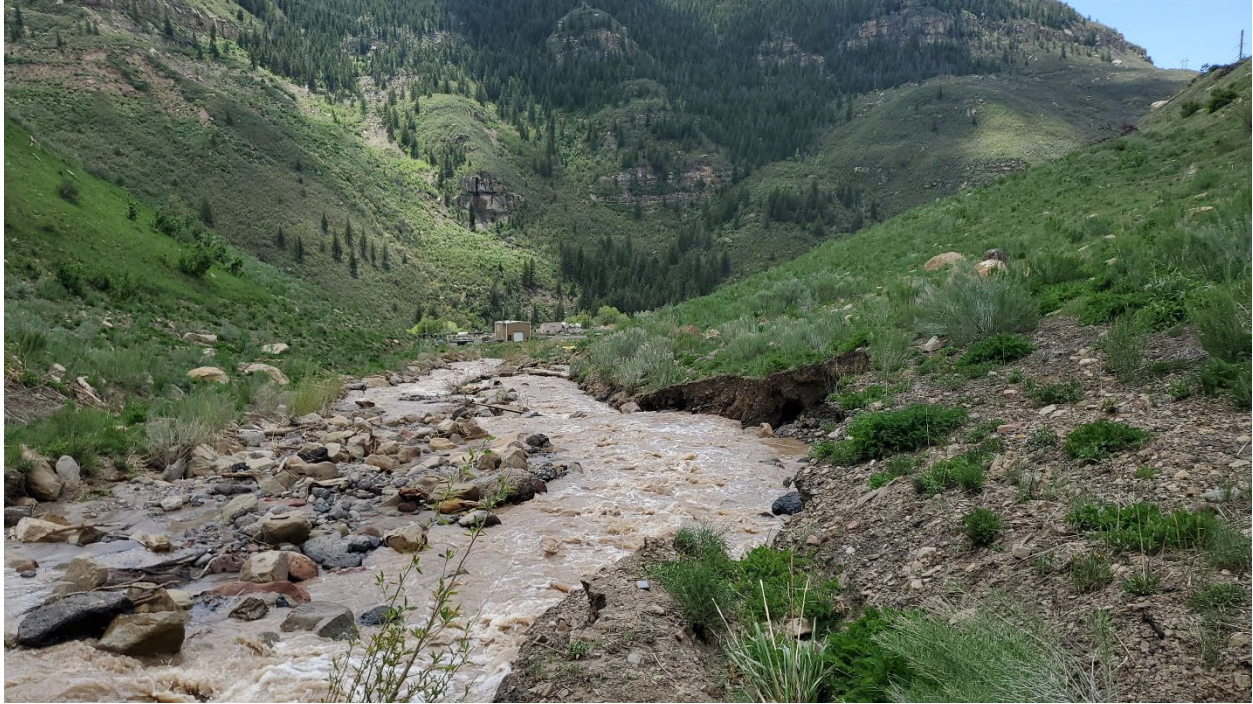
*Figure 11: Damage to stream channel (1)*

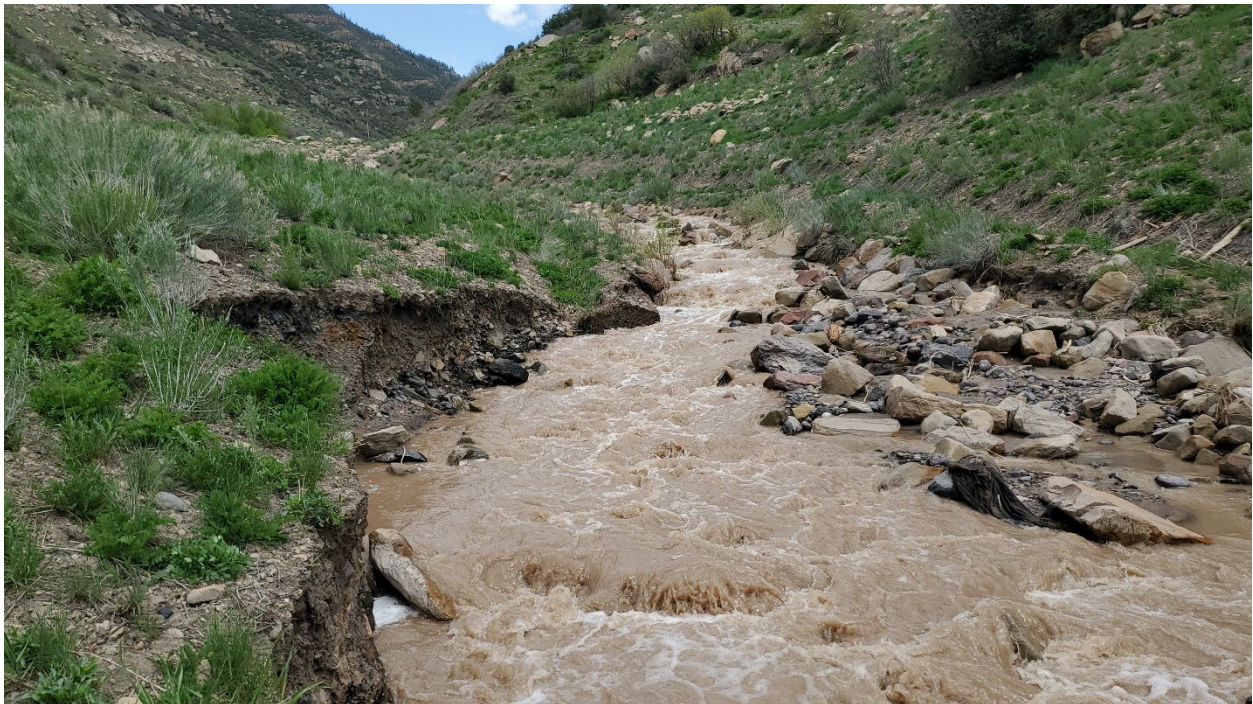
*Figure 12: Damage to stream channel (2)*

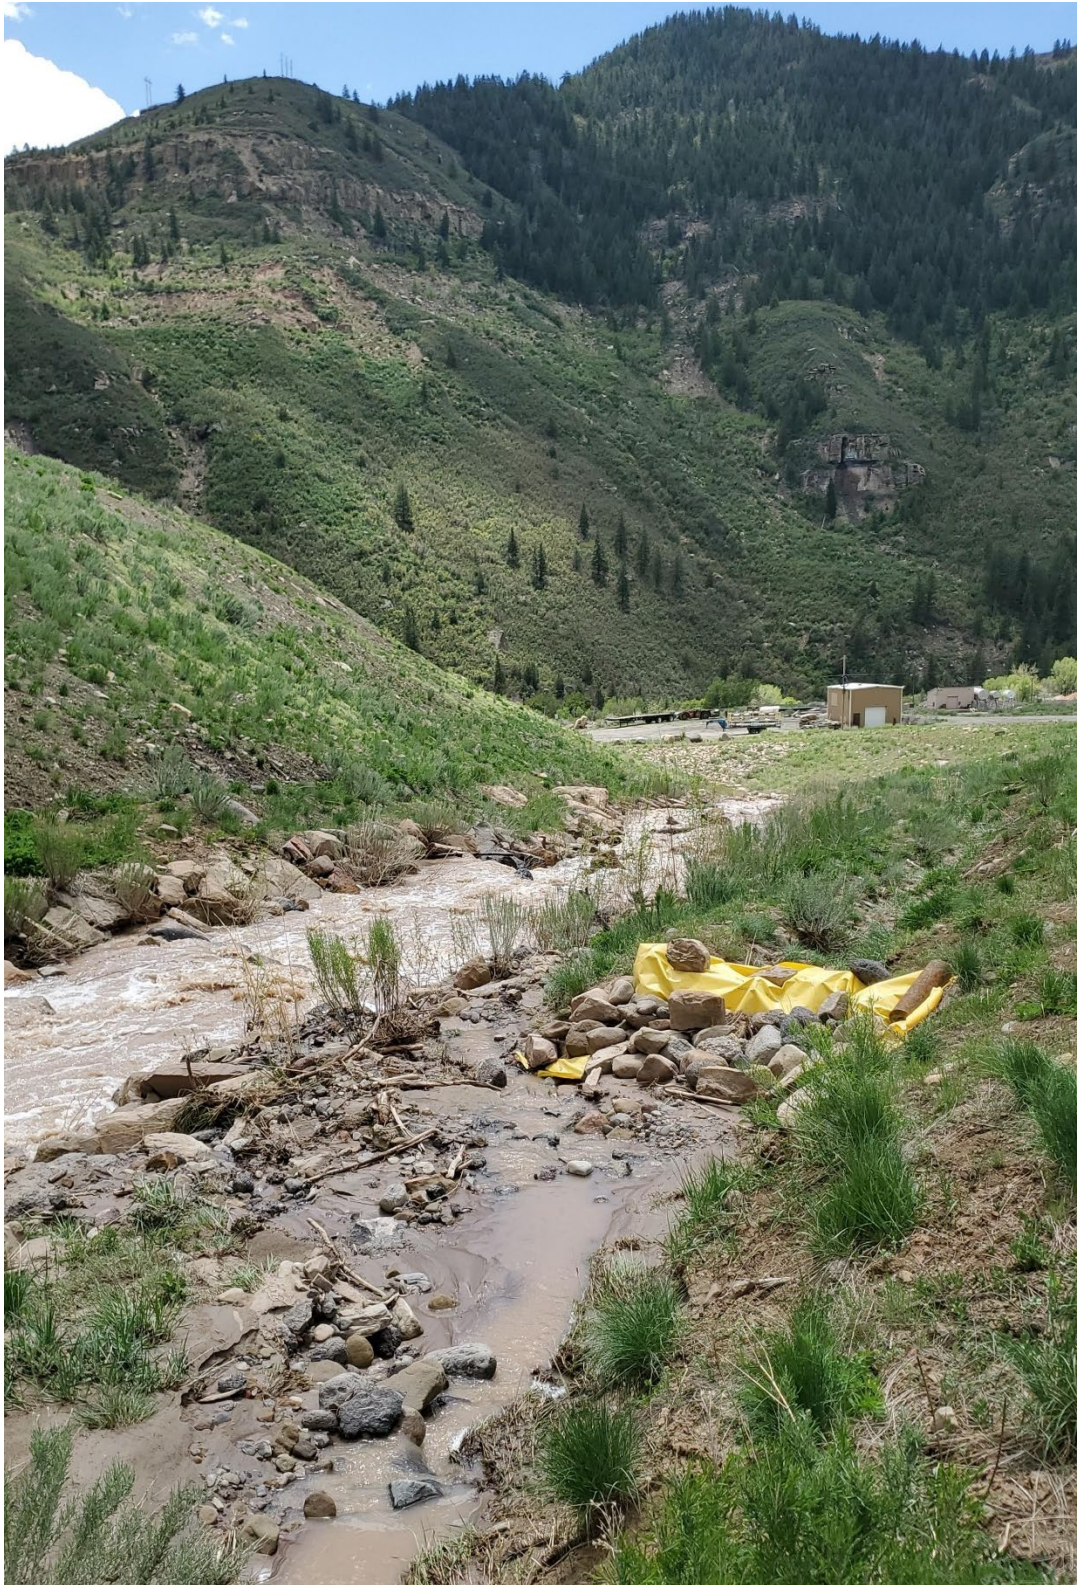
*Figure 13: Dam used to divert water back into channel*

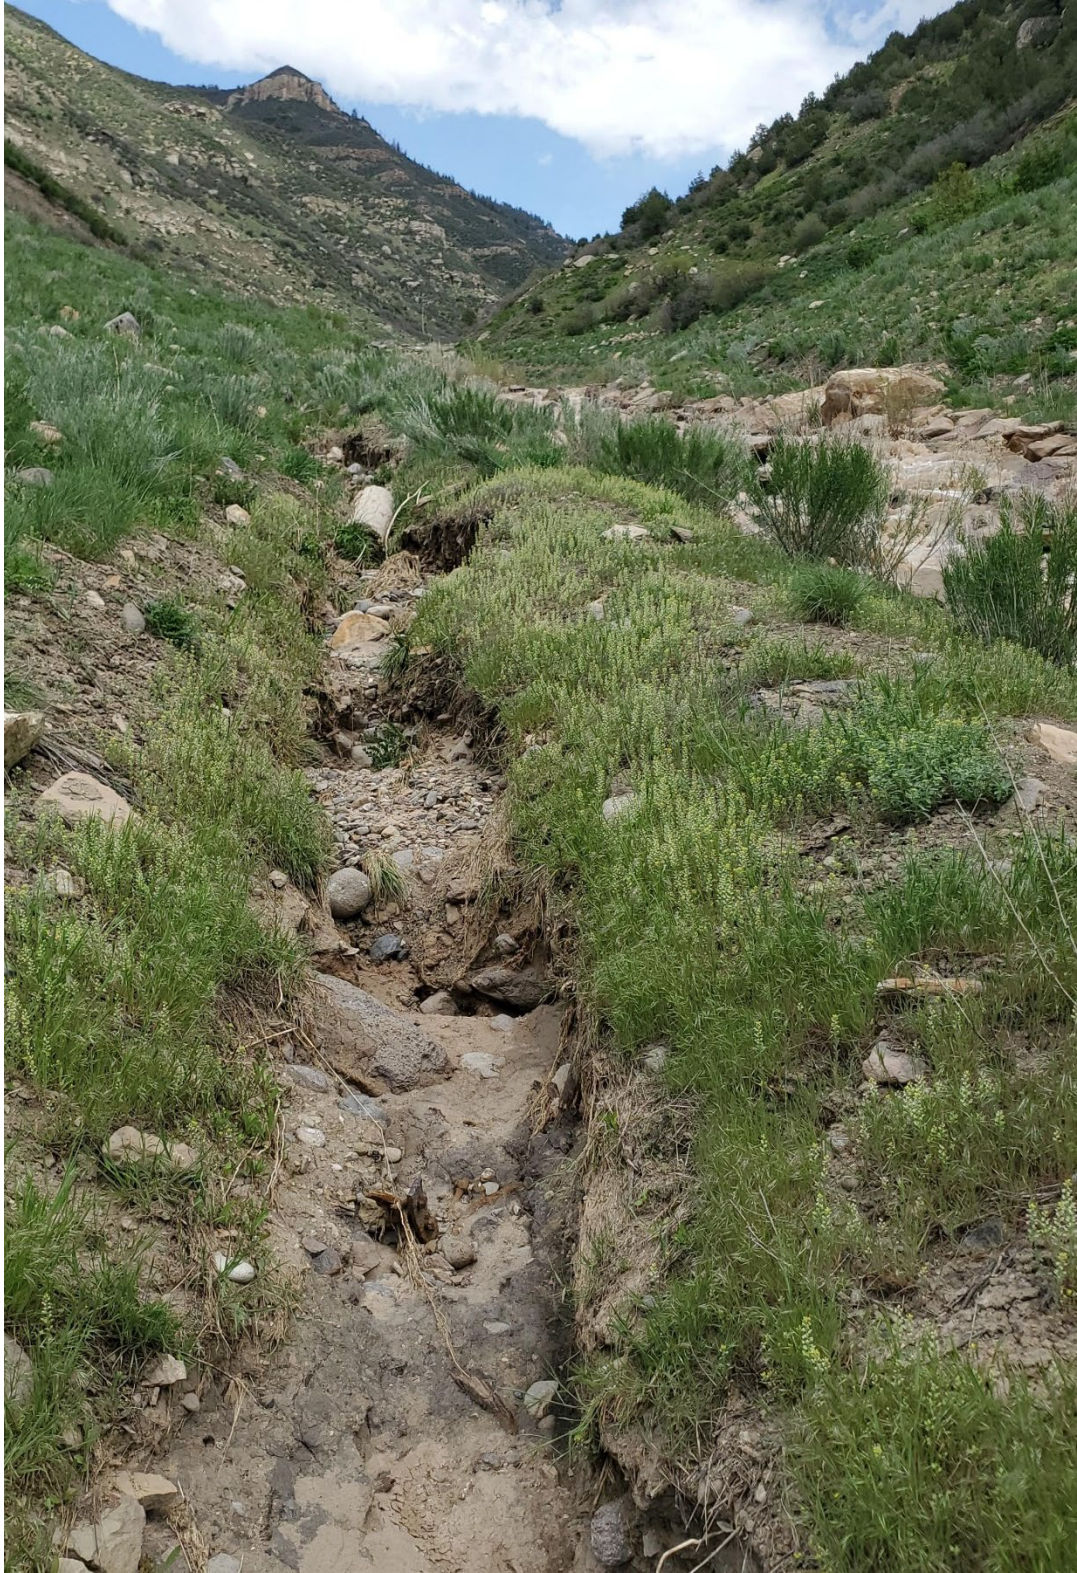
*Figure 14: Erosion in Ditch T-1*

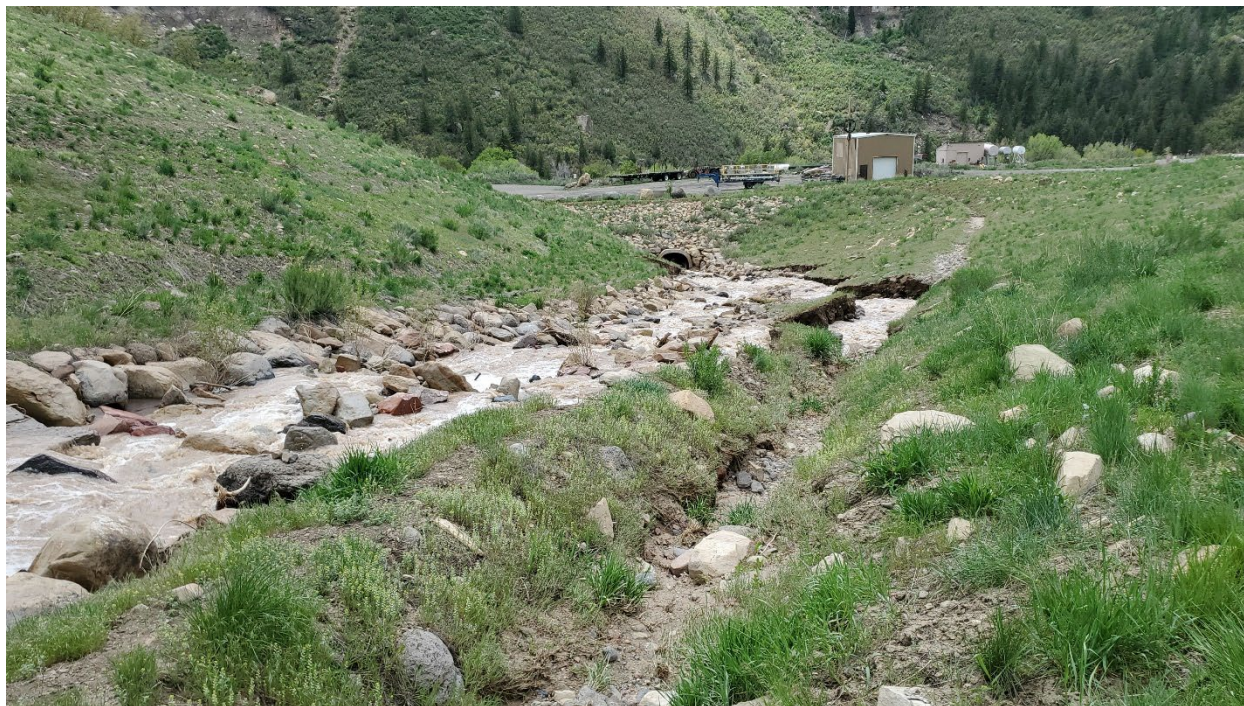
Figure 15: Damage to stream channel (3)

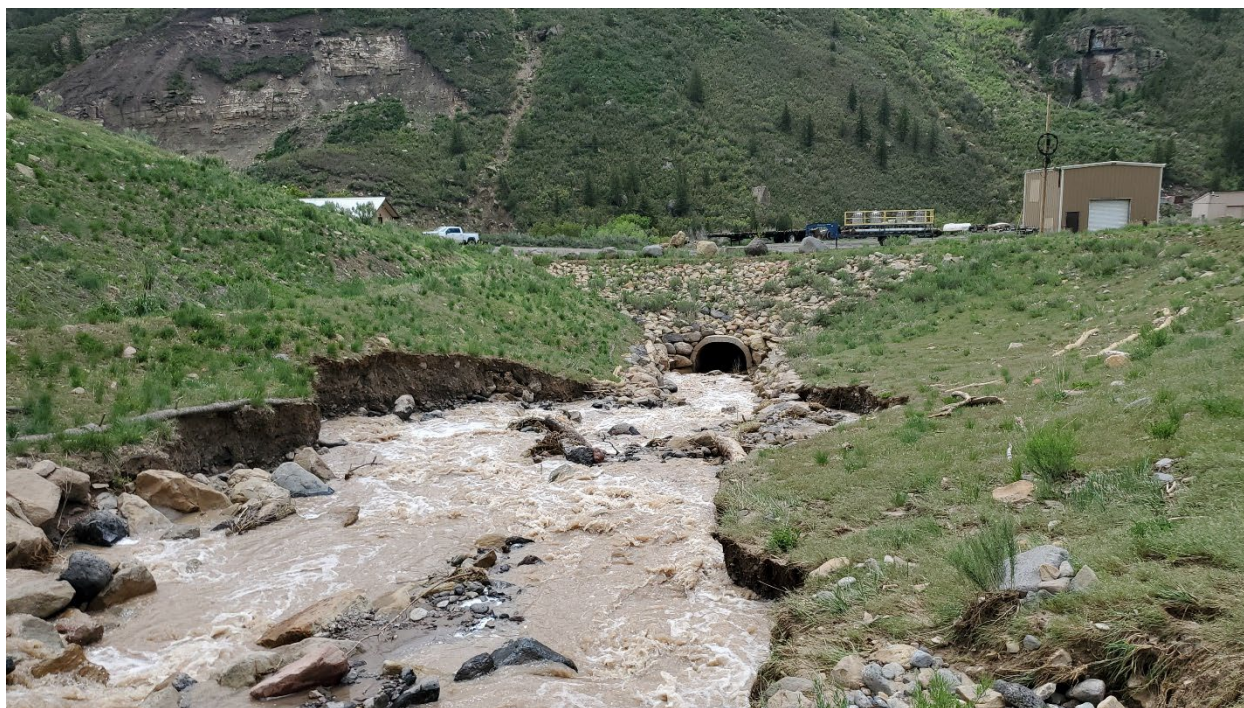
Figure 16: Damage to stream channel (4)

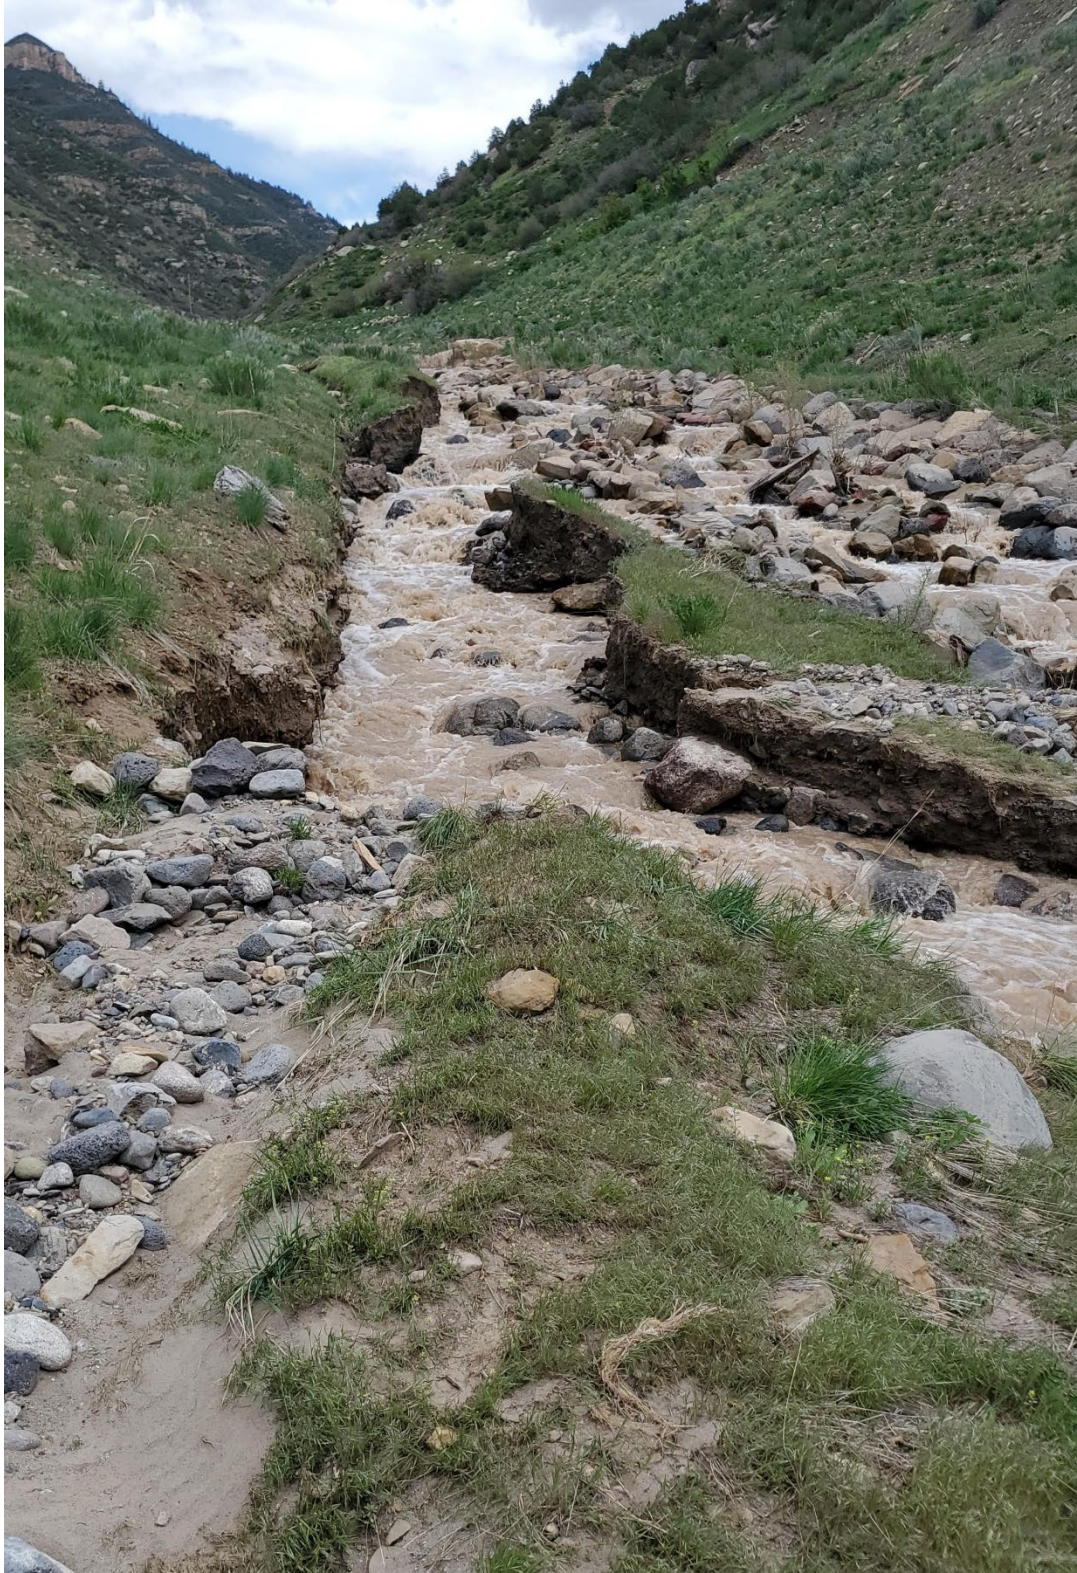
*Figure 17: Damage to stream channel (5)*

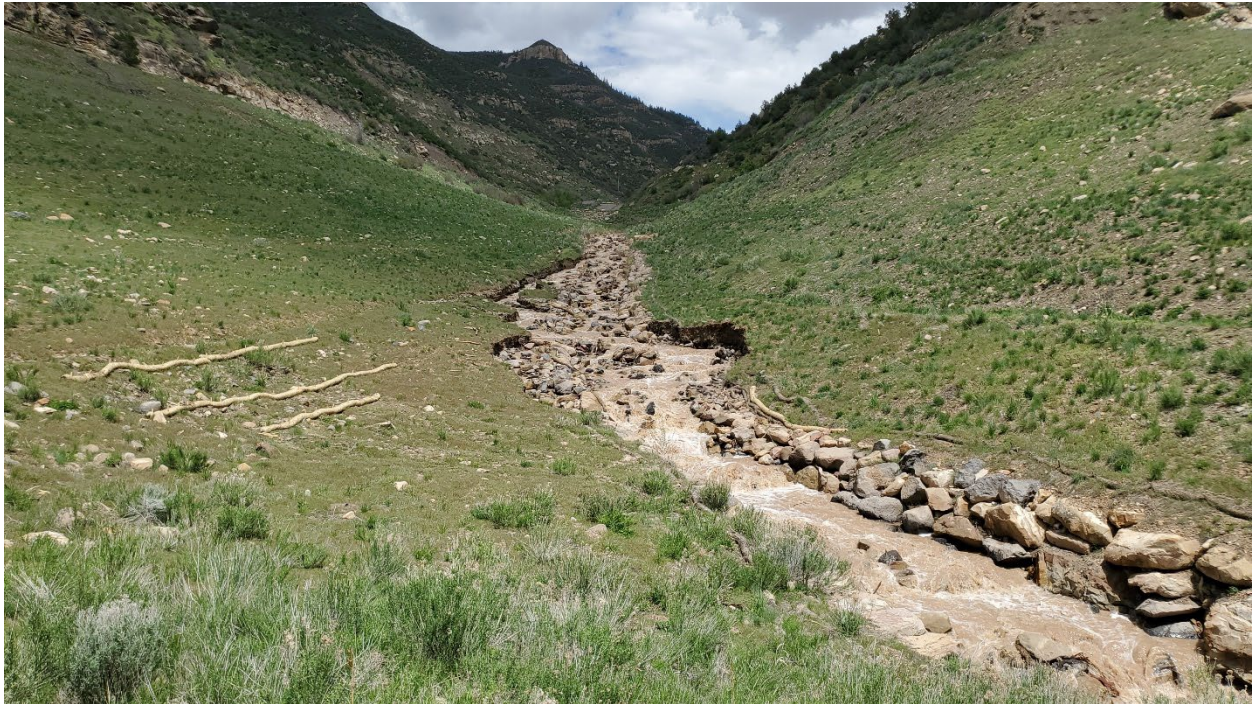
Figure 18: Fresh straw wattles placed in attempt to stabilize slope below Ditch T-1

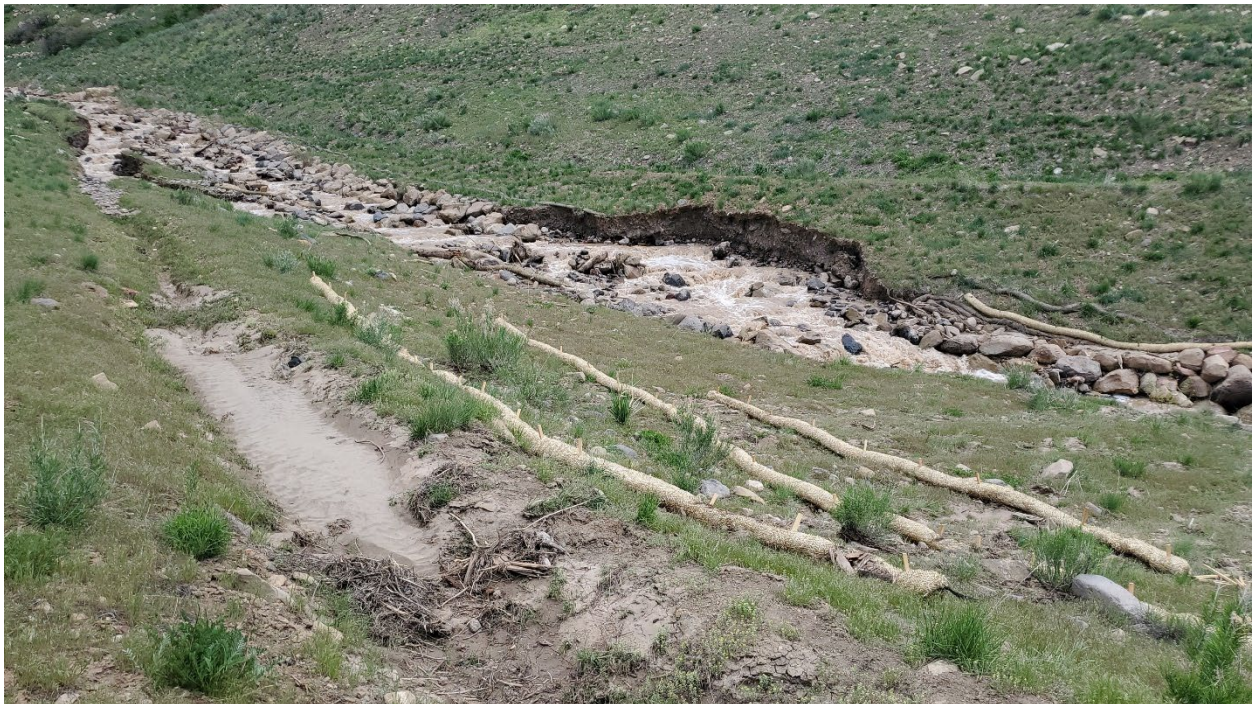
Figure 19: Low spot in Ditch T-1
