MINERALS PROGRAM INSPECTION REPORT
PHONE: (303) 866-3567

MINE NAME: Leadville Mill	MINE/PROSPECTING ID#: M-1990-057	MINERAL: Gold	COUNTY: Lake
INSPECTION TYPE: Monitoring	WEATHER: Clear	INSP. DATE: May 25, 2023	INSP. TIME: 09:53
OPERATOR: Union Milling Company, LLC	OPERATOR REPRESENTATIVE: Steve Craig, Gary Slifka	TYPE OF OPERATION: 110d - Designated Limited Impact	
REASON FOR INSPECTION: Citizen Complaint	BOND CALCULATION TYPE:	BOND AMOUNT: \$64,430.00	
DATE OF COMPLAINT: NA	POST INSP. CONTACTS: None	JOINT INSP. AGENCY: None	
INSPECTOR(S): Lucas West	INSPECTOR'S SIGNATURE:

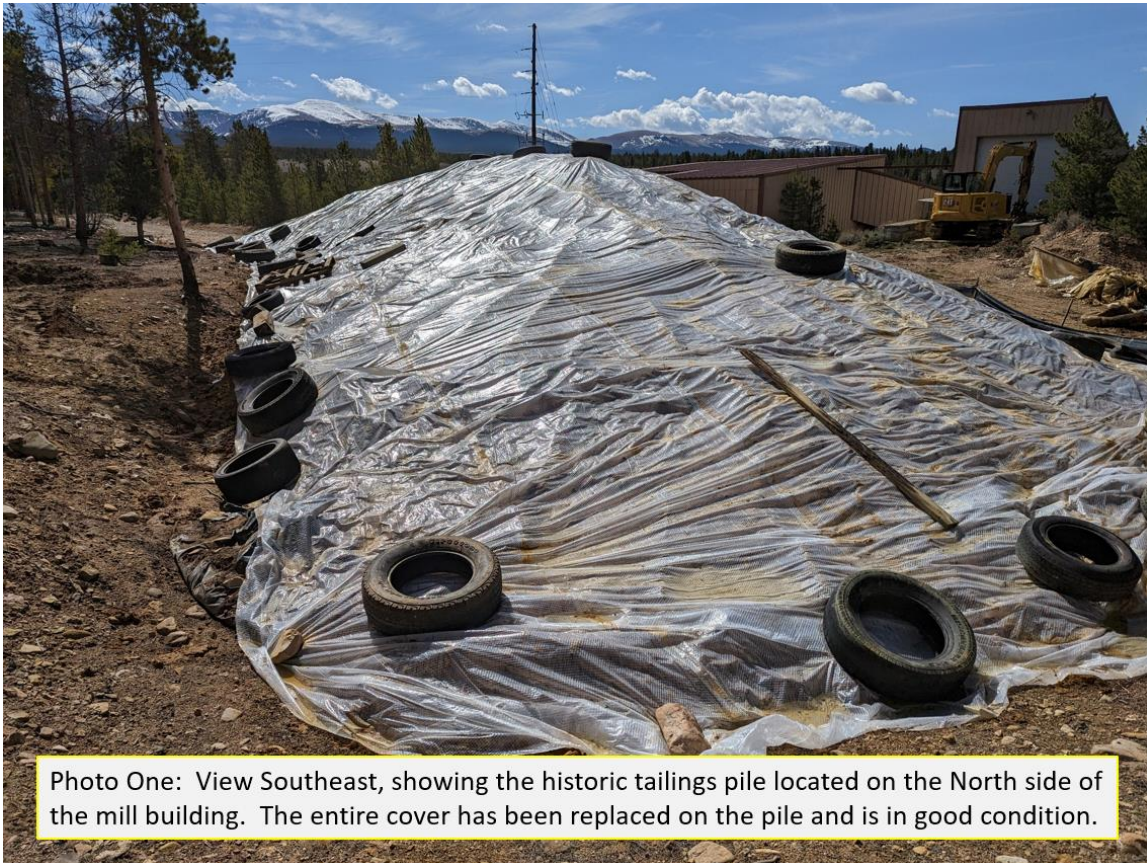
The complaint received, with photographs, showed that the covering that protects a historic tailings pile being stored on the North side of the mill had fallen into disrepair exposing the tailings and leaving the pile prone to erosion and transport. The historic tailings pile was relocated to this area, to be stored on a polypro liner with a visqueen cover under Technical Revision 5 (TR-5) submitted in October of 2020. The Operator was contacted on May 19, 2023 via email, and the inspection was scheduled.

Photo One: View Southeast, showing the historic tailings pile located on the North side of the mill building. The entire cover has been replaced on the pile and is in good condition.

By the time the inspection was conducted, the cited problem had been corrected. The Operator had removed the old liner, and replaced it with new visqueen covering material. Photos One through Three show the replacement covering over the historic tailings pile. The down gradient side of the pile is protected by a silt fence to prevent any material from migrating off the pile. The silt fence is in marginal condition as seen in Photo Four, however new rolls of straw wattles were staged to be installed and take the place of the silt fencing. The Division verbally requested that the Operator send photographic evidence, via email, once the upgrade from silt fence to straw wattle has been completed. Surrounding the pile, the discarded liner has been staged for removal, seen in Photo Four. Conversations with the Operator indicate that the removal would be taking place immediately following the inspection.

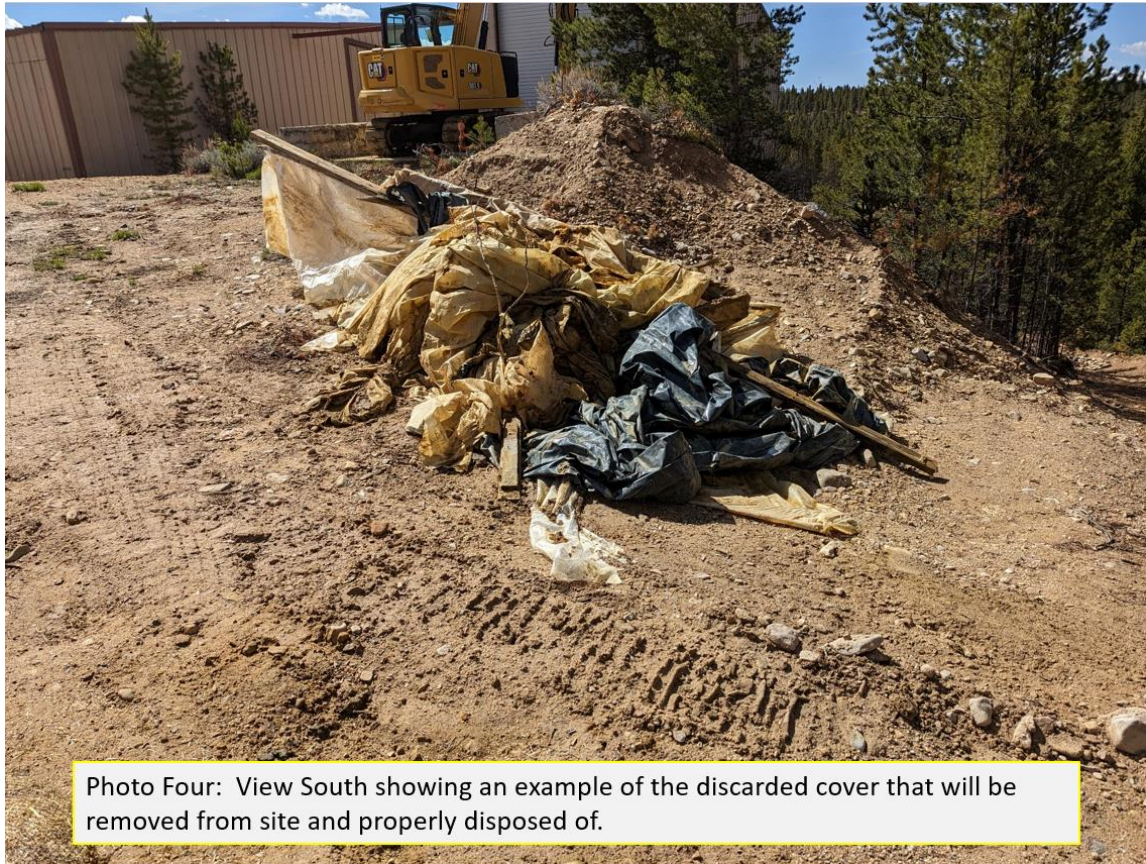
Photo Four: View South showing an example of the discarded cover that will be removed from site and properly disposed of.

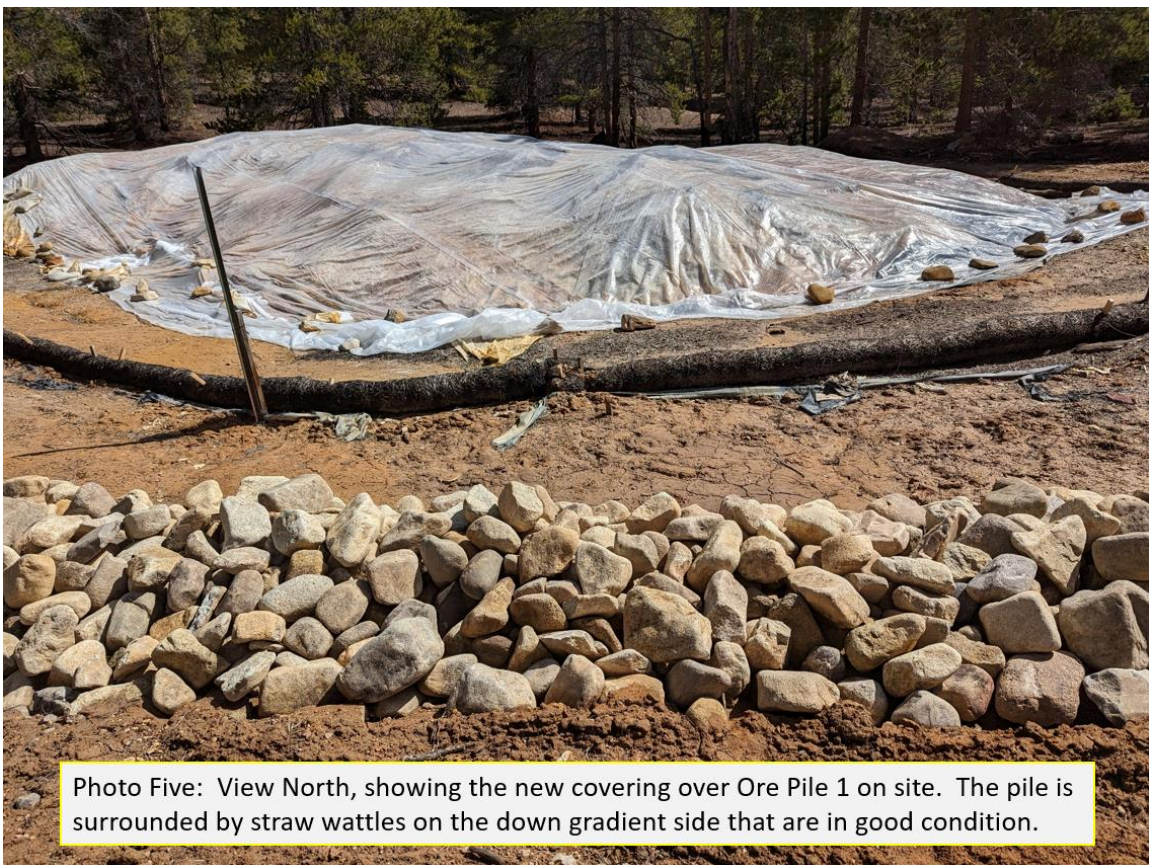
In addition to the historic tailings pile stored on site, there are three piles of ore stored to be processed through the mill. Similar to the historic tailings these piles are required to be covered by the visqueen liner to prevent erosion and leachate from forming. Though not called out in the complaint, the Operator surveyed the three piles and conducted repairs where necessary. The covering over Ore Pile 3 was also found to be in disrepair and the entirety of its cover has been replaced as seen in Photo Five. The covering over Ore Pile 2 was found to not need repaired, and the covering over Ore Pile One only needed minor repairs. Piles 2 and 1 can be seen in Photos Six and Seven respectively. All of these piles are protected around their perimeter with straw wattles which were in good condition and functioning as designed.

Photo Five: View North, showing the new covering over Ore Pile 1 on site. The pile is surrounded by straw wattles on the down gradient side that are in good condition.

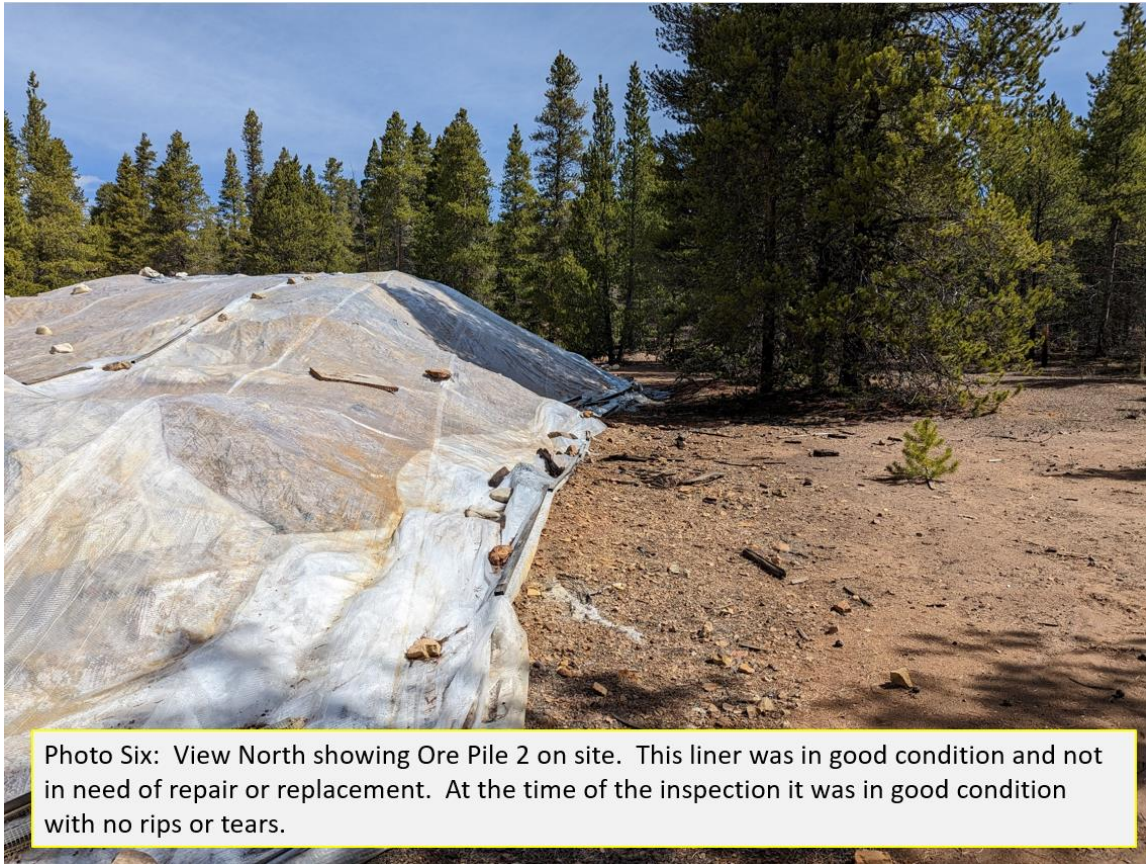
Photo Six: View North showing Ore Pile 2 on site. This liner was in good condition and not in need of repair or replacement. At the time of the inspection it was in good condition with no rips or tears.

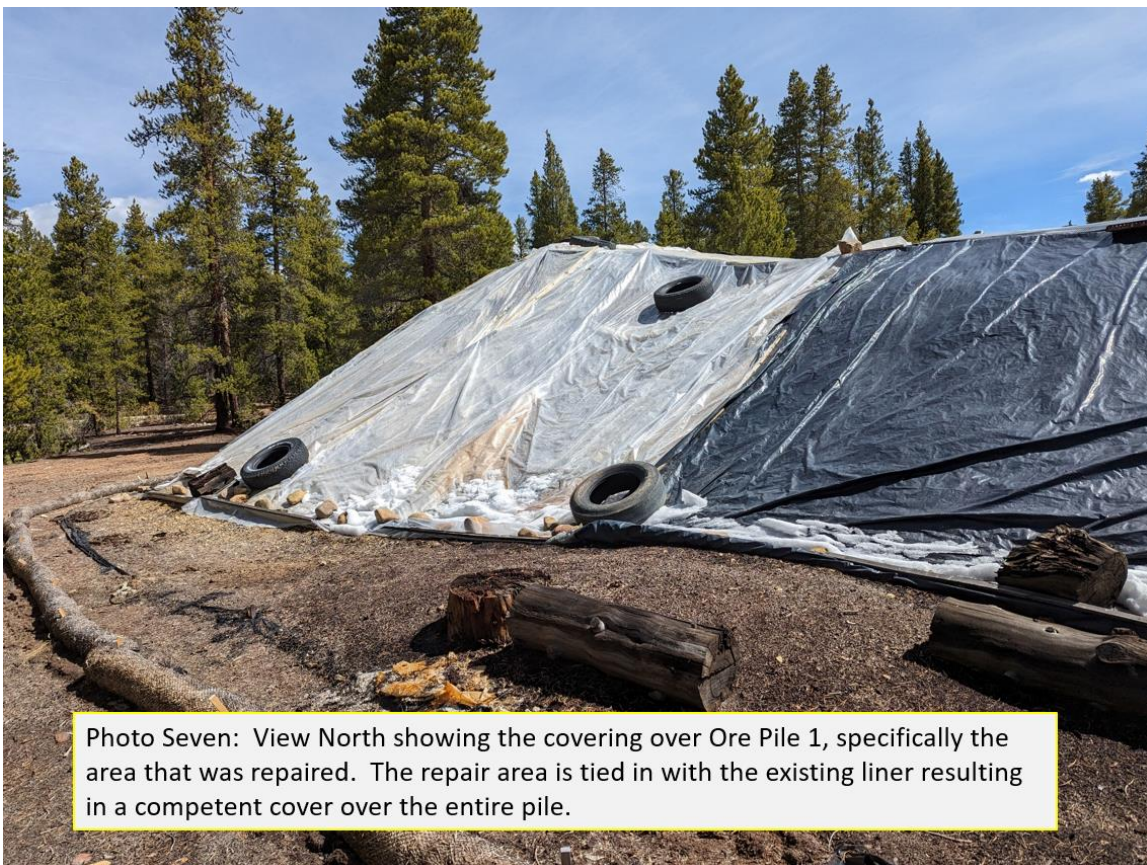
Photo Seven: View North showing the covering over Ore Pile 1, specifically the area that was repaired. The repair area is tied in with the existing liner resulting in a competent cover over the entire pile.
